FIFTEENTH STATUS REPORT
TO THE
PENNSYLVANIA PUBLIC UTILITY COMMISSION

NORTH HEIDELBERG SEWER COMPANY
AQUA PENNSYLVANIA WASTEWATER, INC., AS RECEIVER

SEWAGE COMPLIANCE INSPECTION REPORT

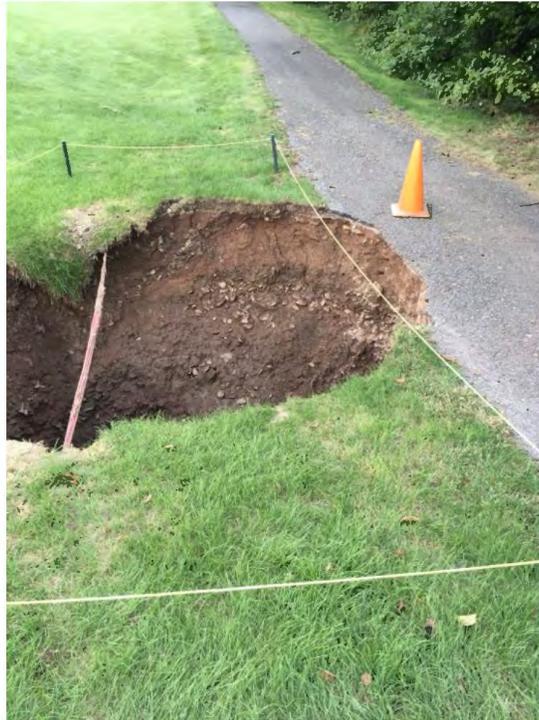
I followed up with a site visit. I could not access the STP during the inspection; the inspection was conducted from outside the perimeter fence. Treatment units are offline. The sinkhole was observed on the golf cart path between the STP and the stream—This is the site of the culvert collapse (Figure 1). There are sewage solids on the ground around the treatment units on the east side of the control building (Figure 2). Access to the outfall is very overgrown. I attempted to locate the outfall but was unable. No apparent sewage solids were noted at Northkill Creek. A small volume of turbid water was observed flowing adjacent to the EQ tank and infiltrating into the gravel, possibly raw sewage. Following the site visit I called Mr. McCollough and recommended notifying downstream users of site conditions.

Figure 1- photo taken by Kevin Buss, shows sink hole at the site of the culvert failure.

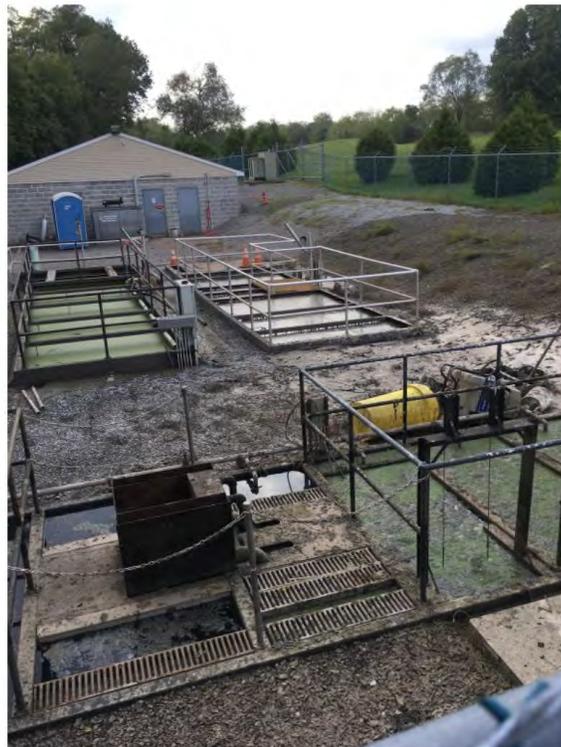
Figure 2- photo taken by Kevin Buss, shows area around east treatment units.
