**Re: Letter Of Notification Of PPL Electric Utilities Corporation, Filed Pursuant To 52 Pa. Code Chapter 57 Subchapter G, For Approval Of The Rebuild Of The Double-Circuit Manor-Millwood 230 kV/Face Rock-Millwood 69 kV Transmission Lines Connecting The Manor 230-69 kV Substation And The Millwood 230-69 kV Substation In Conestoga Township, Manor Township, And Pequea Township, Lancaster County, Pennsylvania  
Docket No. A-2021**

# MANOR-MILLWOOD 230 kV COR-TEN® REBUILD PROJECT

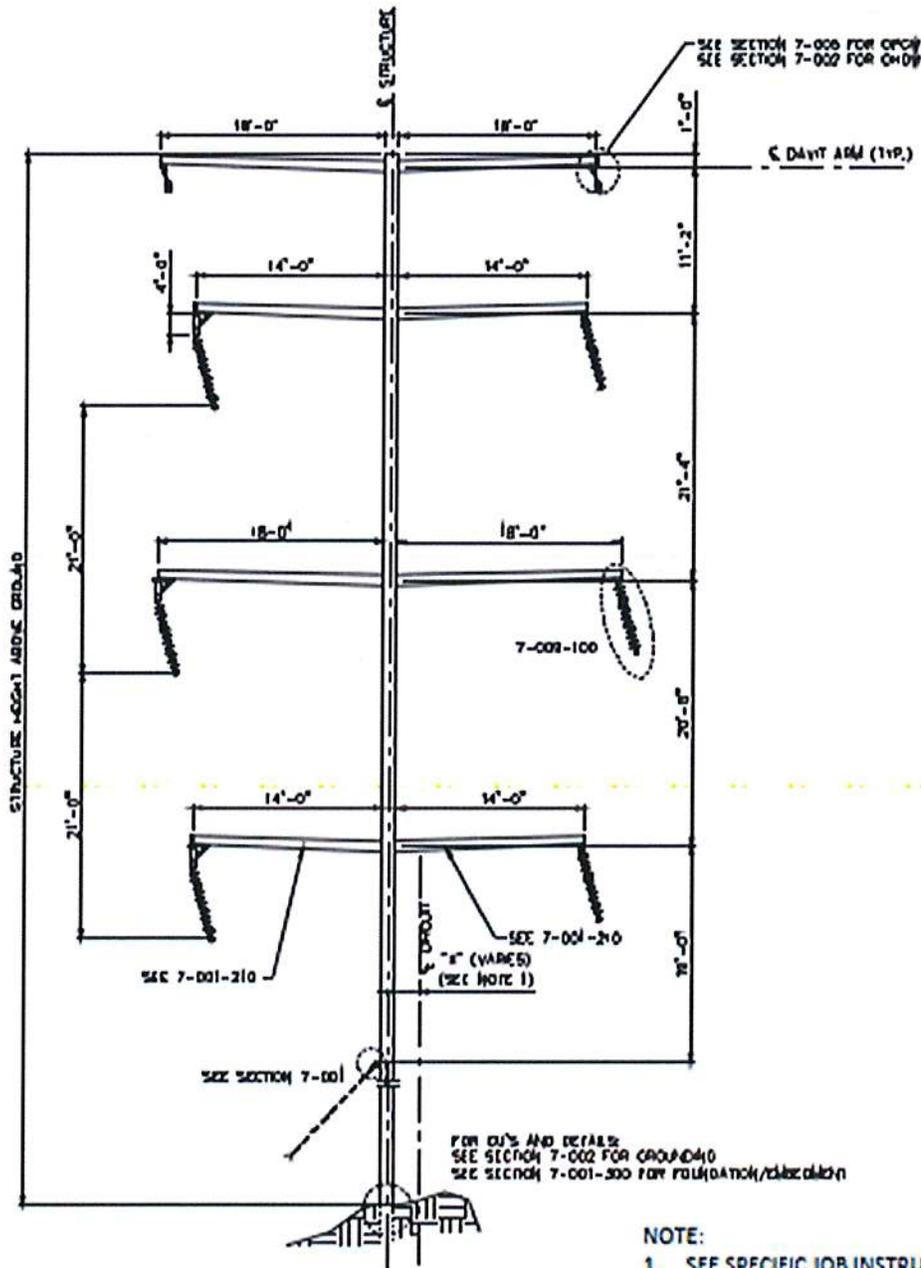
<b>7-009-062</b>	Revision: 0
	230kV Long Span Double Circuit Steel Pole 1° to 10° Angle Suspension Structure	Effective Date: 3/18/2016
		Sheet 1 of 1

Figure 2-2: Typical 230 kV Long Span Double-Circuit Steel Pole Angle Suspension Structure

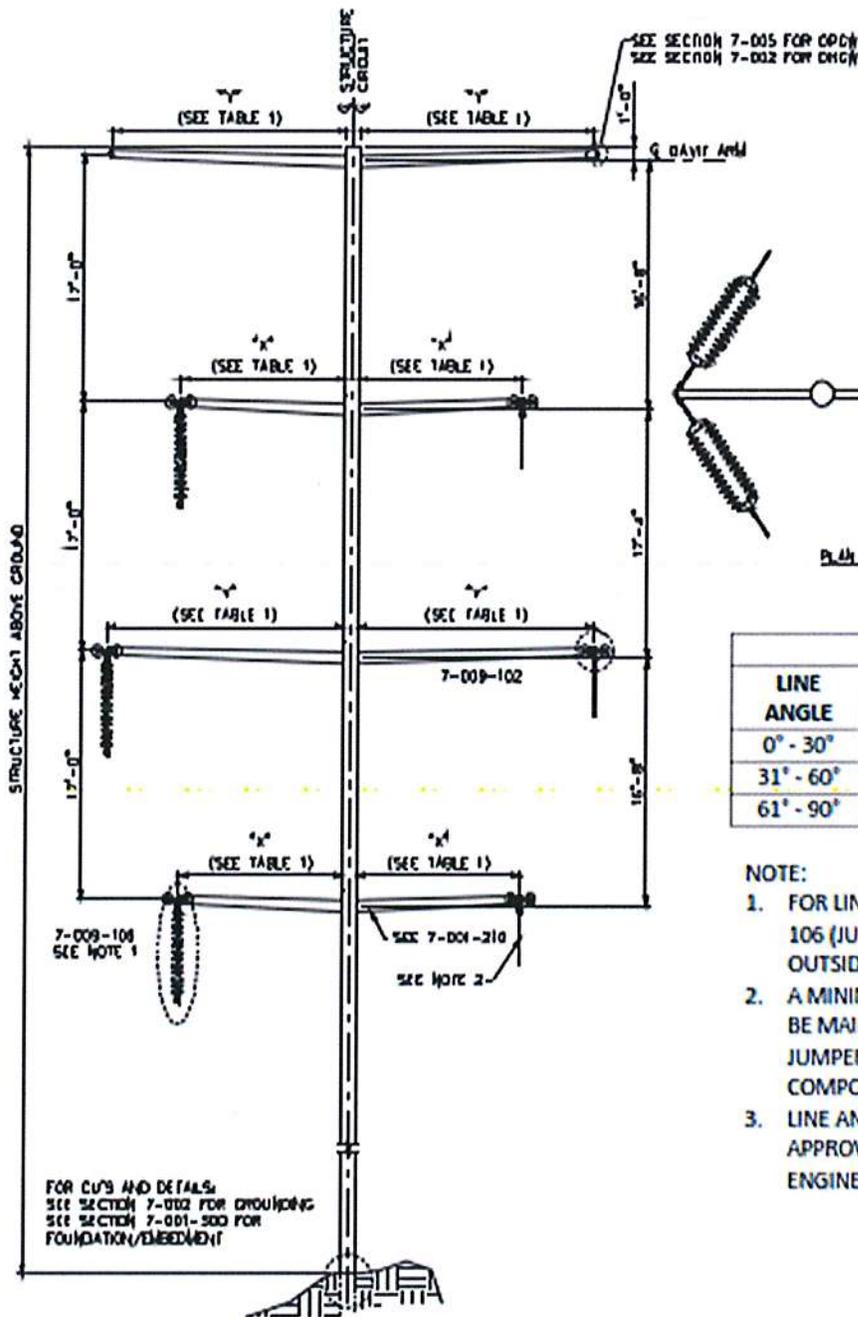
PPL Electric Utilities	<b>7-009-064</b> 230kV Long Span Double Circuit Steel Pole 0° To 90° Angle Tension on Arm Structure	Revision: 0 Effective Date: 3/18/2016 Sheet 1 of 1
---	---	--

Figure 2-3: Typical 230 kV Long Span Double-Circuit Steel Pole Angle Tension on Arm Structure

LINE ANGLE	DAVIT ARM LENGTH "X"	DAVIT ARM LENGTH "Y"
0° - 30°	12'-0"	16'-0"
31° - 60°	14'-0"	18'-0"
61° - 90°	17'-0"	21'-0"

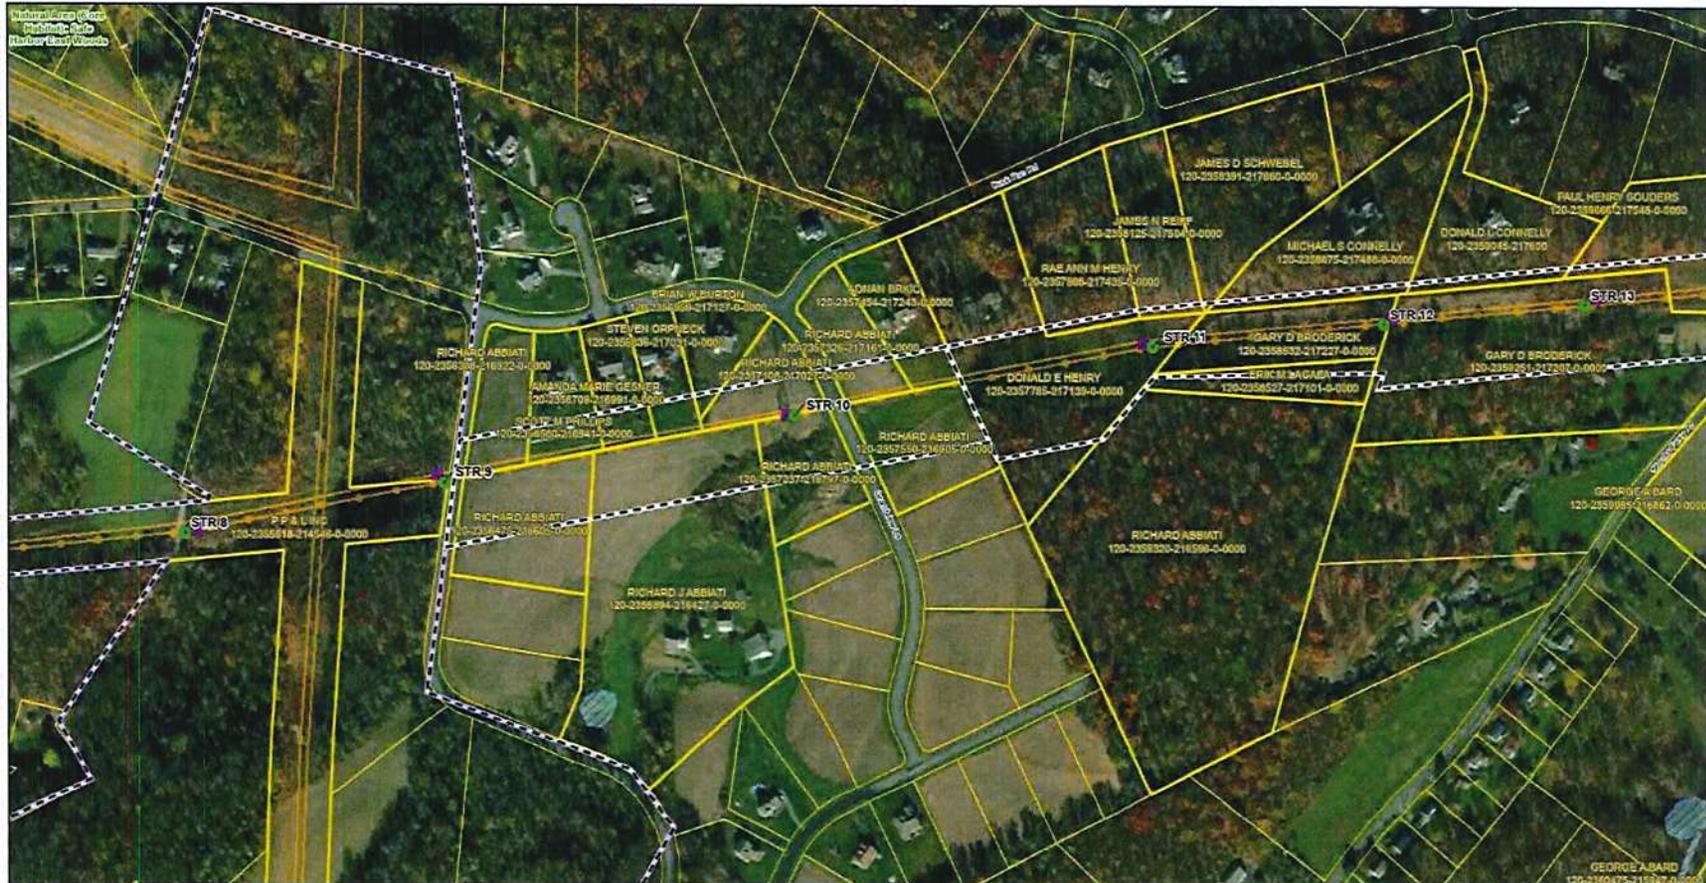
Figure 3-1c: Aerial Map of the Project

- Proposed Structure
- Existing Structure (To Be Replaced)
- Existing PPL Fee Owned ROW
- Existing PPL ROW
- Parcels Crossed by ROW
- Adjacent Parcels
- NW Wetlands
- Natural Areas (Core Habitat)

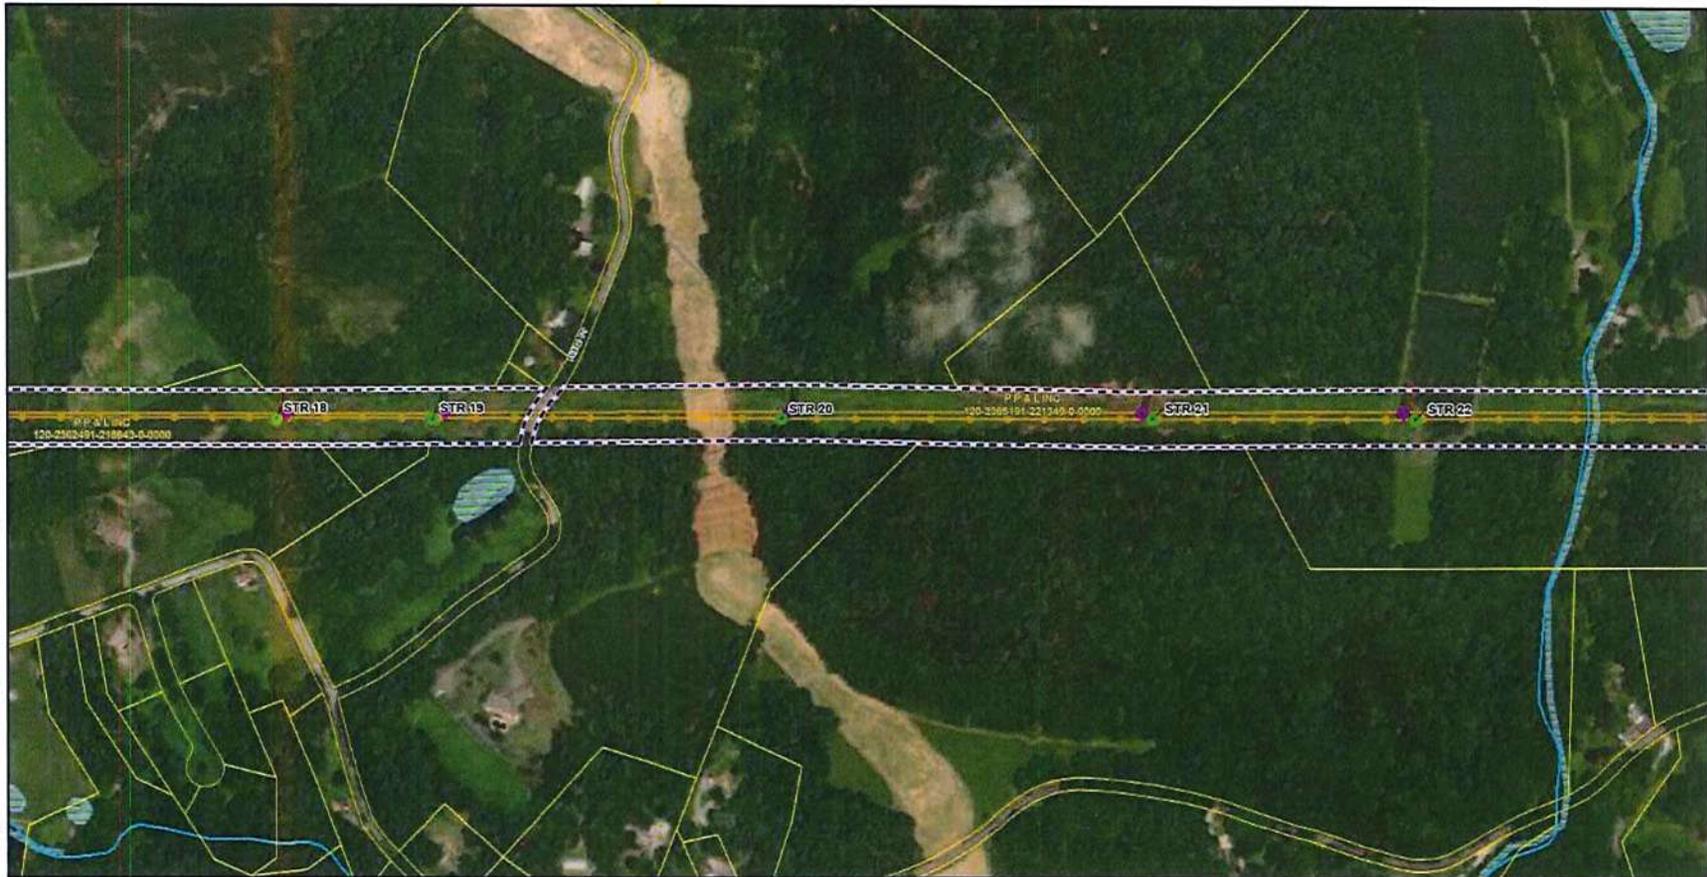
Figure 3-1e: Aerial Map of the Project

- Proposed Structure
- Existing Structure (To Be Replaced)
- Existing PPL Fee Owned ROW
- Parcels Crossed by ROW
- Adjacent Parcels
- Chapter 93 Designated Use Stream
- WWF
- NW1 Wetlands

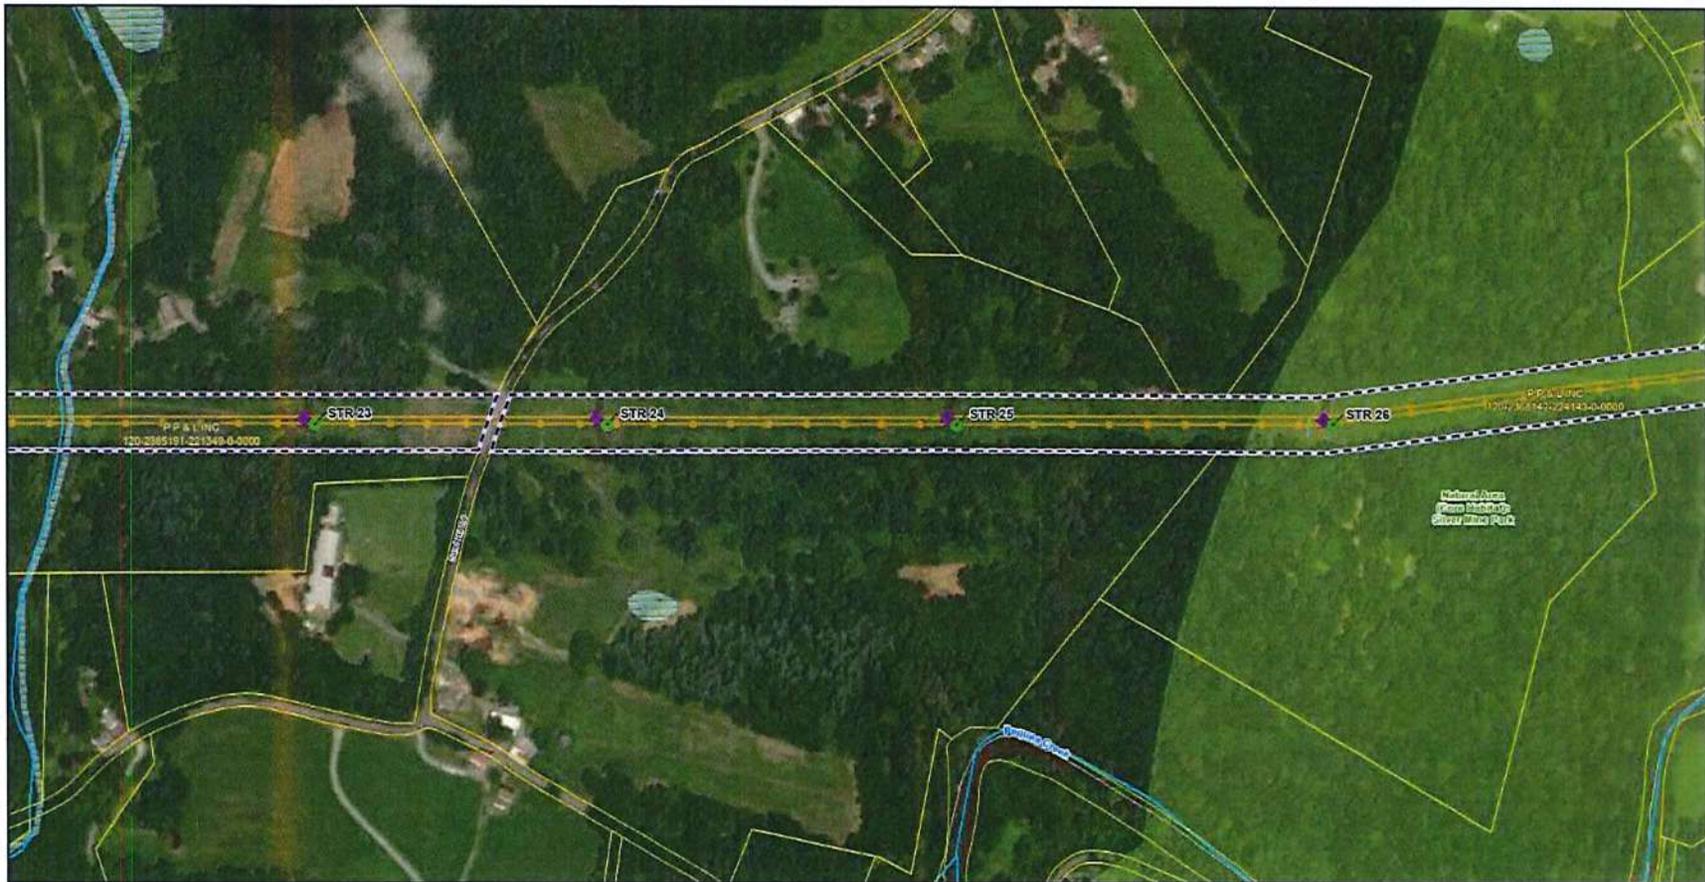
Figure 3-1f: Aerial Map of the Project

- Proposed Structure
- Existing Structure (To Be Replaced)
- Existing PPL Fee Owned ROW
- Parcels Crossed by ROW
- Adjacent Parcels
- Chapter 93 Designated Use Stream
- WWF
- NW Wetlands
- Natural Areas (Core Habitat)
- Existing Transmission Lines
  - 85 kV
  - 230 kV

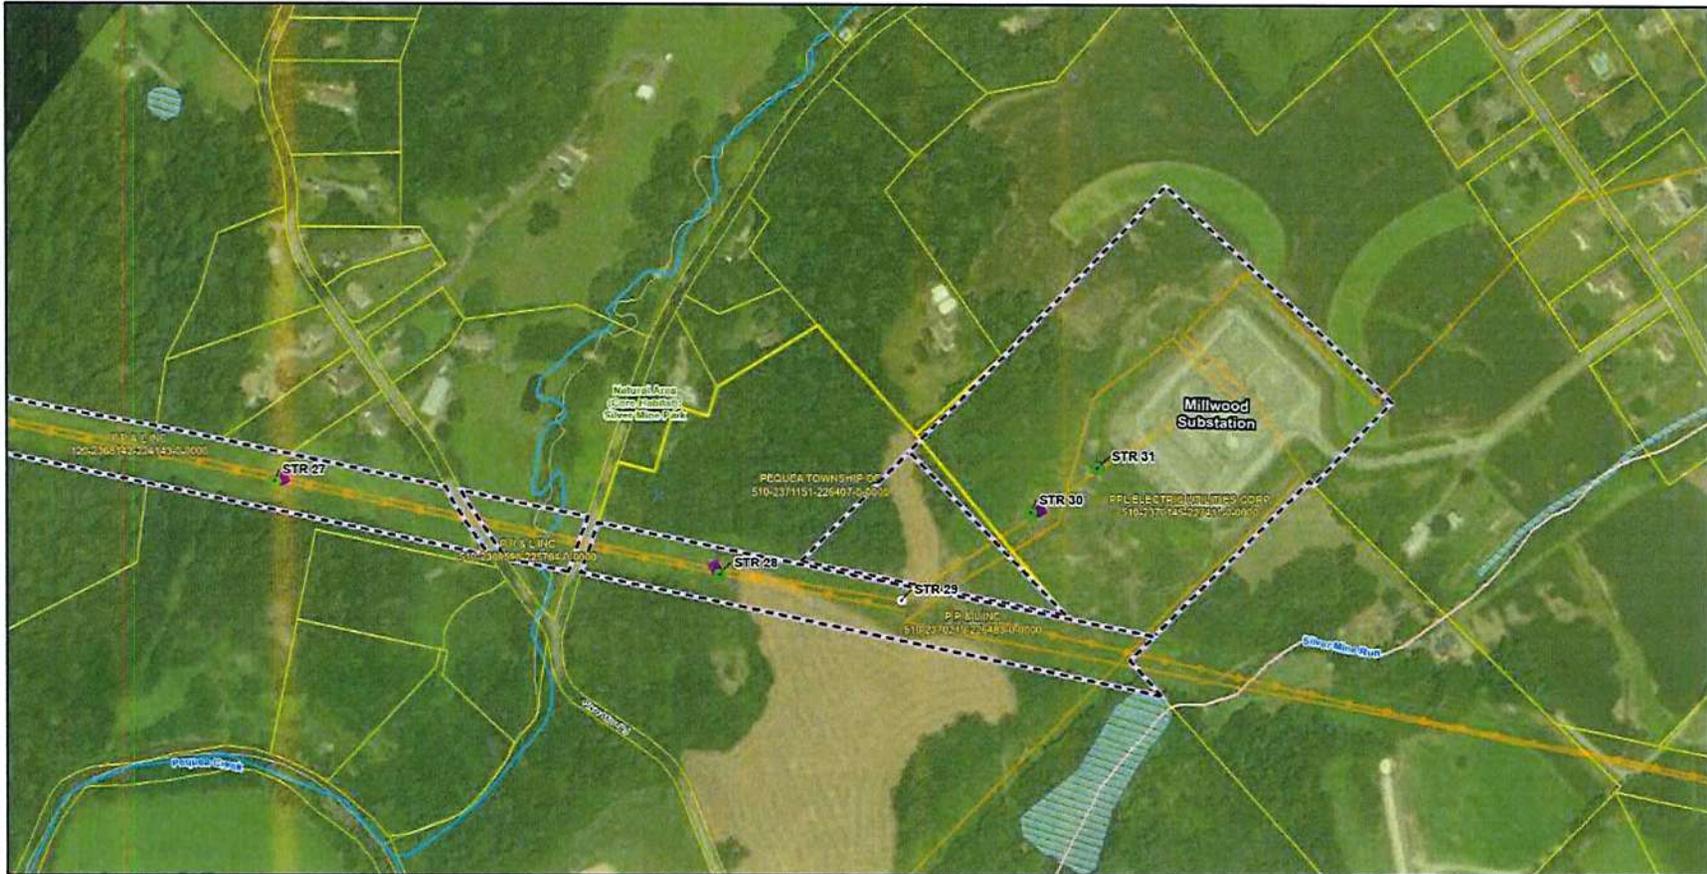
Figure 3-1g: Aerial Map of the Project

- Existing Structure (To Remain)
- Proposed Structure
- Existing Structure (To Be Replaced)
- Existing PPL Fee Owned ROW
- Parcels Crossed by ROW
- Adjacent Parcels
- Chapter 93 Designated Use Stream
- T2P
- WAP
- KW1 Wetlands
- Natural Areas (Cove Habitat)
- Existing Transmission Lines
- 69 kV
- 230 kV
