**INITIAL STATUS REPORT TO THE
PENNSYLVANIA PUBLIC UTILITY COMMISSION**

DEER HAVEN, LLC (SEWER)
AQUA PENNSYLVANIA WASTEWATER, INC., AS RECEIVER

DOCKET NO. P-2024-3050549

Dated: October 15, 2024

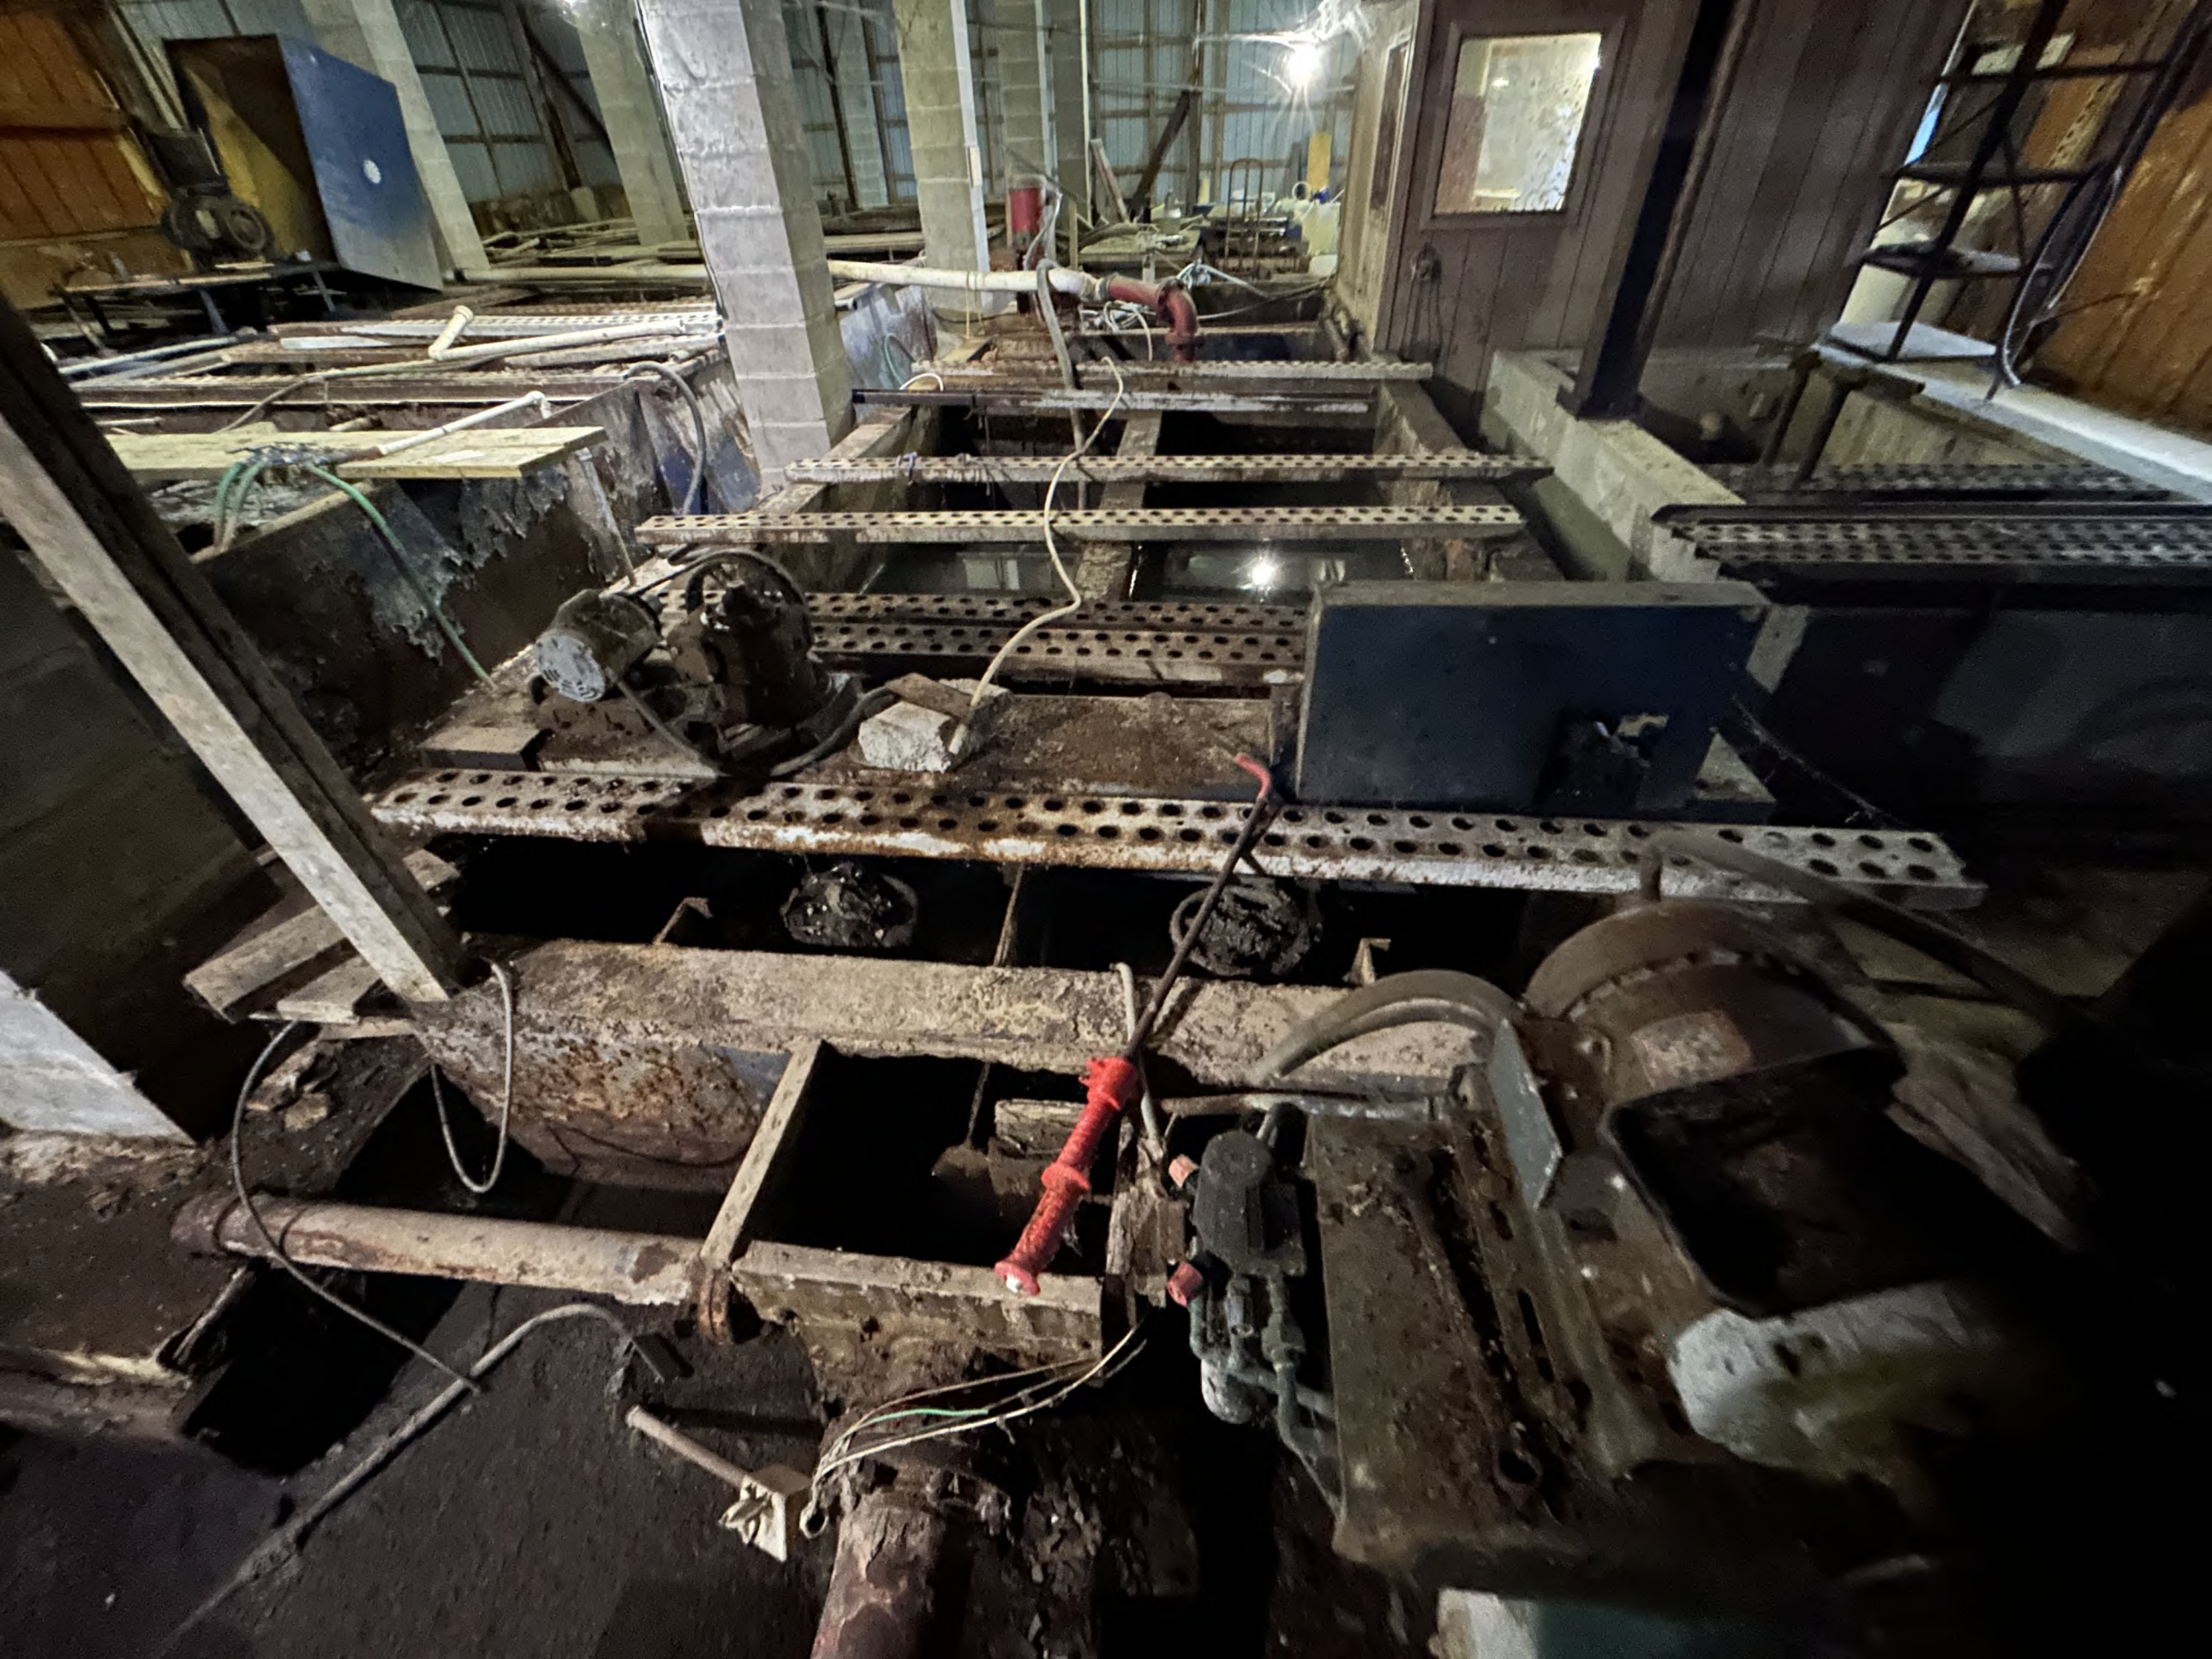
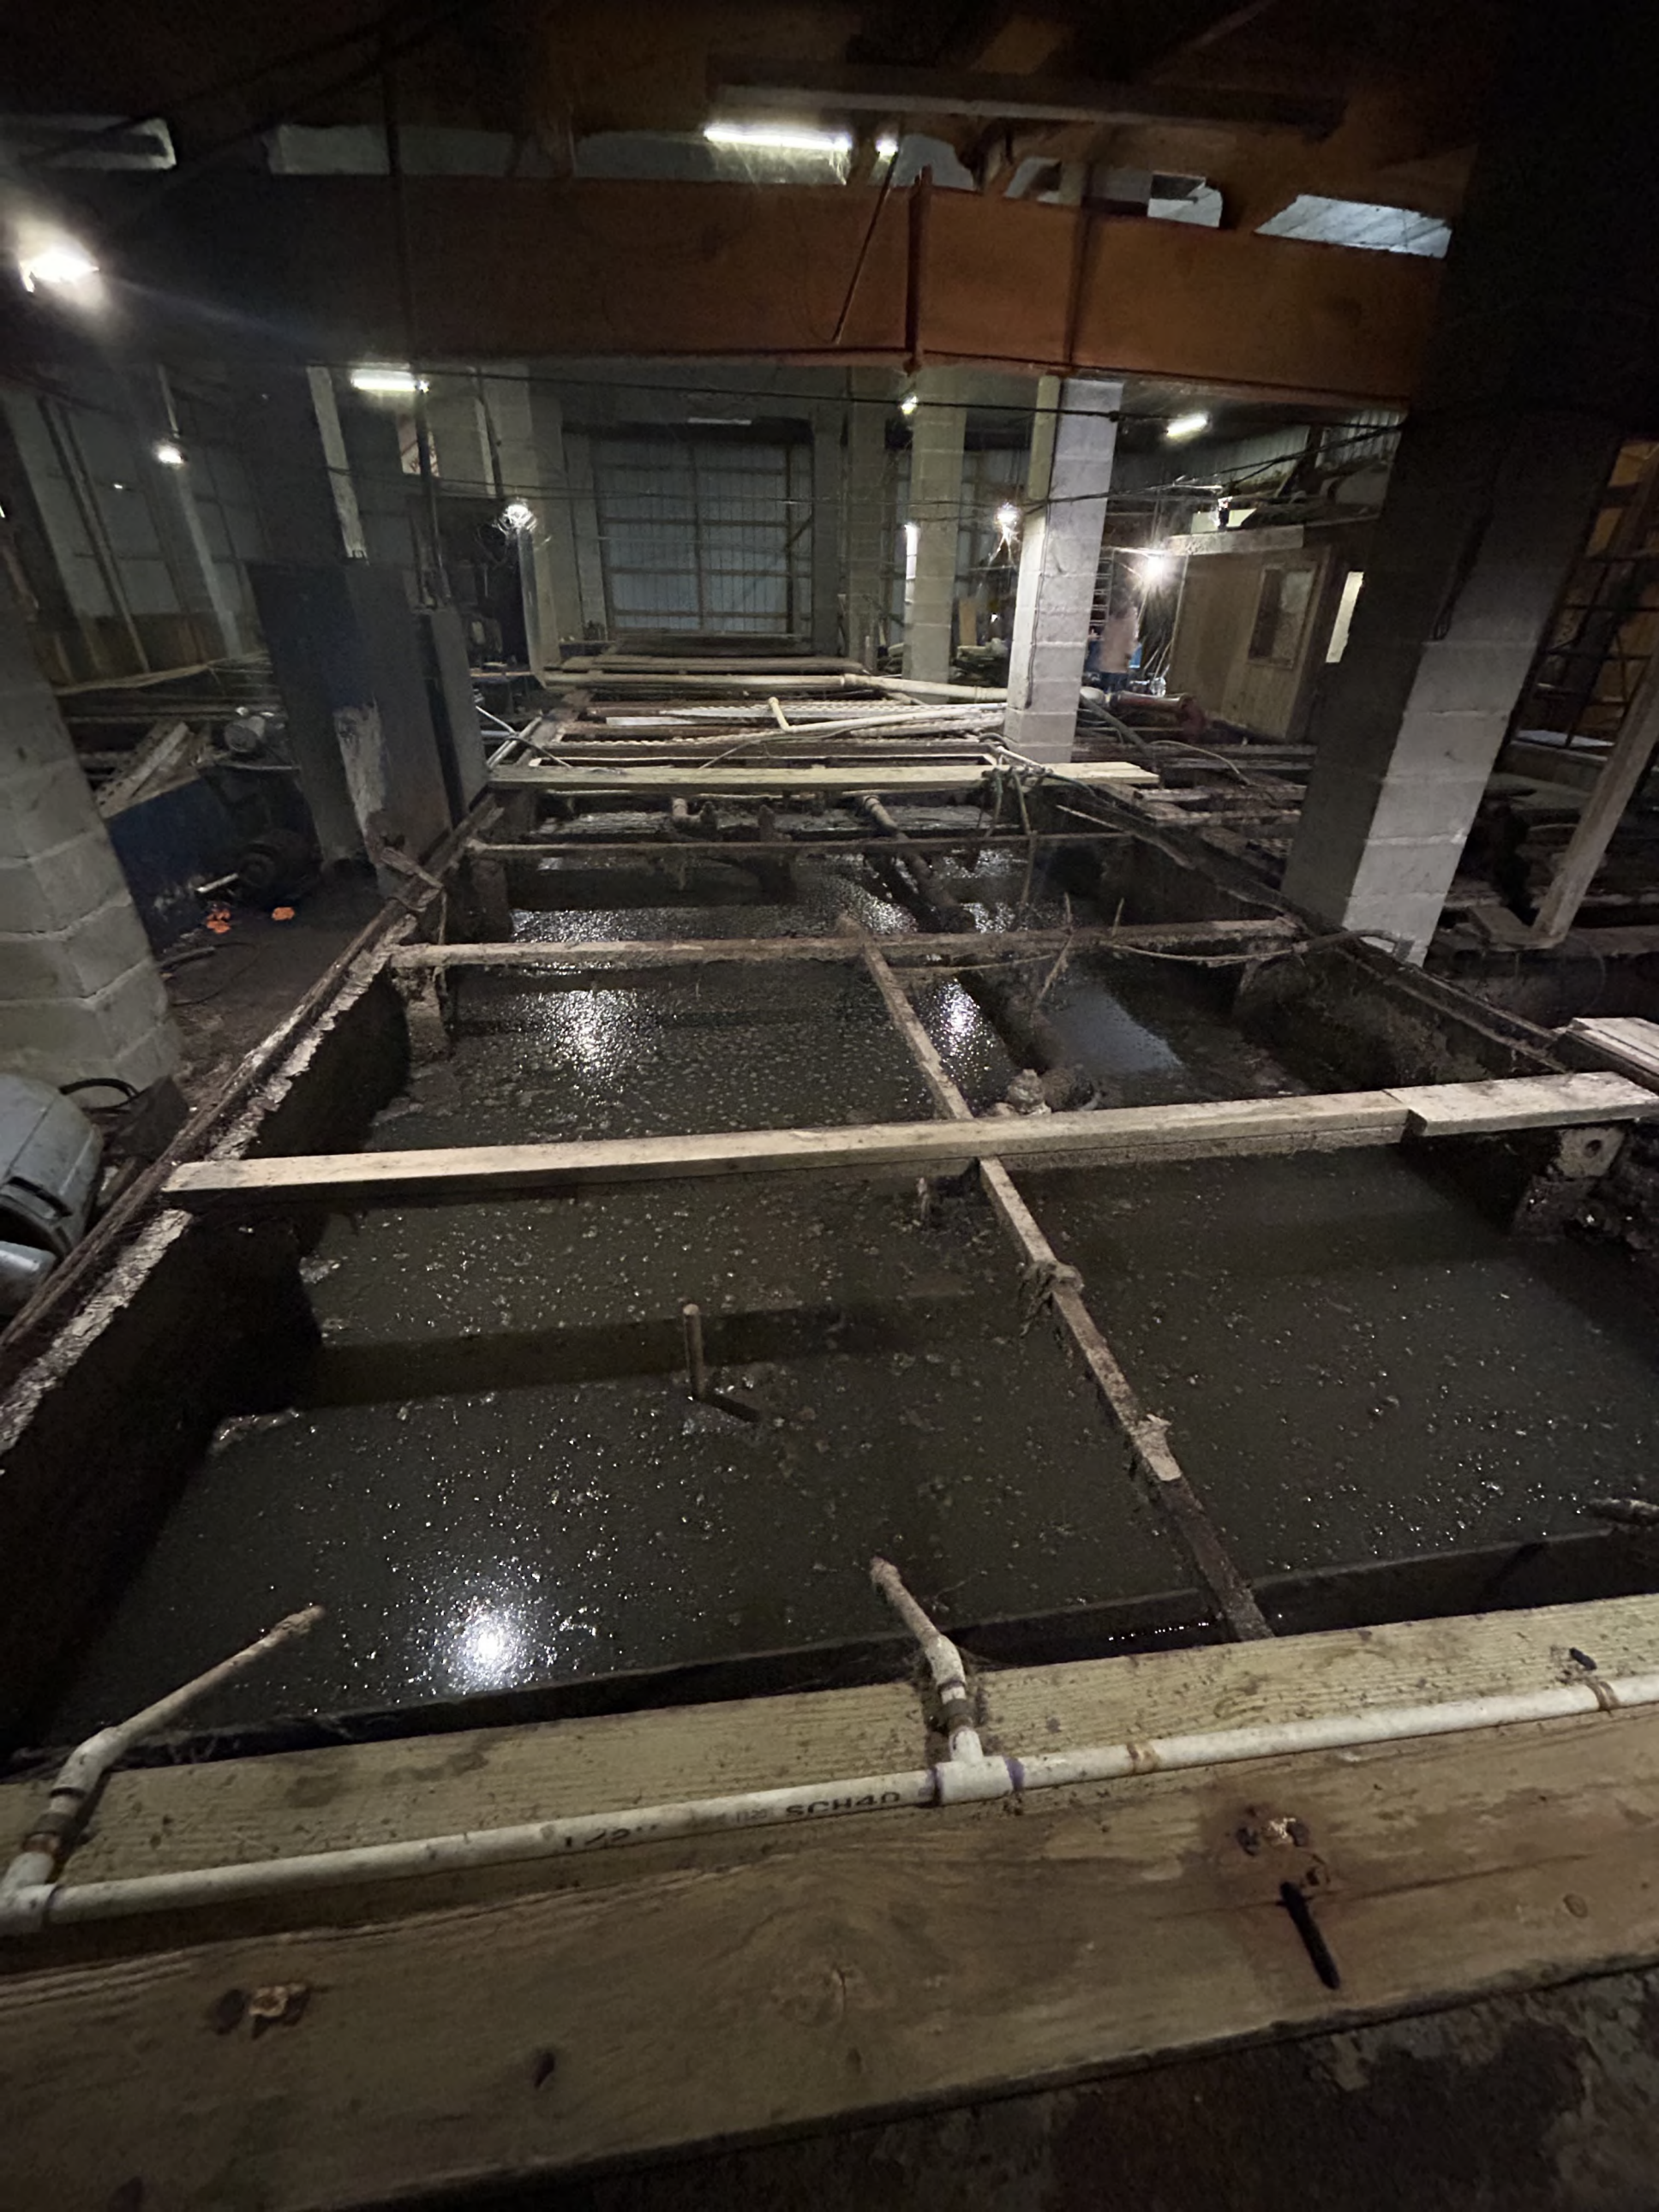
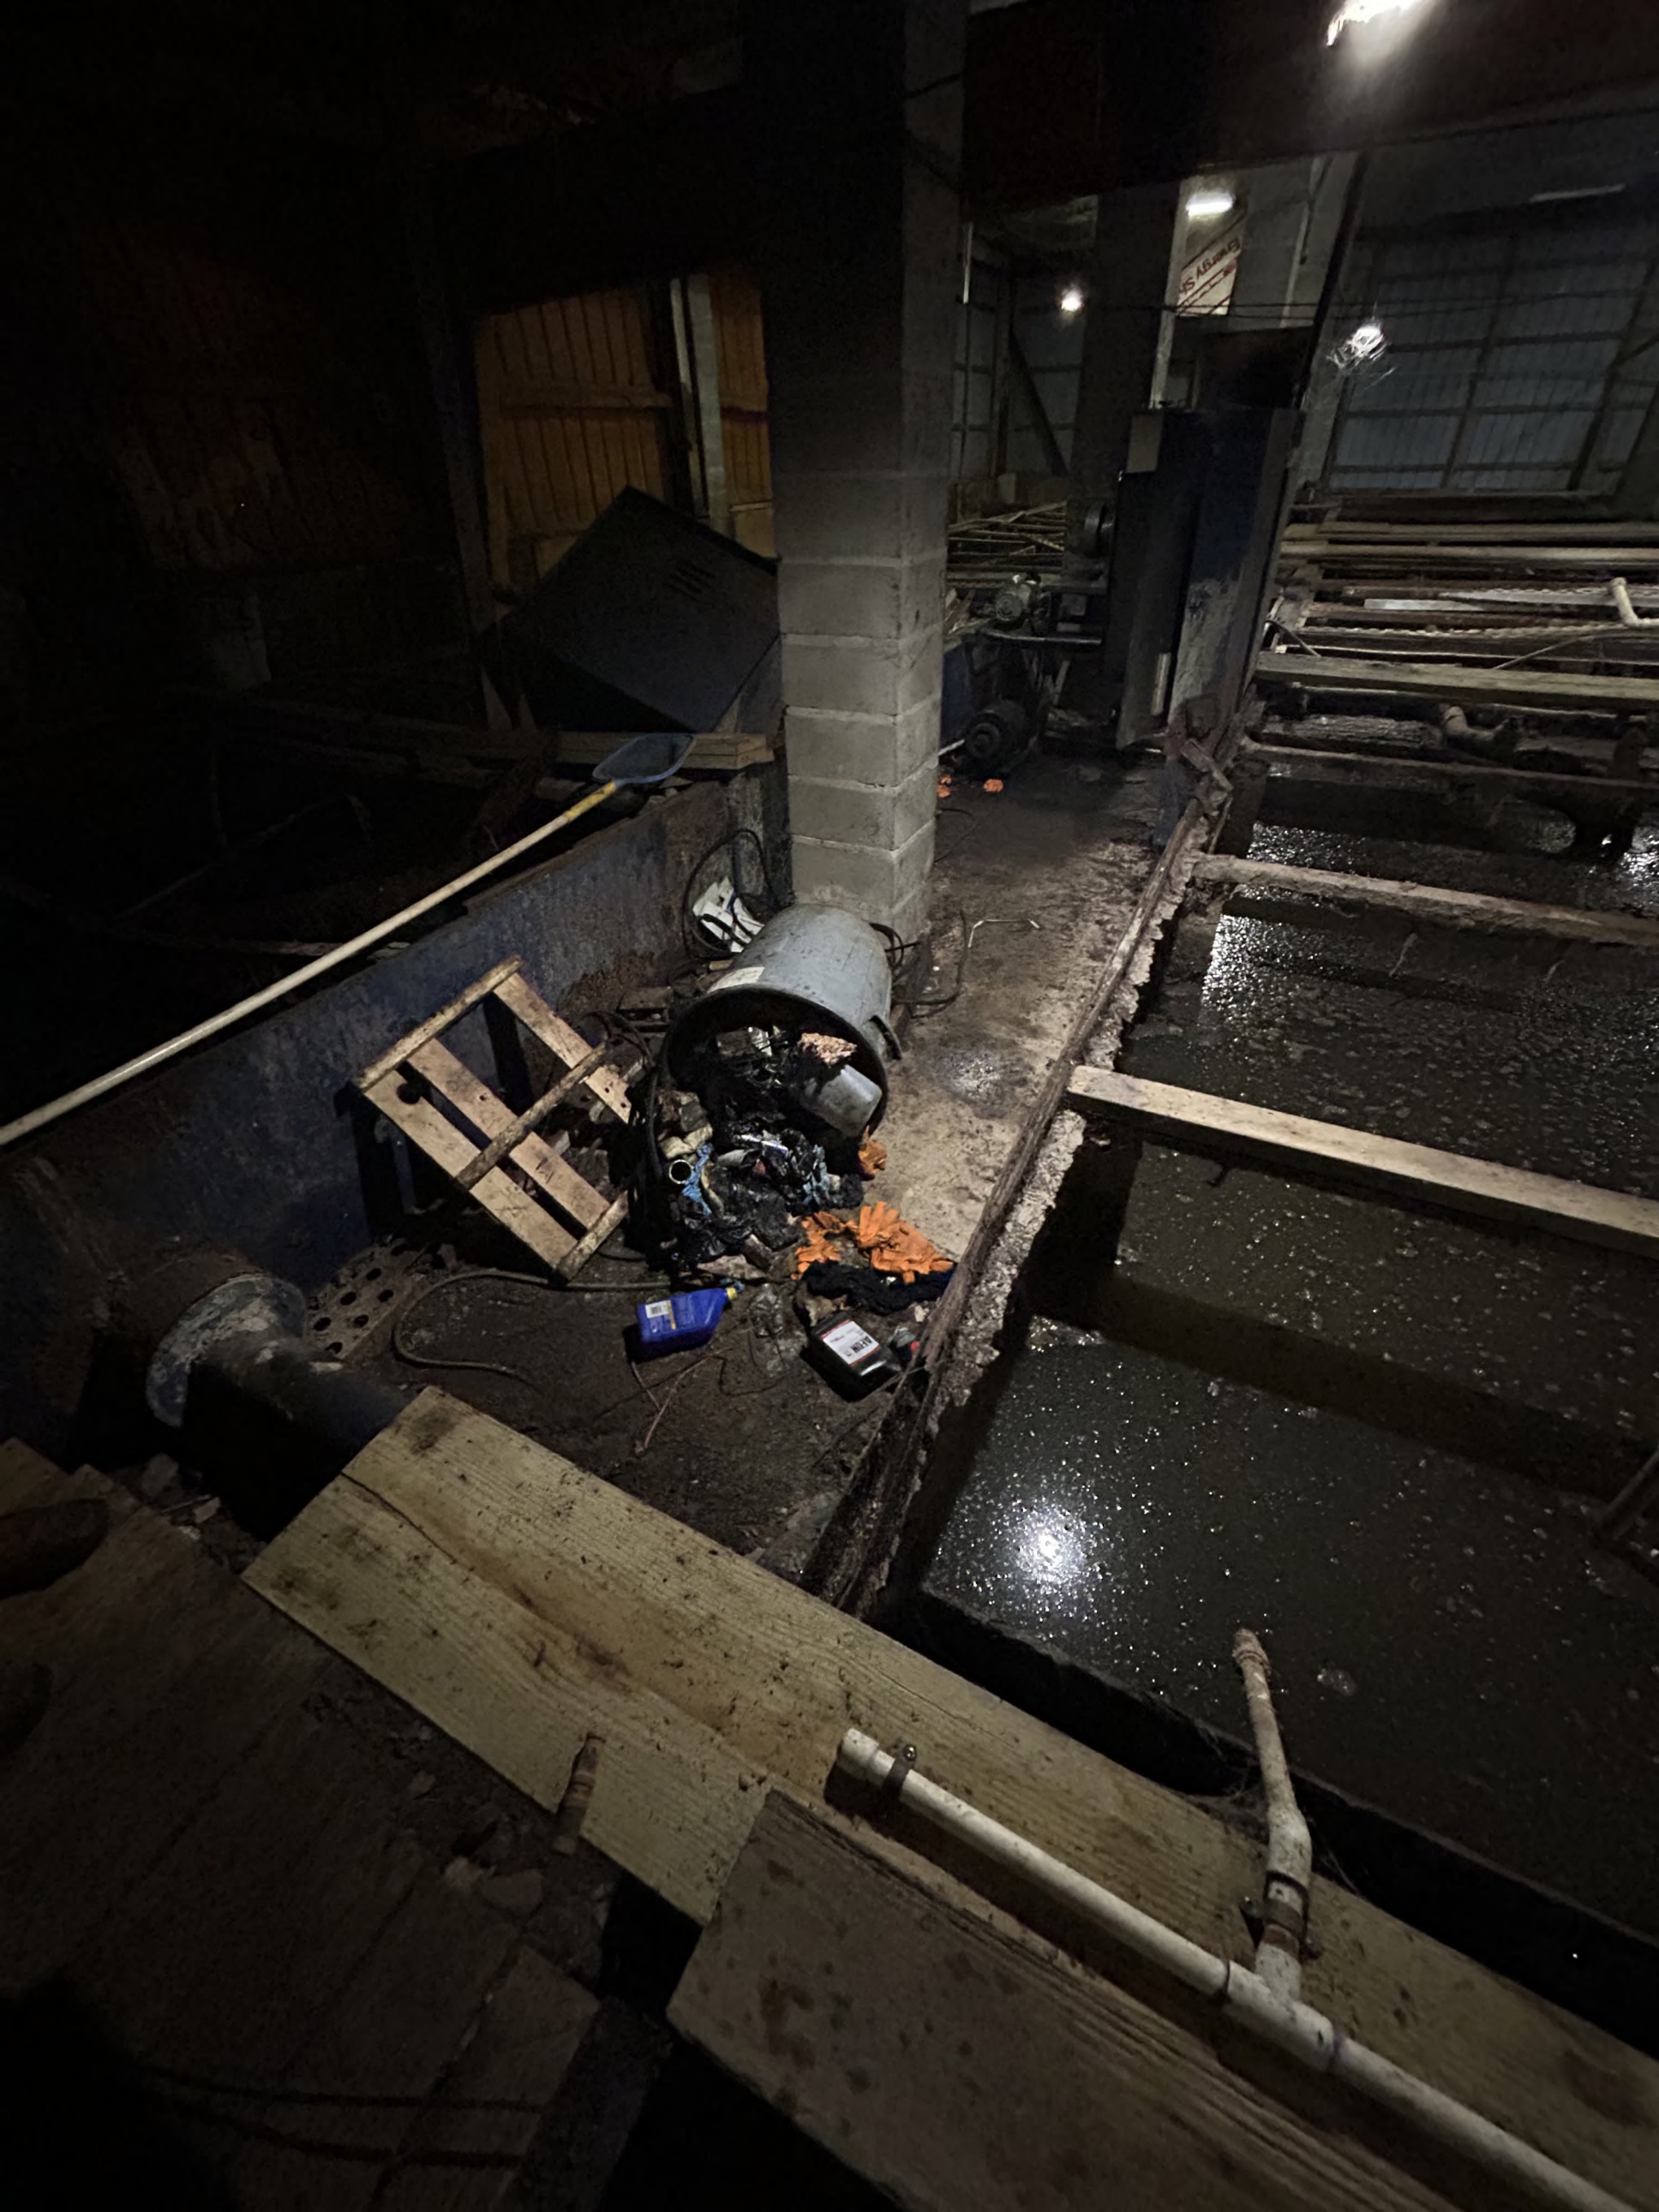
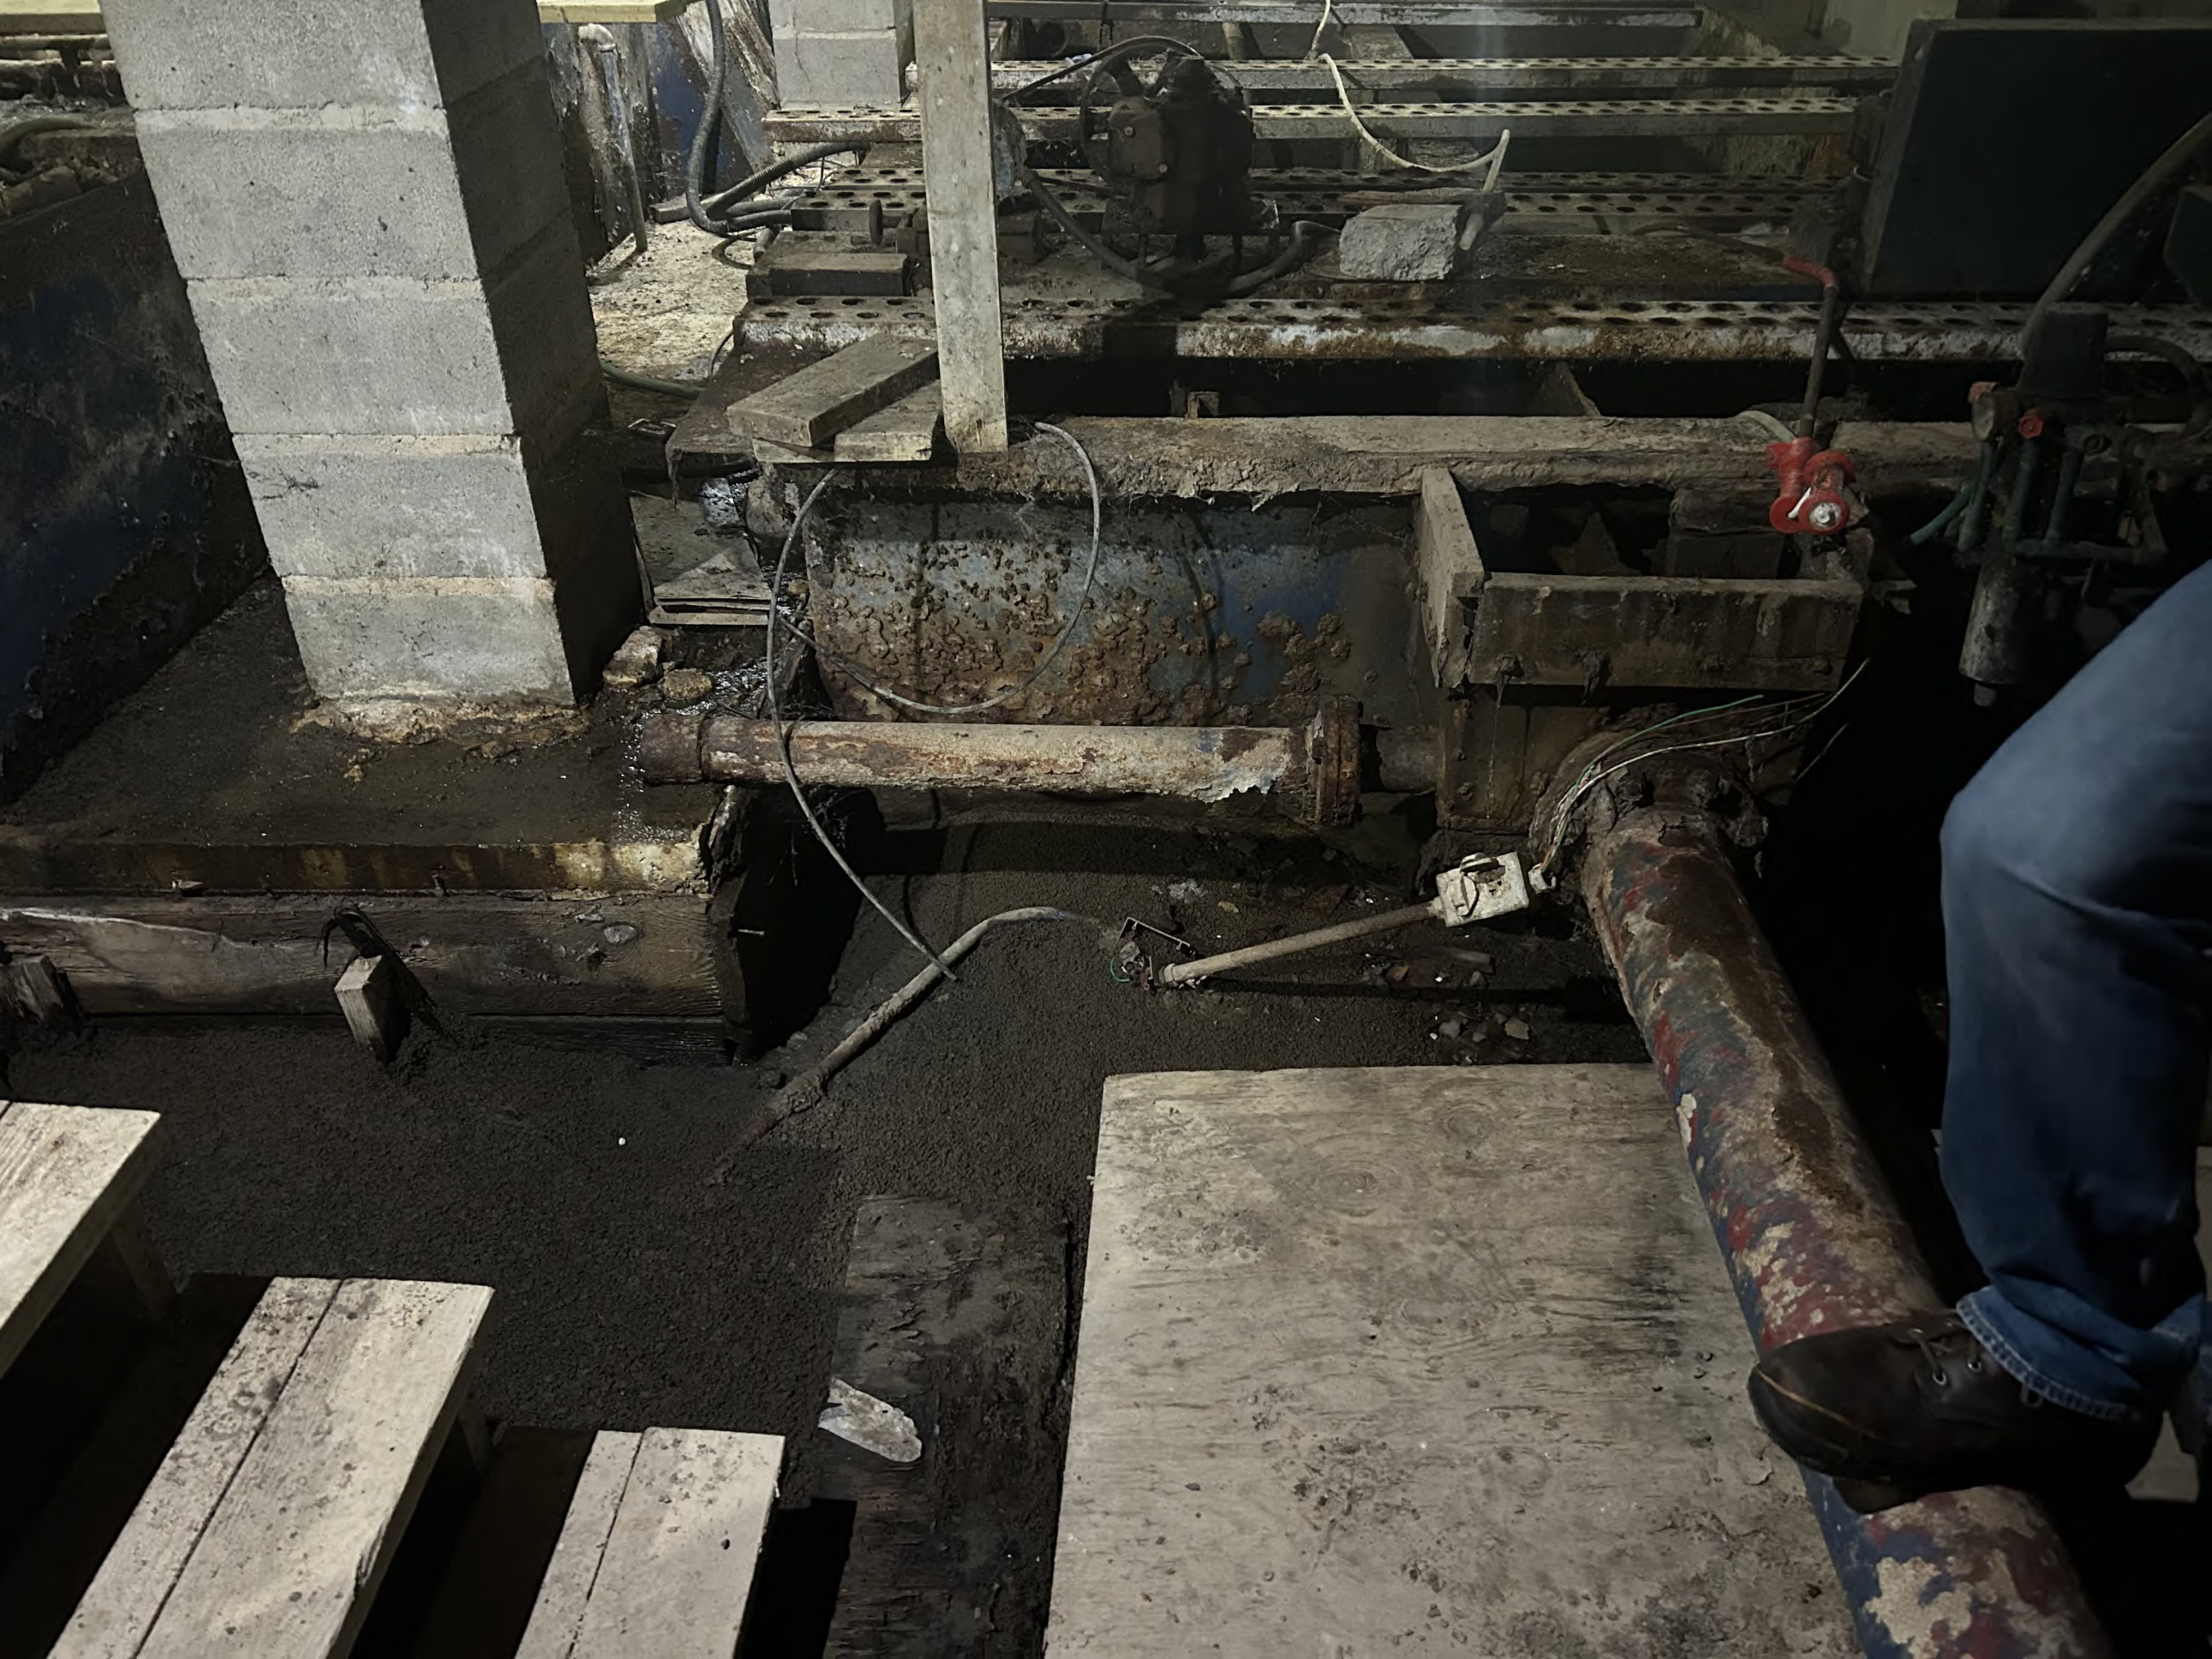
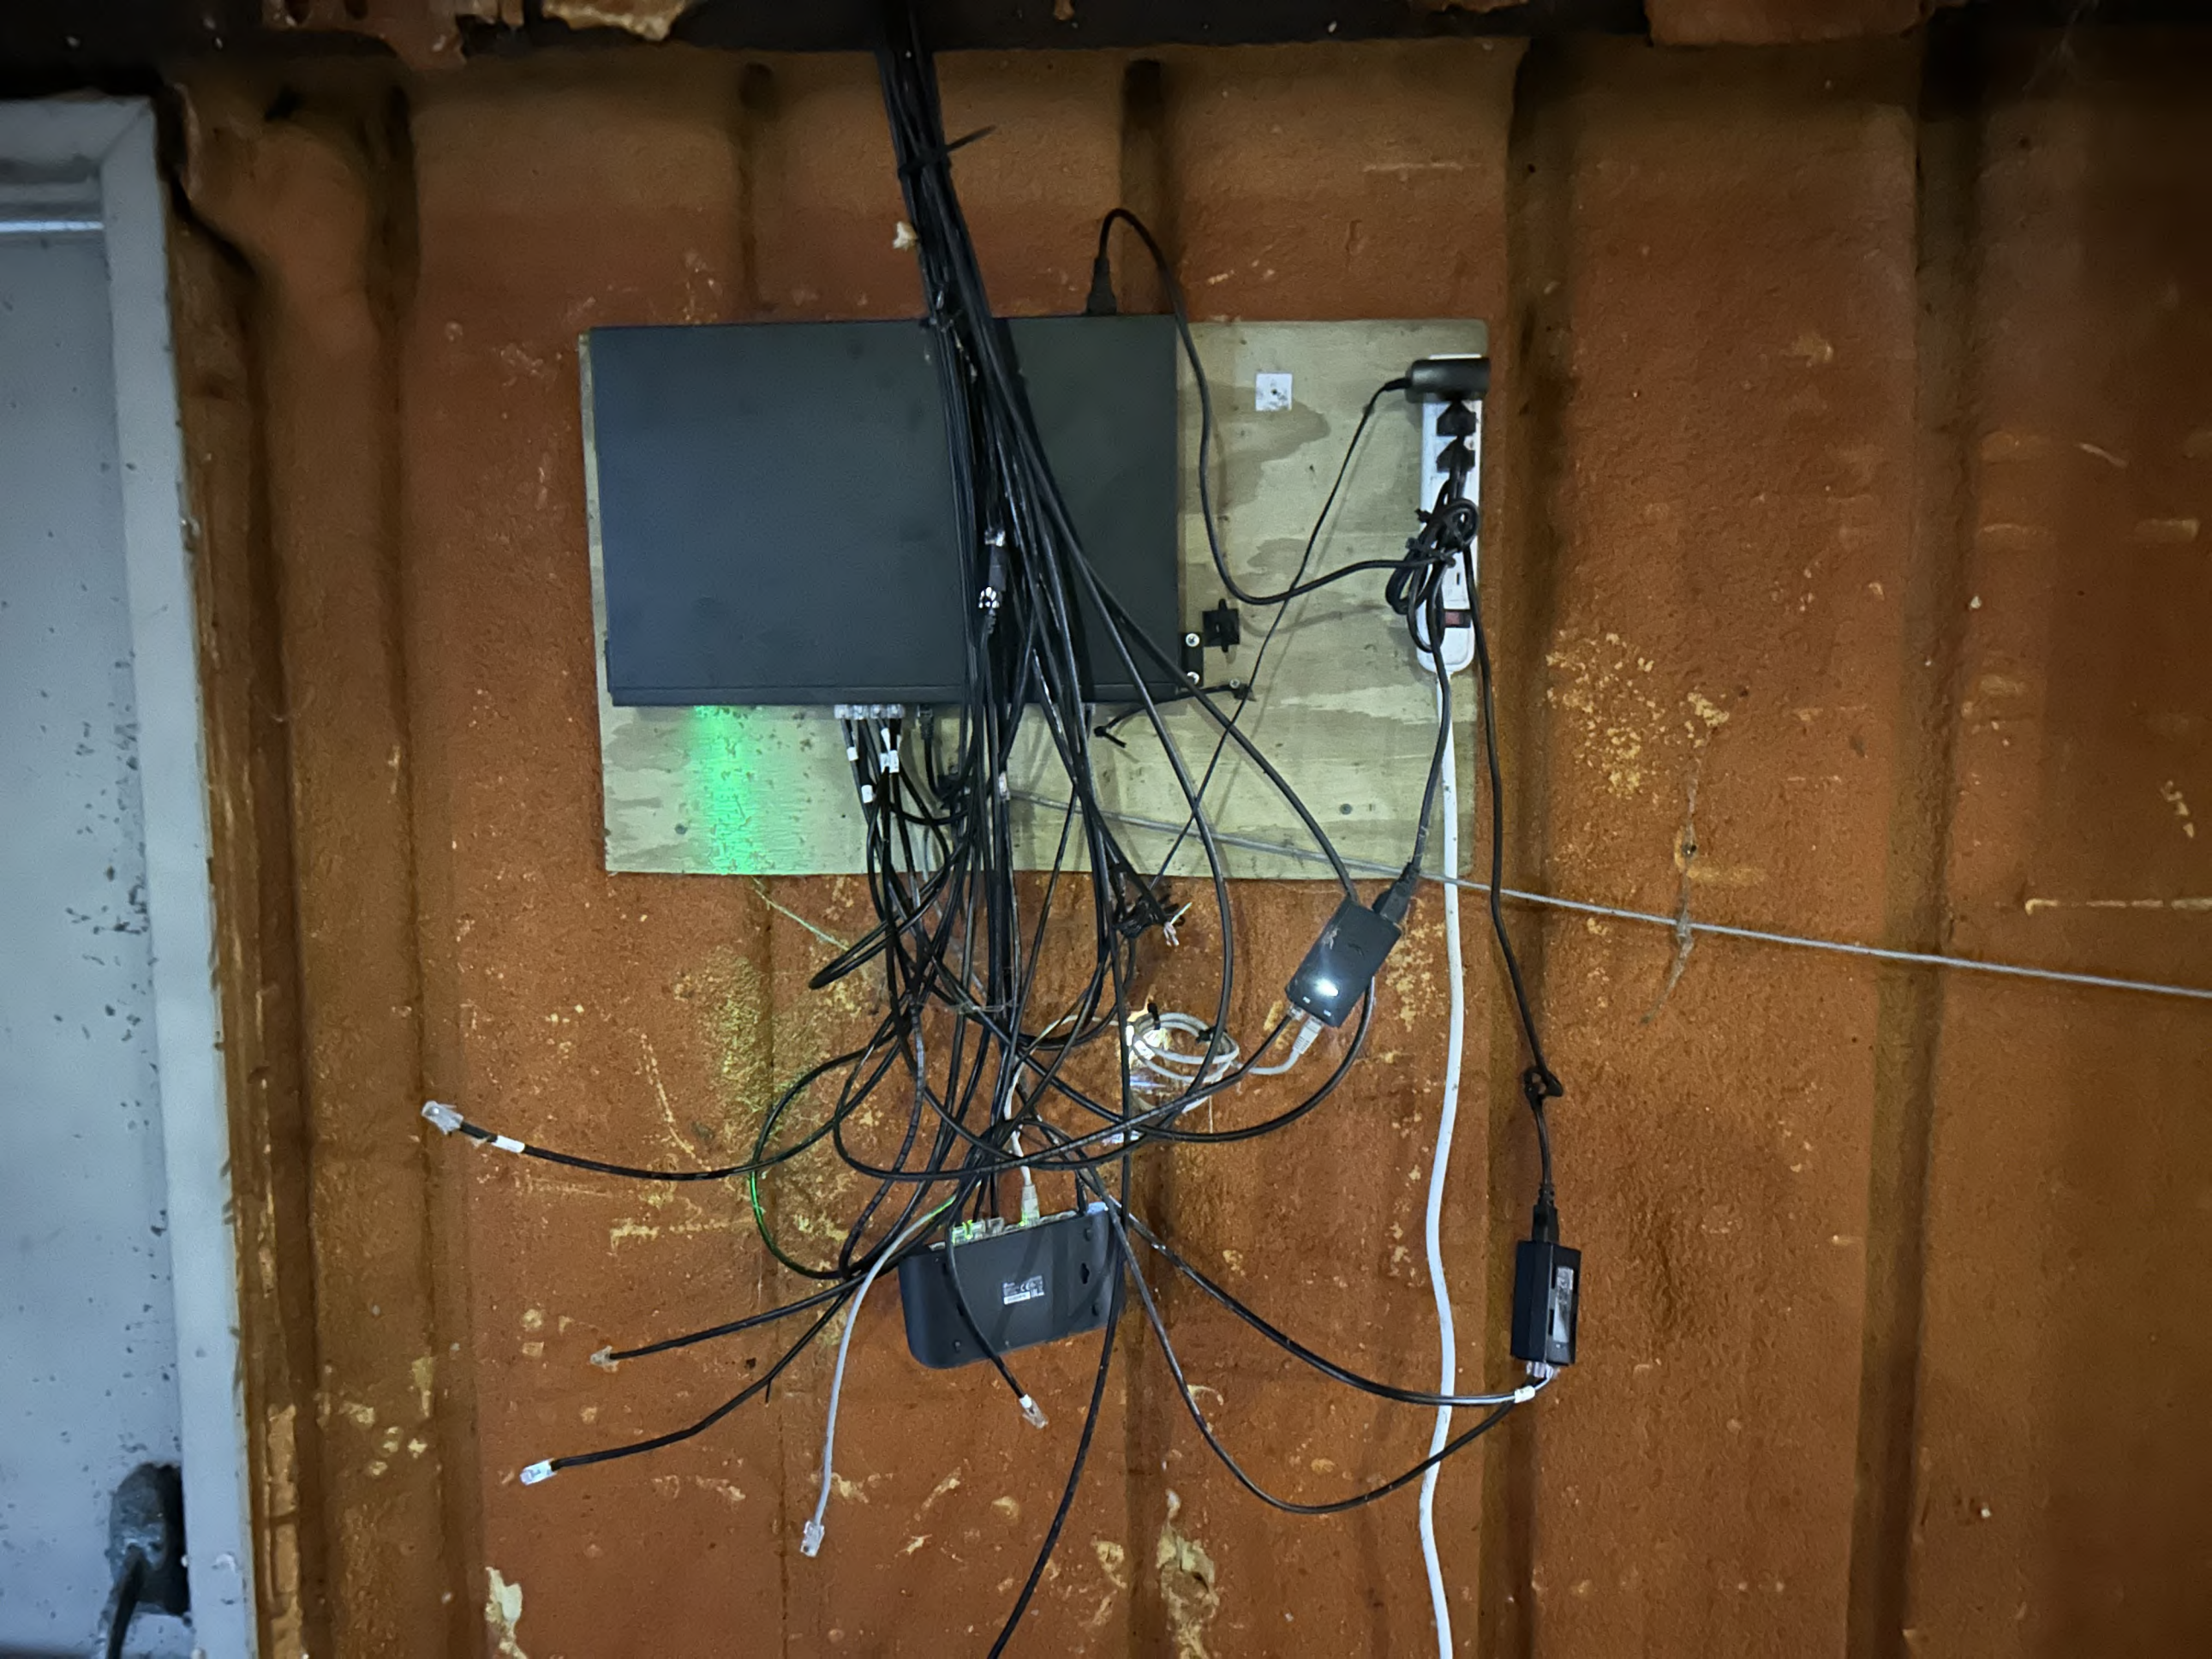
ATTACHMENT A

On August 15, 2024, Aqua began its Receivership duties for the DH Sewer system, and visited the wastewater treatment plant ("WWTP") facilities in the evening of August 15, 2024 to assess the state of operations of the DH Sewer system. On August 16, 2024, a full complement of Aqua personnel arrived onsite to begin a full assessment of the system and its operations. Aqua performed a walkthrough of the DH Sewer facilities and immediately was concerned with the lack of treatment occurring in the existing facilities. Aqua employees also identified as a concern the structural integrity of the WWTP building. Photographs of the DH Sewer facilities when Aqua came onsite are included with this Status Report as **Attachment A**.

Within the WWTP, Aqua found that only primary treatment was occurring in the treatment train as the second process train is unusable. Wastewater enters the aeration tank for primary treatment then moves to a clarifier to settle solids, then to the chlorine contact tank for disinfection and finally discharge to the lake. Aqua notes that aeration, a chloring pump, and DelPac for phosphorus removal were on and running upon Aqua's arrival. However, Aqua observed that there was essentially no biological activity in the aeration processes, minimal disinfection, and the partially treated wastewater was being discharged into Lake Wallenpaupack near a marina. This is in violation of the facility's NPDES permit. Aqua informed the Pennsylvania Department of Environmental Protection ("DEP") of this discharge. Aqua took wastewater composite samples

Regarding the WWTP structure itself, as can be seen in the photographs included as Attachment A, the WWTP structure had deteriorated and was non-operational. A section of the old WWTP structure appears to have collapsed years ago and a new area was erected over the collapsed structure without clearing the collapsed structure. This made access to plant equipment and walking around the facility unsafe. Aqua’s concern was for the safety of its employees and contractors, and thereafter locked the WWTP structure and instructed all employees and contractors not to enter. To confirm Aqua’s concerns, Aqua obtained a structural engineer to review the WWTP which was determined “Not Safe To Be Occupied”. The structural engineer’s email is included in this Status Report as **Attachment D**. Similar unsafe conditions were observed related to the electrical equipment which included panels with the front face removed and unsafe workmanship. In general, the facility’s condition is poor, and has many safety hazards throughout. These conditions represent what appears to be years of poor maintenance and care to safety of the work areas.

The existing facility has a many deficiencies and in my professional opinion is **NOT SAFE TO BE OCCUPIED**.

There are reinforced CMU retaining walls at the South East corner of the building. The walls are showing signs of deterioration, deflection and bowing. This wall is beginning to fail.

The interior of the building is a complex combination of an existing failed metal building structure and a "Newer" steel column, wooden wall girt, and wooded truss system.

The existing Metal "Butler" Building had already failed in the past and was partially demolished. What is left of the existing metal building is poorly shored by 2x4 posts that rest on the metal process tanks, or wooden framing below. The existing metal building roof purlins are severely corroded and have deflected several feet. Portions of the metal moment frame were cut and left in place. These frames can be moved by pushing on them.

At some point it was attempted to building a steel/wooden hybrid pole type structure. Steel columns, masonry columns and a steel roof support structure above the existing metal building and process tanks were added. While installing the steel columns, the horizontal metal building girts that were left in place were cut on each side of the steel column, which compromises the force transfer during wind storms. Portions of the exterior walls can be shaken in and out several inches when pushed on. There is a location when the existing electrical service comes into the building where the electrical service is mounted to the old steel building and the horizontal girts and steel frame are cut. Adjacent to this area the wooden building wall girts also are cut and are not anchored to a wooden post. The exterior metal siding is not attached to either the old metal building or the wooden wall girts in several locations.

Around the process tanks there are wooden frames placed on grade with plywood for a walking surface. This is a hazard as there are many areas where there are rotted holes in the plywood either exposed or covered up by loose laying plywood.

The process tanks are in poor condition. The top bracing channels are severely deteriorated and collapsing. There is little to no safety grating over the tanks and any grating planks are deteriorating and not anchored down, so they could move if walked on. Some grating planks are rusted in half and remain resting on the top of the tank and a severely corroded center support stiffener. There is no safety railing around the tanks and the stairs are not anchored and shift when stepped on.

Again, it is my professional opinion that this building should not be occupied as there are numerous safety issues along with the potential of portions of the building to collapse, either by itself or during a wind event.

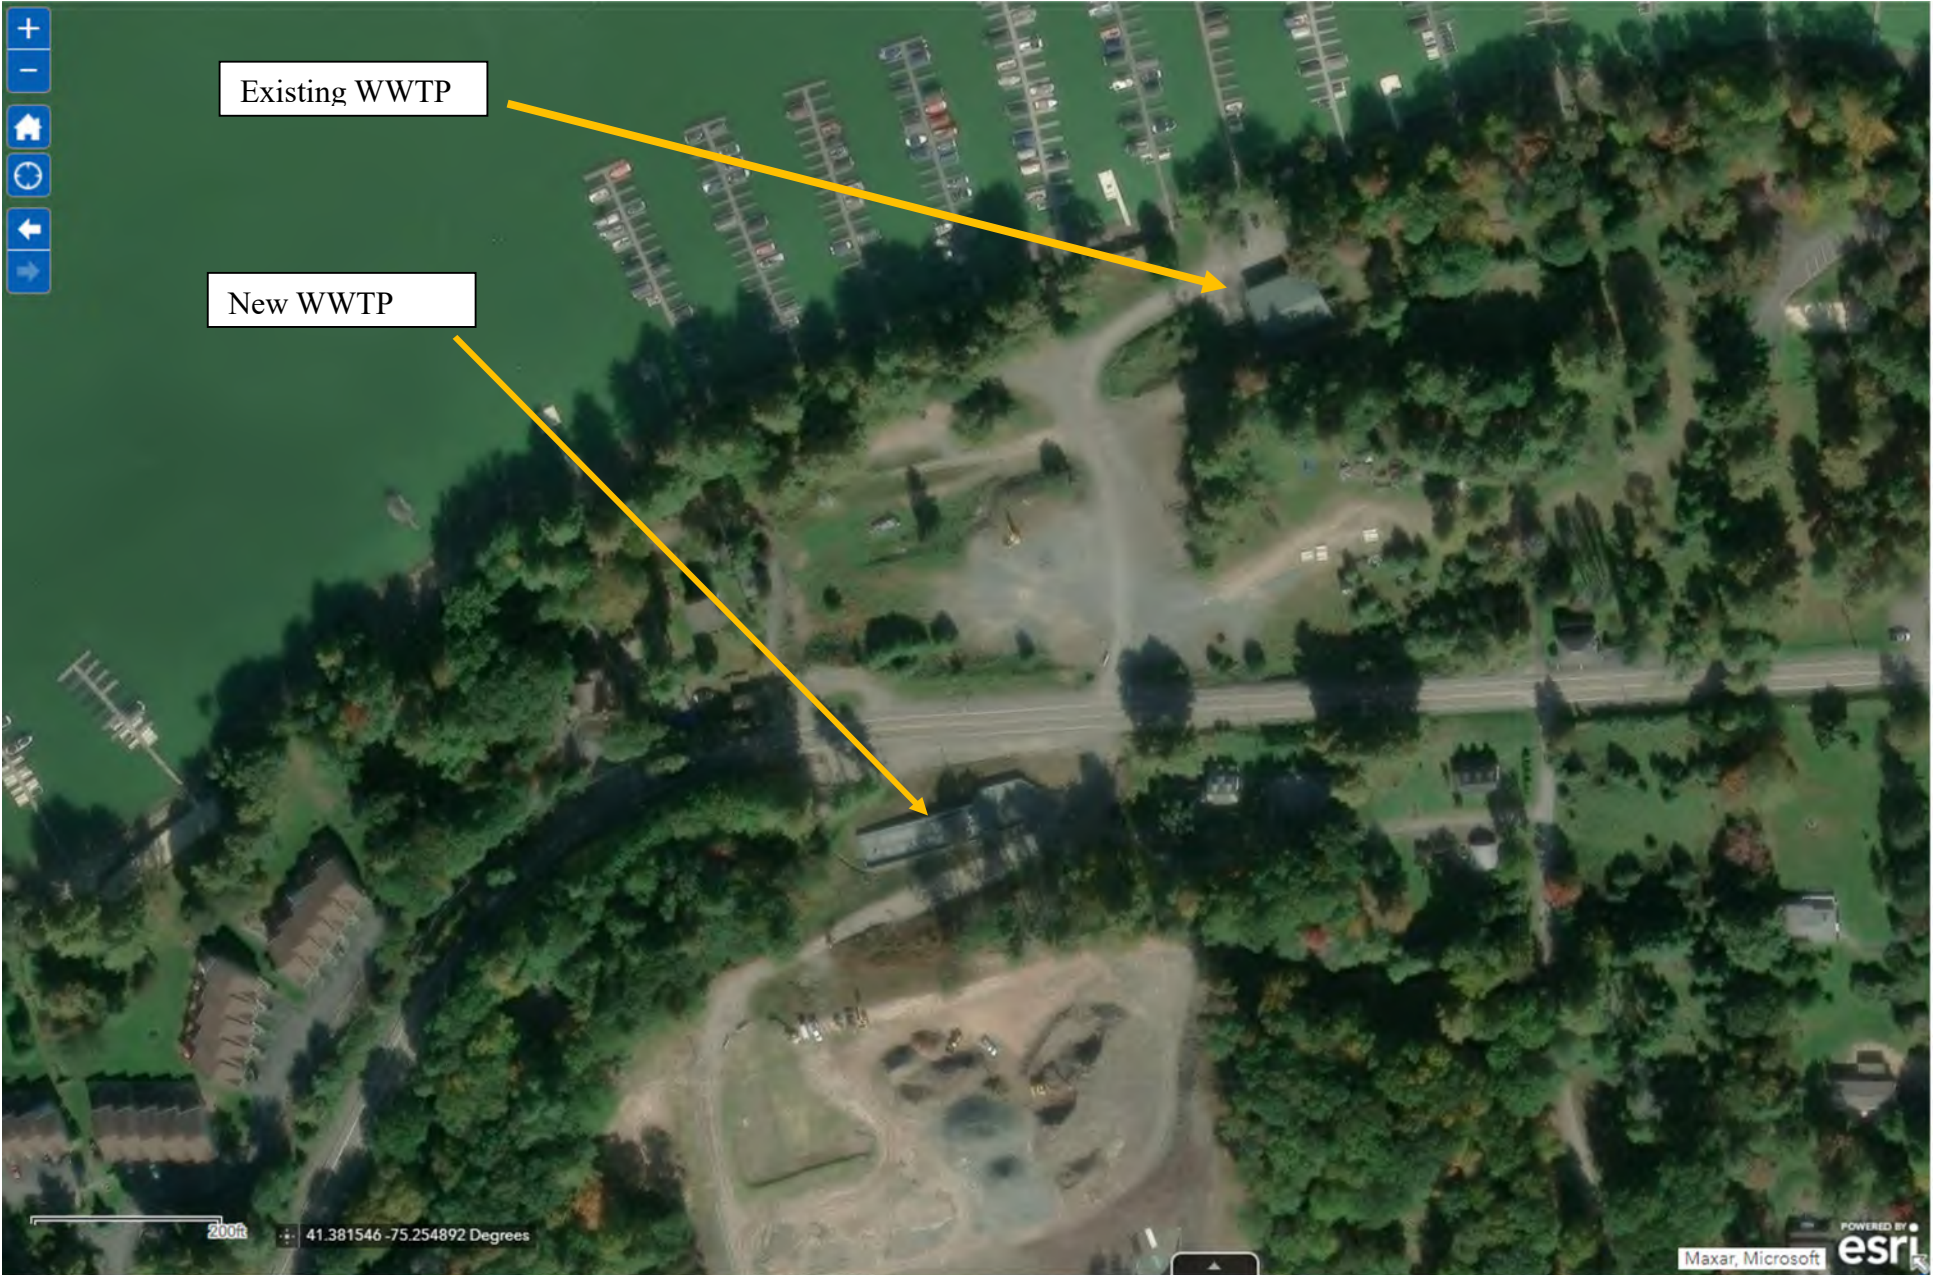
ATTACHMENT C

Existing WWTP

New WWTP
