**VIA ELECTRONIC DELIVERY**Rosemary Chiavetta, Secretary  
Pennsylvania Public Utility Commission  
Commonwealth Keystone Building  
400 North Street, Second Floor  
Harrisburg, Pennsylvania 17120**Re: Joint Letter of Notification Filing of Mid-Atlantic Interstate Transmission, LLC and FirstEnergy Pennsylvania Electric Company for the Geneva–Morgan Street 115 kV GMO Transmission Line Tap Project in Greenwood Township, Crawford County, Pennsylvania**  
**Docket No. \_\_\_\_\_**

Enclosed for filing on behalf of Mid-Atlantic Interstate Transmission, LLC. (“MAIT”) and FirstEnergy Pennsylvania Electric Company (“FE PA”) is a Joint Letter of Notification (“LON”), requesting approval for the Geneva–Morgan Street 115 kV GMO Transmission Line Tap Project (“Project”). This LON is filed pursuant to the Pennsylvania Public Utility Commission’s (“Commission”) regulations at 52 Pa. Code § 57.72(d). Copies of this LON or a Notice of Filing have been served upon the parties as required by 52 Pa. Code § 57.74 and noted in the attached Certificate of Service.

Geneva-Morgan Street 115 kV GMO Transmission Line Tap Project
	115kV Single Circuit Wood Pole Equivalent Tubular Steel Tap Structure Vertica

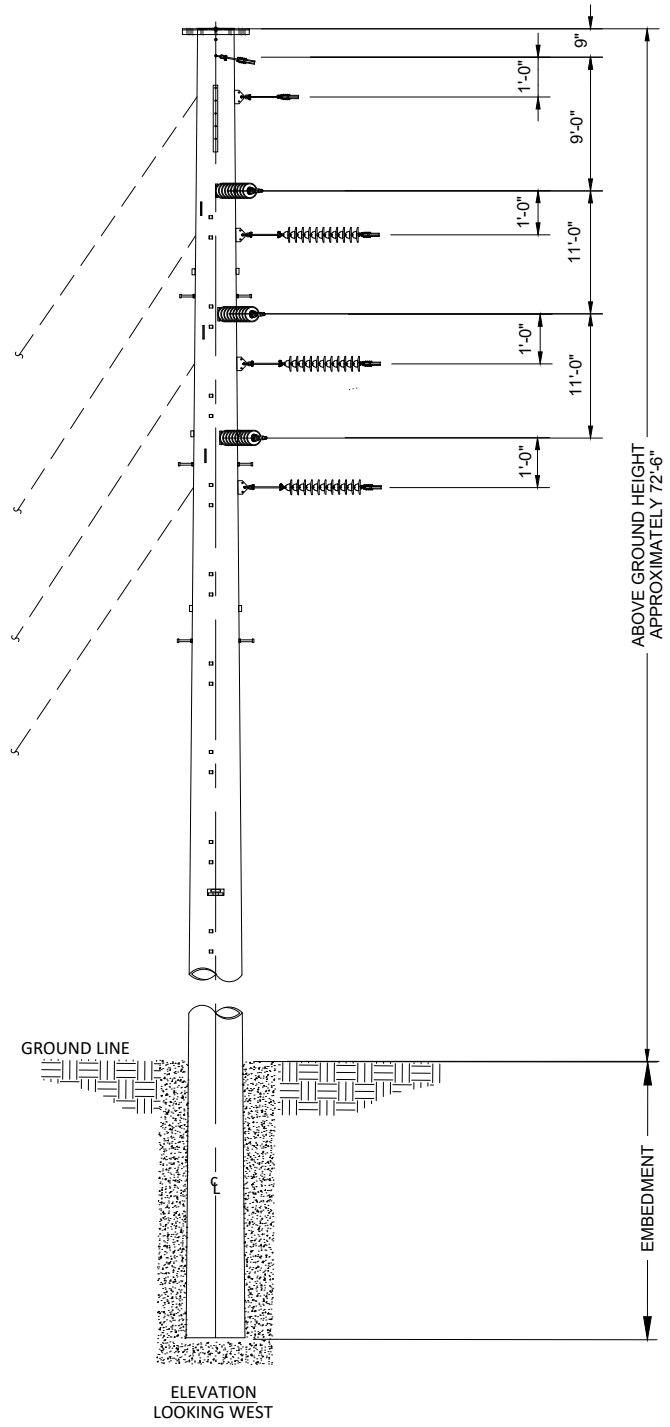
STRUCTURE	AGH (FT)
5A	72.5

- **Exhibit 2:** an overview depicting the general layout of the Project;
  - **Exhibit 3:** a depiction of the general configuration for a single circuit wood pole equivalent tubular steel tap structure vertical single pole;

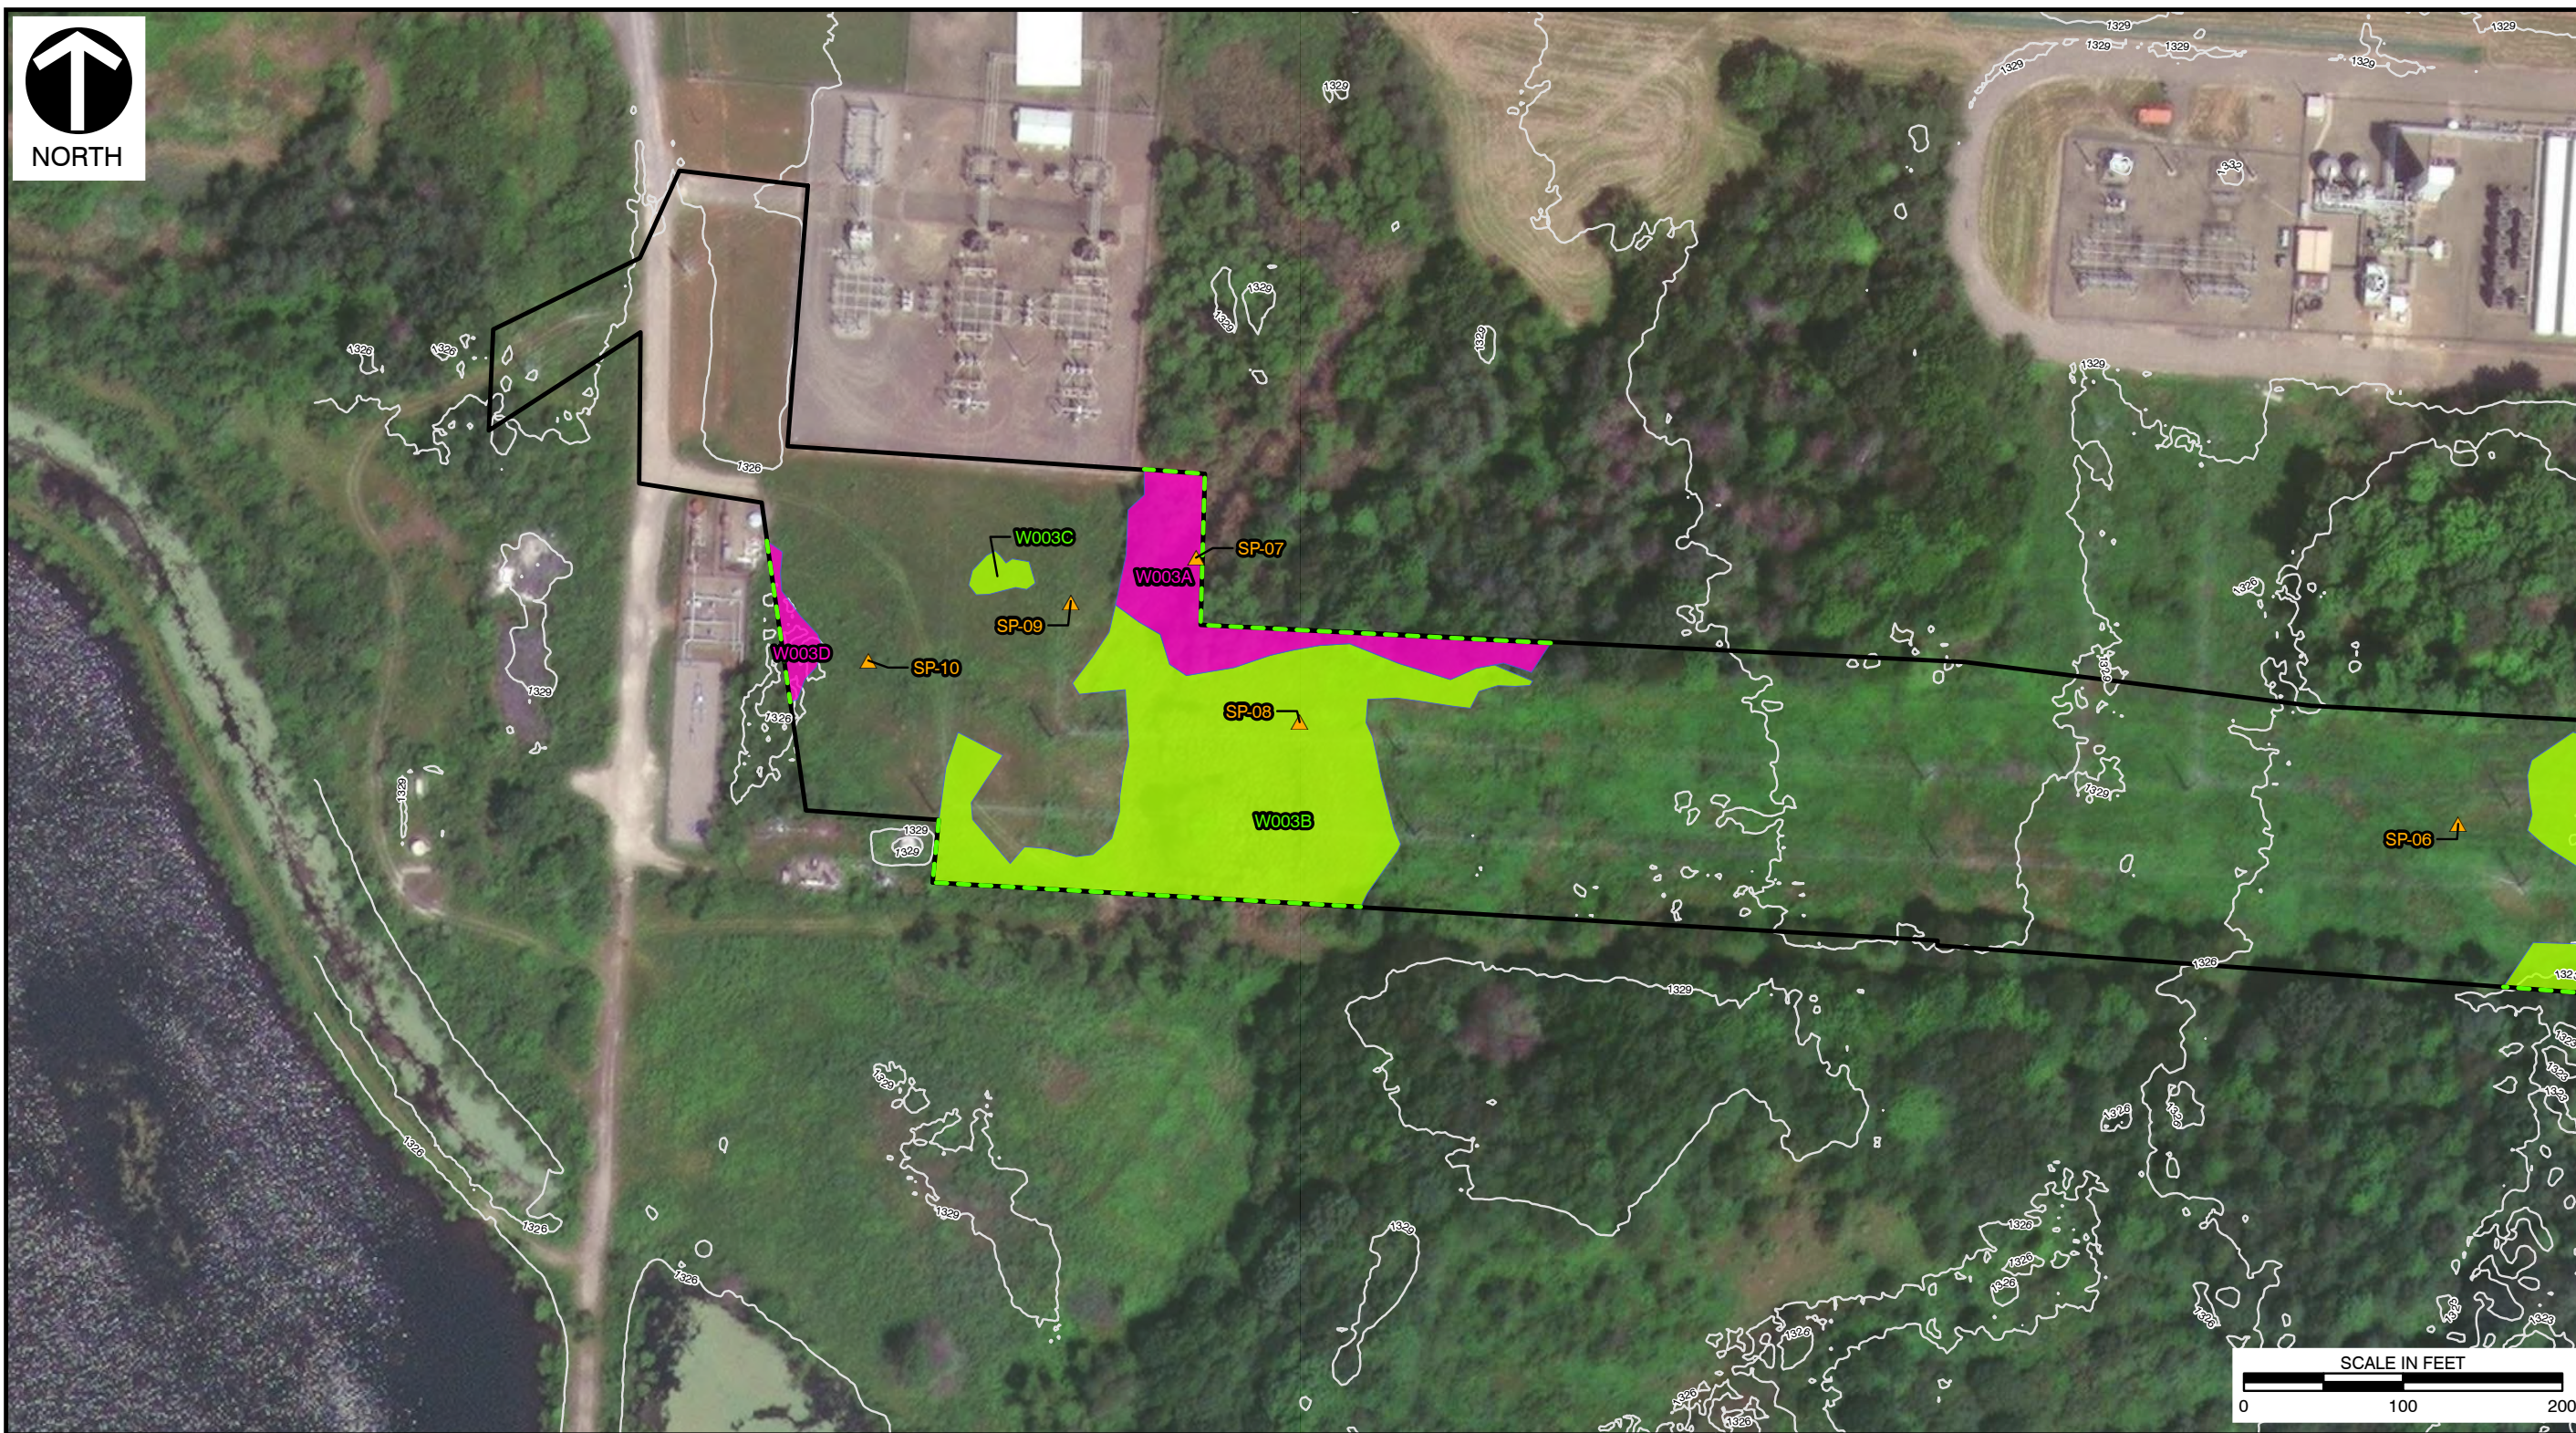
MID-ATLANTIC INTERSTATE TRANSMISSION (MAIT) GENEVA-MORGAN ST. 115KV LINE CRAWFORD COUNTY, PENNSYLVANIA		
<b>WATERS DELINEATION MAP</b>		
APPROVED BY: TCC*	PROJECT NO: 326-630	FIGURE NO: <b>3-1</b>

<b>LEGEND</b>	
SAMPLING POINT	WETLAND - PEM
OPEN BOUNDARY	WETLAND - PFO
3 FT. INTERVAL CONTOURS	AREA OF INTEREST (AOI)

CEC staff conducted a field delineation on July 1, and July 29, 2024, to identify, delineate, and classify wetlands, streams, and other waters within the AOI. The AOI consisted of a maintained lawn adjacent to an industrial development, meadow right-of-way, forest, and emergent and scrub-shrub wetlands. In total, three wetlands comprised of seven components were found within the AOI (Figure 3). No streams or other waters were observed. A photographic summary is included in Appendix B. Wetland Determination Data Sheets are provided in Appendix C.

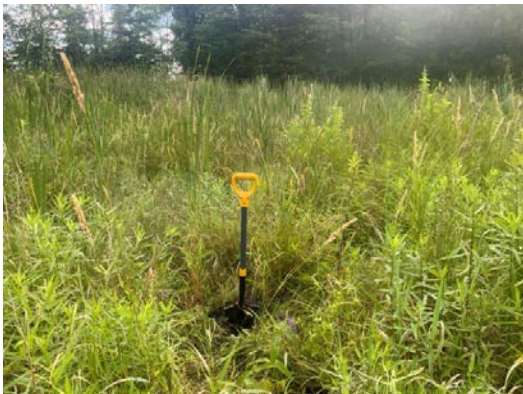
1. Sample Point SP-01, W001A  
Facing Northeast

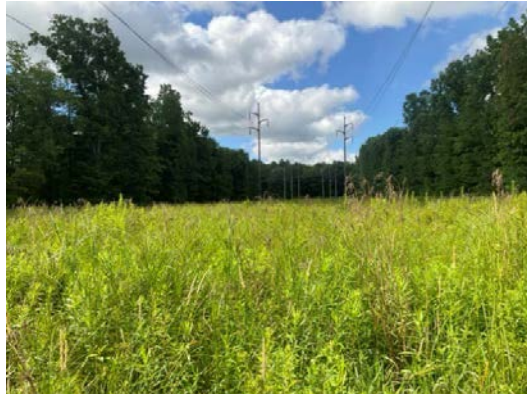
2. W001A (PEM) Overview  
Facing South

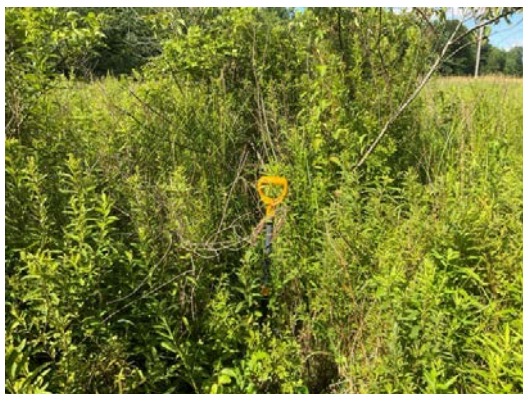
3. Sample Point SP-02, W001B  
Facing Southwest

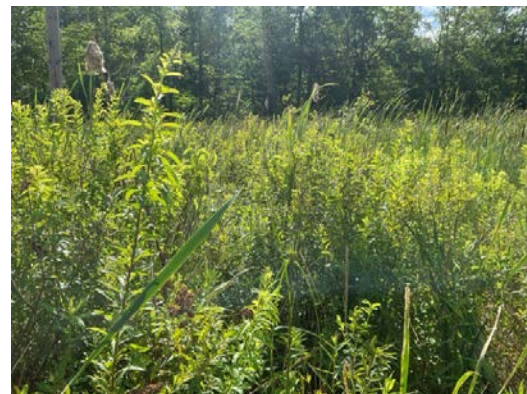
4. W001B (PSS) Overview  
Facing East

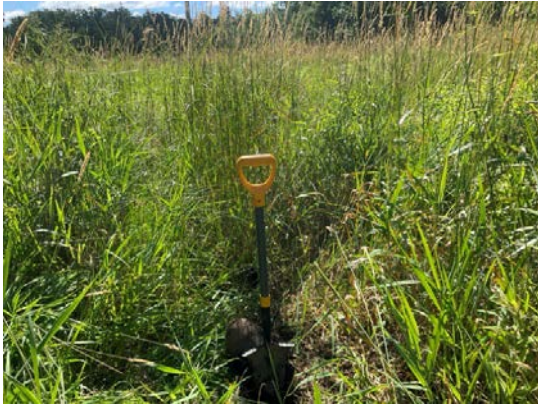
7. Sample Point SP-05, W002  
Facing East

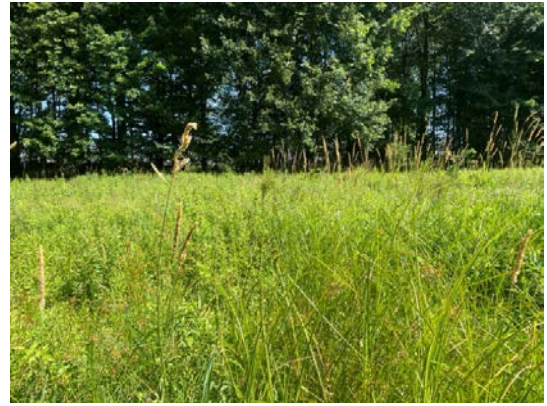
8. W002 (PEM) Overview  
Facing North

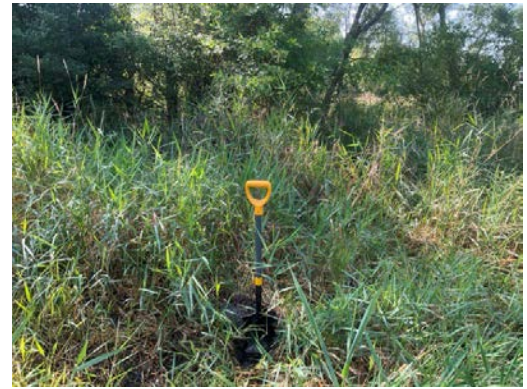
10. Sample Point SP-07, W003A  
Facing Southeast

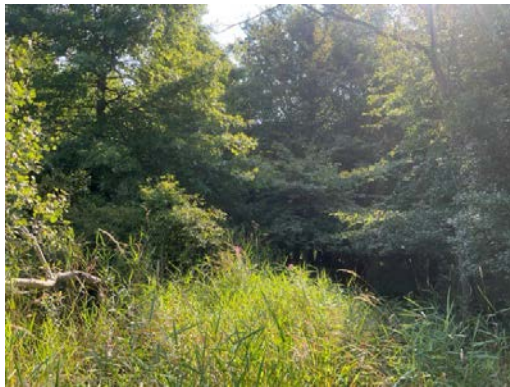
11. W003A (PFO) Overview  
Facing Northeast

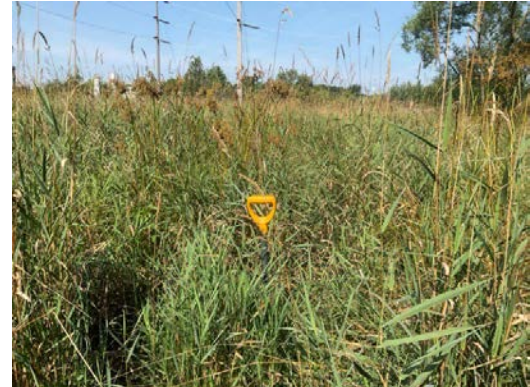
12. Sample Point SP-08, W003B  
Facing West

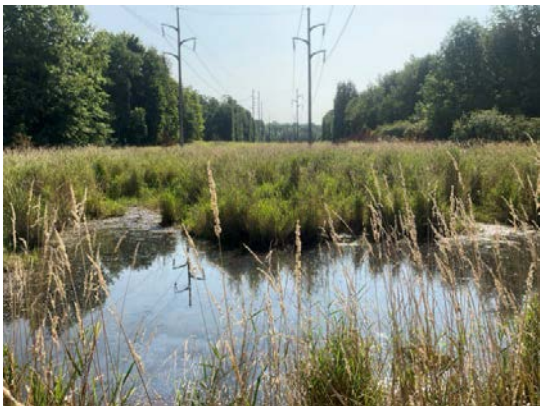
**13. W003B (PEM) Overview  
Facing East**

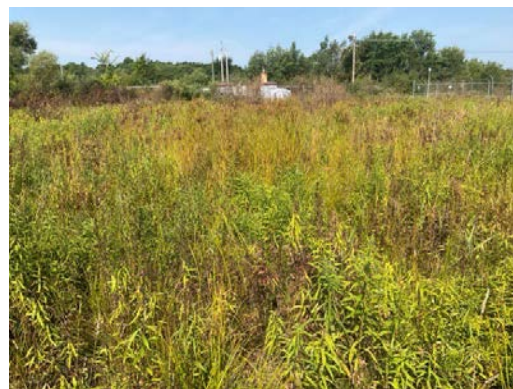
**16. W003C (PEM) Overview  
Facing West**

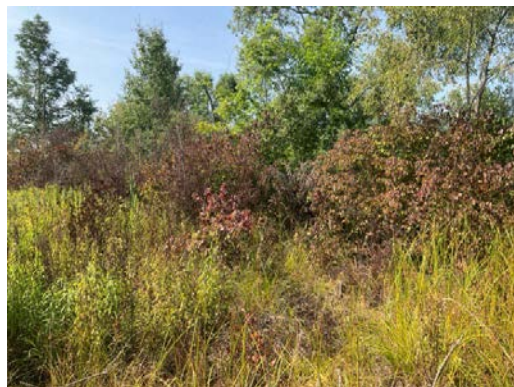
**17. W003D (PFO) Overview  
Facing Southwest**

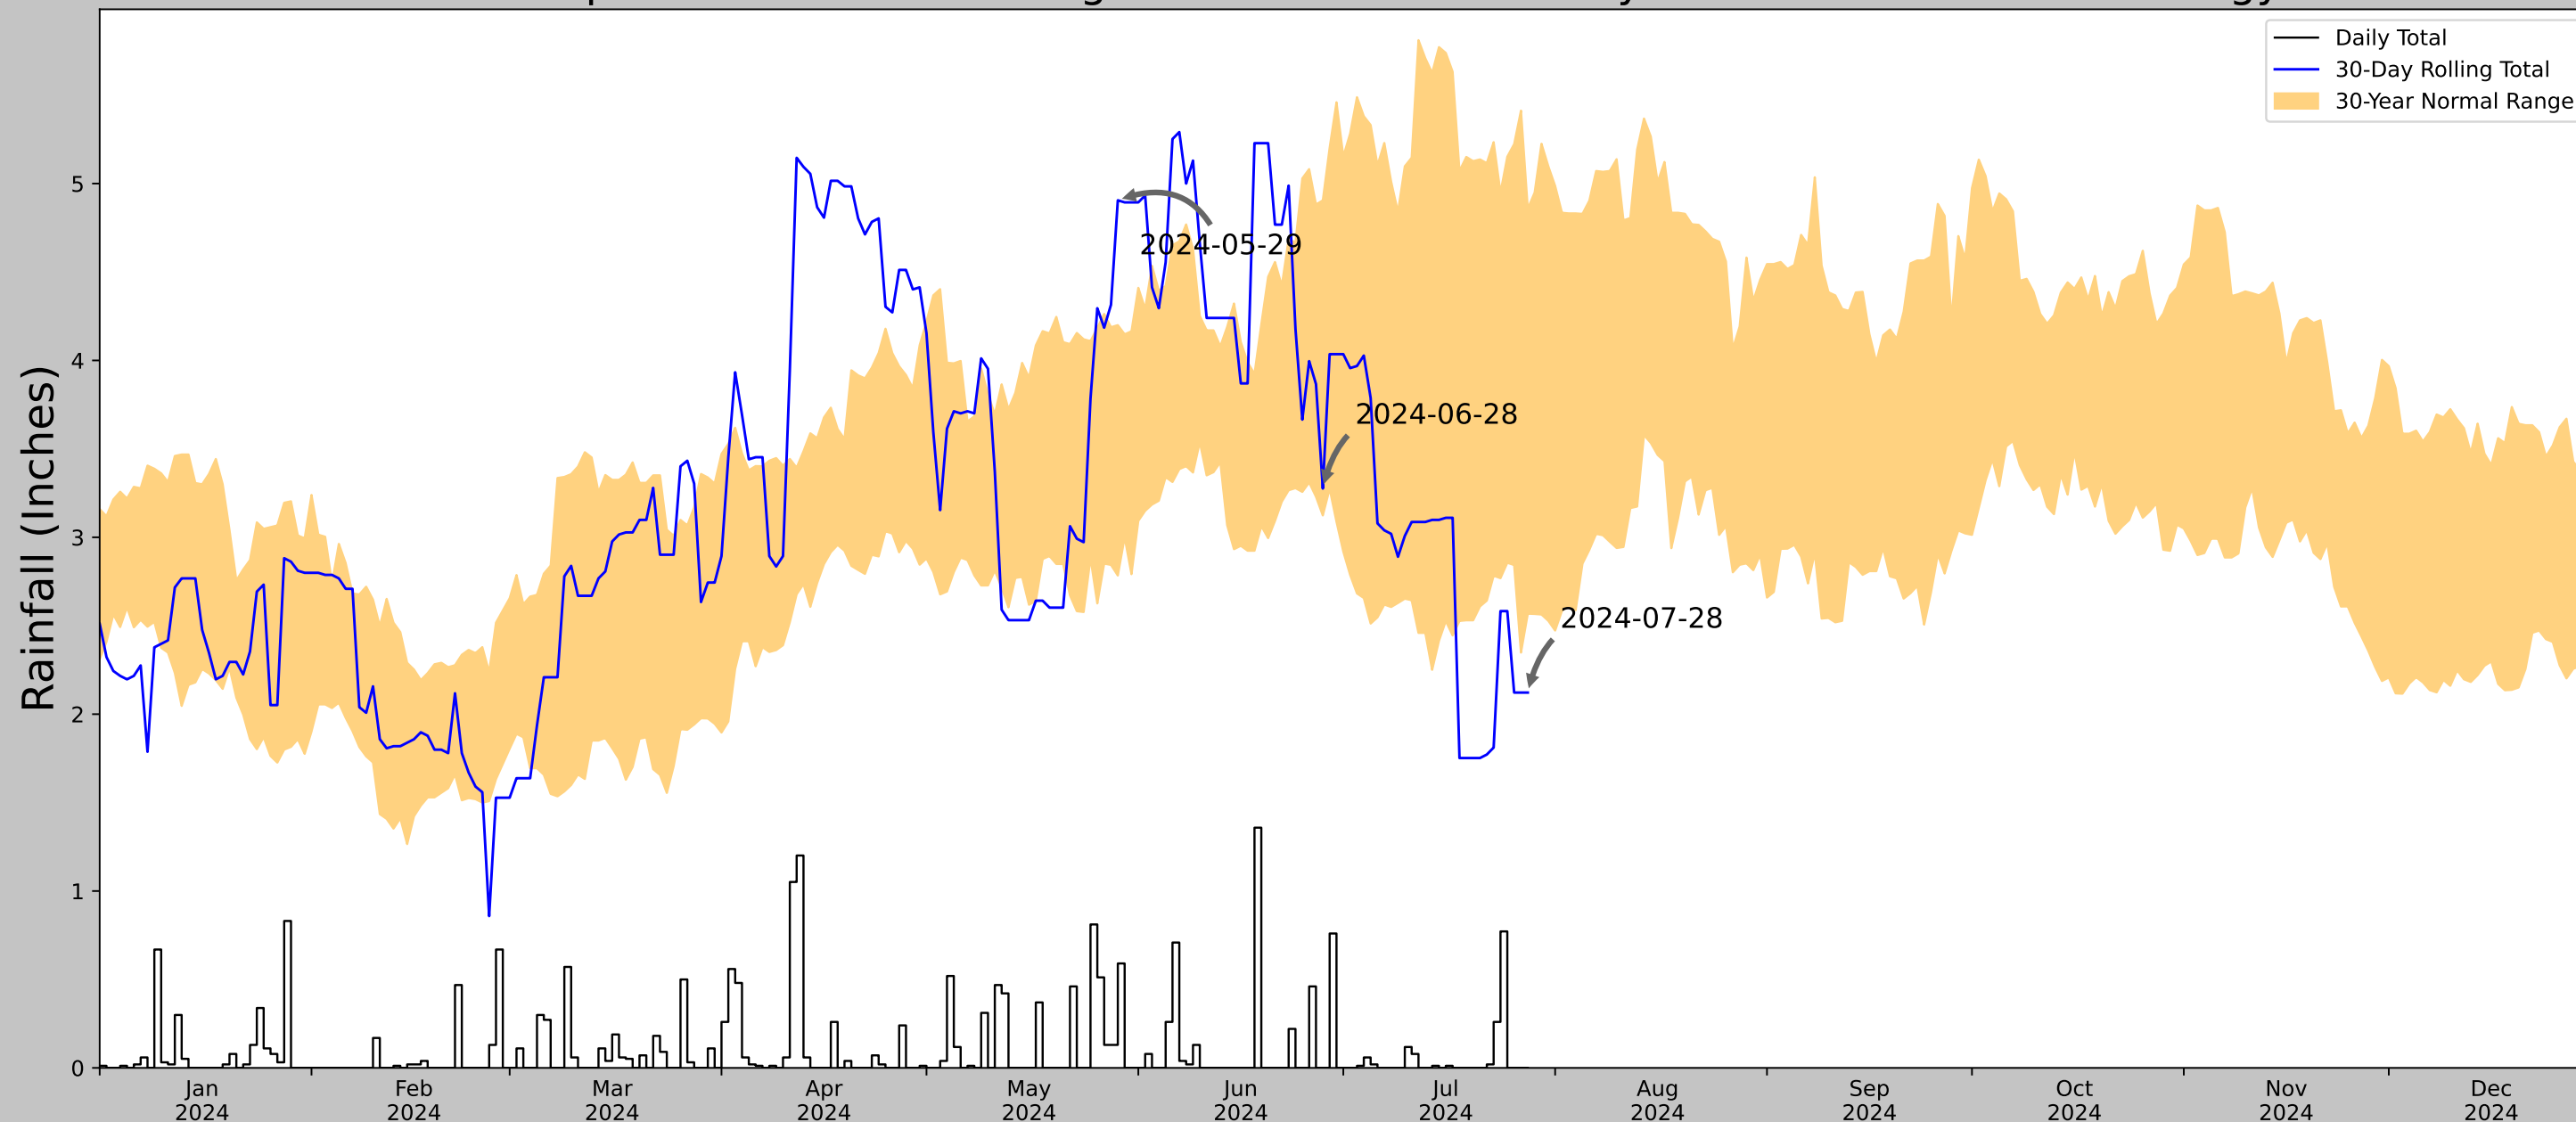
## Antecedent Precipitation vs Normal Range based on NOAA's Daily Global Historical Climatology Network

Coordinates	41.529936, -80.211804
Observation Date	2024-07-28
Elevation (ft)	1322.329806
Drought Index (PDSI)	Incipient drought (2024-06)
WebWIMP H <sub>2</sub> O Balance	Dry Season

30 Days Ending	30 <sup>th</sup> %ile (in)	70 <sup>th</sup> %ile (in)	Observed (in)	Wetness Condition	Condition Value	Month Weight	Product
2024-07-28	2.56811	4.85748	2.122047	Dry	1	3	3
2024-06-28	3.123622	4.905118	3.275591	Normal	2	2	4
2024-05-29	2.783858	4.199606	4.905512	Wet	3	1	3
Result							Normal Conditions - 10

CEC ran the Antecedent Precipitation Tool (APT) to assess the climatic conditions at the time of the field delineation. The APT compares antecedent or recent rainfall conditions for this location versus the range of normal rainfall conditions that occurred during the preceding 30 years. The APT tool evaluates normal precipitation conditions, assesses the presence of drought conditions, and the approximate dates of wet and dry seasons for a given location. The APT analysis indicated

normal conditions were present at the time of the field delineation. Additionally, the Palmer Drought Severity Index (PDSI) indicated incipient drought at the time of the analysis. The results of the APT analysis are included in Appendix E.

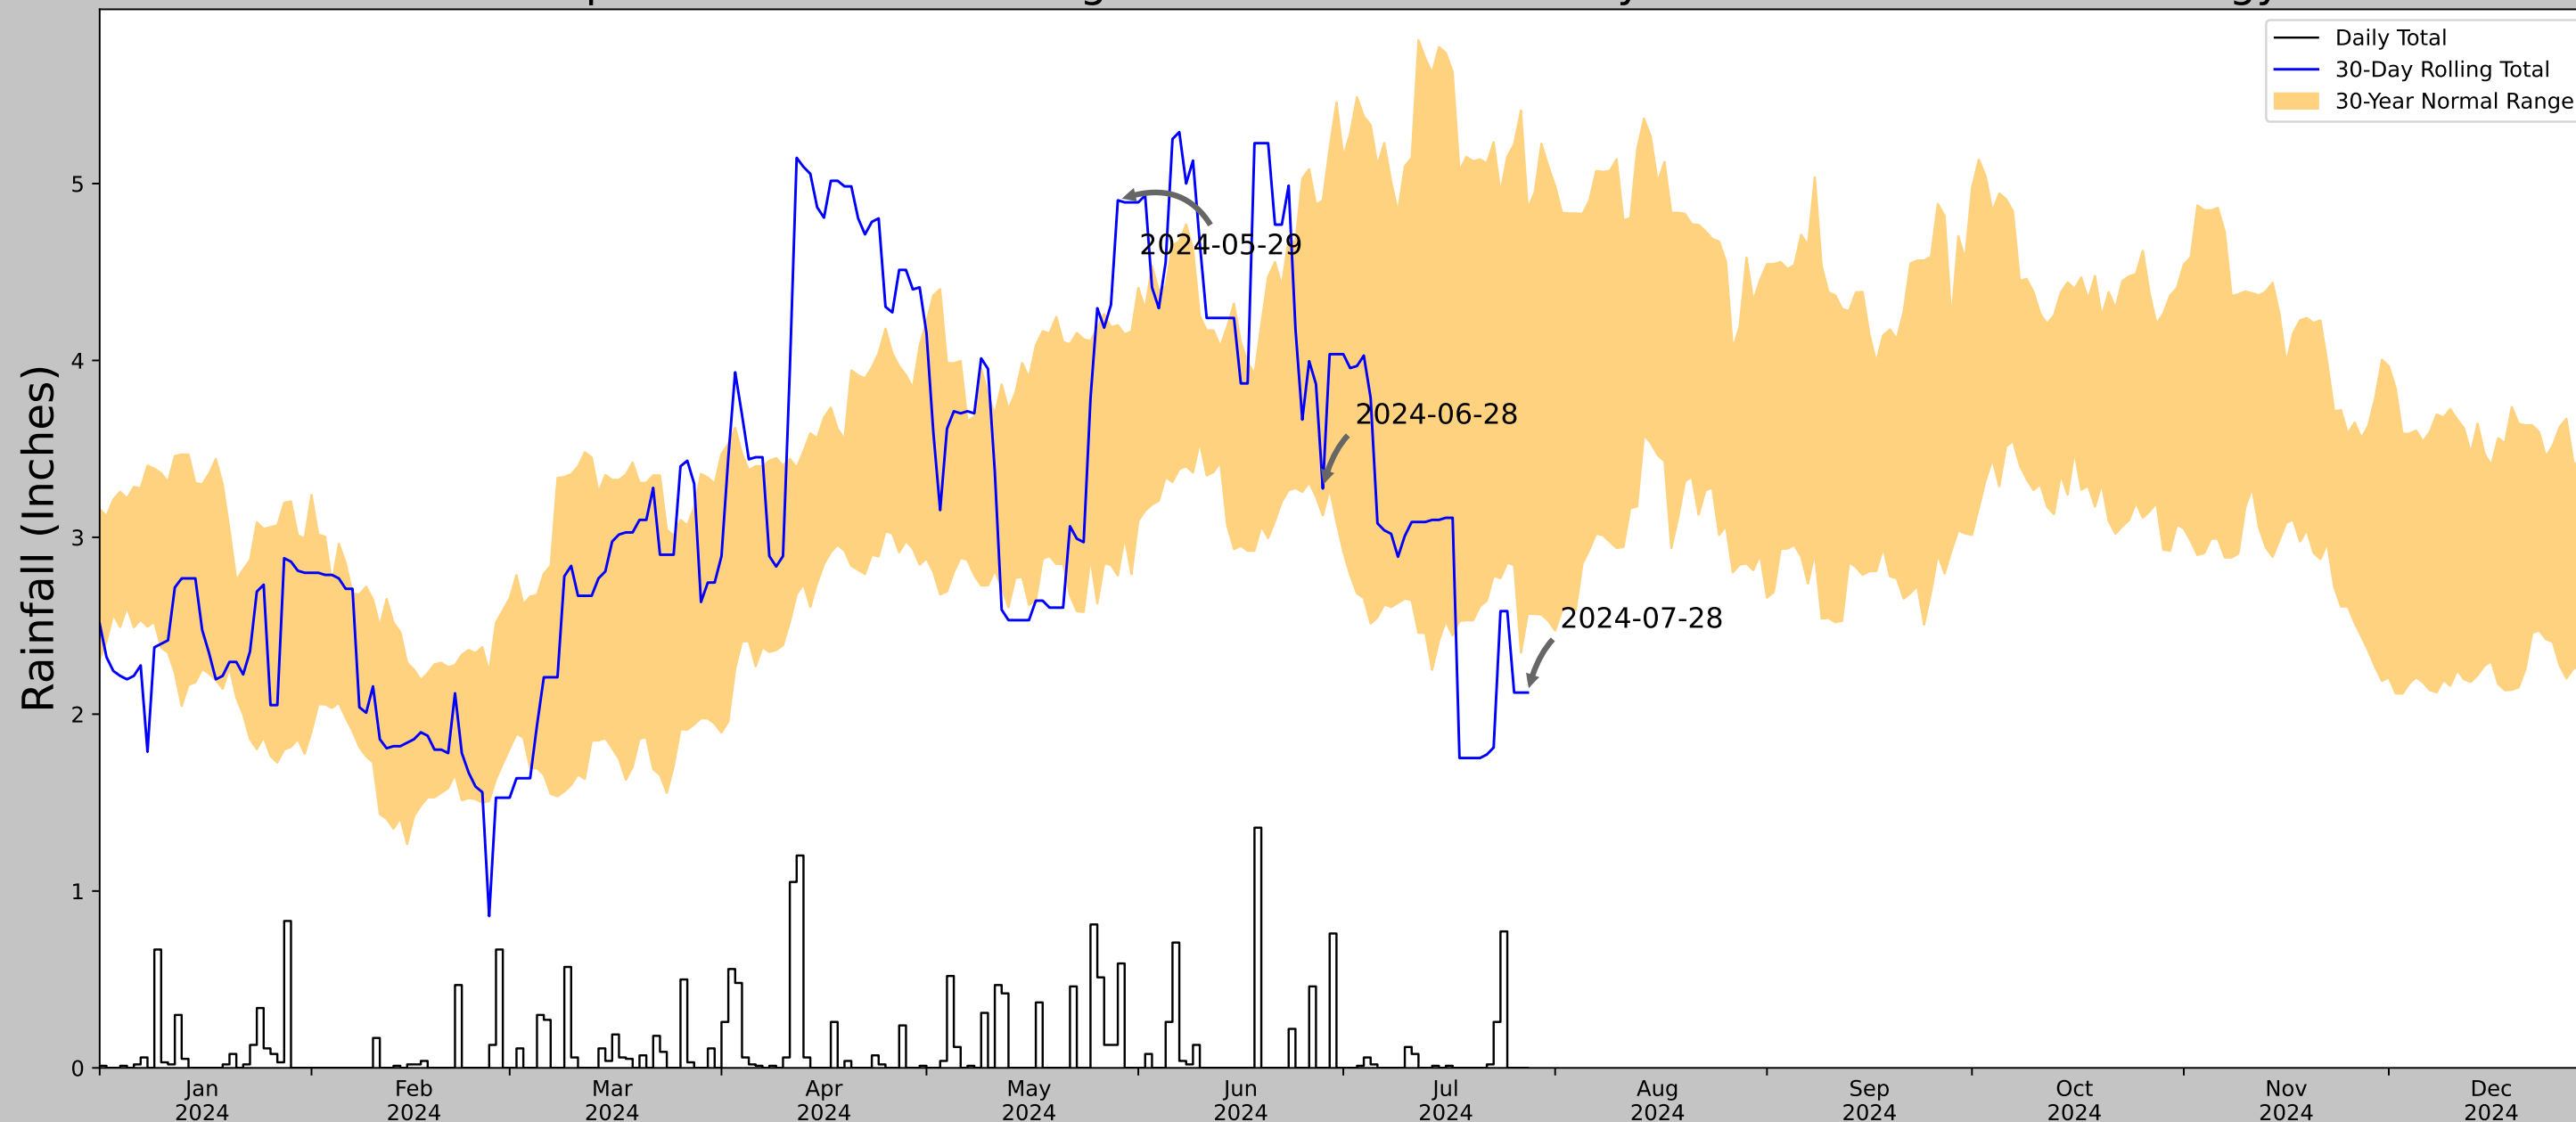
## Antecedent Precipitation vs Normal Range based on NOAA's Daily Global Historical Climatology Network

Coordinates	41.529936, -80.211804
Observation Date	2024-07-28
Elevation (ft)	1322.329806
Drought Index (PDSI)	Incipient drought (2024-06)
WebWIMP H <sub>2</sub> O Balance	Dry Season

30 Days Ending	30 <sup>th</sup> %ile (in)	70 <sup>th</sup> %ile (in)	Observed (in)	Wetness Condition	Condition Value	Month Weight	Product
2024-07-28	2.56811	4.85748	2.122047	Dry	1	3	3
2024-06-28	3.123622	4.905118	3.275591	Normal	2	2	4
2024-05-29	2.783858	4.199606	4.905512	Wet	3	1	3
Result							Normal Conditions - 10

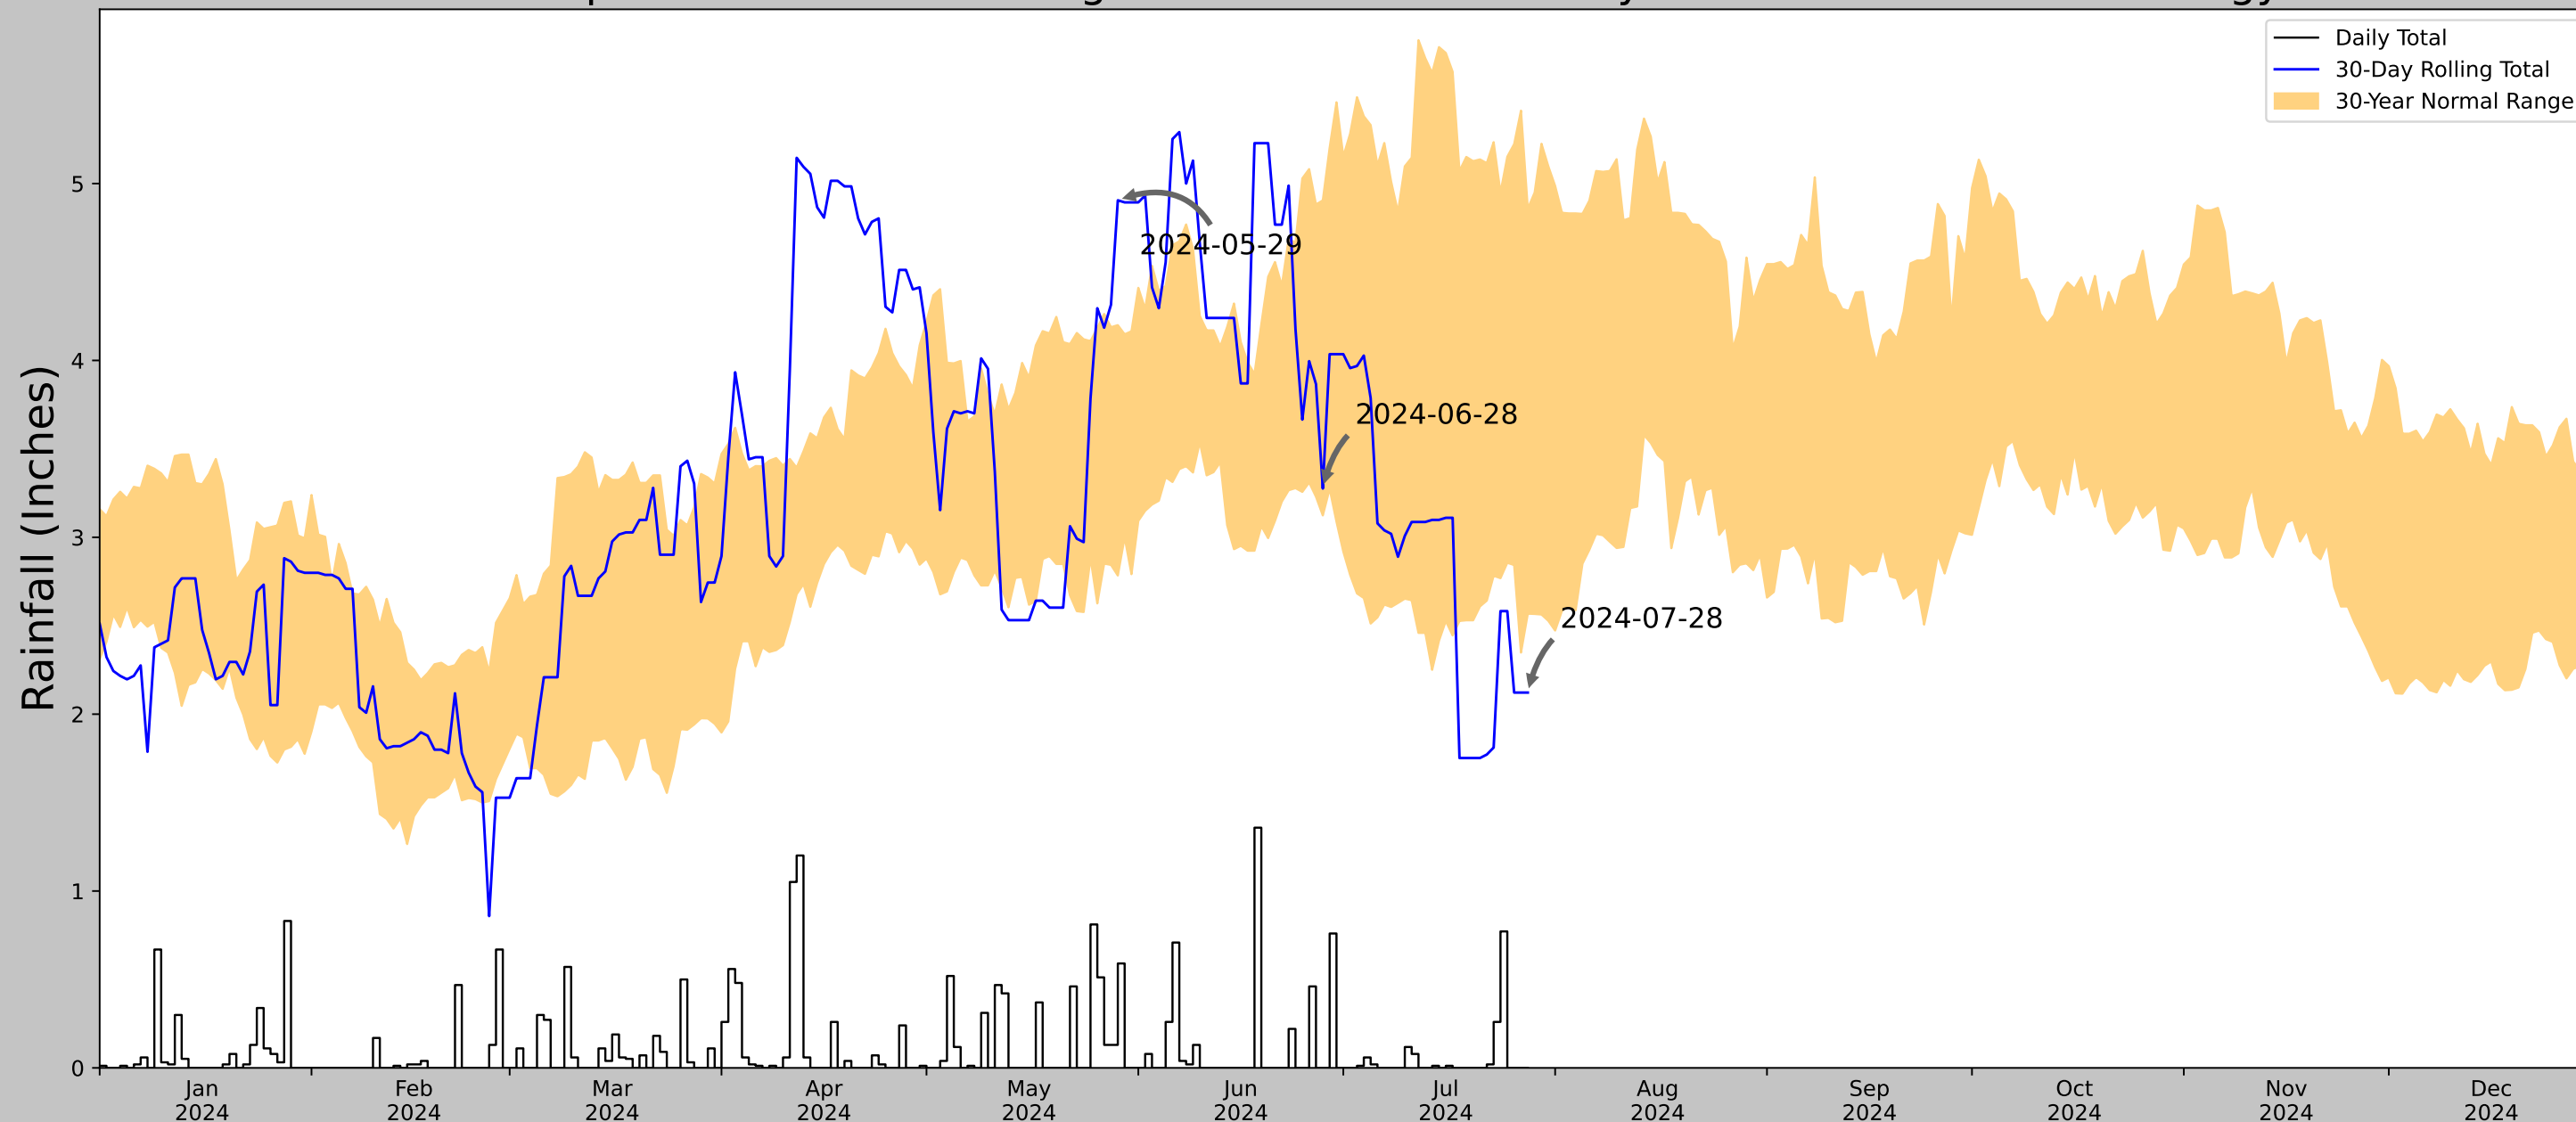
## Antecedent Precipitation vs Normal Range based on NOAA's Daily Global Historical Climatology Network

Coordinates	41.498508, -80.103198
Observation Date	2024-07-28
Elevation (ft)	1467.38042
Drought Index (PDSI)	Incipient drought (2024-06)
WebWIMP H <sub>2</sub> O Balance	Dry Season

30 Days Ending	30 <sup>th</sup> %ile (in)	70 <sup>th</sup> %ile (in)	Observed (in)	Wetness Condition	Condition Value	Month Weight	Product
2024-07-28	2.56811	4.85748	2.122047	Dry	1	3	3
2024-06-28	3.123622	4.905118	3.275591	Normal	2	2	4
2024-05-29	2.783858	4.199606	4.905512	Wet	3	1	3
Result							Normal Conditions - 10

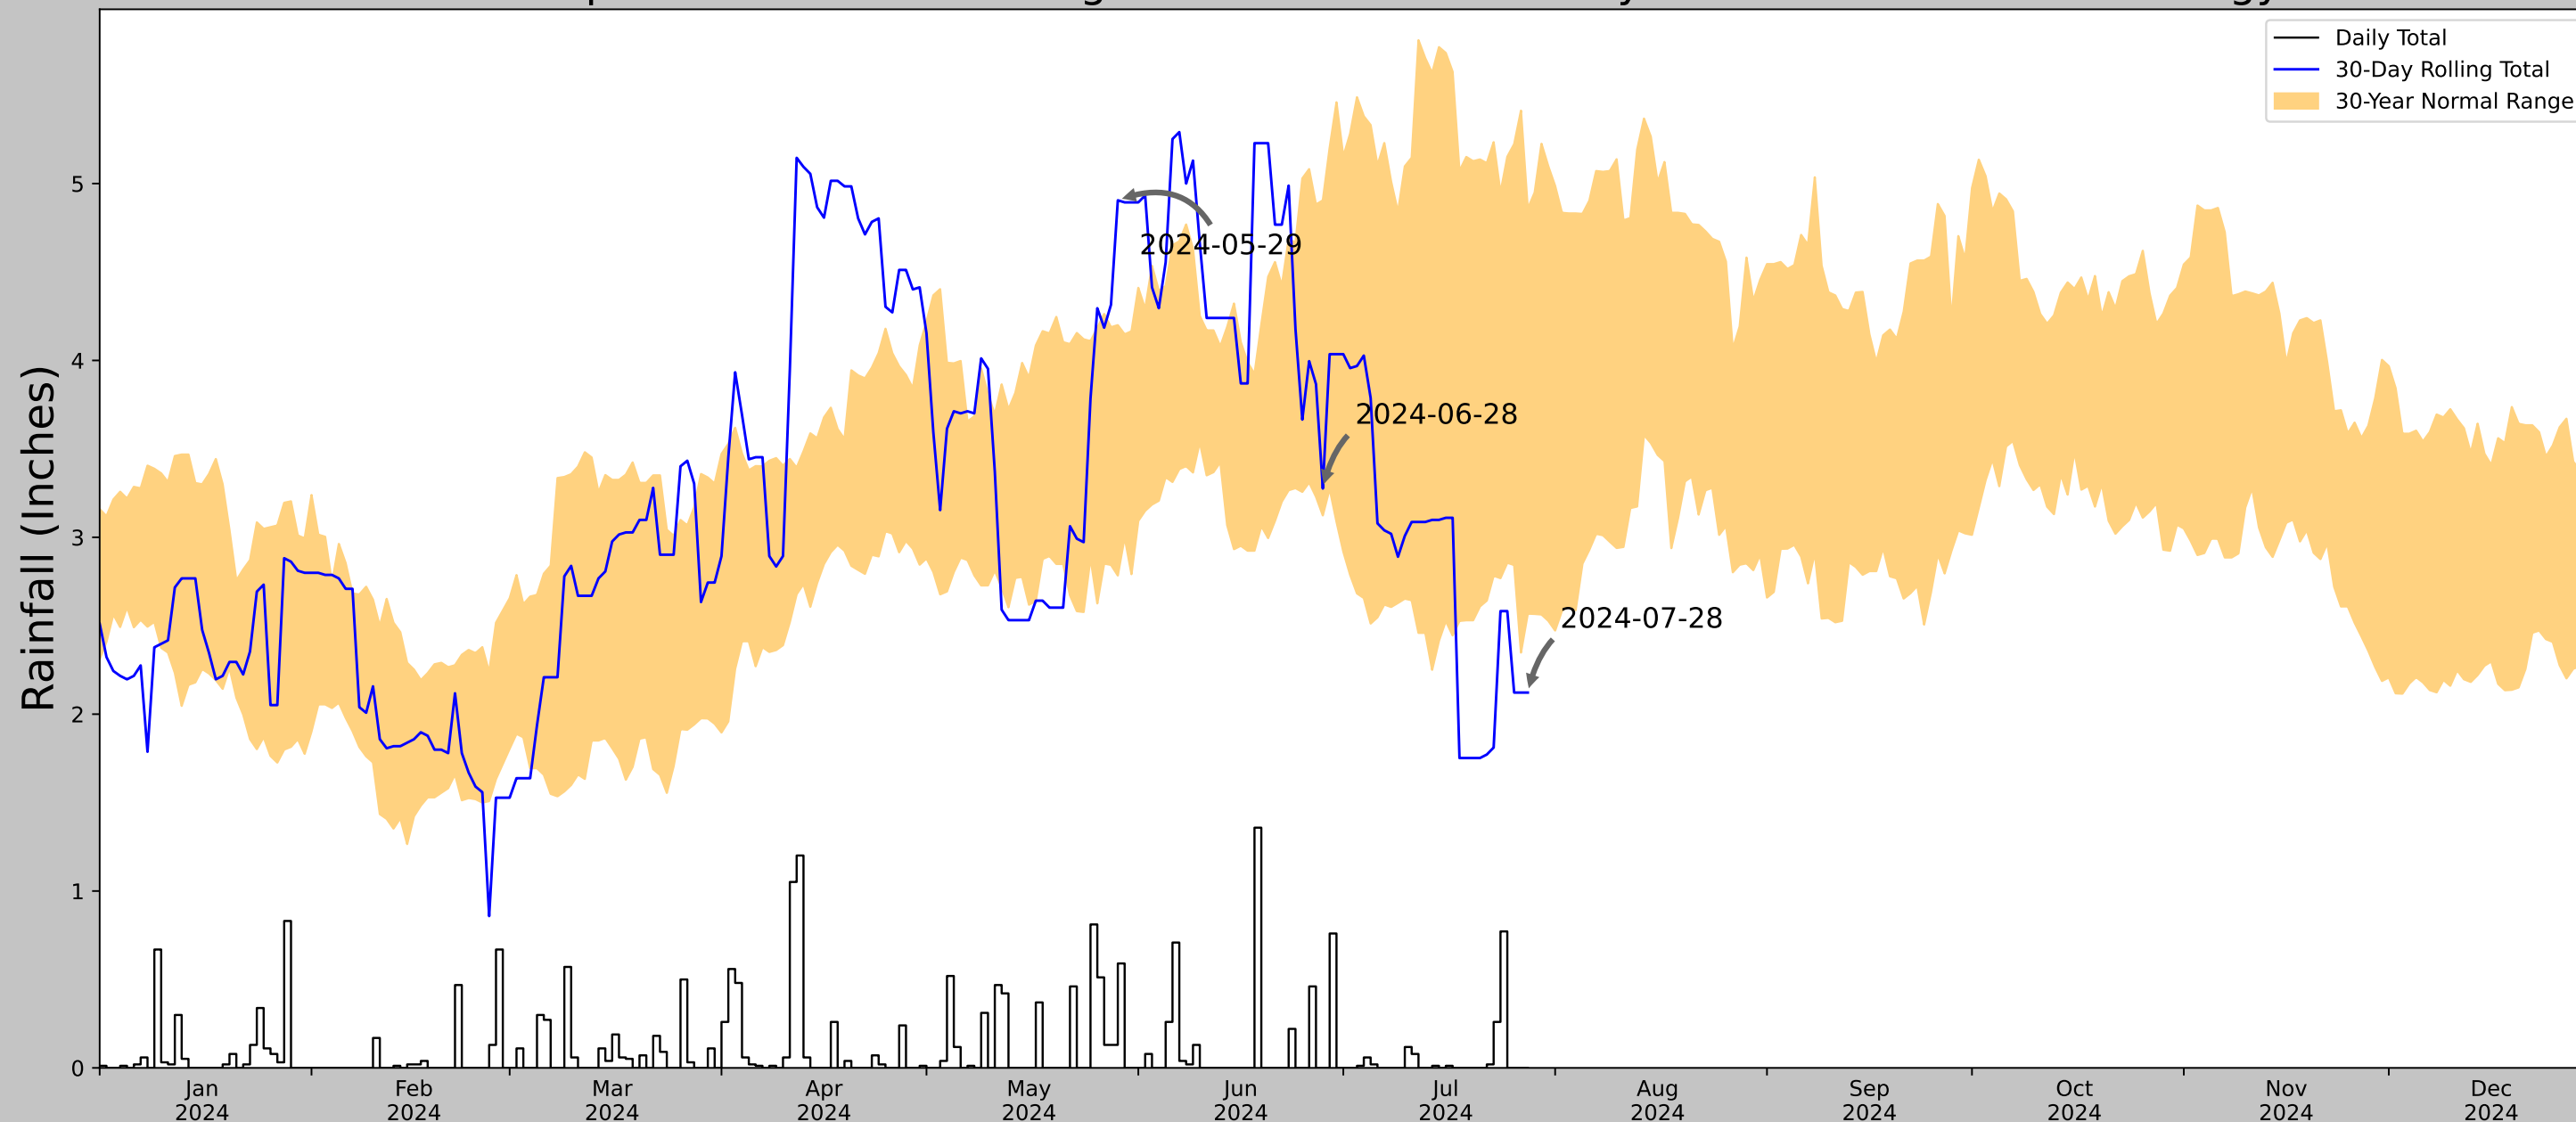
## Antecedent Precipitation vs Normal Range based on NOAA's Daily Global Historical Climatology Network

Coordinates	41.516621, -80.179868
Observation Date	2024-07-28
Elevation (ft)	1336.10617
Drought Index (PDSI)	Incipient drought (2024-06)
WebWIMP H <sub>2</sub> O Balance	Dry Season

30 Days Ending	30 <sup>th</sup> %ile (in)	70 <sup>th</sup> %ile (in)	Observed (in)	Wetness Condition	Condition Value	Month Weight	Product
2024-07-28	2.56811	4.85748	2.122047	Dry	1	3	3
2024-06-28	3.123622	4.905118	3.275591	Normal	2	2	4
2024-05-29	2.783858	4.199606	4.905512	Wet	3	1	3
Result							Normal Conditions - 10
