**VIA ELECTRONIC DELIVERY**Rosemary Chiavetta, Secretary  
Pennsylvania Public Utility Commission  
Commonwealth Keystone Building  
400 North Street, Second Floor  
Harrisburg, Pennsylvania 17120**Re: Joint Letter of Notification Filing of Mid-Atlantic Interstate Transmission, LLC and FirstEnergy Pennsylvania Electric Company for the Geneva–Morgan Street 115 kV GMO Transmission Line Tap Project in Greenwood Township, Crawford County, Pennsylvania**  
**Docket No. \_\_\_\_\_**

Enclosed for filing on behalf of Mid-Atlantic Interstate Transmission, LLC. (“MAIT”) and FirstEnergy Pennsylvania Electric Company (“FE PA”) is a Joint Letter of Notification (“LON”), requesting approval for the Geneva–Morgan Street 115 kV GMO Transmission Line Tap Project (“Project”). This LON is filed pursuant to the Pennsylvania Public Utility Commission’s (“Commission”) regulations at 52 Pa. Code § 57.72(d). Copies of this LON or a Notice of Filing have been served upon the parties as required by 52 Pa. Code § 57.74 and noted in the attached Certificate of Service.

Geneva-Morgan Street 115 kV GMO Transmission Line Tap Project
	115kV Single Circuit Wood Pole Equivalent Tubular Steel Tap Structure Vertica

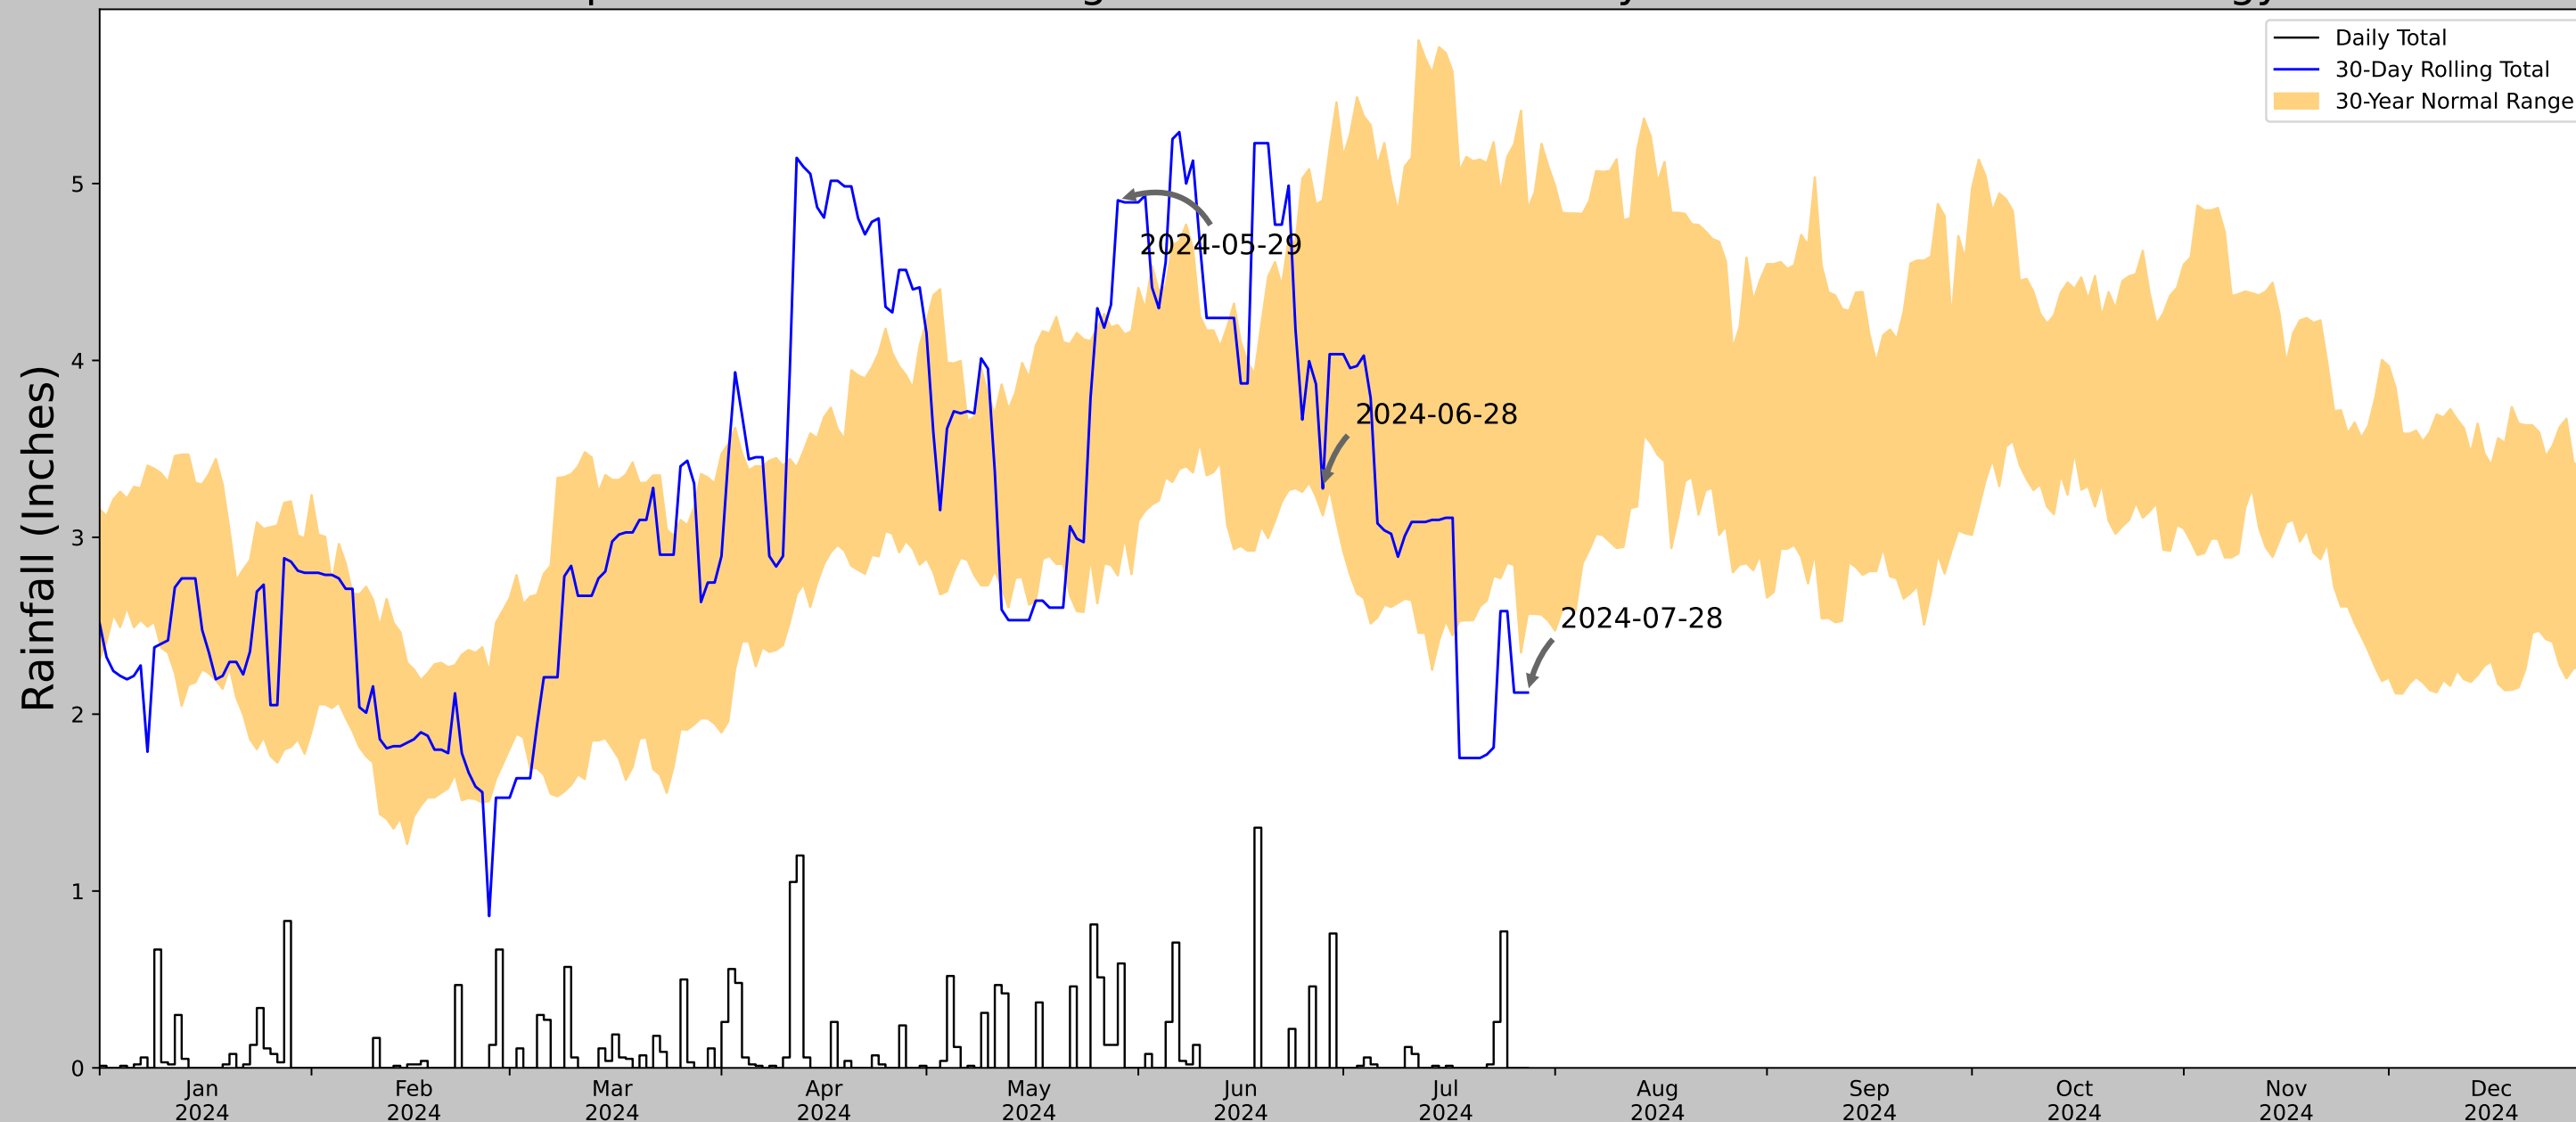
## Antecedent Precipitation vs Normal Range based on NOAA's Daily Global Historical Climatology Network

Coordinates	41.549522, -80.119796
Observation Date	2024-07-28
Elevation (ft)	1161.687393
Drought Index (PDSI)	Incipient drought (2024-06)
WebWIMP H <sub>2</sub> O Balance	Dry Season

30 Days Ending	30 <sup>th</sup> %ile (in)	70 <sup>th</sup> %ile (in)	Observed (in)	Wetness Condition	Condition Value	Month Weight	Product
2024-07-28	2.56811	4.85748	2.122047	Dry	1	3	3
2024-06-28	3.123622	4.905118	3.275591	Normal	2	2	4
2024-05-29	2.783858	4.199606	4.905512	Wet	3	1	3
Result							Normal Conditions - 10
