**In re: Joint Petition of Pennsylvania-American Water Company and
the Pennsylvania Department of Environmental Protection
Requesting an *Ex Parte* Emergency Order in Regard to
Receivership of East Dunkard Water Authority**

Docket No. P-2023-3043950

Fourth Quarter 2024 Status Report

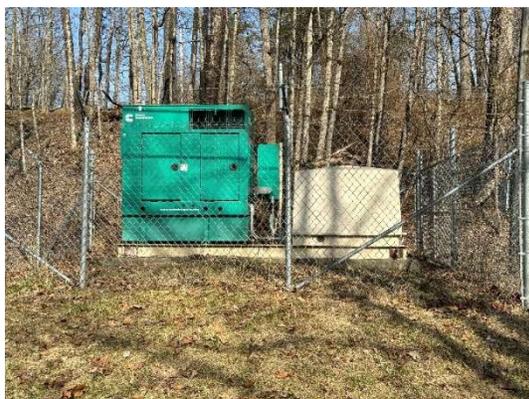
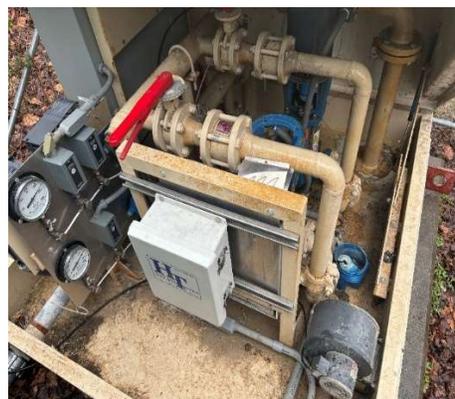
(3) *Davistown Pump Station*: This is a newer station in fair condition (see photos). Short-term needs include replacement of pumps and variable frequency drives, and installation of electric surge protection. These improvements are being planned for 2024 under the CDBG.

Long-term needs include installation of air release valves; replacement of heater and enclosure; extension of security fence around incoming electrical equipment; access road improvements; and installation of new SCADA platform equipment.

UPDATE: Partially completed. Pumps and VFD's were replaced. Timing of remainder changed to POST-CLOSE. No CDBG funding.

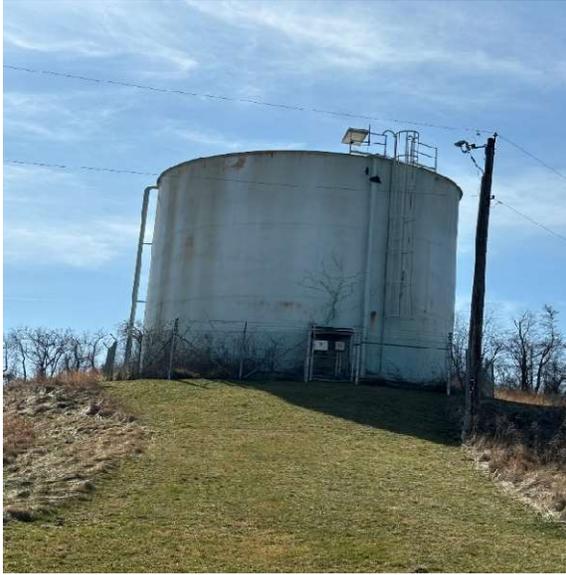
(7) *Donley Tank*: This is an older tank in poor condition (see photo). The tank is in need of rehabilitation including painting; installation of a new valve pit; gate and fence replacement and other security improvements;

access road improvements; and installation of new SCADA platform equipment

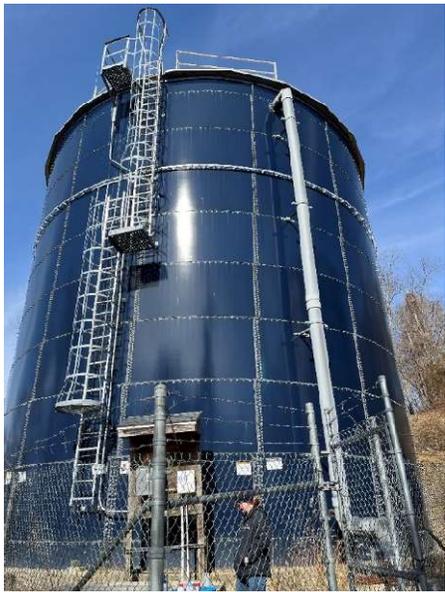
(8) *New Griffin Tank*: This is a newer tank in good condition (see photo). PAWC has already improved the access road to this tank. There are short-term improvements planned for the tank under the plant entry point project (see Section 4.1.1.10). No other improvements are needed.
