**In re:            Joint Petition of Pennsylvania-American Water Company and  
the Pennsylvania Department of Environmental Protection  
Requesting an *Ex Parte* Emergency Order in Regard to  
Receivership of East Dunkard Water Authority**

**Docket No. P-2023-3043950**

**First Quarter 2025 Status Report**

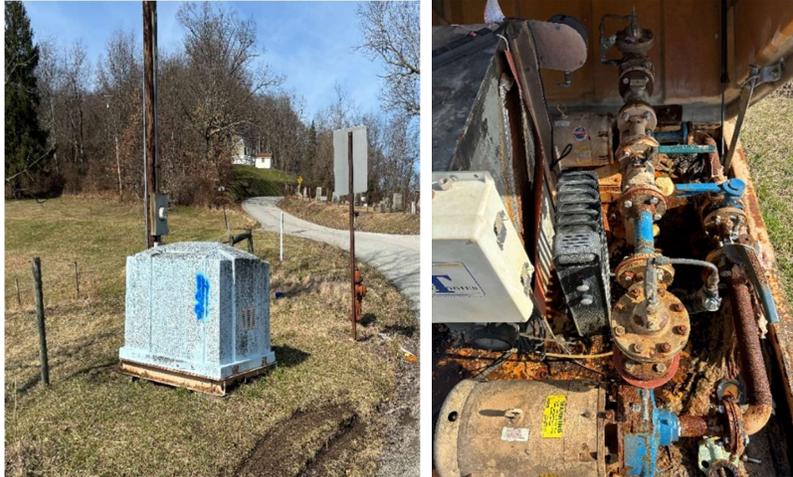
*(1) Bald Hill Pump Station*: This is an older station in poor condition. It is also situated very close to a public roadway with little protection from vehicle accidents (see photos).

Short-term needs include replacement of both pumps, and repair SCADA communication issues. PAWC has secured an emergency permit from the Department to replace the pumps at the station. The new pumps were ordered and received from the manufacturer and plans are currently being made to retain a contractor to install them. SCADA work will proceed once the pumps are replaced.

pump station outage; addition of a connection for a portable generator; and installation of new SCADA platform equipment . Eventually this station should be replaced in a new location with a facility that is designed to meet current Department regulations..

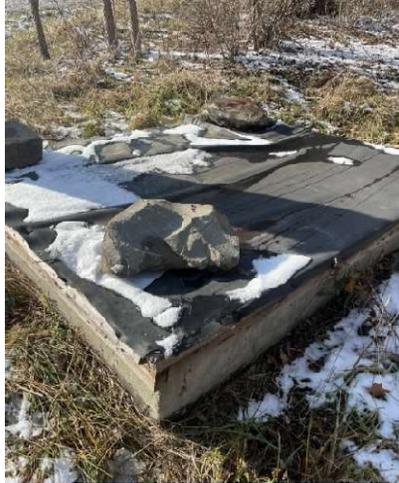
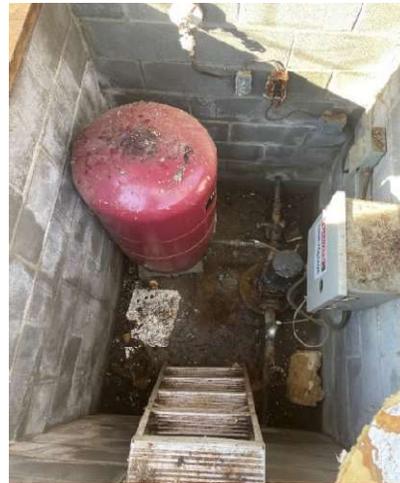
(2) *Bealls Run Pump Station*: This is also an older station in poor condition (see photos). Long-term needs include installation of a permanent top and security fencing; installation of an additional fire hydrant to allow temporary pump-around in case of pump station outage; addition of a connection for a portable generator; and installation of new SCADA platform equipment. These improvements will likely be done during the complete replacement of the current facility.

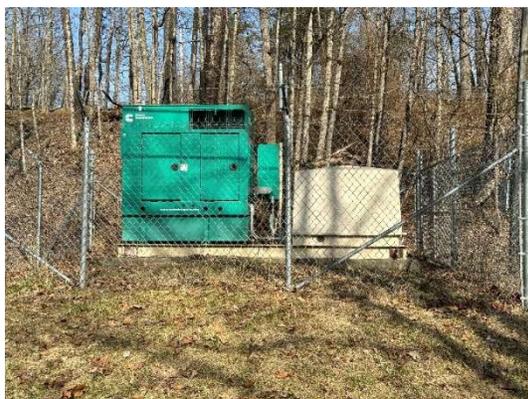
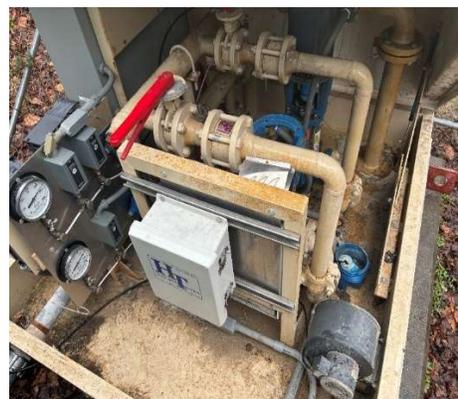
(3) *Davistown Pump Station*: This is a newer station in fair condition (see photos). Short-term needs include replacement of pumps and variable frequency drives, and installation of electric surge protection. These improvements are being planned for 2024 under the CDBG.

UPDATE: Partially completed. Pumps and VFD's were replaced. Timing of remainder changed to POST-CLOSE. No CDBG funding.

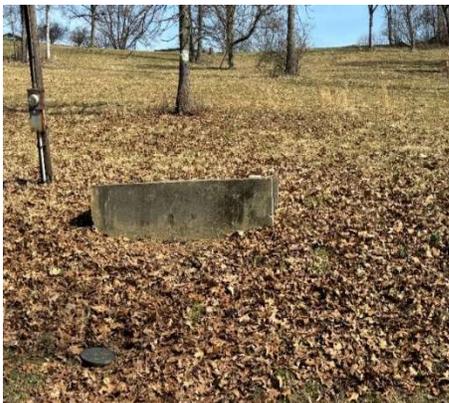
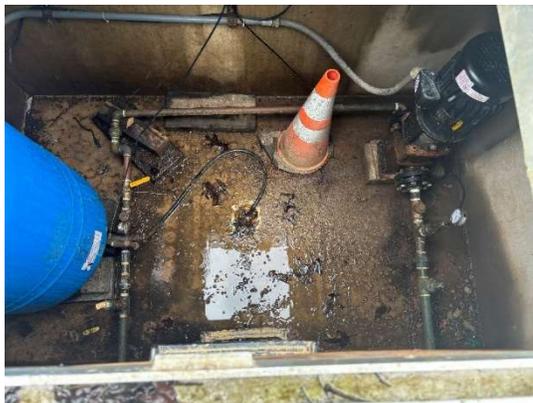
(4) *Laurel Run Pump Station*: This is an older station in fair condition (see photos). Long-term needs include replacement of electric service;

installation of safety steps; replacement of interior piping; installation of security fencing; installation of an additional fire hydrant to allow temporary pump-around in case of pump station outage; addition of a connection for a portable generator; and installation of new SCADA platform equipment.

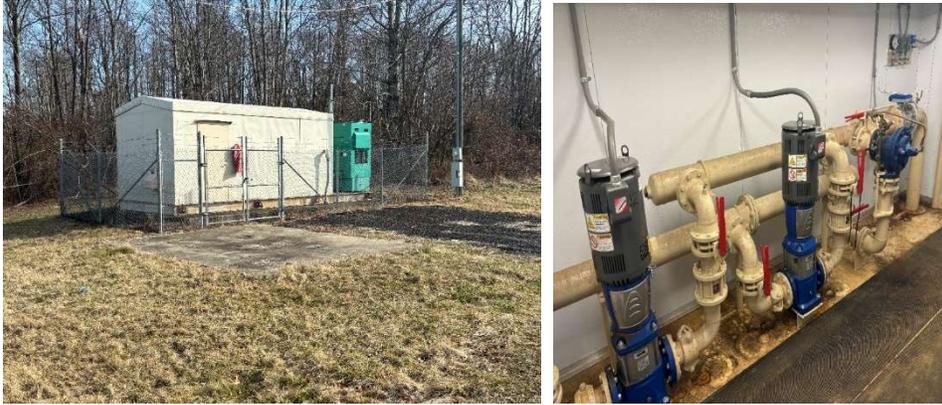
(5) *Rocky Hollow Pump Station*: This is a newer station in relatively good condition (see photos). Short-term needs include replacement of variable frequency drives and installation of electric surge protection. These improvements are being planned for 2024 under the CDBG.

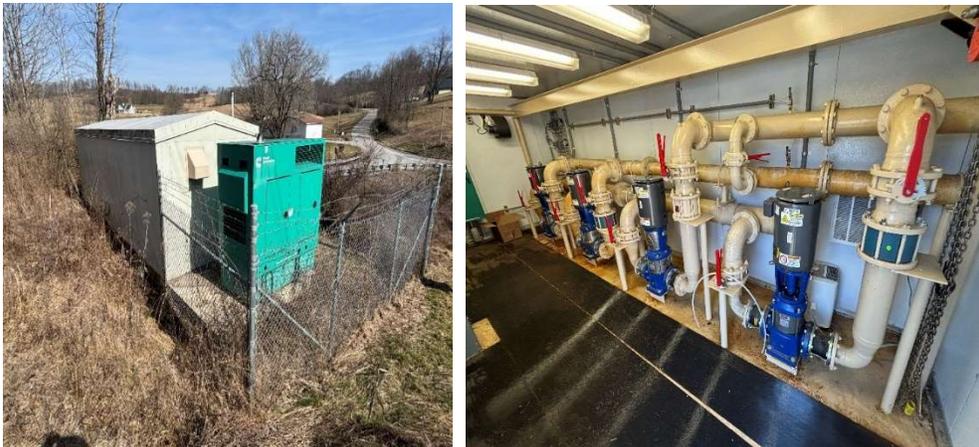
(6) *Willow Tree Pump Station*: This is a newer station in relatively good condition (see photos). PAWC has already replaced four (4) failed variable frequency drives to restore station operation. Additional short-term needs include installation of electric surge protection and line reactors. These improvements are being planned for 2024 under the CDBG.

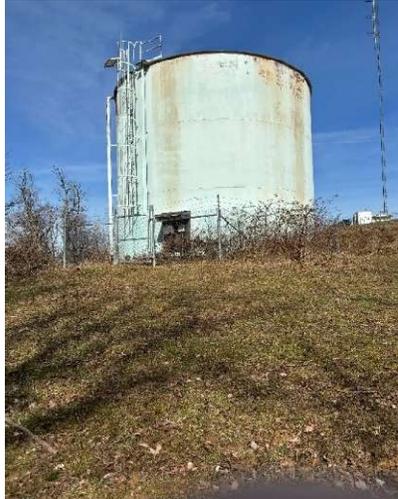
(1) *Abel Tank*: This is an older tank in poor condition (see photo). The tank is in need of rehabilitation including painting; installation of a new valve pit; gate/fence replacement and other security improvements; access road improvements; and installation of new SCADA platform equipment.

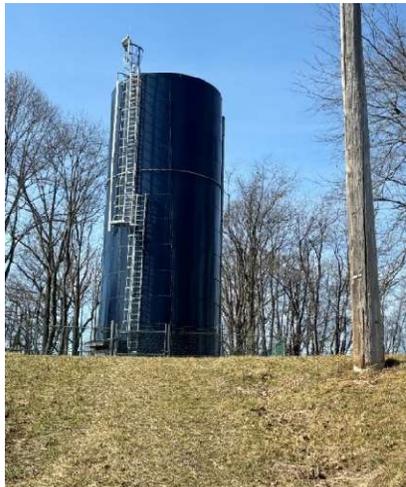
(2) *Alicia Tank*: This is a newer tank in good condition (see photo). The tank is in need of security enhancements; minor leaks fixed; access road improvements; removal of the old valve pit (safety hazard); and installation of new SCADA platform equipment.

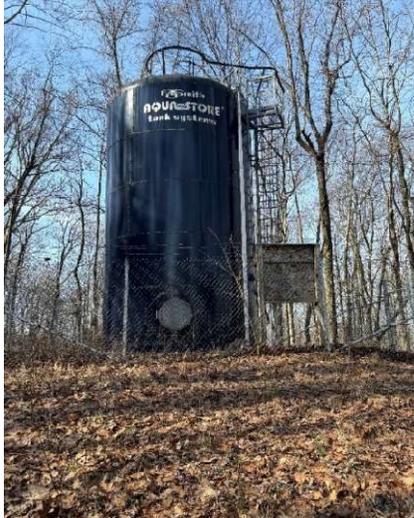
(3) *Bald Hill Tank*: This is a newer tank in good condition (see photo). The tank is in need of security enhancements; overflow pipe modifications; access road improvements; and installation of new SCADA platform equipment.

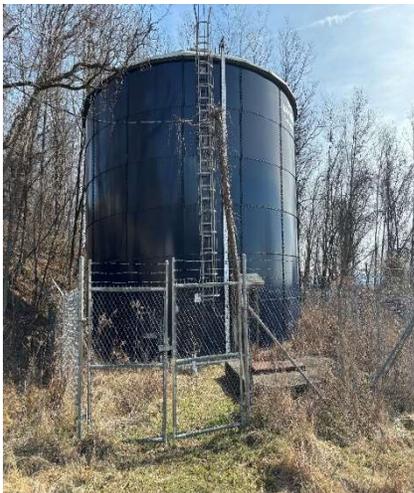
(4) *Bobtown Tank*: This is a newer tank in good condition (see photo). The tank is in need of security enhancements; electrical service replacement; overflow pipe modifications; site grading and access road improvements; and installation of new SCADA platform equipment.

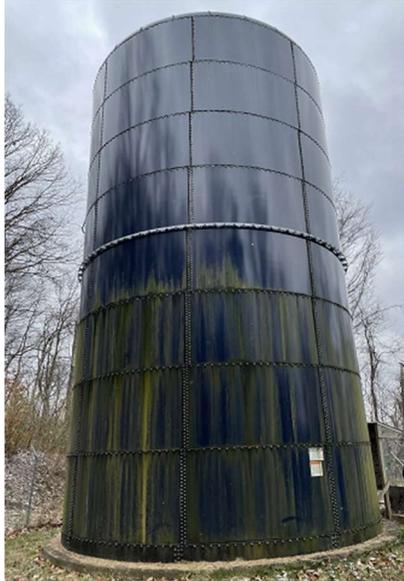
(5) *New Clark Tank*: This is a newer tank in good condition (see photo). The tank is in need of security enhancements; overflow pipe modifications; access road improvements; and installation of new SCADA platform equipment.

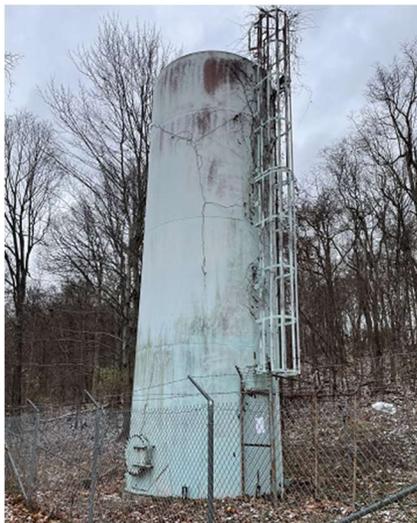
(6) *Old Clark Tank*: This is an older tank in poor condition (see photo). A hydraulic modeling analysis is required to determine if this older tank needs to remain in service along with the new one. If the tank is not needed, it should be decommissioned and removed. If it is needed, the tank should be rehabilitated including painting and related security and SCADA improvements.

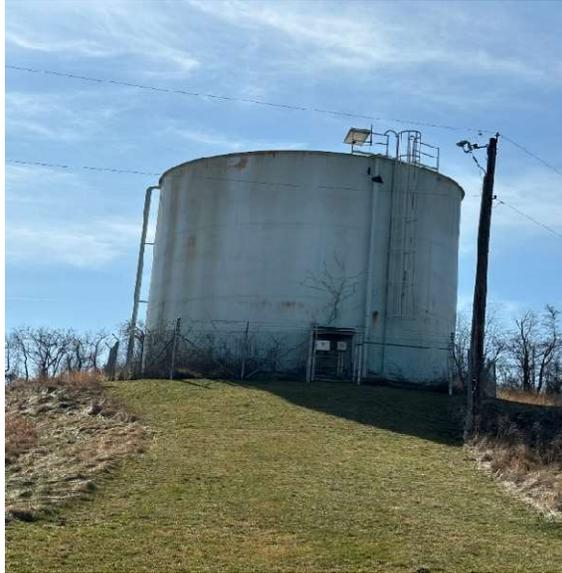
(7) *Donley Tank*: This is an older tank in poor condition (see photo). The tank is in need of rehabilitation including painting; installation of a new valve pit; gate and fence replacement and other security improvements;

access road improvements; and installation of new SCADA platform equipment

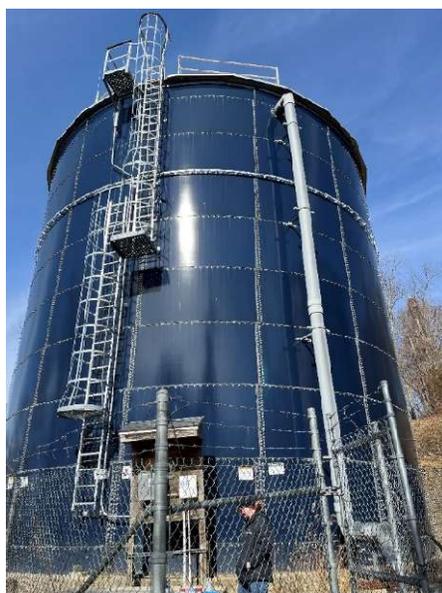
(8) *New Griffin Tank*: This is a newer tank in good condition (see photo). PAWC has already improved the access road to this tank. There are short-term improvements planned for the tank under the plant entry point project (see Section 4.1.1.10). No other improvements are needed.

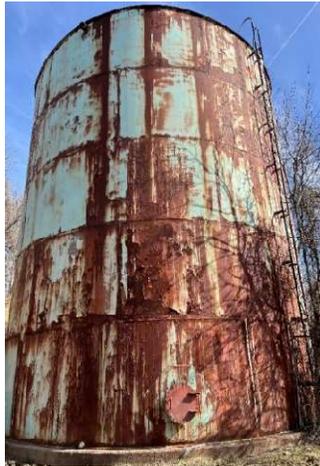
(9) *Old Griffin Tank*: This is an older tank in poor condition (see photo) that is not currently in service. A hydraulic modeling analysis is required to determine if there is a need to put this older tank back in service together with the new one. If the tank is not needed, it should be decommissioned and removed. If it is needed, the tank should be rehabilitated including painting.

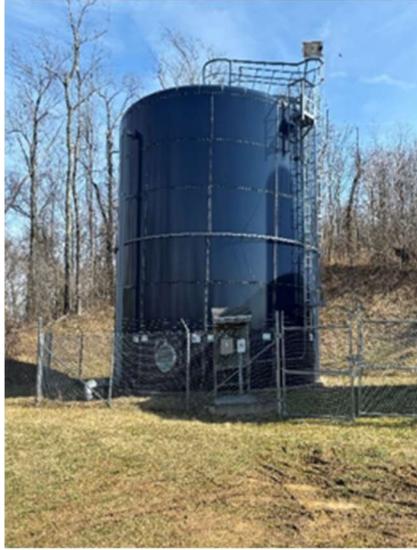
(10) *New Sugar Grove Tank*: This is a newer tank in good condition (see photo). The tank is in need of security enhancements; overflow pipe modifications; access road improvements; and installation of new SCADA platform equipment.

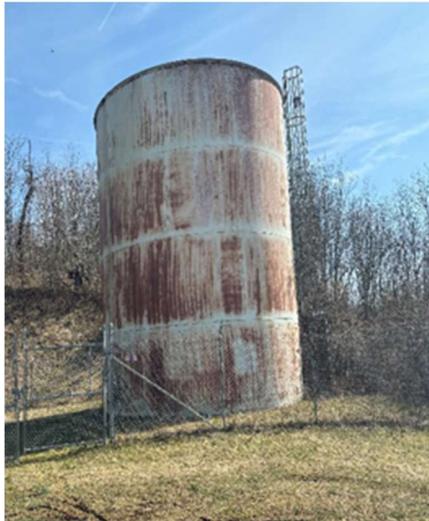
(11) *Old Sugar Grove Tank*: This is an older tank in poor condition (see photo). A hydraulic modeling analysis is required to determine if this older tank needs to remain in service along with the new one. If the tank is not needed, it should be decommissioned and removed. If it is needed, the tank should be rehabilitated including painting, along with related security and SCADA improvements.
