**Re: Letter of Notification of Mid-Atlantic Interstate Transmission, LLC, For Approval To Loop Approximately 0.21 Miles Of The Existing Double-Circuit Middletown Junction-Smith Street No. 2 115 Kilovolt Transmission Line Into Raintree Substation In Manchester Township, York County, Pennsylvania
Docket No. A-2025-_____**

LETTER OF NOTIFICATION

RAINTREE SUBSTATION PROJECT WETLANDS

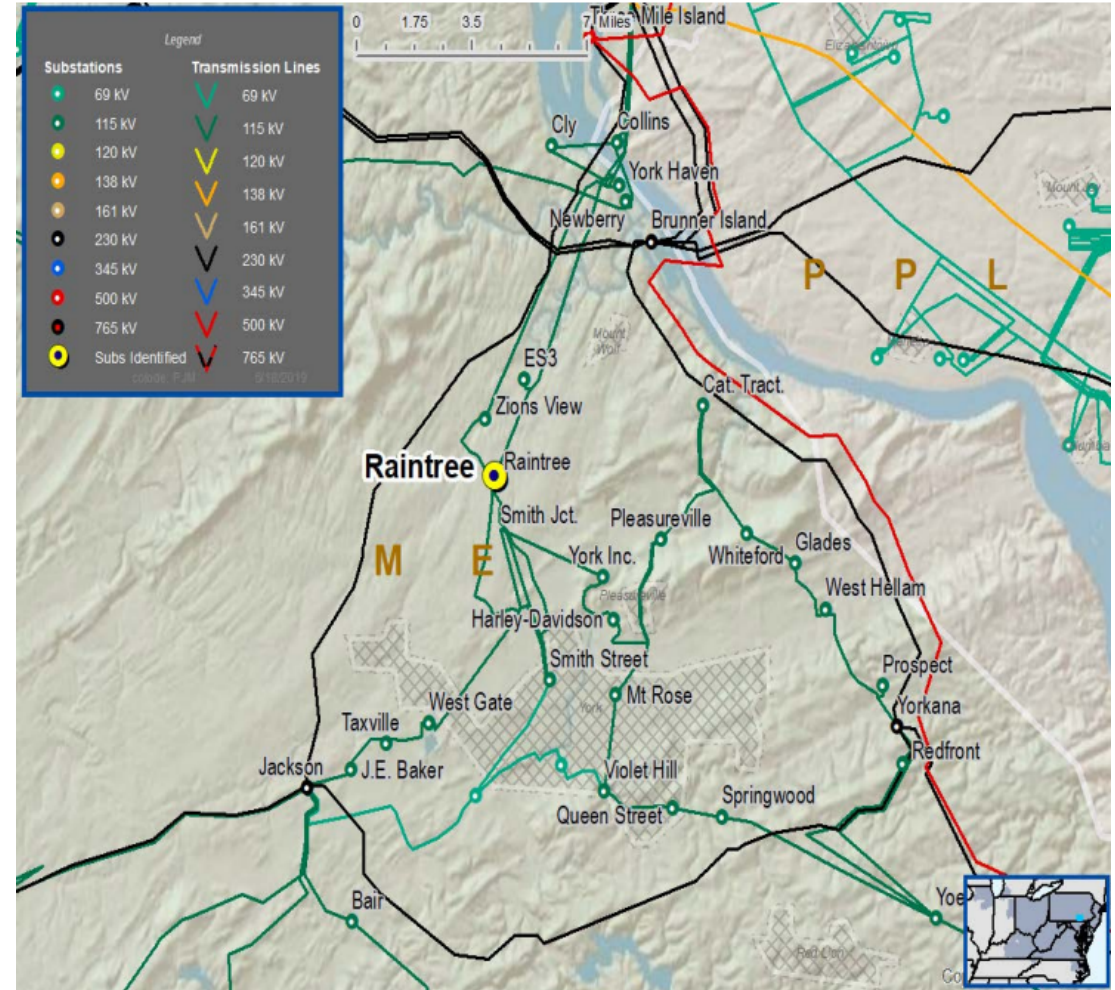
Need Number: ME-2019-053

Problem Statement:

New Customer Connection – A customer requested 115 kV service; anticipated load is 28 MVA; location is near the Raintree Substation

- Construct a four-breaker 115 kV ring bus at Raintree Substation
- Loop the Middletown Junction – Smith Street 115 kV 978 Line into Raintree Substation
- At Raintree Substation
 - Install one control house
 - Install four 115 kV circuit breakers and associated disconnect switches
 - Install two standard transmission line relay panels
- At Middletown Junction Substation
 - Replace existing line relay panels
- At Willis Road (Smith Street) Substation
 - Replace one 115 kV circuit breaker and associated disconnect switches
 - Replace existing line relay panels

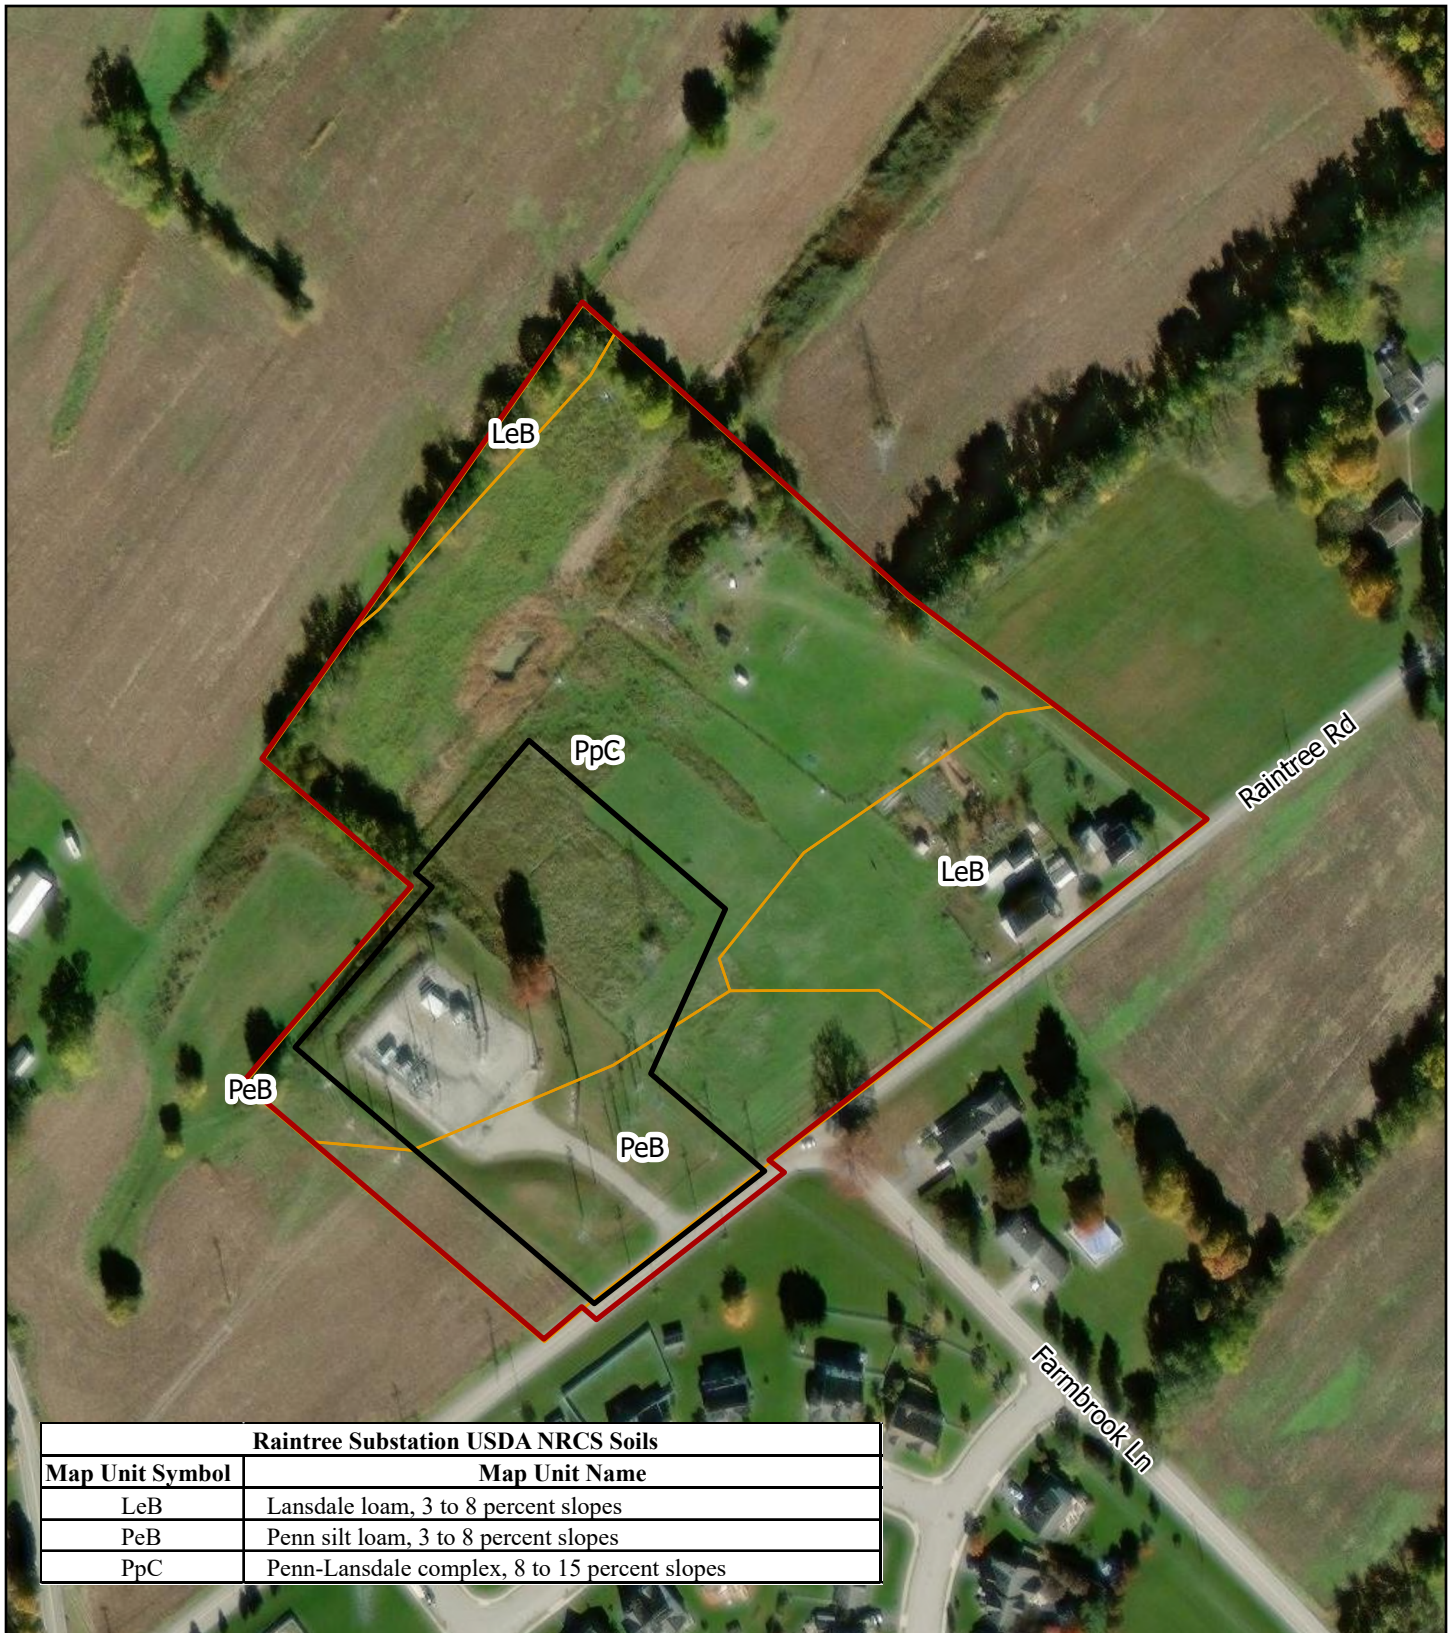
Raintree Substation USDA NRCS Soils	
Map Unit Symbol	Map Unit Name
LeB	Lansdale loam, 3 to 8 percent slopes
PeB	Penn silt loam, 3 to 8 percent slopes
PpC	Penn-Lansdale complex, 8 to 15 percent slopes

Project Study Area
 Wetland Delineation Boundary
 Project Soils (USDA NRCS)

There are no soils within the Study Area with a hydric soil rating. A hydric soil is one that is formed under conditions of saturation, flooding, or ponding long enough during the growing season to develop anaerobic conditions in the upper part and typically found within wetlands. The soil mapping units are listed below in **Table 1. Soil Characteristics within the Study Area**.

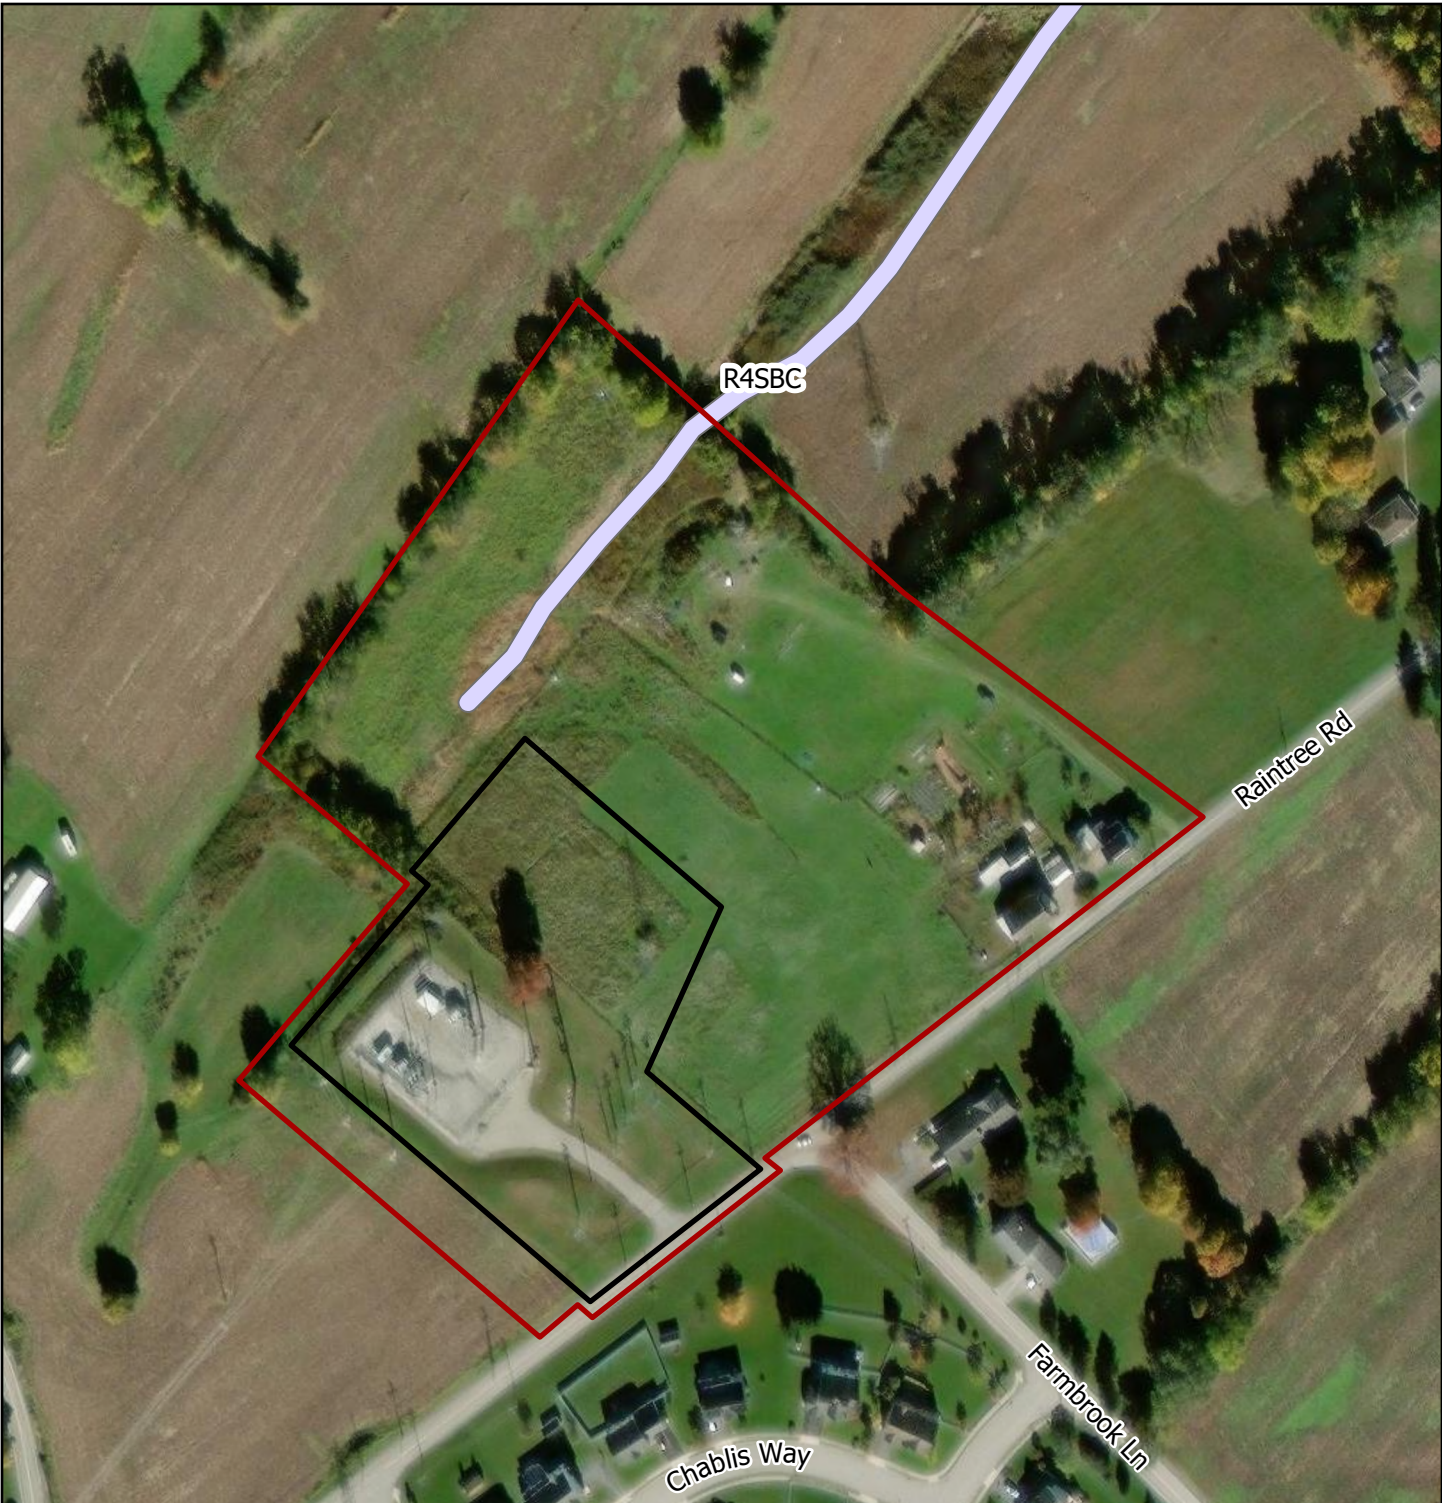
Raintree Substation Project National Wetland Inventory Map

Raintree Substation National Wetland Inventory Wetlands and Waterways

Riverine, Intermittent, Streambed, Seasonally Flooded

Project Study Area
	Wetland Delineation Boundary
National Wetland Inventory: Wetlands and Waterways	
	Freshwater Emergent Wetland
	Freshwater Forested/Shrub Wetland
	Freshwater Pond
	Lake
	Riverine
September 2024

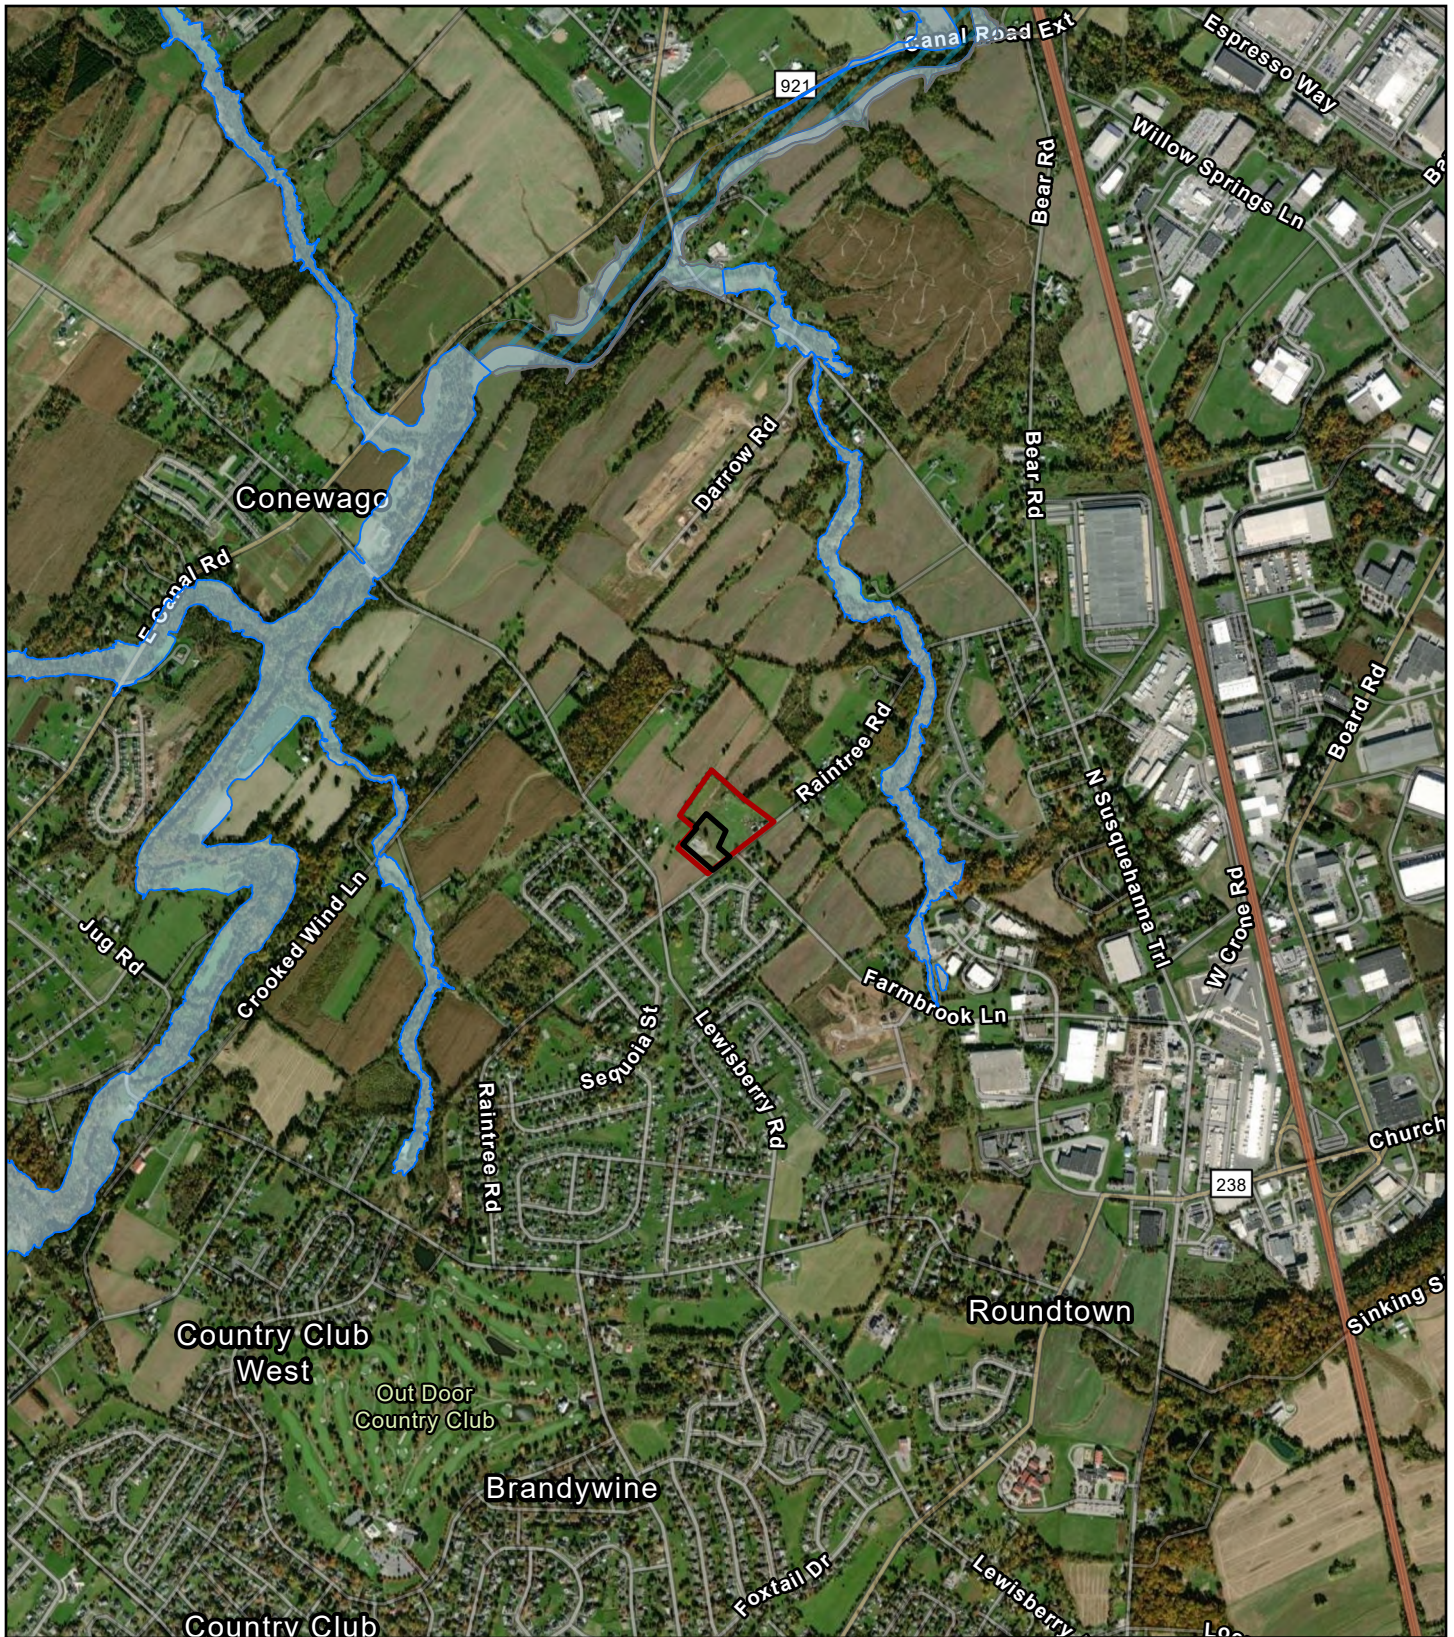
Project Study Area
	Wetland Delineation Boundary
Effective FEMA Floodplain	
	100 Year Floodplain (1% Chance)
	500 Year Floodplain (0.2% Chance)
	Floodway (1% Chance)

FEMA's National Flood Hazard Layer presents FIRM maps that illustrate the extent of a 100-year storms floodway and associated floodplain. In areas where no FEMA FIRM map exists, it's assumed that the floodway extends 50-ft from the waterbodies top-of-bank.

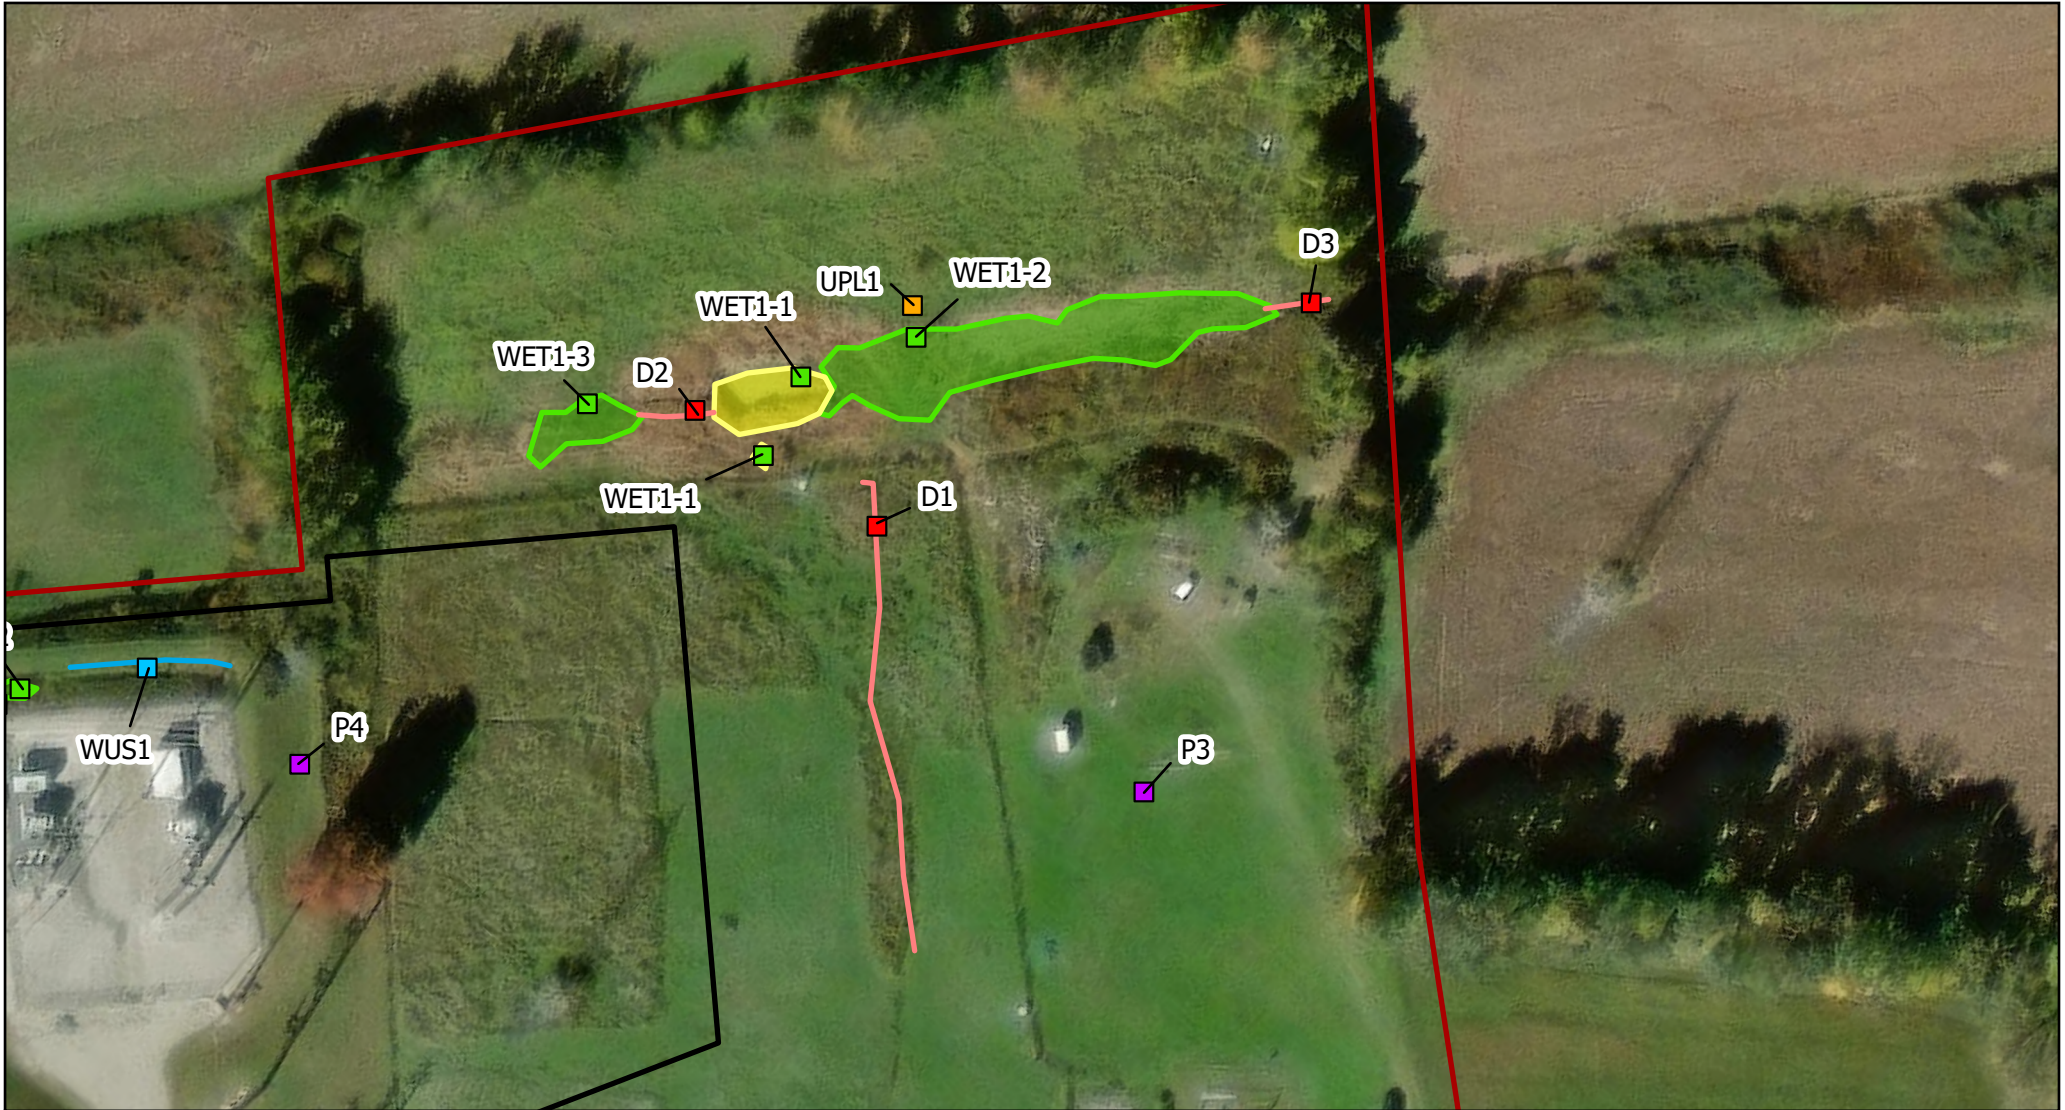
**Raintree Substation
York County, Pennsylvania
Wetland Delineation Map**

Delineated Wetlands		Wetland Data Point	Project Area
Palustrine Emergent	Waterway Data Point	Drain Data Point	Wetland Delineation Boundary
Palustrine Unconsolidated Bottom	Upland Data Point	Photo Point	
Delineated Waterways			
Ephemeral			
Drainage Ditch

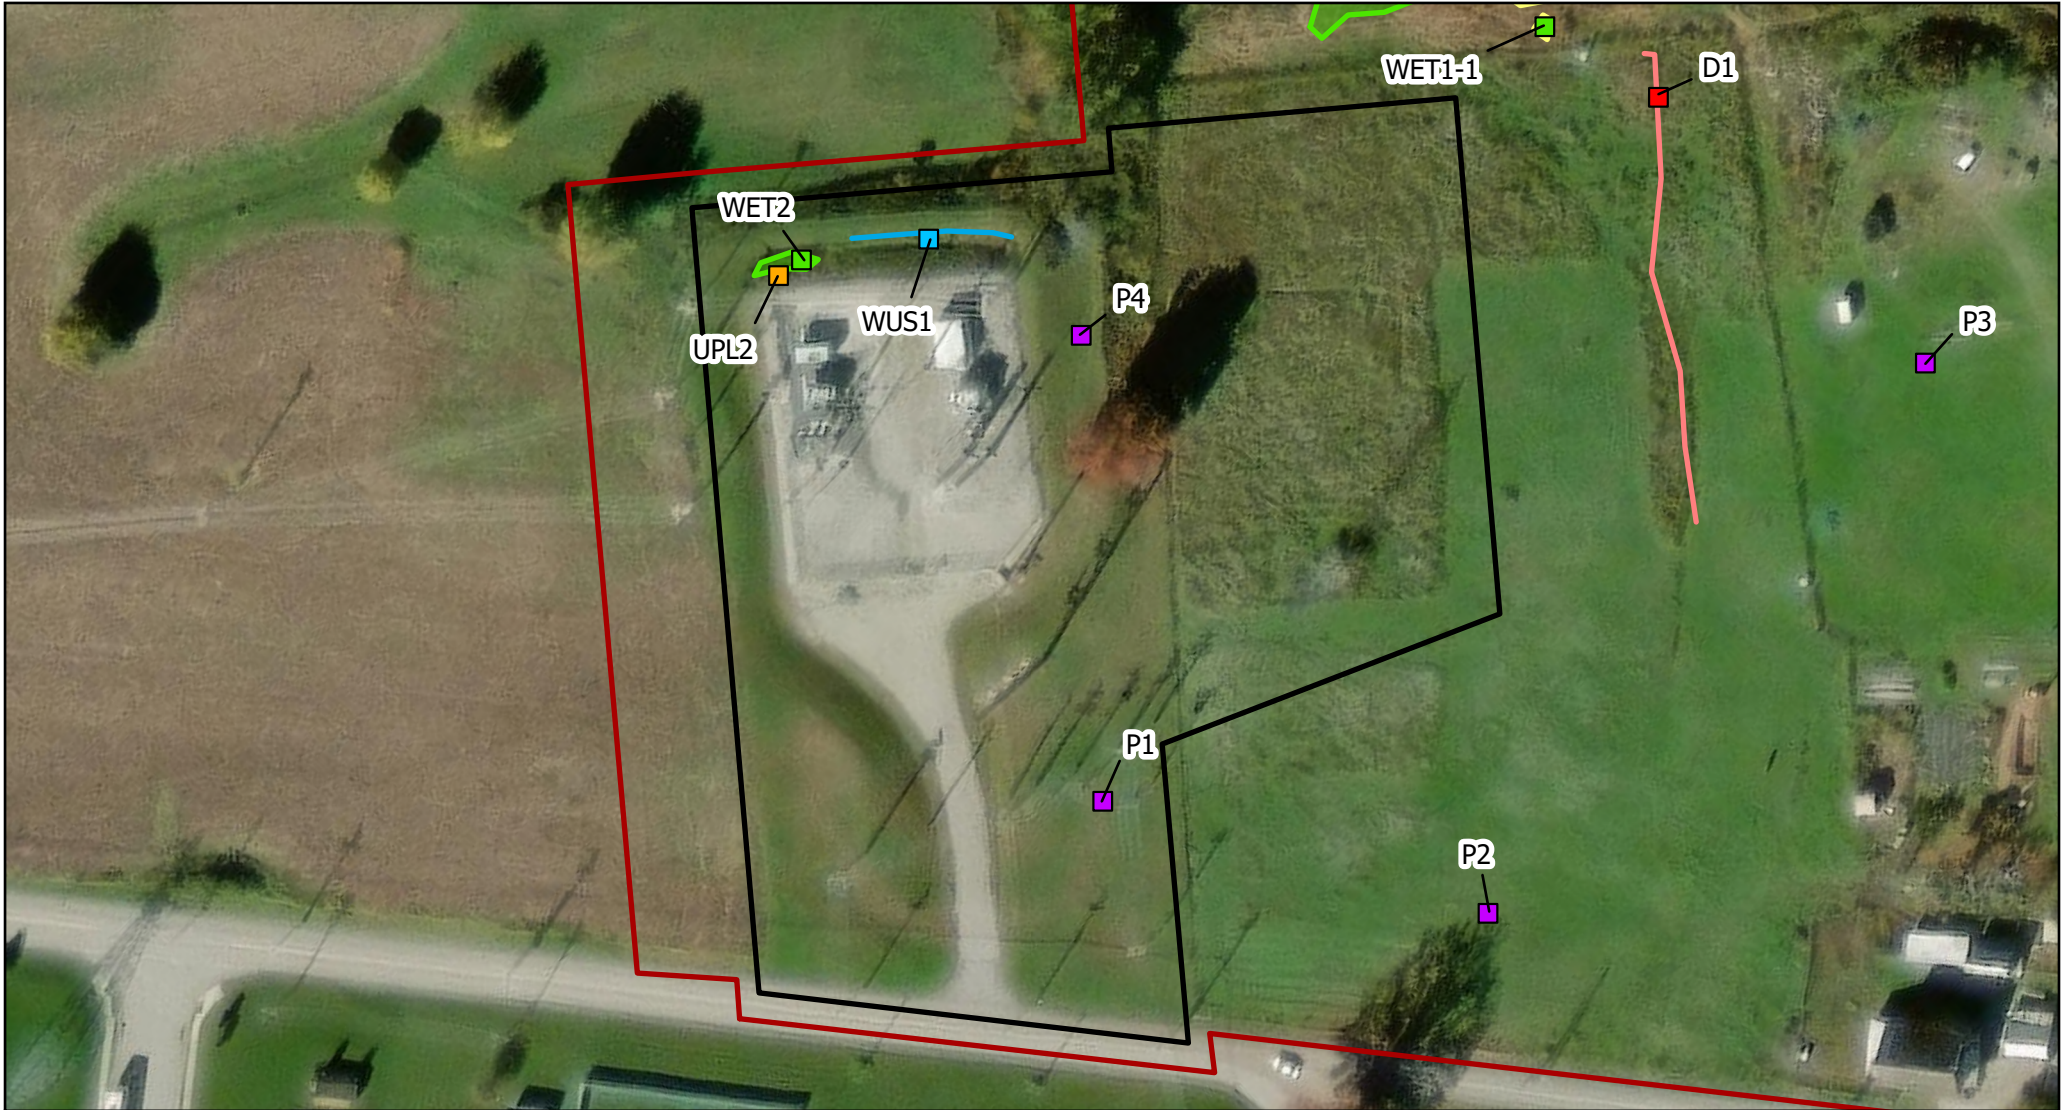
**Raintree Substation
York County, Pennsylvania
Wetland Delineation Map**

Delineated Wetlands	Wetland Data Point	Project Area
Palustrine Emergent	Waterway Data Point	Wetland Delineation Boundary
Palustrine Unconsolidated Bottom	Drain Data Point	
Delineated Waterways	Upland Data Point	
Ephemeral	Photo Point	
Drainage Ditch

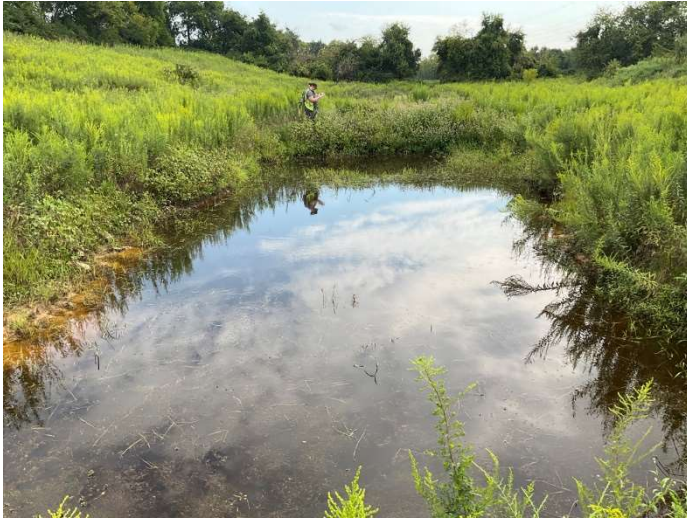
Photo 1: WET1-1 – Palustrine Unconsolidated Bottom

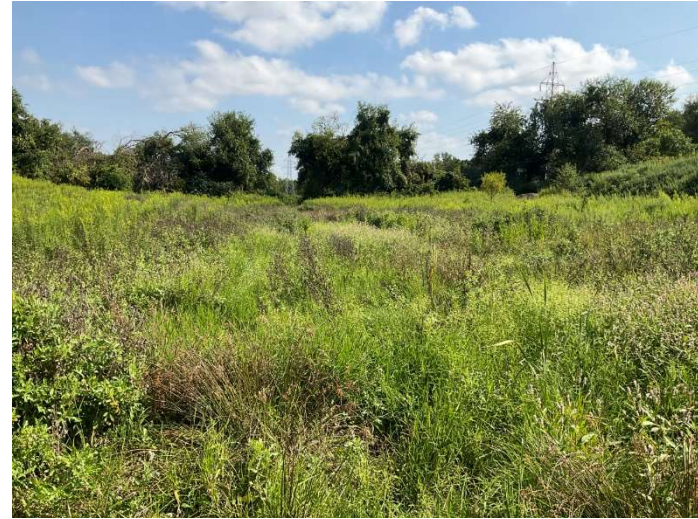
Photo 2: WET1-2 – Palustrine Emergent

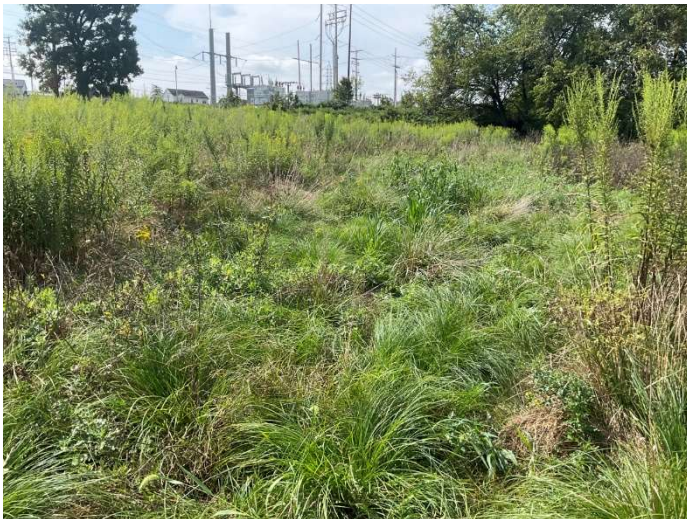
Photo 3: WET1-3 – Palustrine Emergent

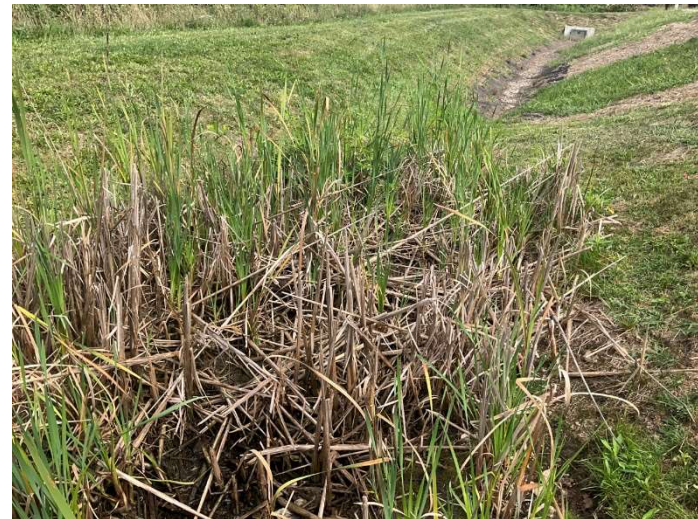
Photo 4: WET2 – Palustrine Emergent

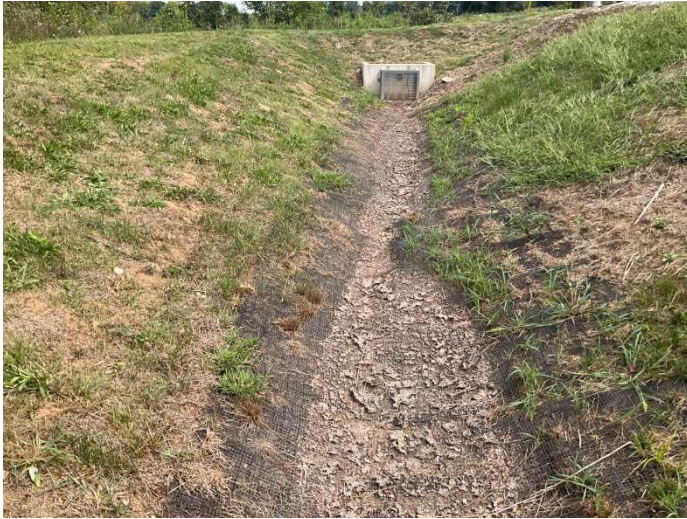
Photo 5: WUS1 – Ephemeral – Downstream

TRIBUTARY ID	TRIBUTARY NAME	COWARDIN	LINEAR FEET IN STUDY AREA	PHOTO #	COMMENTS
WUS1	Isolated	Intermittent (R4)	84	5-6	Small excavated channel northwest of substation, flows to culvert. No culvert outflow found.

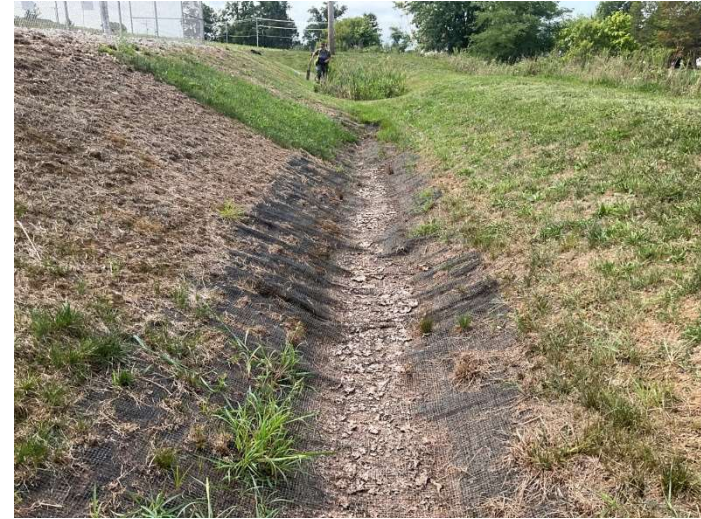
Photo 6: WUS1 – Ephemeral – Upstream

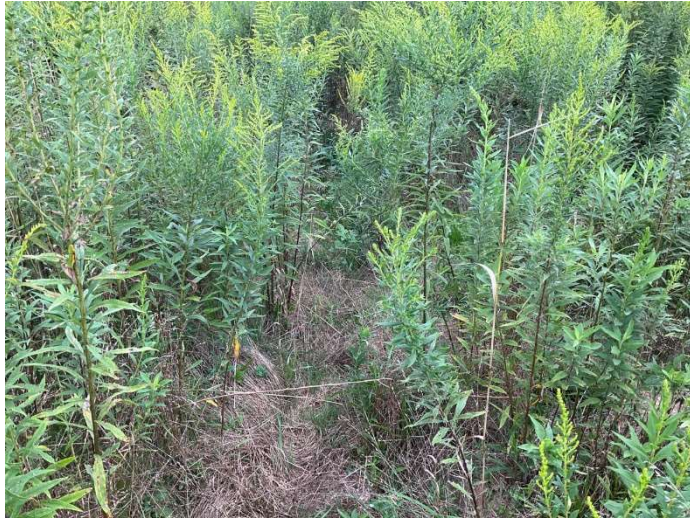
Photo 7: D1 – Drainage Ditch

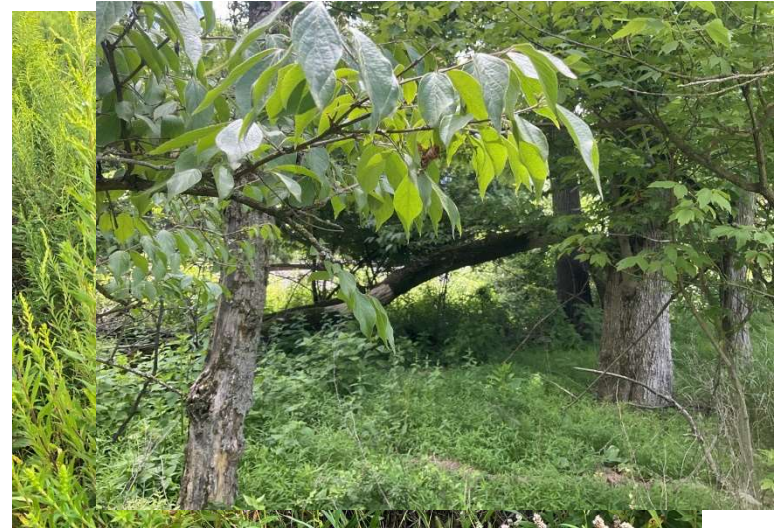
Photo 8: D2 – Drainage Ditch

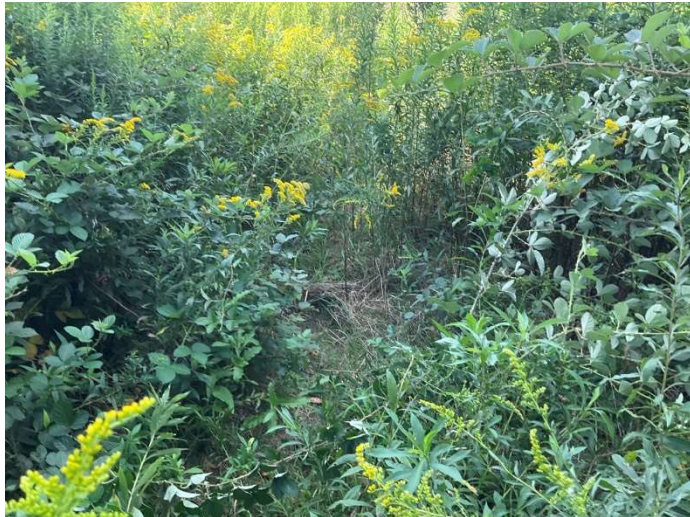
Photo 9: D3 – Drainage Ditch
