**Re: Joint Letter Of Notification of Keystone Appalachian Transmission Company and FirstEnergy Pennsylvania Electric Company for Approval to Tap the Existing Dutch Fork–Windsor 138 Kilovolt Transmission Line to the New MPLX Grahek Substation in Donegal Township, Washington County, Pennsylvania.
Docket No. A-2025-_____**

Dutch Fork - Windsor 138 kV Transmission Line
Interconnection Project

DUTCH FORK-WINDSOR 138 kV
 TRANSMISSION LINE
 INTERCONNECTION PROJECT

Civil & Environmental Consultants, Inc. (CEC) conducted a waters delineation for FirstEnergy's Dutch Fork-Windsor Tap project located in Donegal Township, Washington County, Pennsylvania (Figure 1). The proposed project consists of building a new tap line from an existing FirstEnergy transmission line to a new MPLX facility. This report includes the findings of a desktop data review and field delineation of current site conditions. The purpose was to identify, characterize, and delineate wetlands, streams, and other waters located within the approximate 90-acre area of interest (AOI). This report presents the methodology and findings.

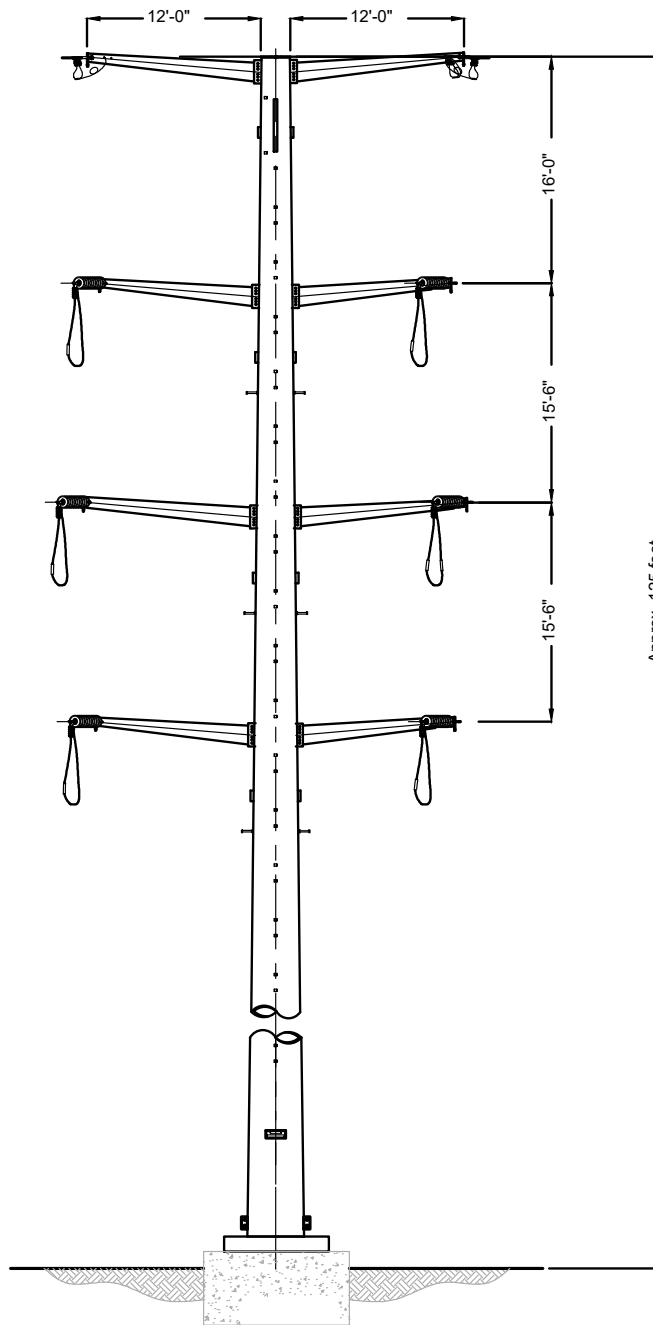
Exhibit 4

Transmission Lines. Existing double circuit lattice structure #123, which is approximately 100 feet tall, will be replaced with a new double circuit steel deadend tap structure, approximately 125 feet tall, as depicted in **Exhibit 4**. Existing double circuit lattice structures #122 (approximately 75 feet tall) and #126 (approximately 100 feet tall) will also be replaced. Structure #122 will be replaced with one single circuit steel pole switch structure (approximately 80 feet tall), as depicted in **Exhibit 5**, to serve the Dutch Fork-Windsor 138 kV Transmission Line and with one single circuit steel pole deadend (approximately 80 feet tall), as depicted in **Exhibit 6**, to serve the Gordon-Windsor 138 kV Transmission Line. Structure # 126 will also be replaced with one single circuit steel pole switch structure (approximately 100 feet tall), as depicted in **Exhibit 5**, to serve the Dutch Fork-Windsor 138 kV Transmission Line and with one single circuit steel pole deadend (approximately 100 feet tall), as depicted in **Exhibit 6**, to serve the Gordon-Windsor 138 kV Transmission Line. Both new switch structures will support new 2000 Amp Supervisory Control and Data Acquisition (“SCADA”) controlled switches. The facilities and assets described in this paragraph will be owned and operated by KATCo.²

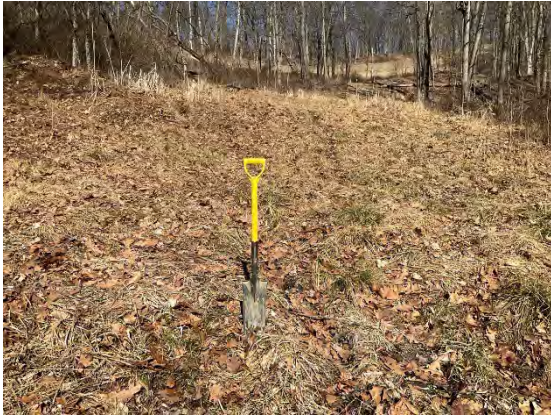
1. Wetland Test Site, SP-1, Wetland 1A
Photo Facing: North

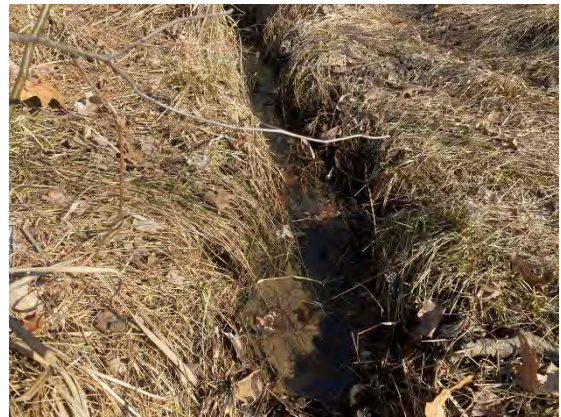
30. Overview of Stream 1, INT
Photo Facing: Upstream
