**Re: Joint Letter Of Notification of Keystone Appalachian Transmission Company and FirstEnergy Pennsylvania Electric Company for Approval to Tap the Existing Dutch Fork–Windsor 138 Kilovolt Transmission Line to the New MPLX Grahek Substation in Donegal Township, Washington County, Pennsylvania.  
Docket No. A-2025-\_\_\_\_\_**

DUTCH FORK-WINDSOR 138 kV  
TRANSMISSION LINE  
INTERCONNECTION PROJECT

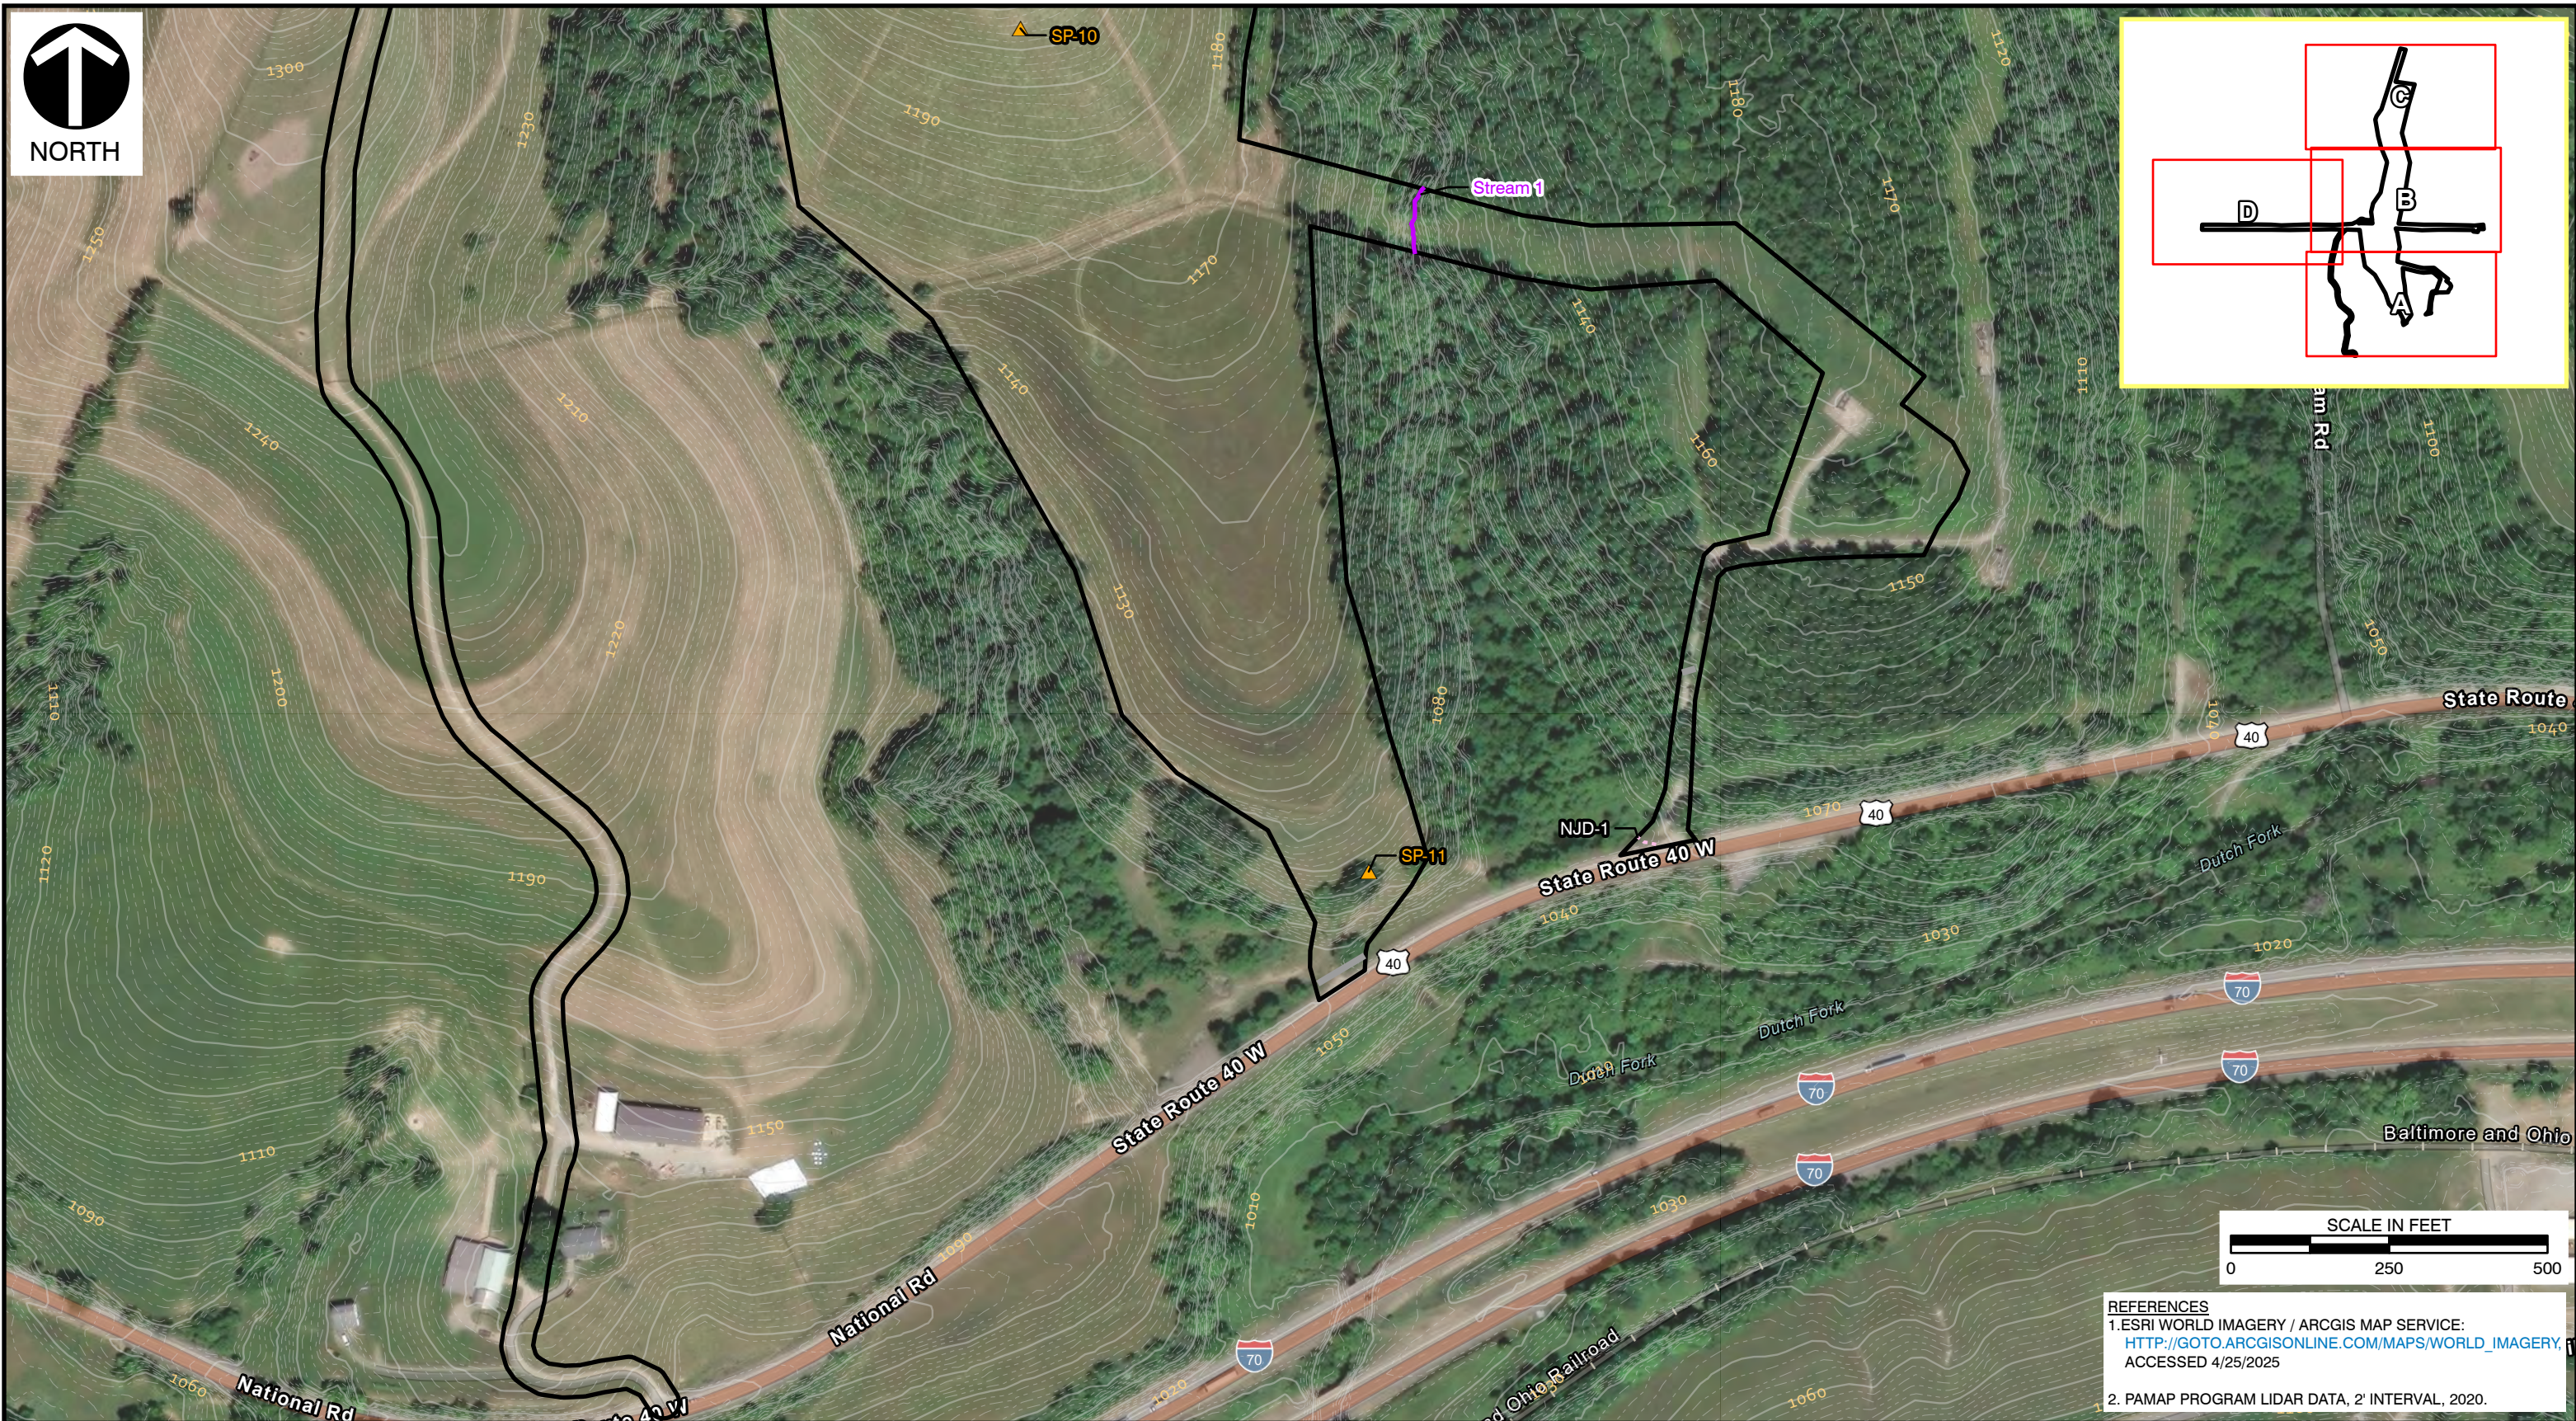
APPROVED BY:	MRM*	FIGURE NO:	3A
PROJECT NO:	350-499

LEGEND			
	SAMPLING POINT		INDEX CONTOURS
	CULVERT LINE		EPHEMERAL STREAM
	EROSIONAL FEATURE		INTERMITTENT STREAM
	SWALE		PERENNIAL STREAM
	UPLAND DRAINAGE		OPEN BOUNDARY
	DITCH		PEM WETLAND
	AREA OF INTEREST (AOI)		PSS WETLAND
	INTERMEDIATE CONTOURS

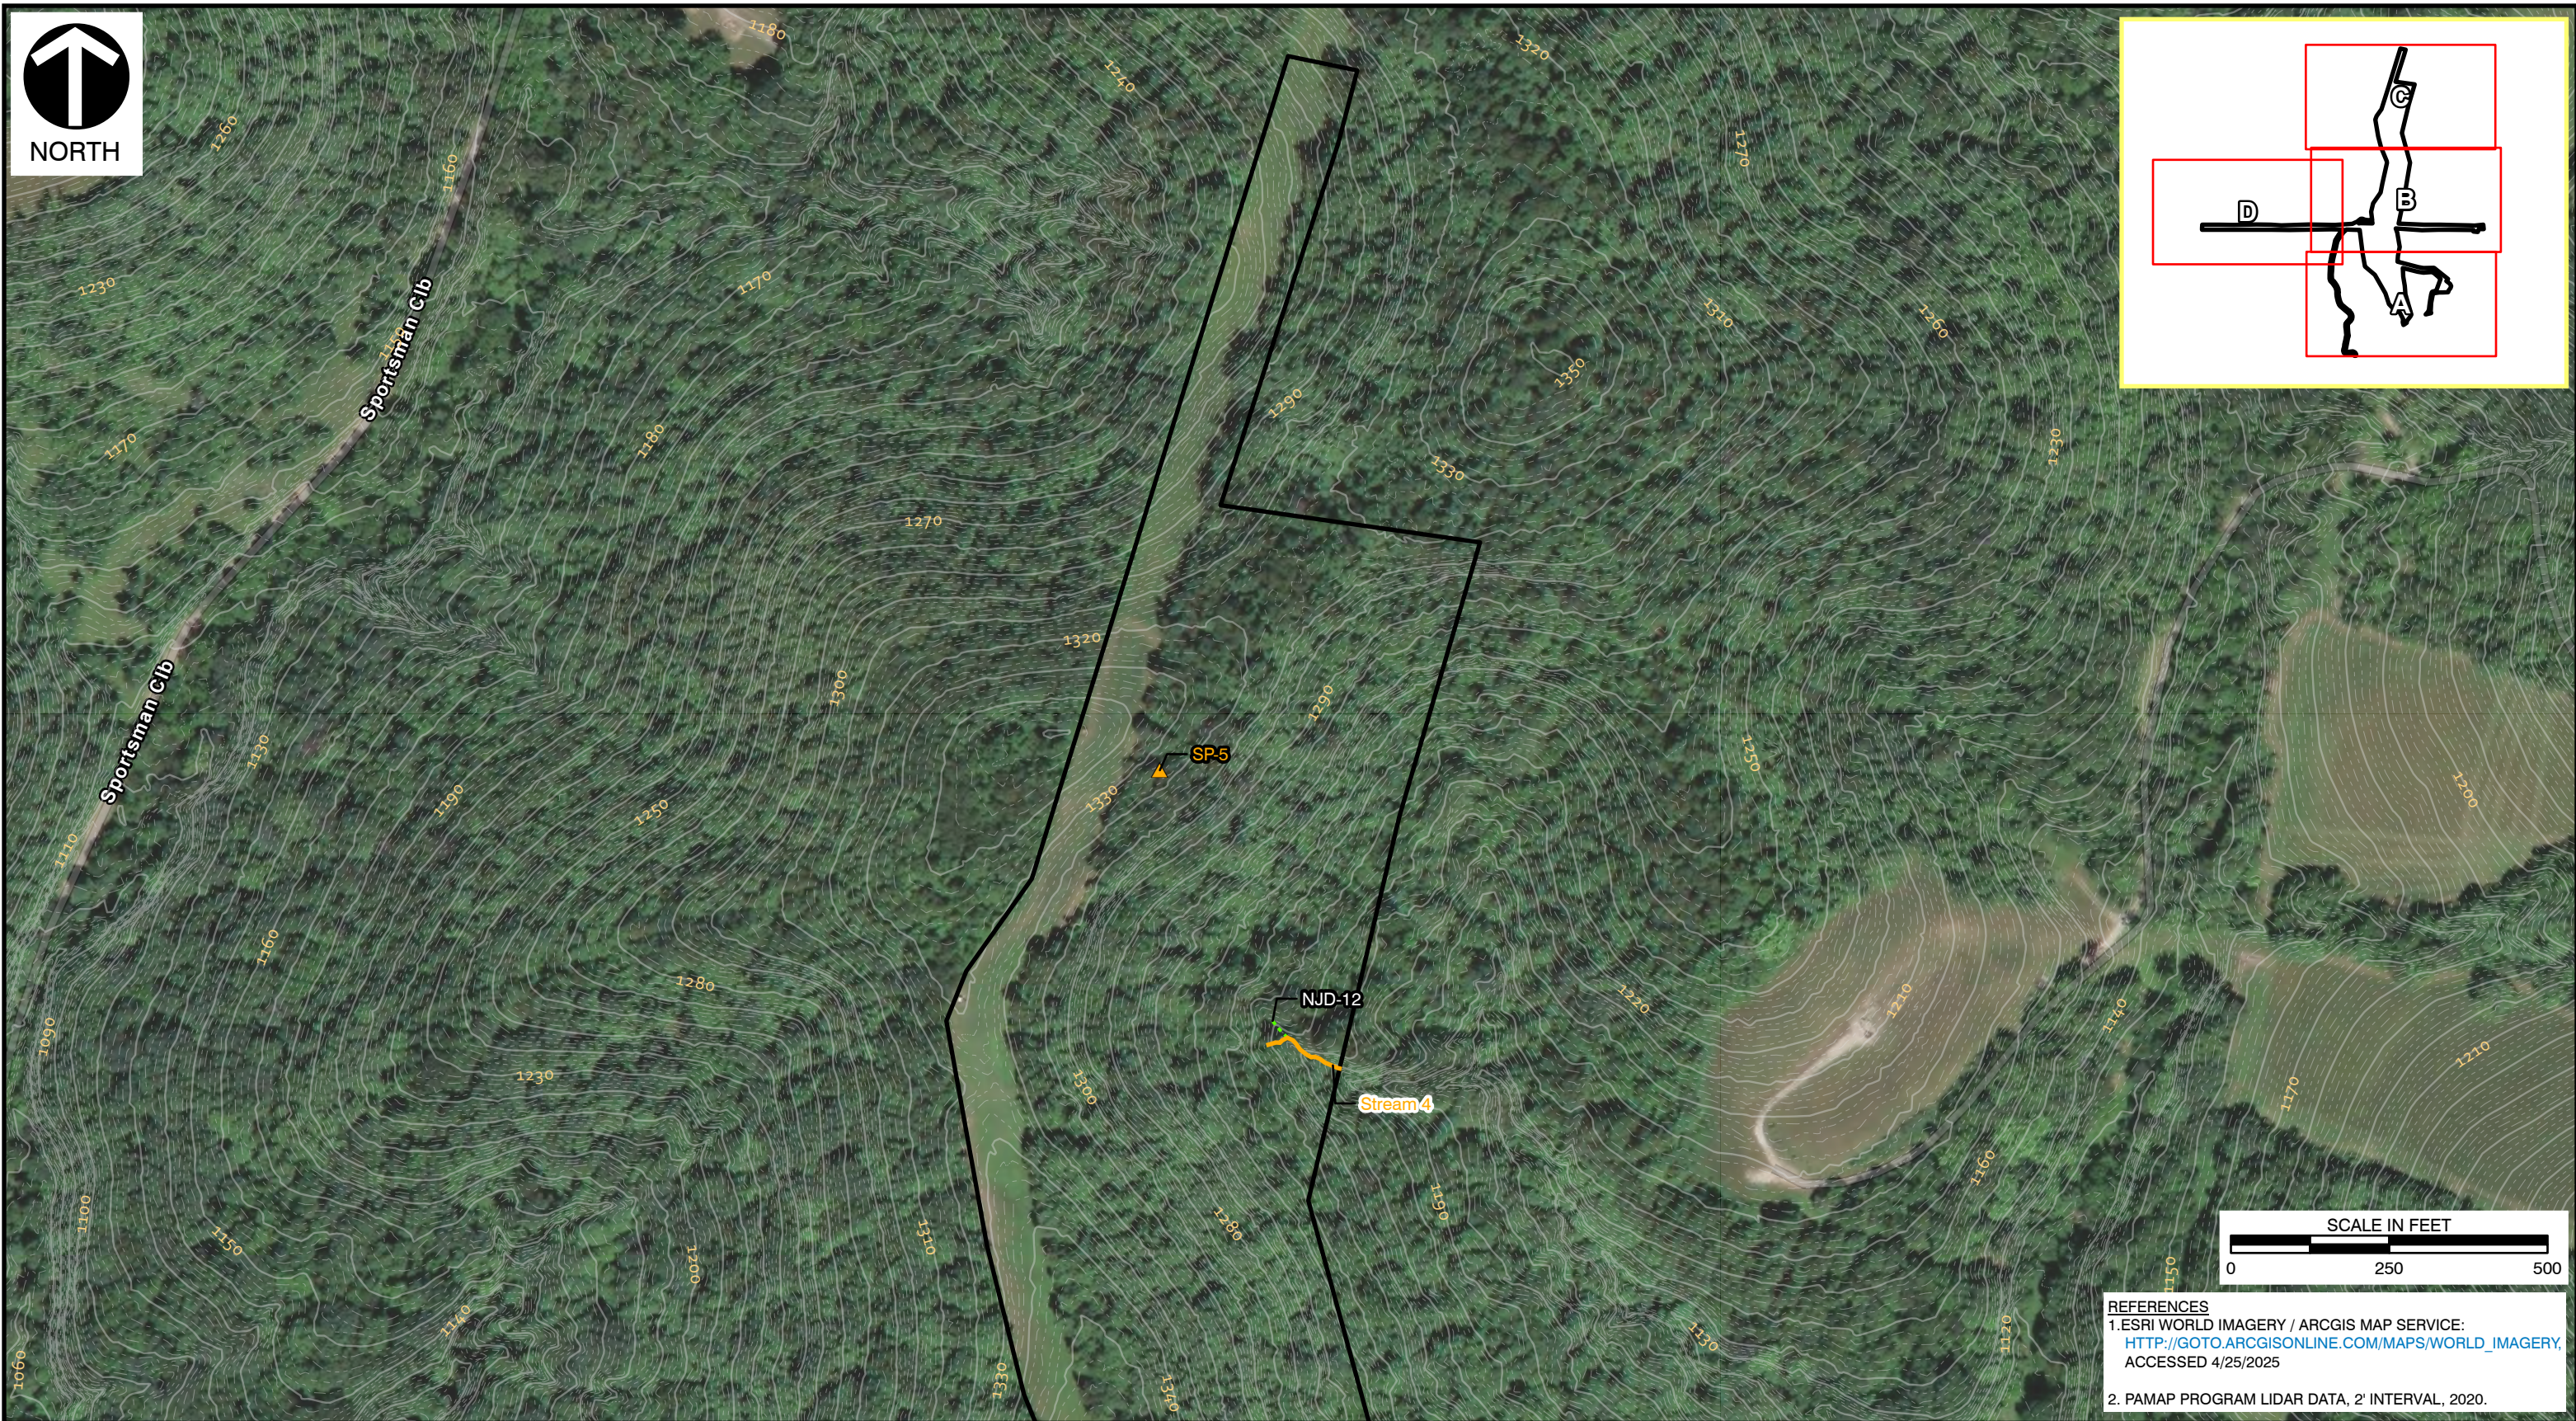
APPROVED BY:	MRM*	FIGURE NO:	<b>3C</b>
PROJECT NO:	350-499

LEGEND			
	SAMPLING POINT		DITCH
	CULVERT LINE		EPHEMERAL STREAM
	EROSIONAL FEATURE		INTERMITTENT STREAM
	SWALE		PERENNIAL STREAM
	UPLAND DRAINAGE		OPEN BOUNDARY
	INDEX CONTOURS		PEM WETLAND
	INTERMEDIATE CONTOURS		PSS WETLAND
	AREA OF INTEREST (AOI)
