In accordance with the Public Utility Commission order in Docket C-80011839, Amtrak submits, herewith, three (3) copies of a detailed inspection report of our findings of the condition of the Spring Mill Road bridge over the railroad in Villanova, PA.

- I. Summary
- II. Introduction
- III. Description
- IV. Detailed Close Up Inspection
 - A. Abutments
 - B. Bridge Deck
 - C. Floor Beams
 - D. Trusses
- V. Rating
- VI. Conclusion and Recommendations

Overhead Bridge 12.12 - Spring Mill Road - Villanova, Pa.

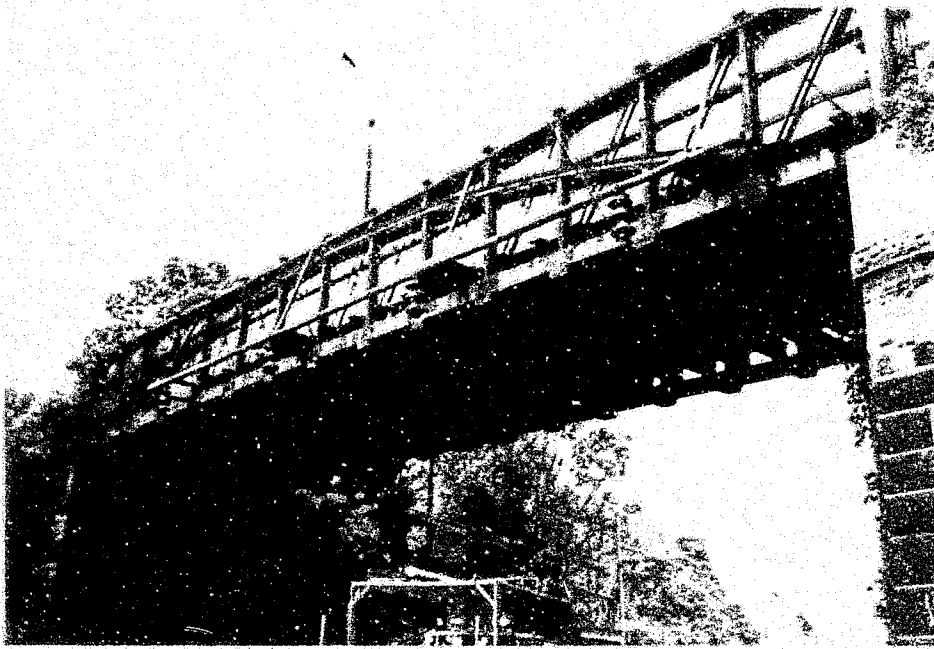
1. East Truss

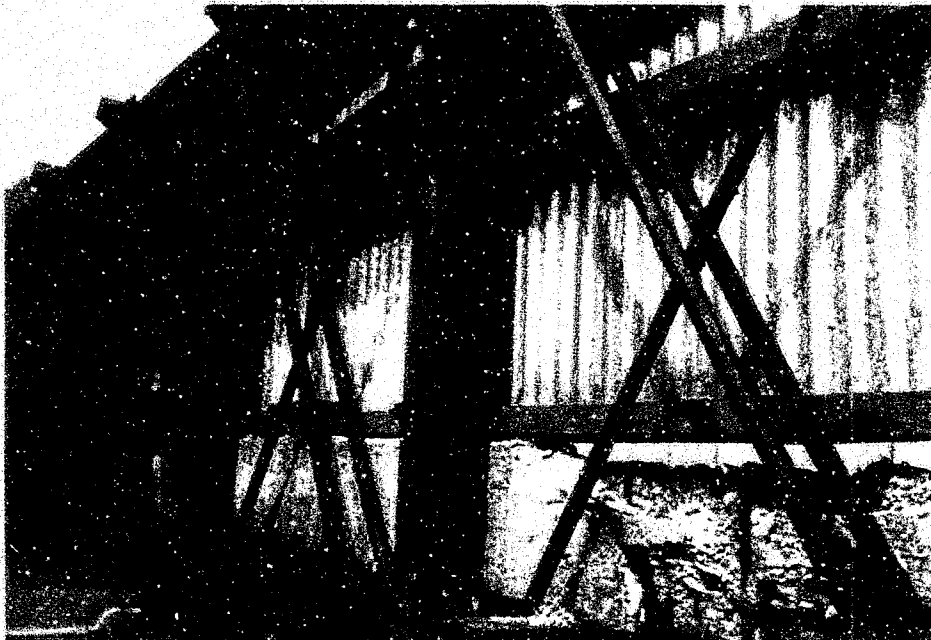
2. West truss, north end, disconnected arch ring
and spalled concrete.

The arch ring on each truss, originally designed to take the dead load, no longer acts as part of the truss. Picture 6, page 10, shows pieces of the arch in place; pieces of the arch, at other locations on the truss, are missing.

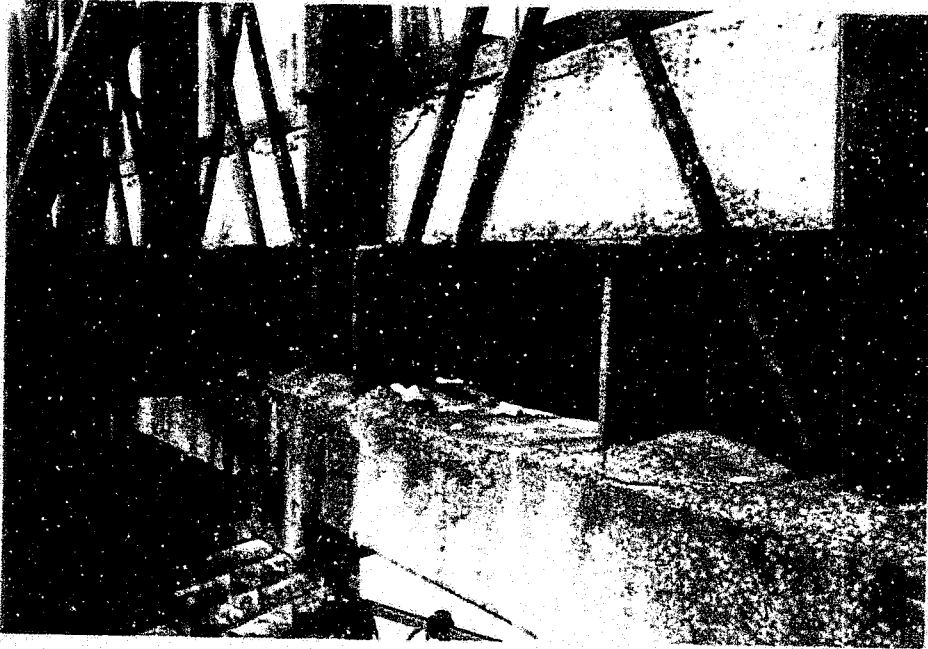
5. Northwest side of bridge.

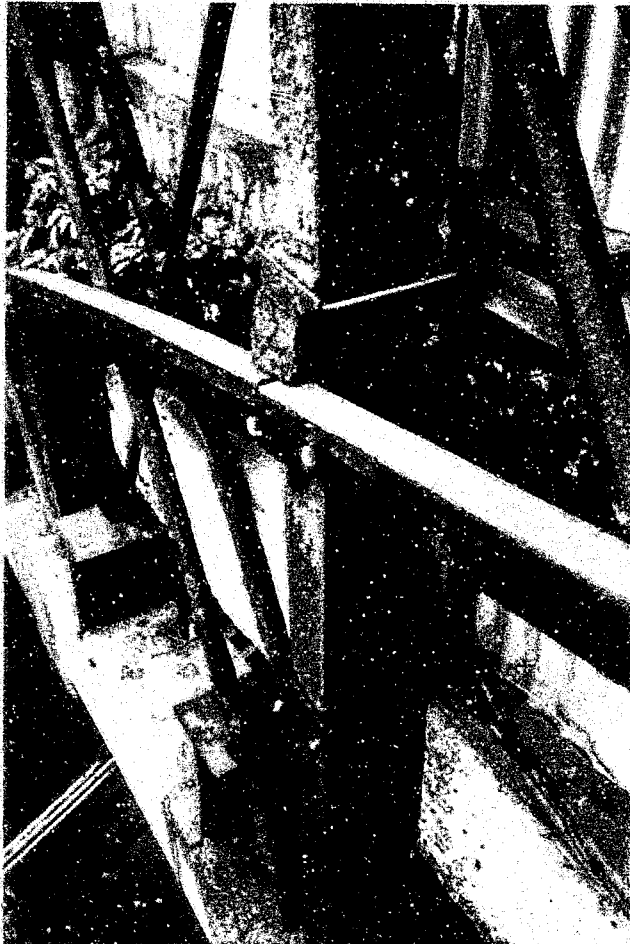
6. Vertical post and arch ring.

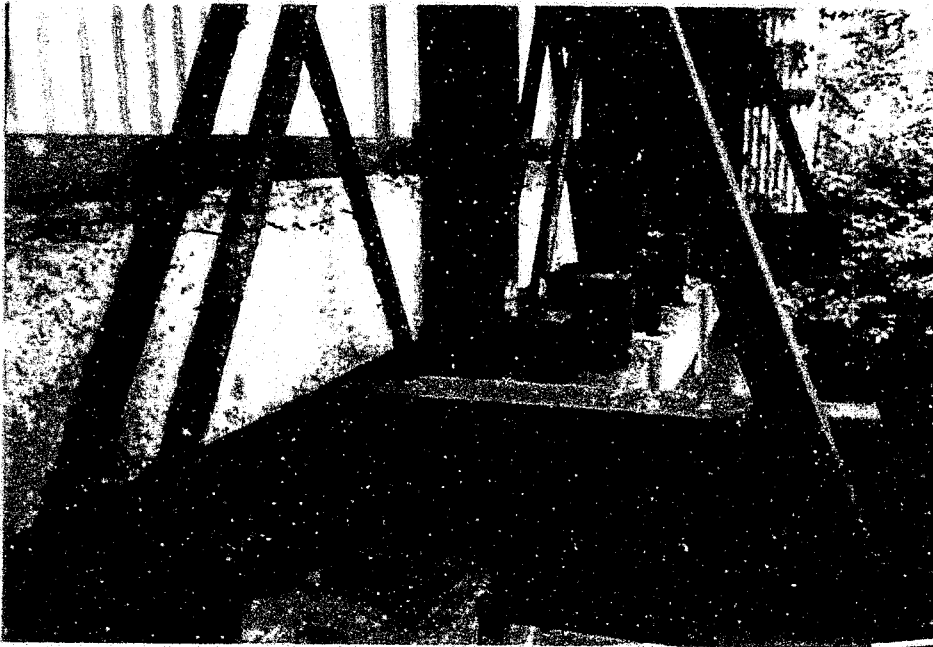
The trusses, which the plans show to be wrought iron, appear generally to be in fair condition but upon closer inspection, there are notable points of concern. The foremost concern is four (4) vertical posts that have cracks extending from the outer flange to partway through the web; the cracks are completely through the outer flanges. Pictures 7, 8, 9, & 10 show three of the four cracked posts. Amtrak is at a loss to accurately explain the nature of the cracks since theoretically, the vertical posts act in compression. These cracks were noted and photographed when the bridge was inspected in 1982. A comparison of the photographs taken recently to those taken in 1982 shows there has been some progression of at least one of the cracks.

7. Westside, crack in 5th vertical from south end.

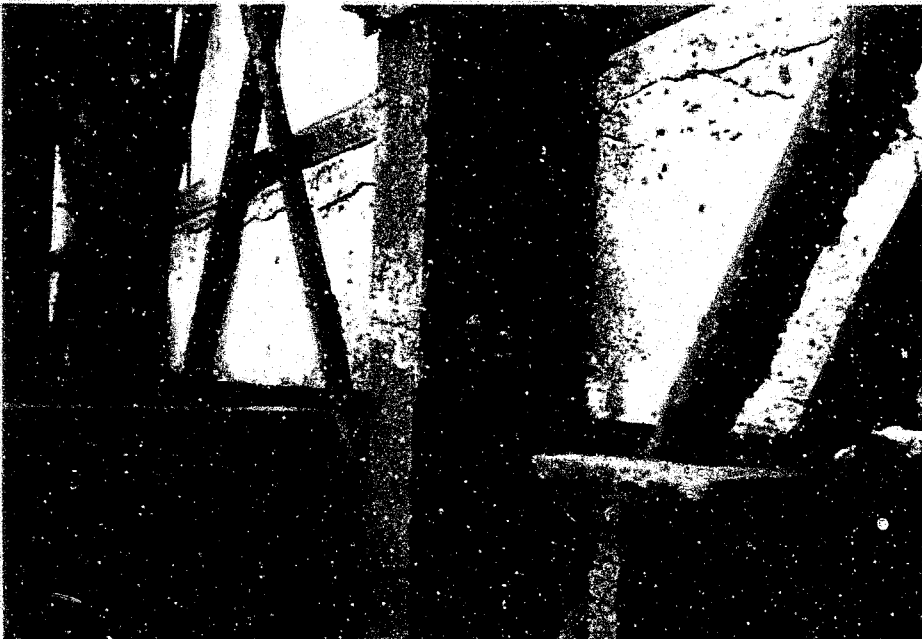
8. Closer view of crack in 5th vertical.

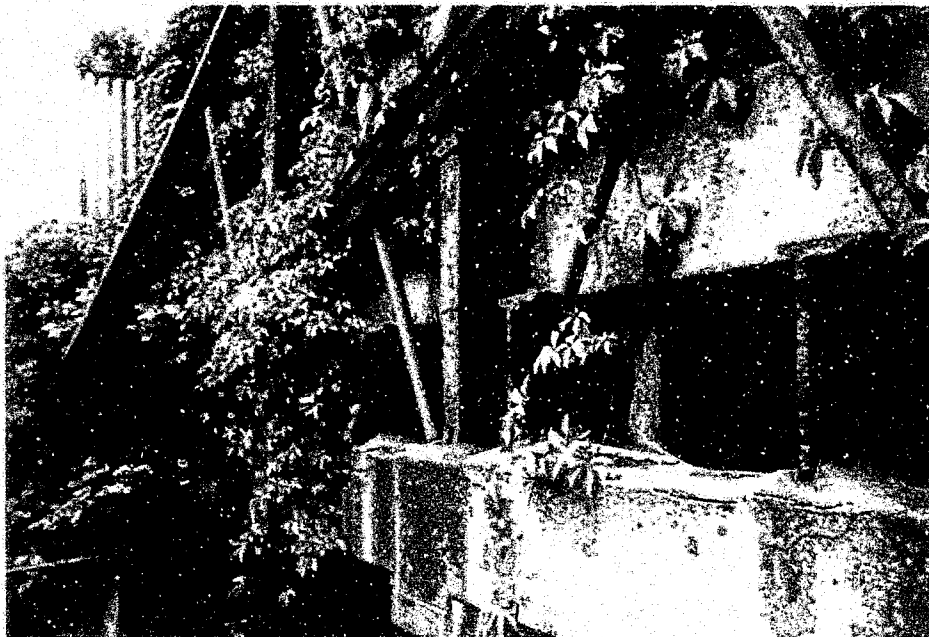
10. East side cracked vertical - 3rd from south end.

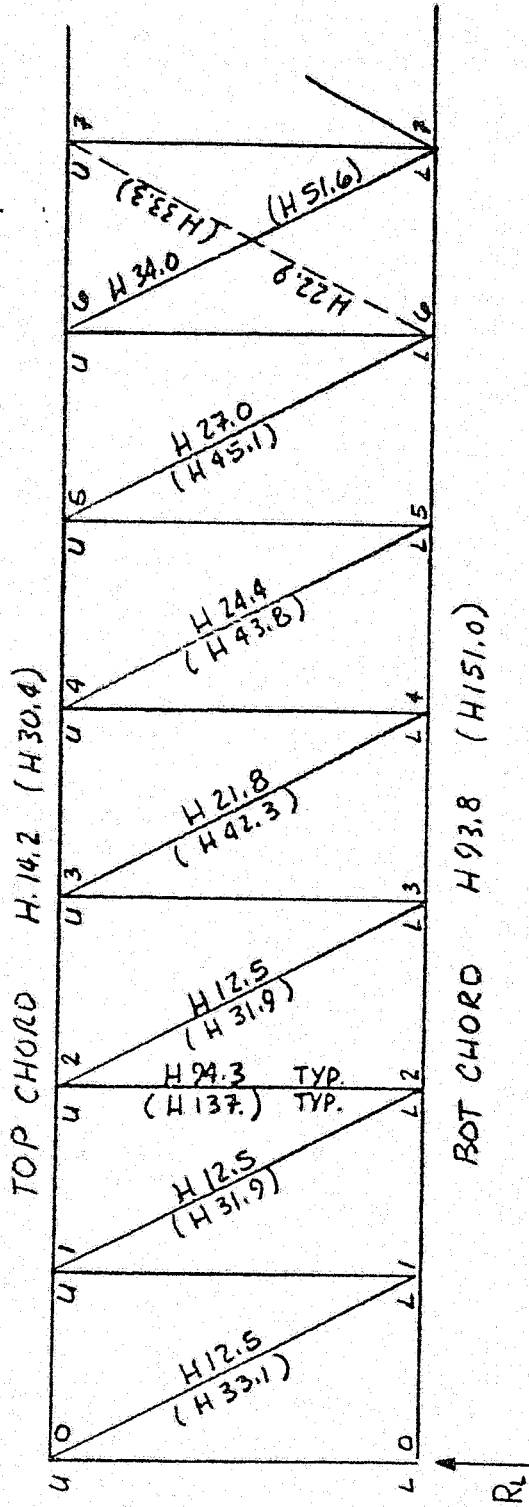
A sample piece of the Wrought Iron truss was then tested to determine its actual yield stress. The testing was performed in cooperation with PennDOT's Material Testing Lab and revealed a yield stress of 55.4 KSI, and an elastic limit of 33.5 KSI. Referring to the AREA Manual (15-7.3.4.3.2) and other literature, the average yield stress for Wrought Iron was considered to be 25 KSI. Based on these results, the ratings were recalculated using an allowable stress of 22 KSI for the Inventory Rating and 32 KSI for the Operating Rating. The resulting rating of the trusses, which affect the bridge rating, are shown in the truss diagram on Page 15, of this report.

H-20 - INVENTORY RATING
(H-30) - OPERATING RATING

According to the rating analysis which was performed based on the actual stresses determined by testing, the bridge rates at H-12.5 for Inventory and H-30.4 for Operating. Our recommendation for posting the Spring Mill Road bridge is not based solely on the results of the rating. PennDOT has been studying the matter of bridge ratings and posting with the idea that unduly low postings pose a great deal of hardship and inconvenience on the traveling public. But if a bridge must be posted for a low load limit, then do so. The posting we recommend for this bridge is 15 Tons. This recommendation considers such factors as characteristics of the bridge, traffic

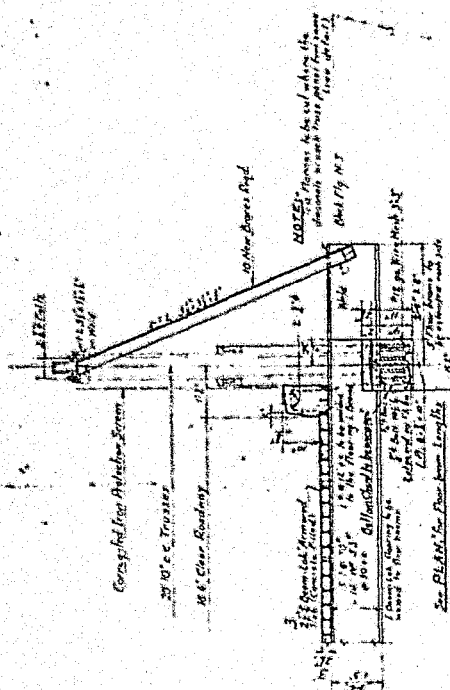
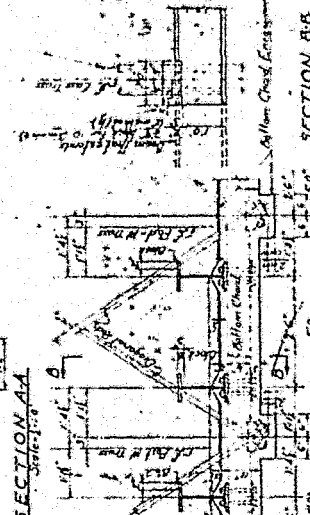
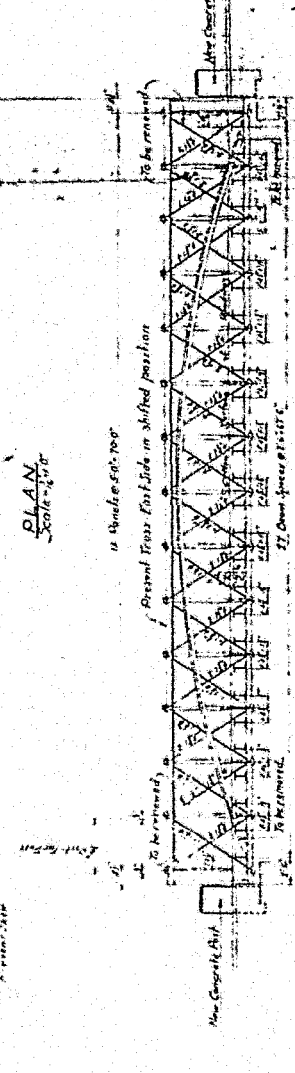
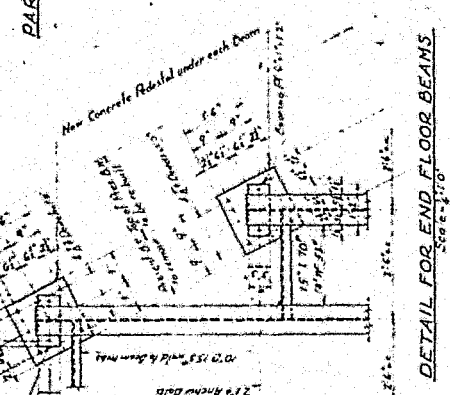
AMTRAK EXHIBIT A-1

In 1945, the Pennsylvania Railroad reconstructed the deck of the Spring Mill Road bridge. The existing deck was replaced with a concrete filled 3" I-Beam Loc armored slab. Exhibit A-1, the plan for the reconstruction of the deck, shows the 3" concrete filled grating on the top flange of the floor beams.

PART ELEVATION OF E. TRUSS
Scale 1/4" = 1'-0"

ELEVATION
Scale 1/4" = 1'-0"

DETAIL FOR END FLOOR BEAMS
Scale 1/4" = 1'-0"

SECTION CC
Scale 1/4" = 1'-0"

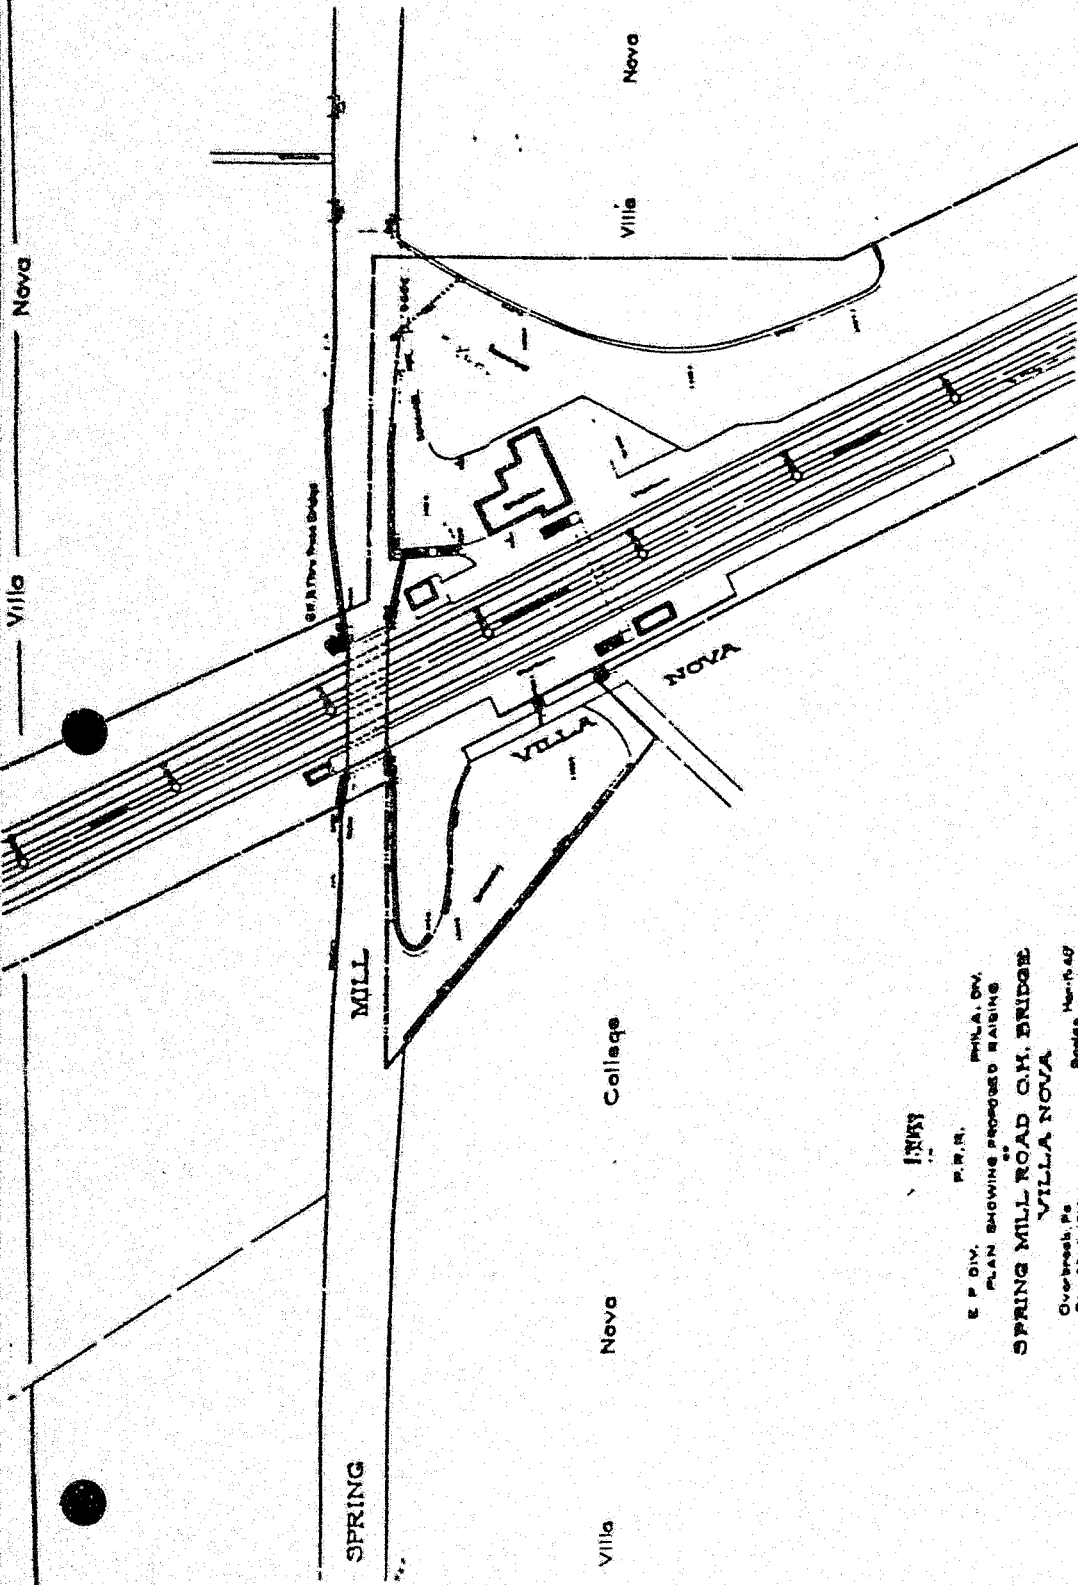
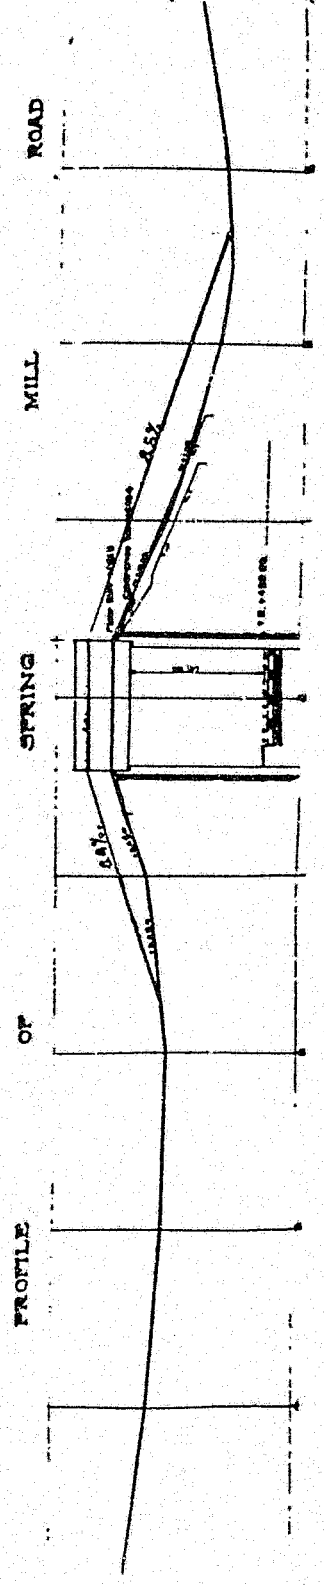
E. P. DIV. PHILA., PA.
 PLAN SHOWING PROPOSED RAISING
 SPRING MILL ROAD O.H. BRIDGE
 VILLA NOVA
 Overbrook, Pa.
 Dec. 23rd, 1914.
