Re: Letter of Notification of Mid-Atlantic Interstate Transmission, LLC for Approval of the Peach Bottom-Three Mile Island 500 Kilovolt Transmission Line Loop to a Point of Interconnection with PPL Electric Utilities Corporation Project in Chanceford Township, York County, Pennsylvania Docket No. _____

LETTER OF NOTIFICATION

- **Exhibit 1:** A depiction of the general location of the Project on a topographic map;
- **Exhibit 2:** A depiction of the general layout of the Project;

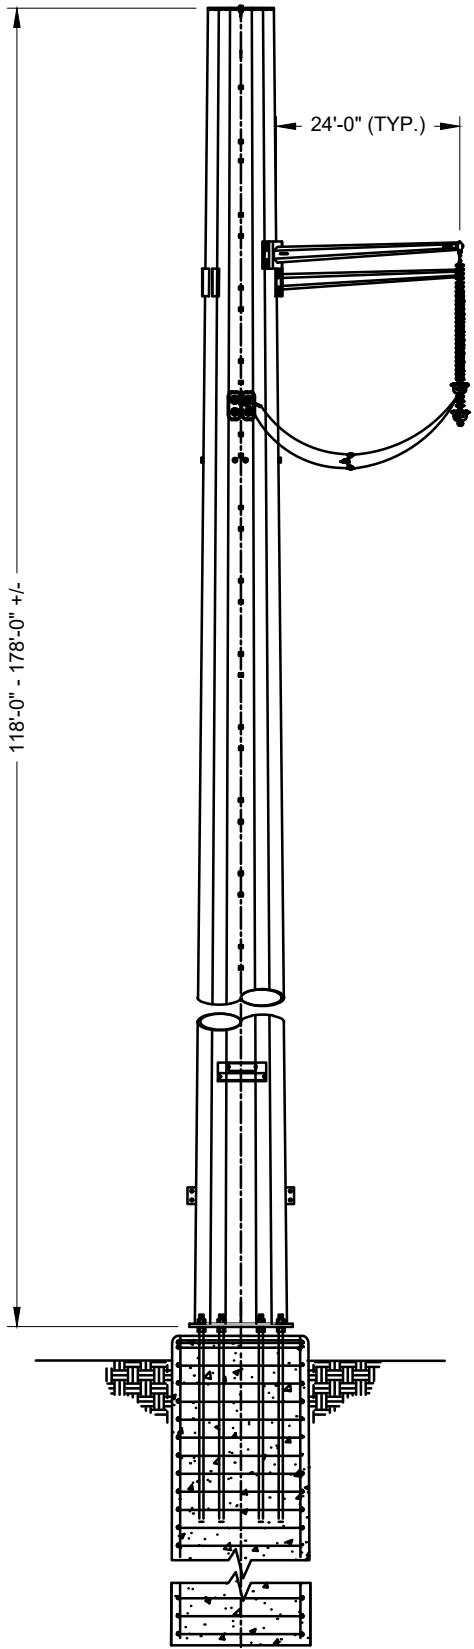
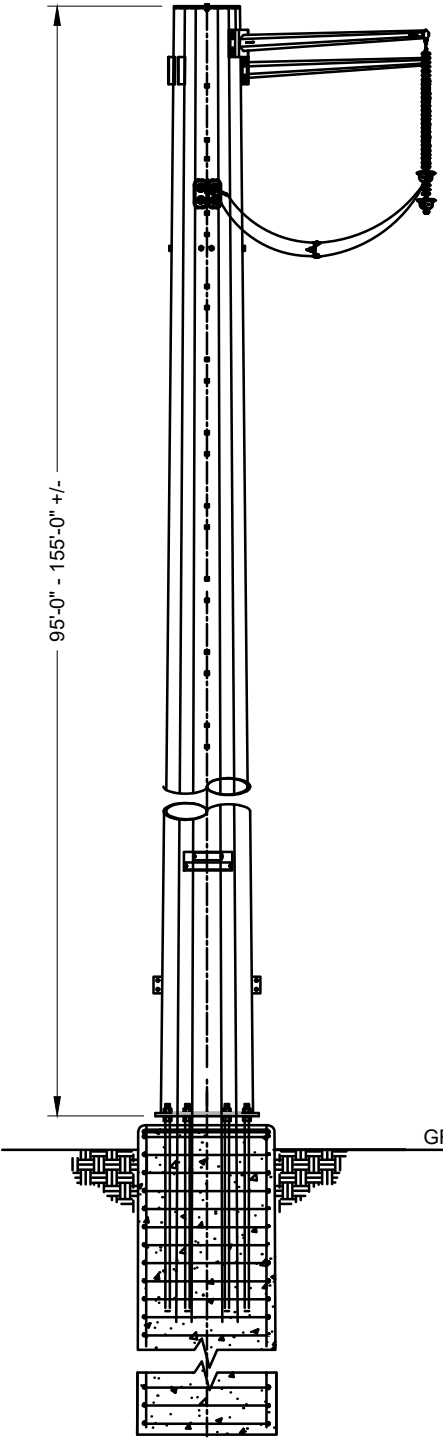
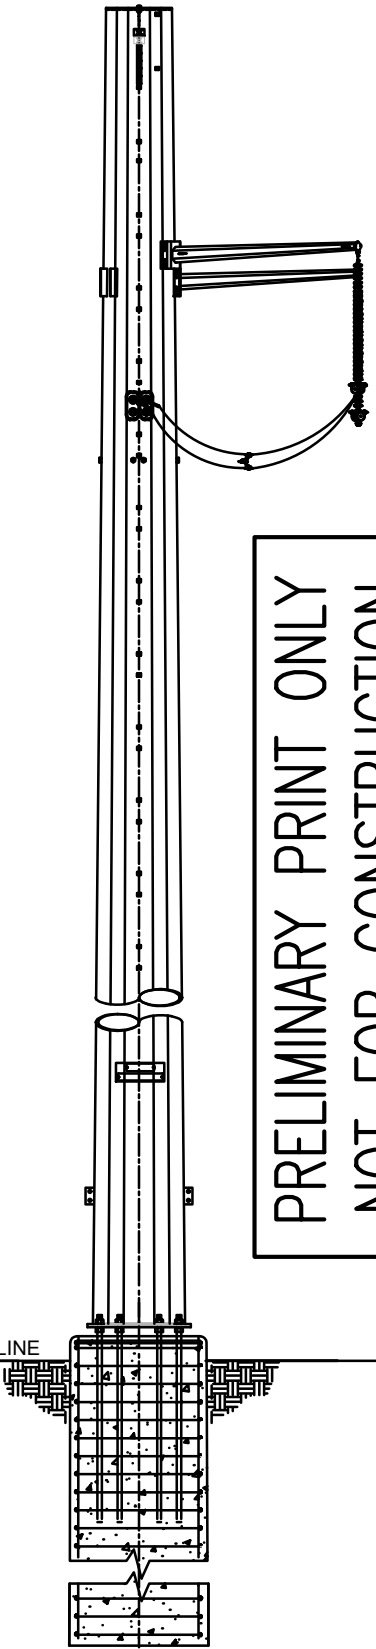
Exhibit 4

- **Exhibit 4:** A depiction of a typical 500 kV single circuit tubular steel horizontal deadend three pole angles 0 to 50 degrees;
- **Exhibit 5:** A depiction of a 500 kV single circuit tubular steel vertical deadend single pole angles 50 to 90 degrees, structure #187A;

20. Four new structures will be installed within the existing 200-foot-wide right-of-way ("ROW"). The four new structures will be approximately 120 to 195 feet in height above grade with span lengths ranging from approximately 310 to 1,000 feet. Two of the new structures are proposed as single circuit tubular steel horizontal deadend three pole structures on drilled pier foundations: structure #186.5 (approximately 180 feet in height above grade) and structure #187.5 (approximately 120 feet in height above grade), as depicted in **Exhibit 4**. The remaining two new structures are proposed as single circuit tubular steel vertical deadend single pole structures on drilled pier foundations: structure #187A (approximately 195 feet in height above grade) and structure #187B (approximately 155 feet in height above grade), as depicted in **Exhibit 5**.

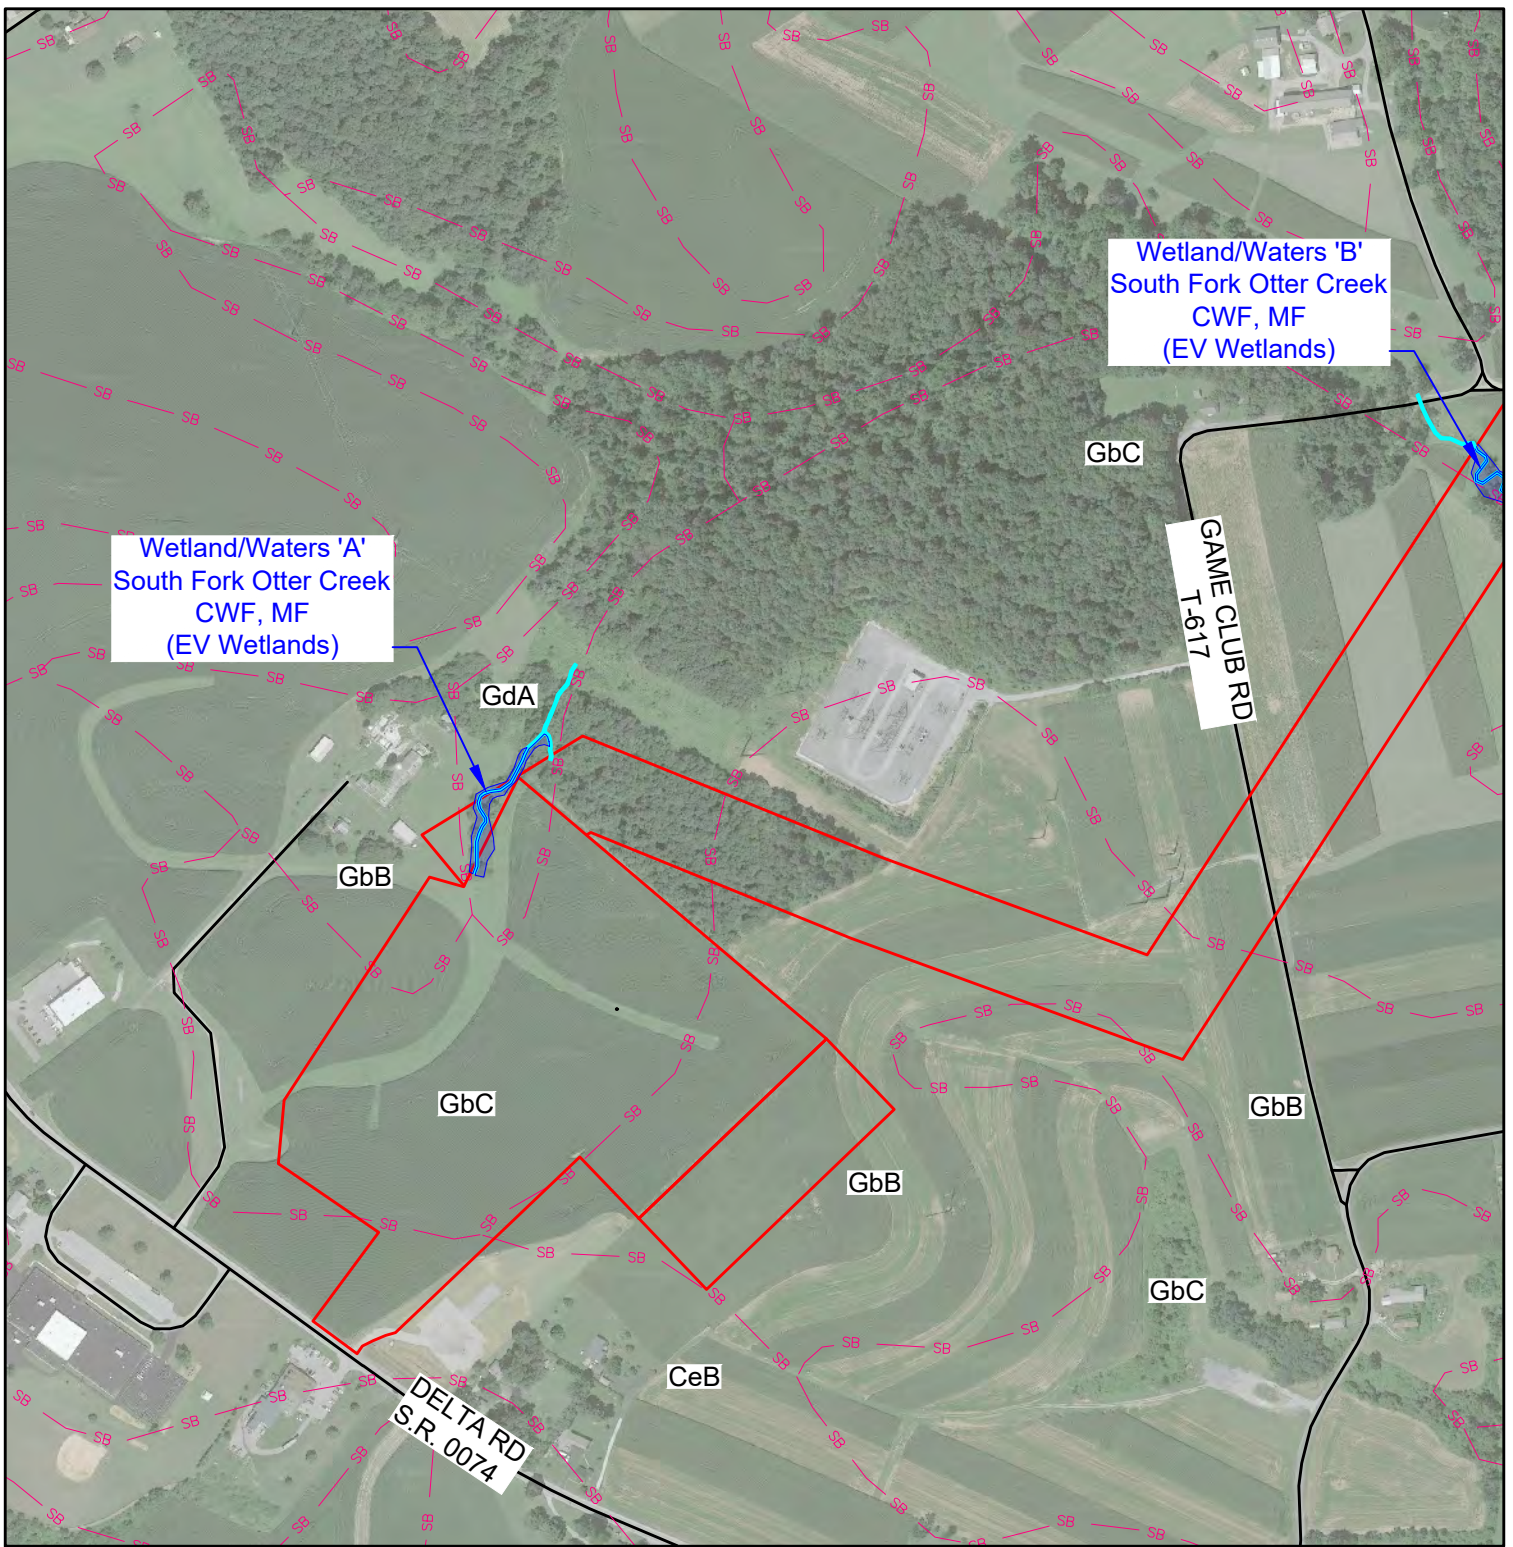
Wetland Delineation
 Figure 4.1: Soils Map
 Chanceford 500kV-230kV Substation
 Chanceford Township
 York County
 Airville Quad

FIGURES 4 show the soil survey map (York County GIS Mapping) with the site marked. The soil survey indicated that six (6) soils would be found on the site. Below are the descriptions for these soils:
