Re: Letter of Notification of Mid-Atlantic Interstate Transmission, LLC for the Johnstown–Seward 230 Kilovolt Transmission Line Rebuild Project in St. Clair Township in Westmoreland County, East Wheatfield Township in Indiana County, and Jackson Township in Cambria County, Pennsylvania
Docket No.

Enclosed for filing on behalf of Mid-Atlantic Interstate Transmission, LLC (“MAIT”) is a Letter of Notification (“LON”), requesting approval for the Johnstown-Seward 230 Kilovolt (“kV”) Transmission Line Rebuild Project (“Project”). This LON is filed pursuant to the Pennsylvania Public Utility Commission’s (“Commission”) regulations at 52 Pa. Code § 57.72(d)(1). Copies of this LON or a Notice of Filing have been served upon the parties as required by 52 Pa. Code § 57.74 and noted on the attached Certificate of Service.

JOHNSTOWN – SEWARD 230KV TRANSMISSION LINE REBUILD PROJECT GENERAL LAYOUT			
MAIT <small>Mid-Atlantic Interstate Transmission, LLC</small>	ASSET/OP. CO.	DWG NO.	SHEET REV.
	MAIT/PN	EXHIBIT 1	1/6

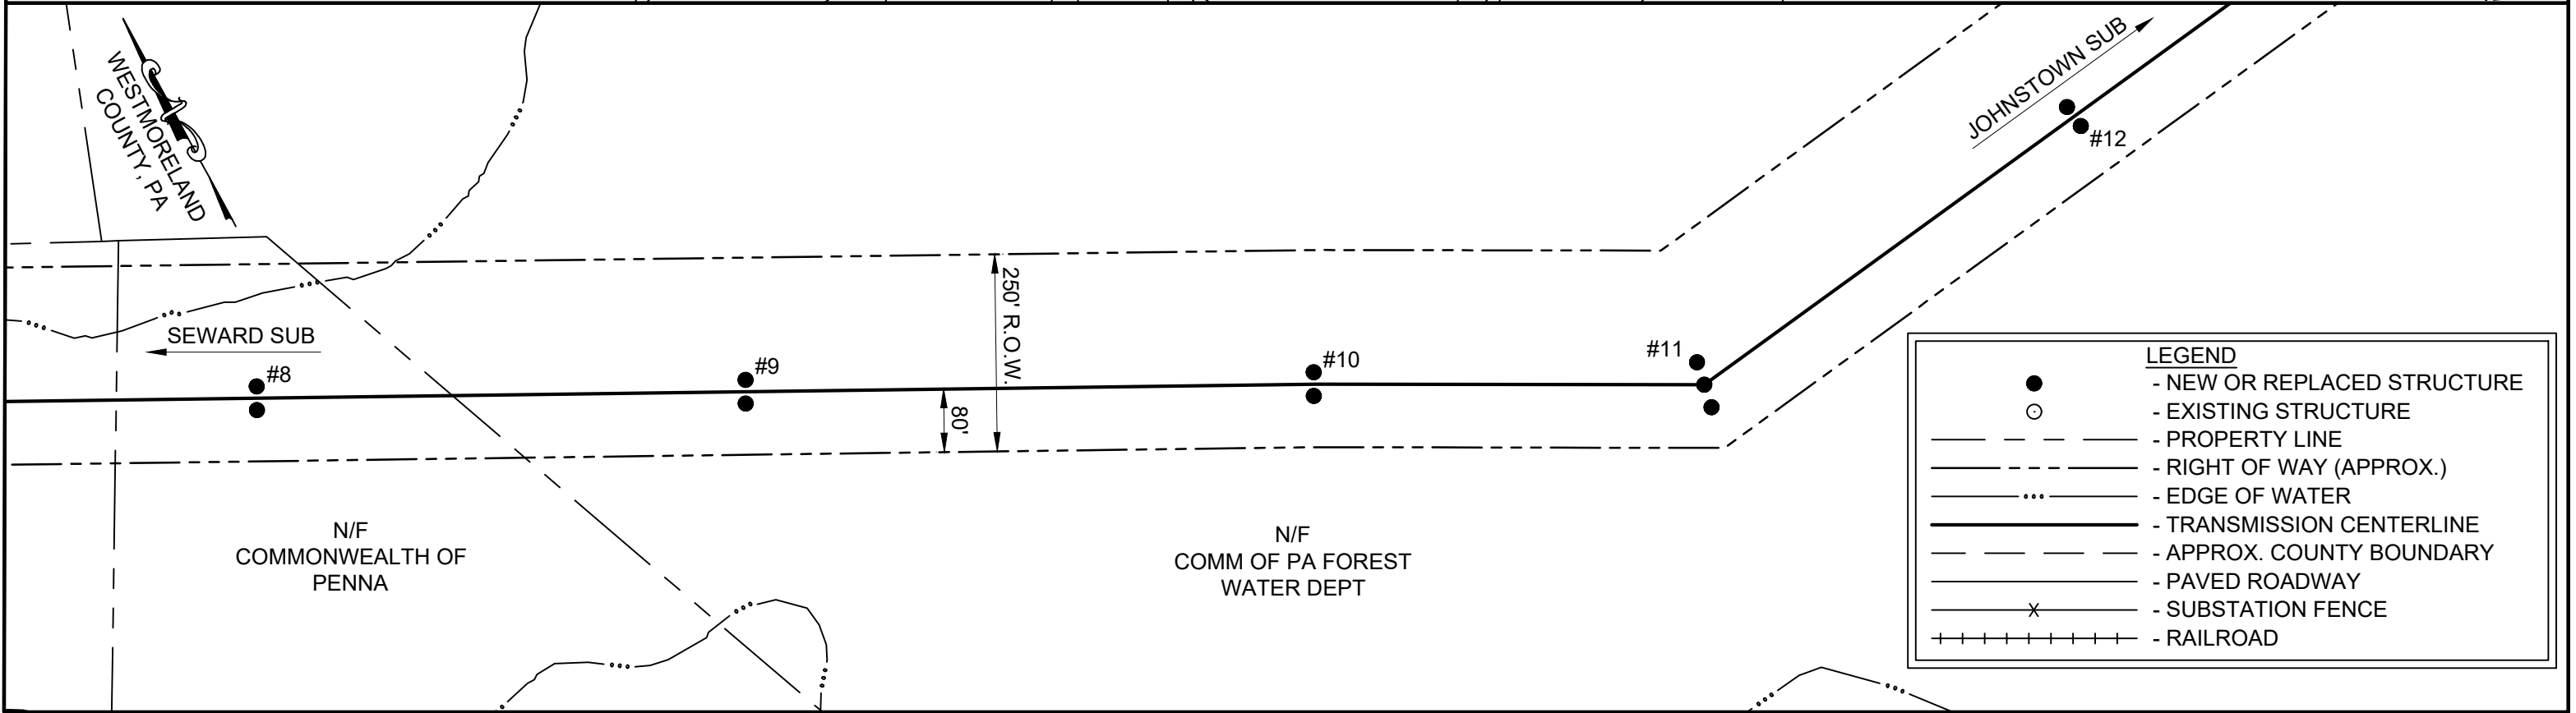
NOTE:
SPAN FROM SEWARD SUBSTATION TO
STR #61 WILL REMAIN AS EXISTING

20. The proposed Project will replace fifty-nine of the existing sixty-one structures. The structure immediately adjacent to the Seward Substation, Structure #61, will remain. Existing structure #26 will be removed and not replaced. Fifty-nine new structures will be installed and consist of eight three-pole steel structures, fifty two pole steel H-frame structures, and one single steel monopole.

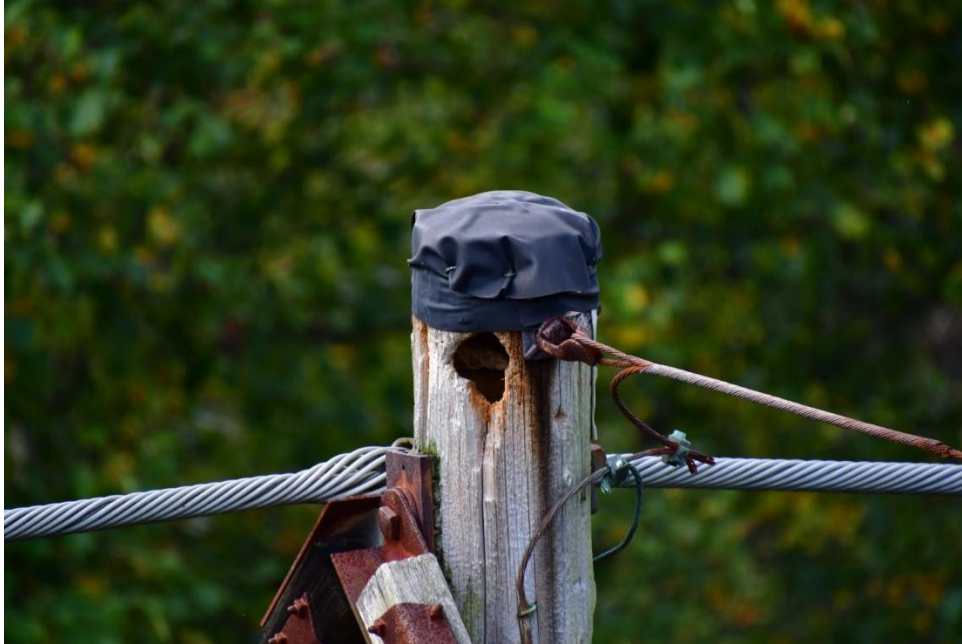
Figure 1: Active woodpecker hole on structure 7. This pole was also repaired in 2016 with a pole top cap due to extensive pole top rot.

11. A wood pole inspection was conducted in 2019 on the Johnstown–Seward 230 kV Transmission Line. As evidenced by the inspection, many structures exhibited more than one deficiency. The inspection identified forty-three structures with decay, fifty-four structures with shell rot, three structures with cracking, and three structures that exhibited fire damage. In addition to the measurable levels of decay and rot, the inspection also identified twelve structures with woodpecker damage and twenty-one structures with insect damage. **Exhibit 10** shows photographic evidence of the found conditions explained above. **Exhibit 10** Table 1 shows a summary of these results, and Table 2 shows the inspection by structure.

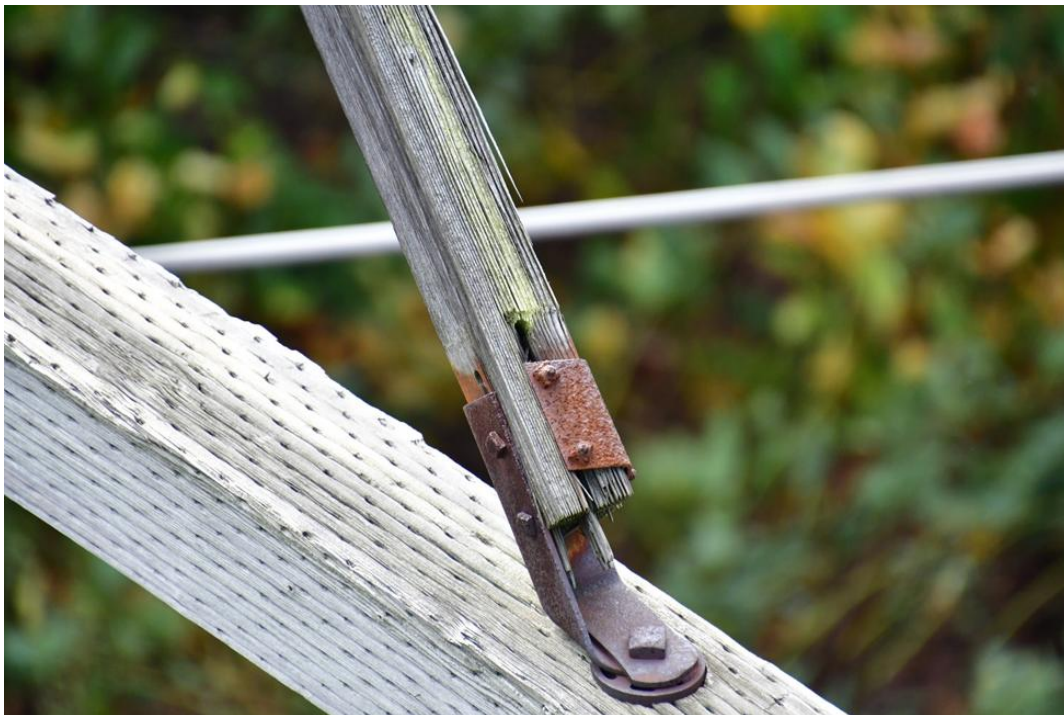
Figure 2: A cross-arm brace or “knees and vees” has degraded, allowing the metal bracket supporting the cross arm to slide down the wood. Located at structure 15.

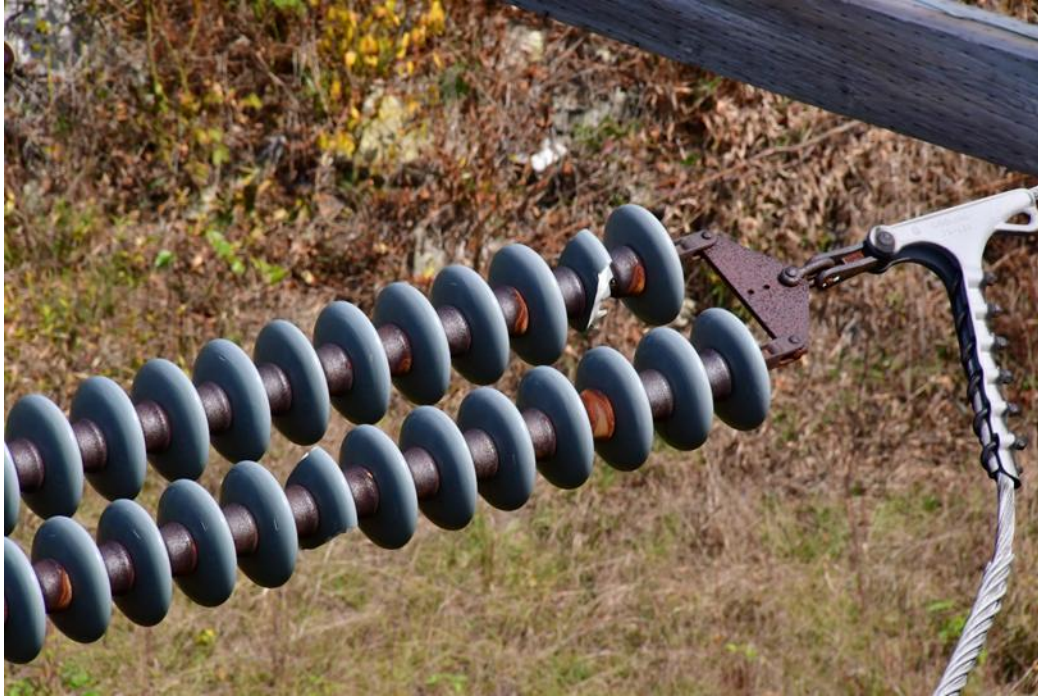
Figure 3: Broken insulator bells original to the construction of the line. Located at structure 43

13. There are eleven historical repairs for broken bells on insulator strings. The majority of the insulators on the Johnstown–Seward 230 kV Transmission Line are original to the line’s construction and are beginning to degrade. As insulators age, the glaze protecting the porcelain bell degrades due to climatic factors, reducing electrical insulation and increasing the risk of flashover or damaging events. Once an insulator is compromised, it can result in flashed and broken insulator bells (*see* Figure 3), and in the worst case, an unscheduled outage. While there have been no unscheduled outages on this transmission line, the eleven repair records associated with broken bells and the two repair records associated with flashed insulators indicate that the insulators are reaching the end of their service life.
