NOTICE OF VIOLATION (NORRIS CITY PUMP STATION)

**NOTICE OF VIOLATION**

Re: Clean Water/Operations/Sewage  
Norris City Avenue Pumping Station  
East Norriton Township  
Montgomery County

**GENERAL INSPECTION REPORT (Non-NPDES)**

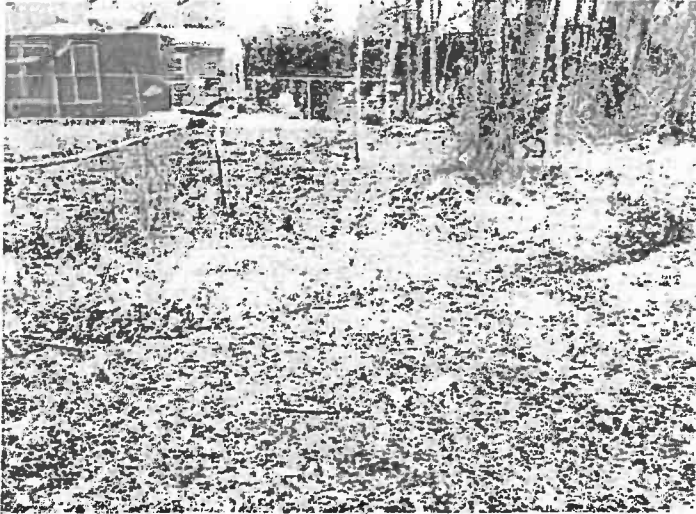
**1. The wooded area on the flood plain behind the Norris City Avenue Pumping Station, 02/16/16.**

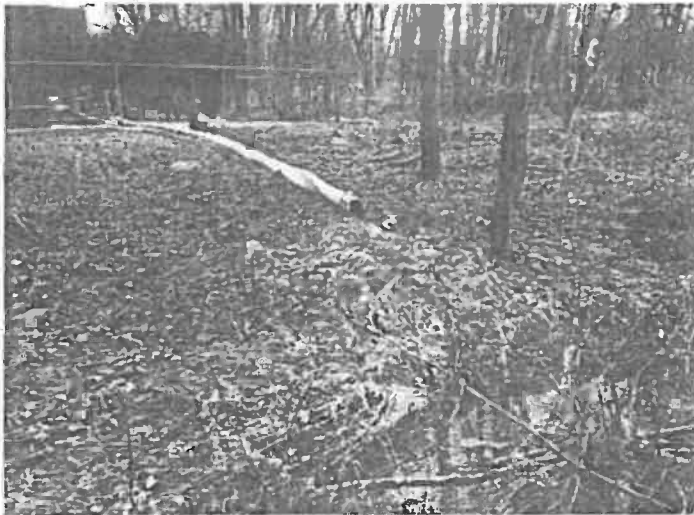
**3. One of the Xylem Portable Pumps and Discharge lines, 02/26/16.**

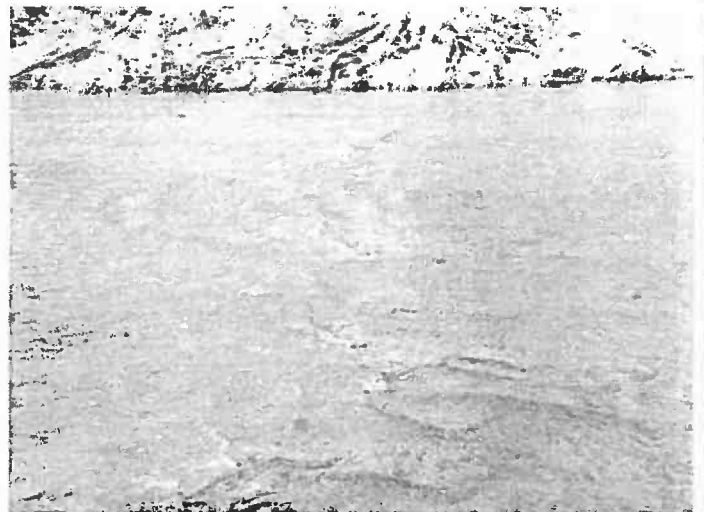
**8. A fast moving section of Stoney Creek upstream of the parking lot for the Norristown Elmwood Zoo, 02/26/16.**

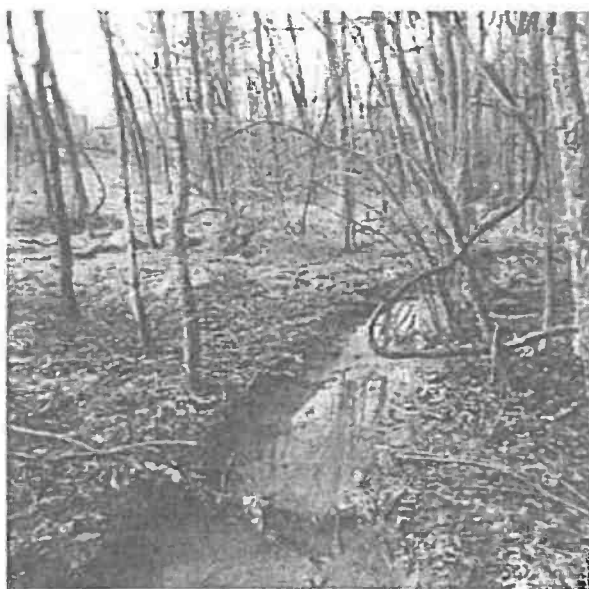
**12. A small Unnamed Tributary to Stoney Creek, 02/26/16.**

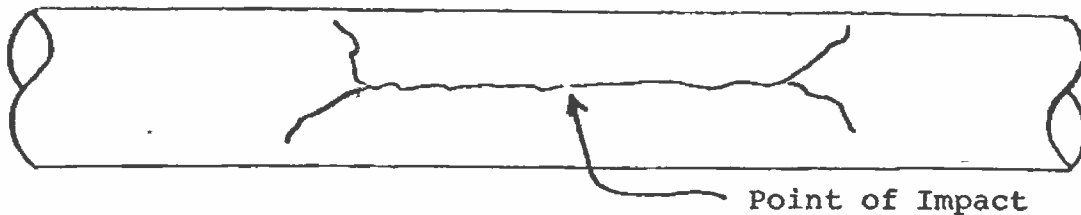
To identify this type of break it should be pointed out that the fracture starts at the point of impact and runs in opposite directions following a generally straight line for some distance. At approximately the same distance from the impact point and on both sides, the crack will start to turn off in another direction or split into two or more directions.

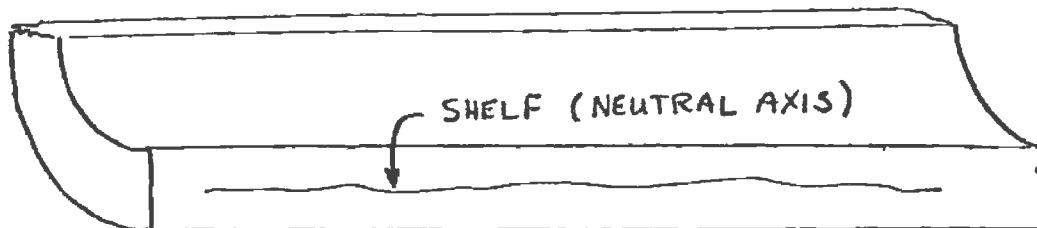
LONGITUDINAL SECTION THROUGH PIPE WALL

A cross section of the pipe wall at the point of impact sometimes has an unusual appearance when compared to the other metal in the vicinity. The line of fracture may show what appears to be a shelf-like structure.

This will help identify the cause of breakage as impact.

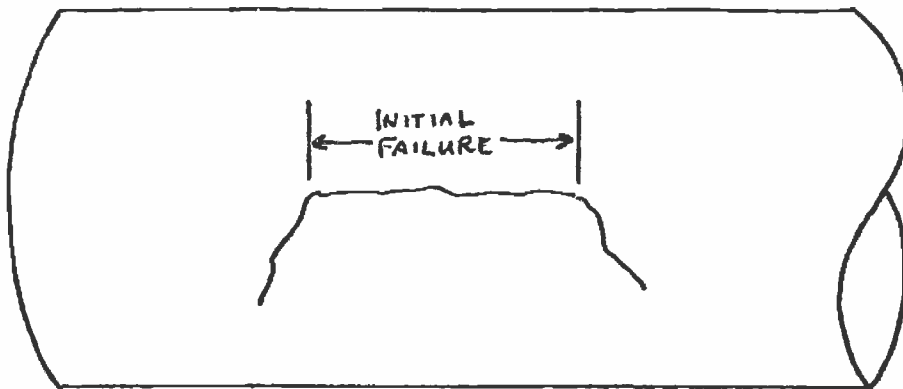
In large diameter pipe which are overloaded externally, failure is by crushing since the pipe is exceedingly strong as a beam. In ring crushing, the initial point of failure is longitudinal due to the ring or hoop stress producing it. The crack will continue in this direction until it is carried off the straight line by bending stresses produced by the rupture. The diameter at which overloading causes crushing failure rather than beam failure is about ten inches. Smaller pipe will generally break transversely due to beam action. It is well to note that a great majority of failures in cast iron pipe are beam failures in small diameter pipe. Crushing failures rarely occur.

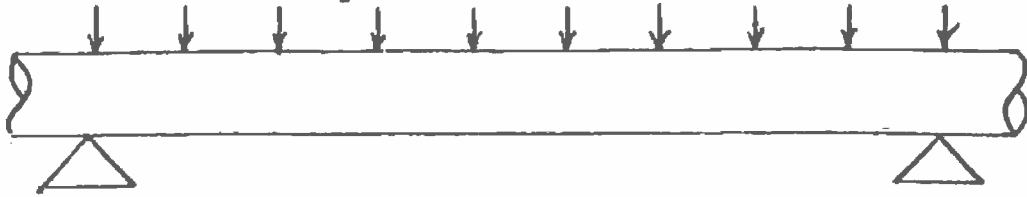
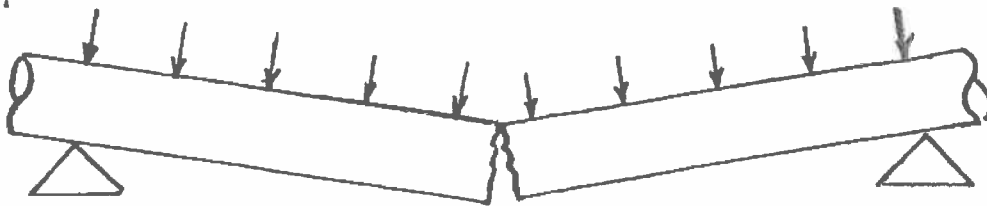
As indicated previously, the major cause of in-service breaks in cast iron pipe is beam action in pipe eight inches and smaller in diameter. A pipe properly laid and not disturbed after laying is not called upon to act as a beam and such a pipe, cannot, therefore fail as a beam. The backfill on pipe so laid stresses it as a ring in compression. Smaller diameter cast iron pipe will withstand, as a ring, many times the load that even an excessive depth of trench might transmit to the pipe. On the other hand, a pipe not properly laid may act as a beam for any of several reasons. If blocks are used near the ends of the pipe and the backfill not properly tamped, the load placed on the pipe tends to bend it downward in the middle. If failure occurs with this type of loading,

the breaks will be opened wider at the bottom than at the top.

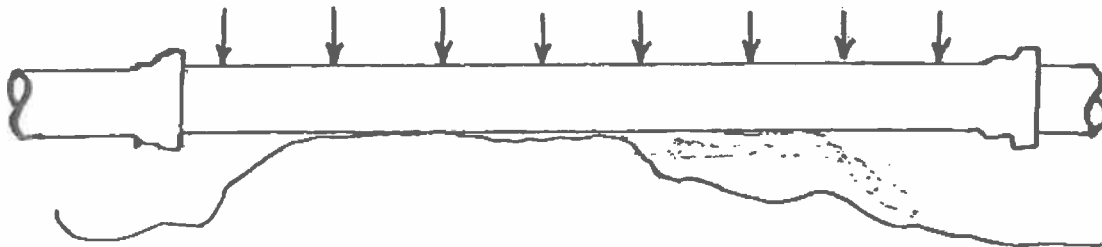
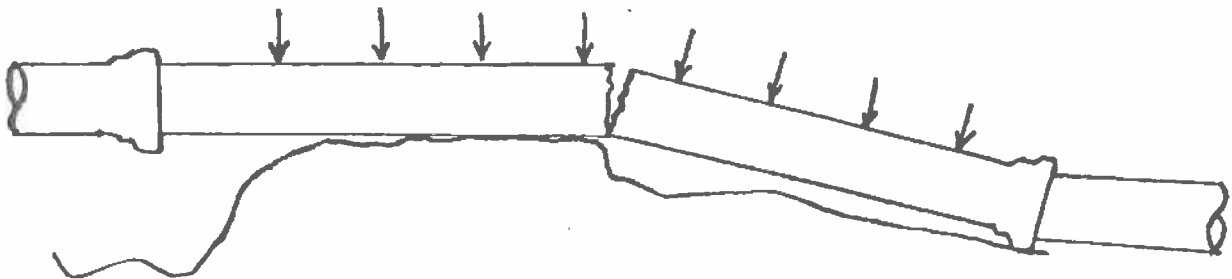
If the bottom of the trench is wavy with deep and long bell holes, the pipe is supported in the middle and comparatively free at the ends. This pipe will bend downward at the ends and if failure occurs the break will be opened wider at the top than at the bottom.

In either of these cases, the pipe breaks straight across near the middle of a length. Breaks of these types are seldom found in sandy soils since the sand very easily flows around the pipe to form a good foundation and in this manner prevents beam action.
