PENNSYLVANIA PUBLIC UTILITY COMMISSION

STAFF'S STATEMENT #1

Crossing #1
AAR No. 518 184M
L.R. 36009
Noble Road
Sadsbury Township
Below Grade
Mile Post 4.03

TESTIMONY OF DAVID A. OLIVER

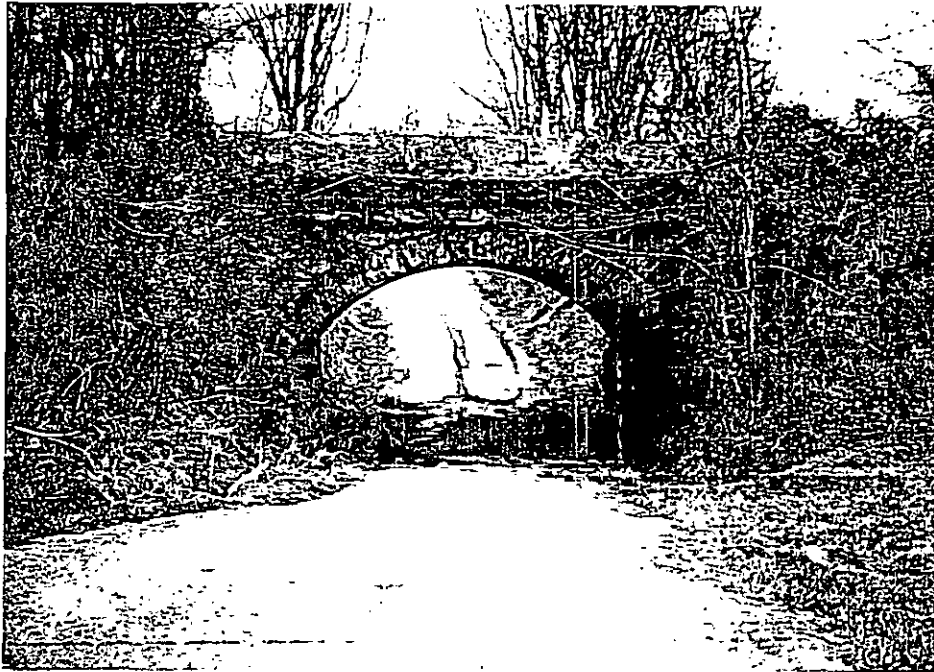
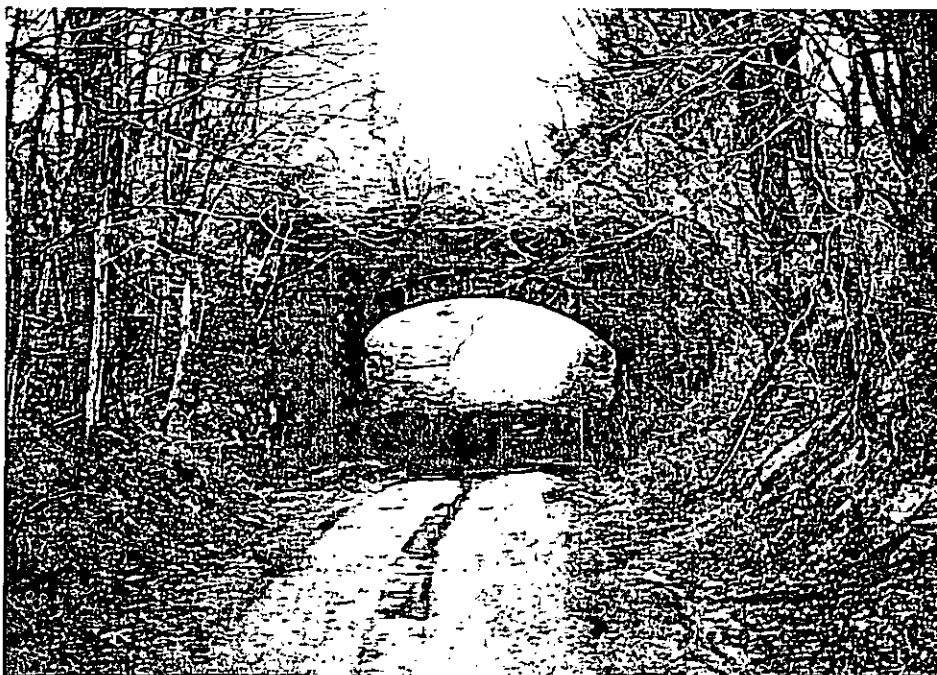
A-00111016
CROSSING #15
AAR 518 201B
T-482, OAK BOTTOM ROAD
PROVIDENCE TOWNSHIP
BELOW GRADE
MILE POST 14.46

10 Q: Please describe the type of structure at Crossing No. 15 and
11 describe its condition.

12 A: The structure is a stone arch in fair condition.

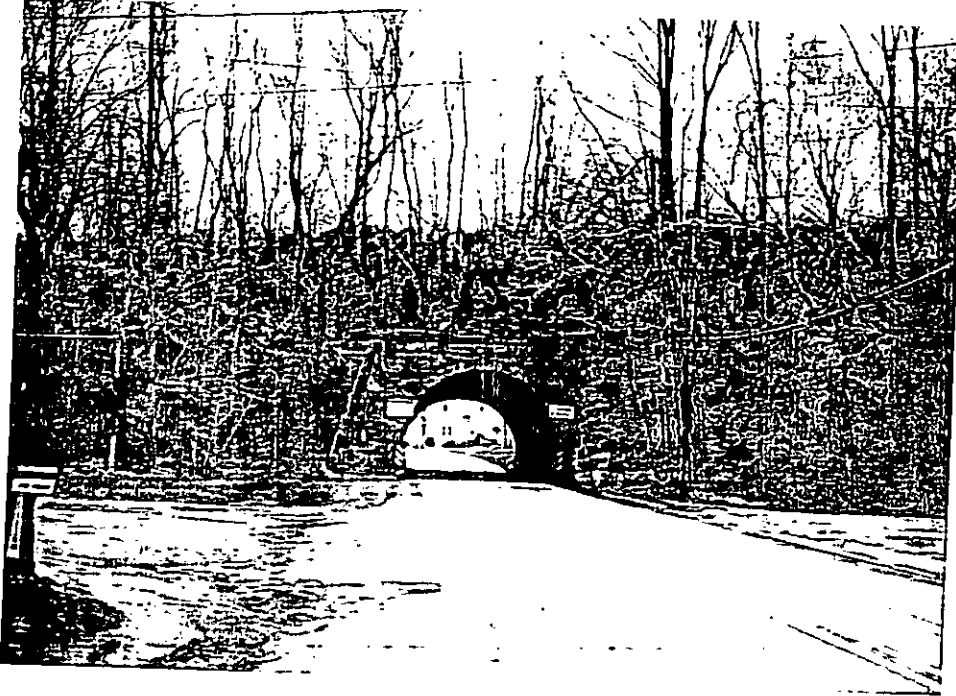
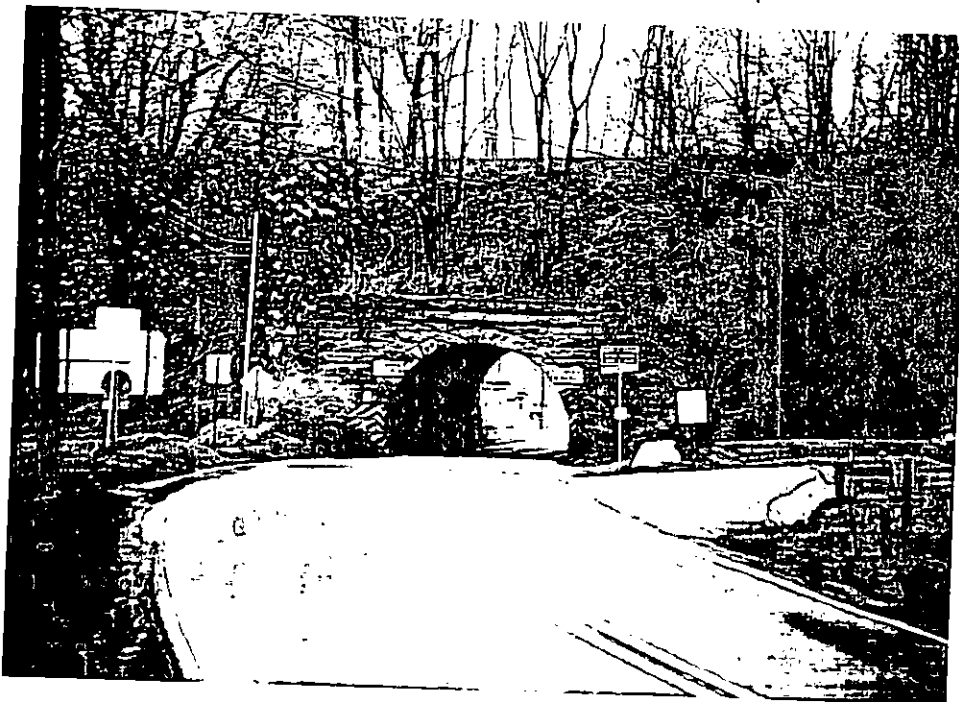
A-00111016
CROSSING #16
AAR 518 202H
T-222
PROVIDENCE TOWNSHIP
BELOW GRADE
MILE POST 14.62

9 Q: Please describe the type of structure at Crossing No. 16 and
10 describe its condition.

11 A: The structure is a stone arch in fair condition.
12

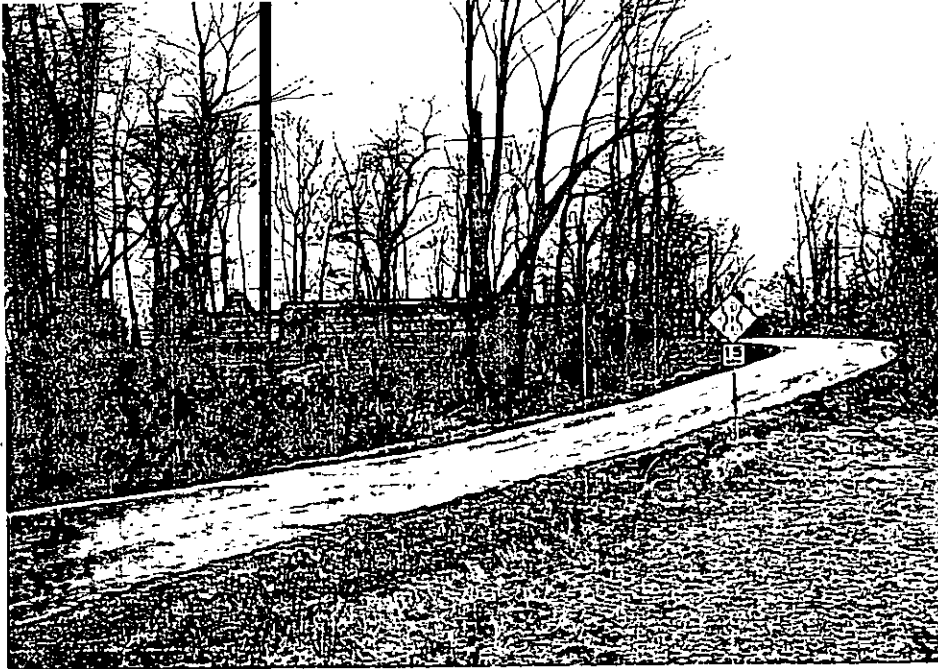
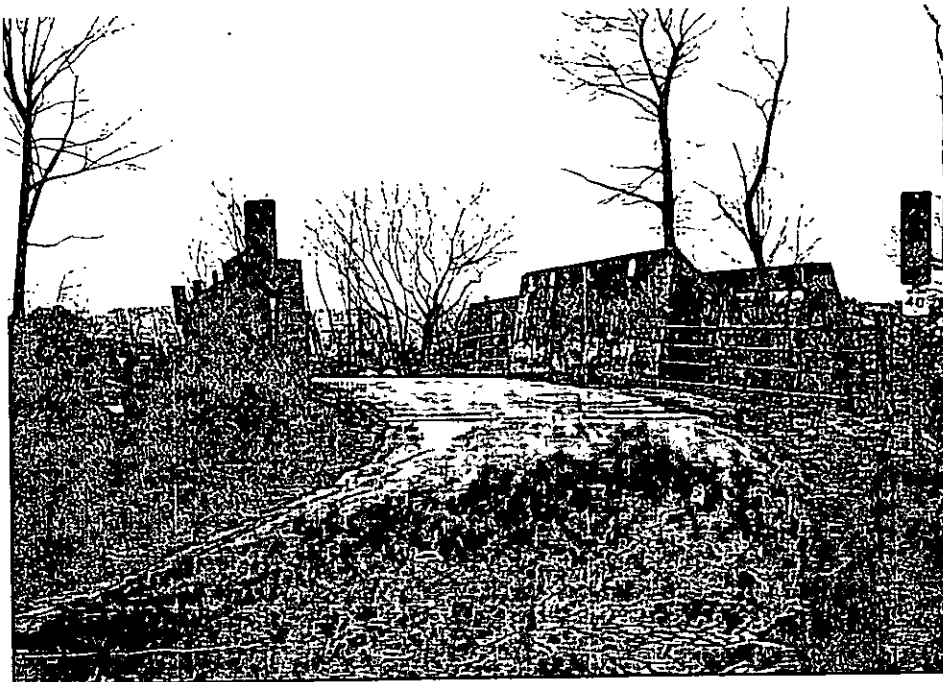
A-00111016
CROSSING #17
AAR 518 203P
L.R. 36172
PROVIDENCE TOWNSHIP
ABOVE GRADE
MILE POST 15.00

9
10 Q: Please describe the type of structure at Crossing No. 17 and
11 describe its condition.

1 Q: Are you aware of any Commission orders which assign
2 maintenance responsibilities for this structure?
3 A: No.
4
5 Q: What work do you believe should be performed at Crossing No.
6 17 in order to promote safety and prevent accidents?
7 A: Remove the existing bridge and place the roadway on earth
8 embankment.
9
10 Q: On what do you base your recommendation?
11 A: Since rail service has been abandoned along the subject rail
12 line, there no longer remains any need for the bridge.
13 Additionally, this crossing has substandard load carrying
14 capacity, roadway width, shoulder width, roadway alignment,
15 stopping distance and sight distance as measured in
16 accordance with PennDOT Roadway Urban Design Criteria
17 revised 6/91. The bridge remaining in place would also
18 prevent any proposed improvements to the roadway.
19
20 Q: Can Crossing No. 17 accommodate trail use if the bridge
21 carrying LR 36172 over Conrail's Enola branch is removed?

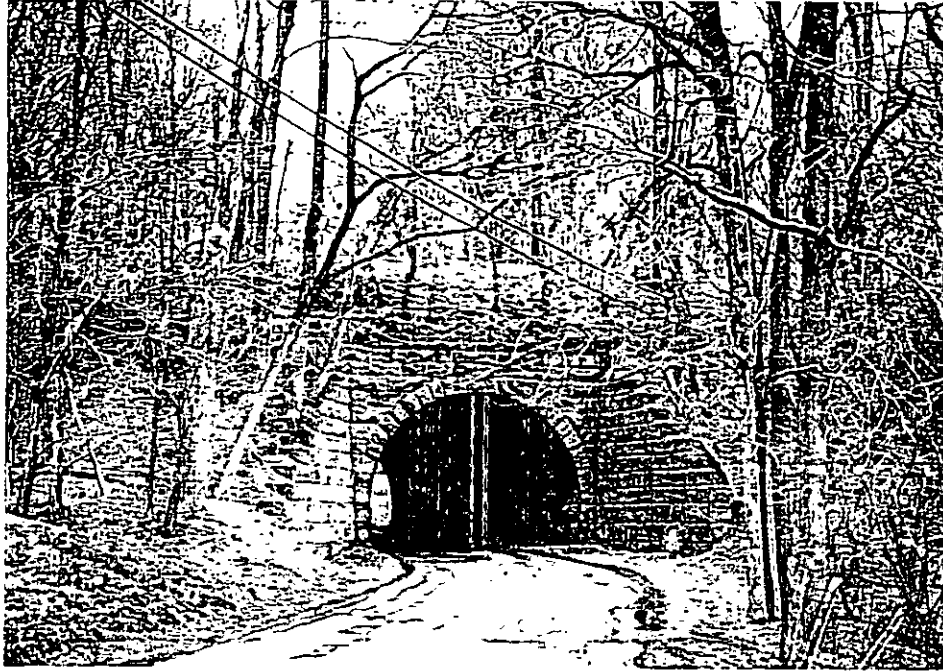
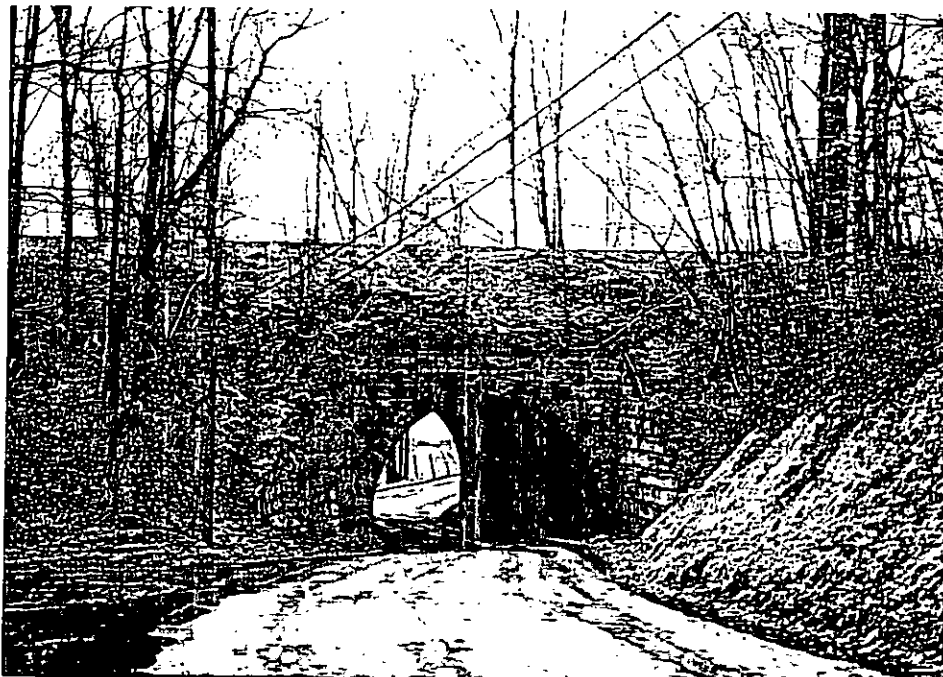
A-00111016
CROSSING #21
AAR 518 207S
T-498, HOLLOW ROAD
PROVIDENCE TOWNSHIP
BELOW GRADE
MILE POST 18.08

10
11 Q: Please describe the type of structure at Crossing No. 21 and
12 describe its condition.

13 A: The structure at Crossing No. 21 is a stone arch in fair
14 condition.

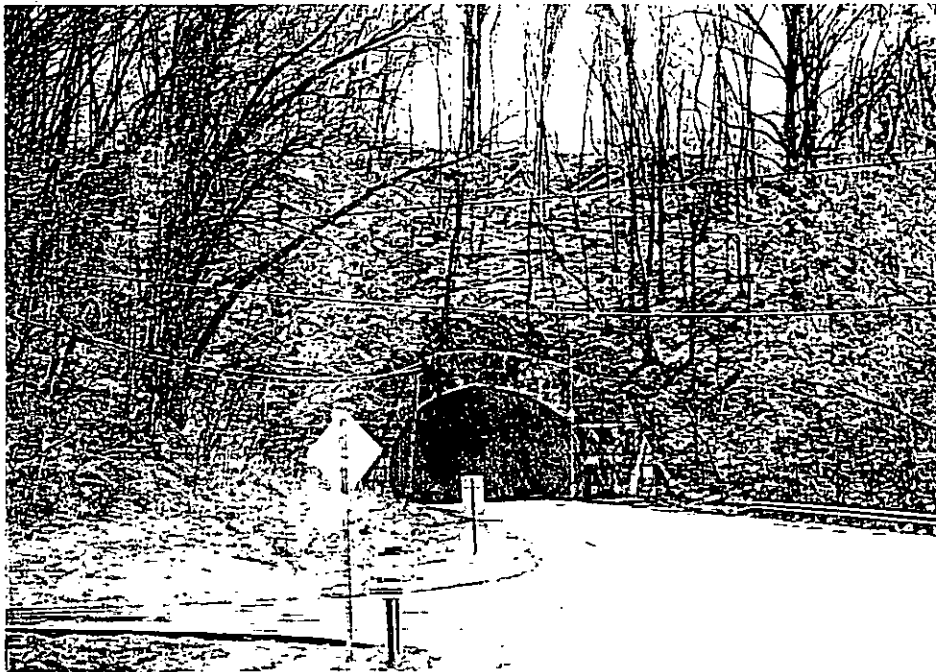
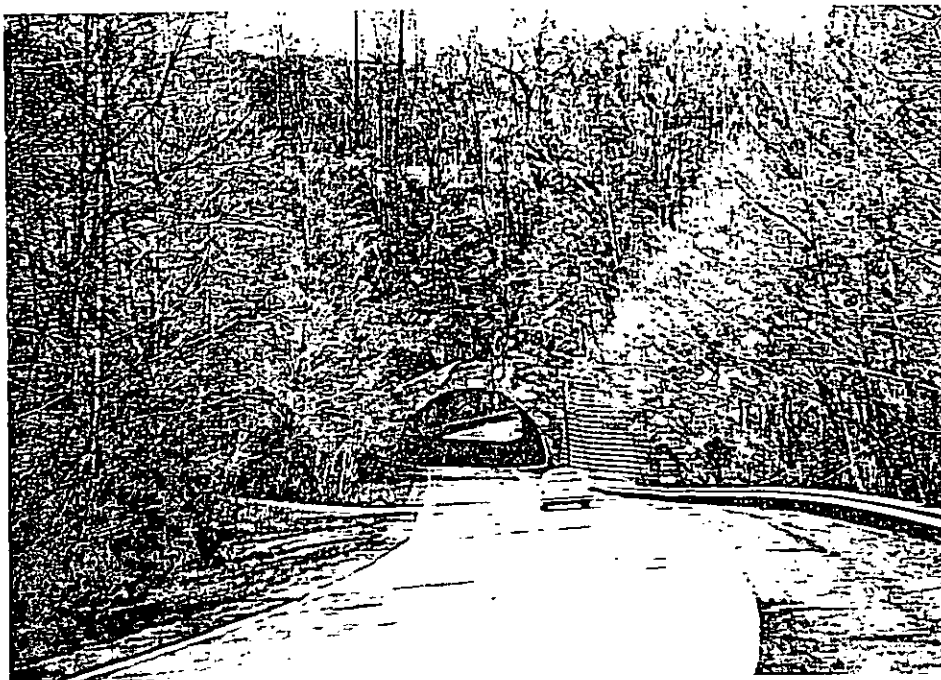
A-00111016
CROSSING #23
AAR 518 209F
L.R. 36007 - RT. 222
PROVIDENCE TOWNSHIP
BELOW GRADE
MILE POST 19.48

9 Q: Please describe the type of structure at Crossing No. 23 and
10 describe its condition.

11 A: The structure at Crossing No. 23 is a stone arch having
12 reinforced concrete extensions at each end in fair
13 condition.

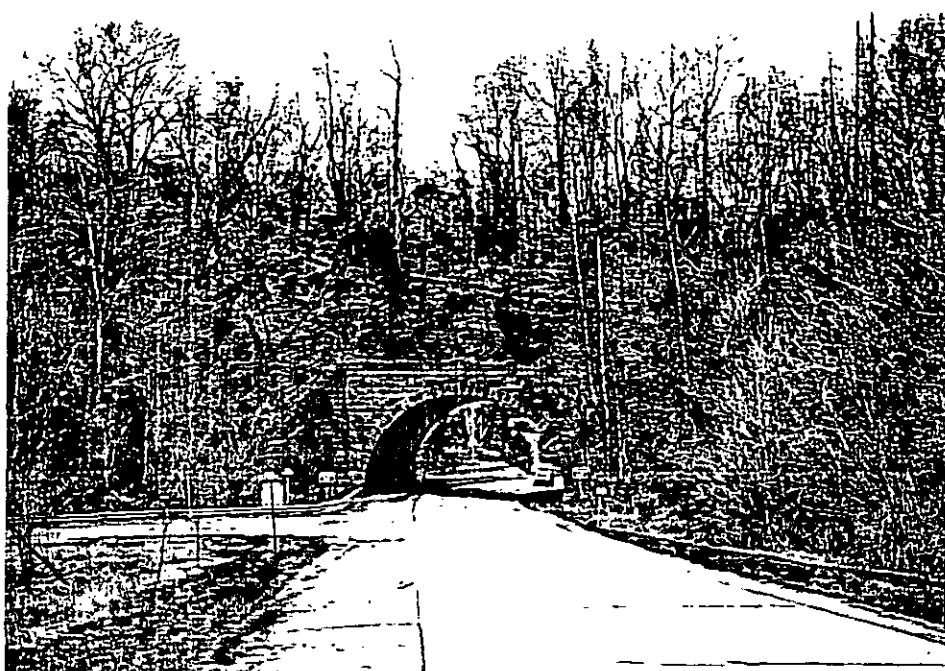
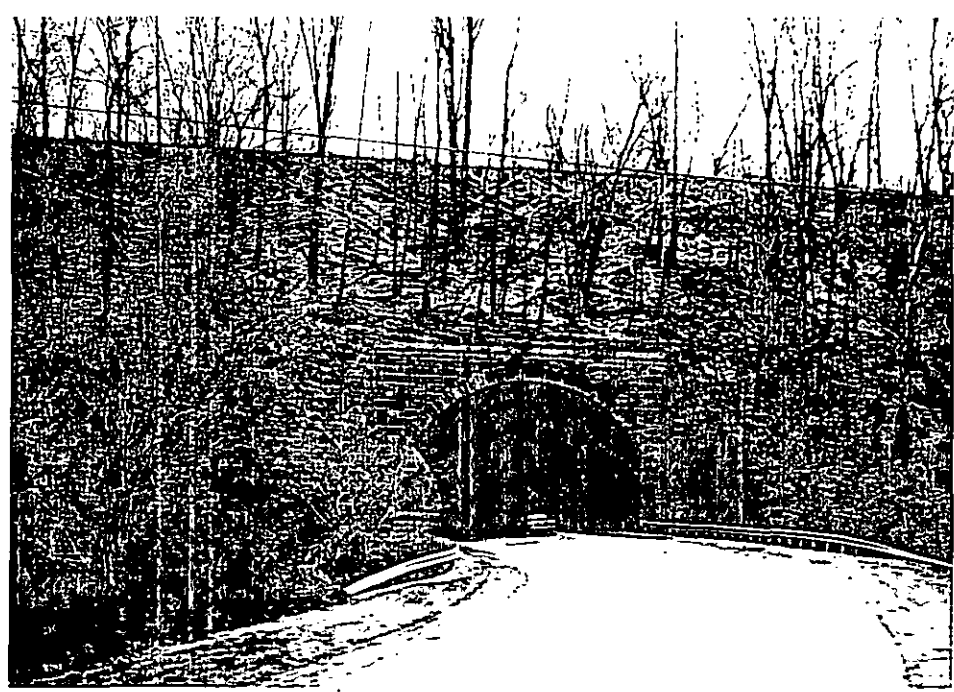
A-00111016
CROSSING #24
AAR 518 210A
L.R. 36025 - RT. 272
PROVIDENCE TOWNSHIP
BELOW GRADE
MILE POST 19.61

7 Q: Please describe the type of structure at Crossing No. 24 and
8 describe its condition.

9 A: The structure at Crossing No. 24 is a stone arch in good
10 condition.
11

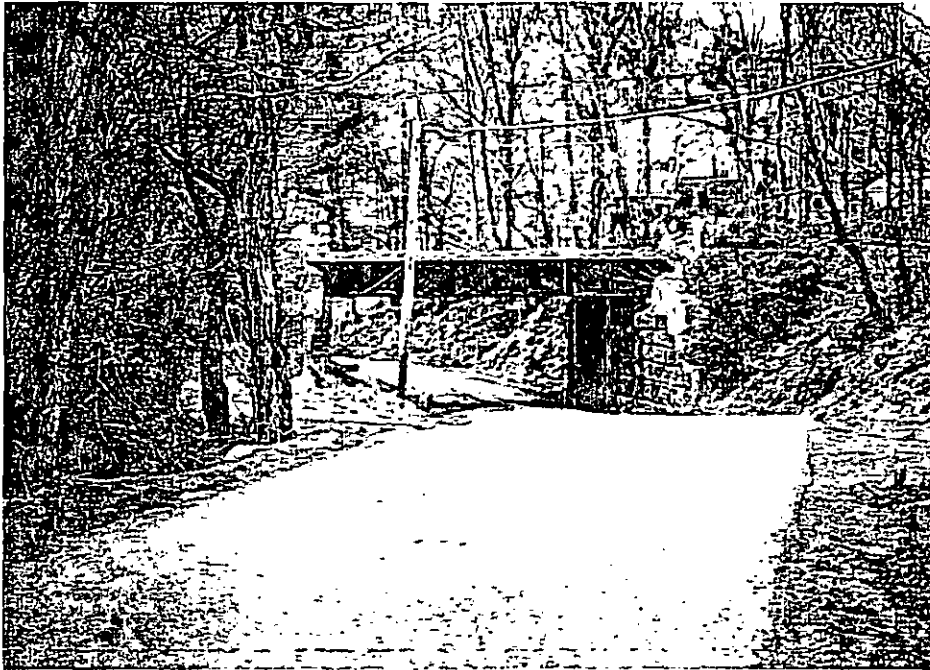
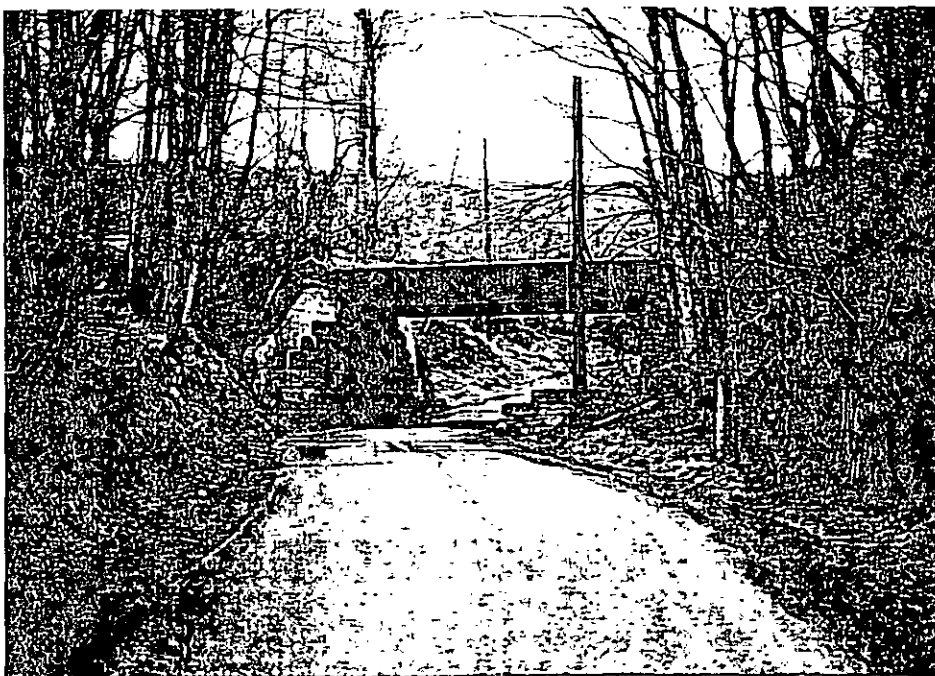
A-00111016
CROSSING #26
AAR 518 212N
T-500, SIGMAN ROAD
PROVIDENCE TOWNSHIP
BELOW GRADE
MILE POST 21.02

9 Q: Please describe the type of structure at Crossing No. 26 and
10 describe its condition.

11 A: The structure at Crossing No. 26 is a single span steel
12 girder in fair condition.
13

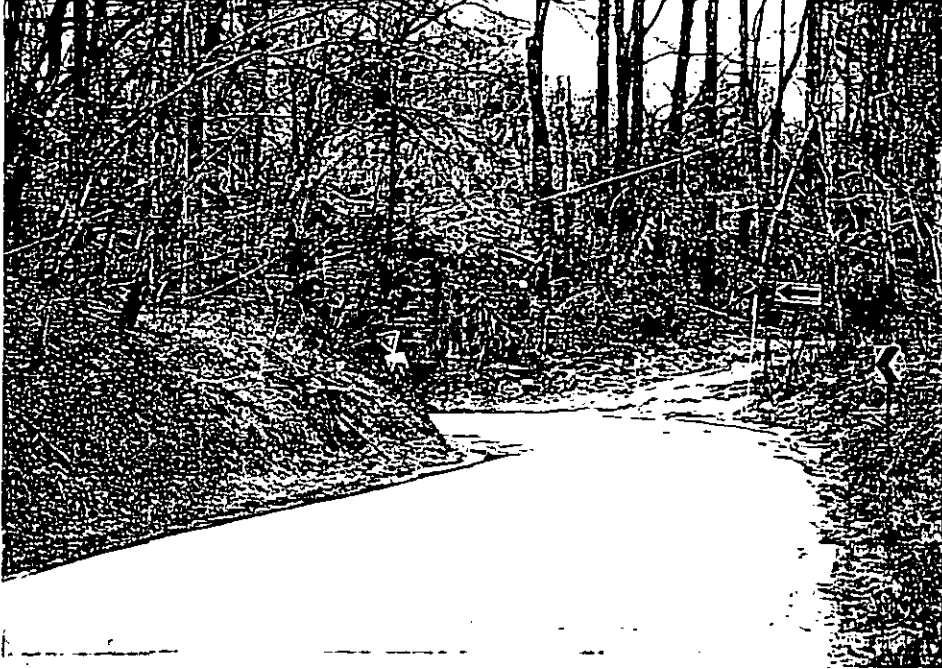
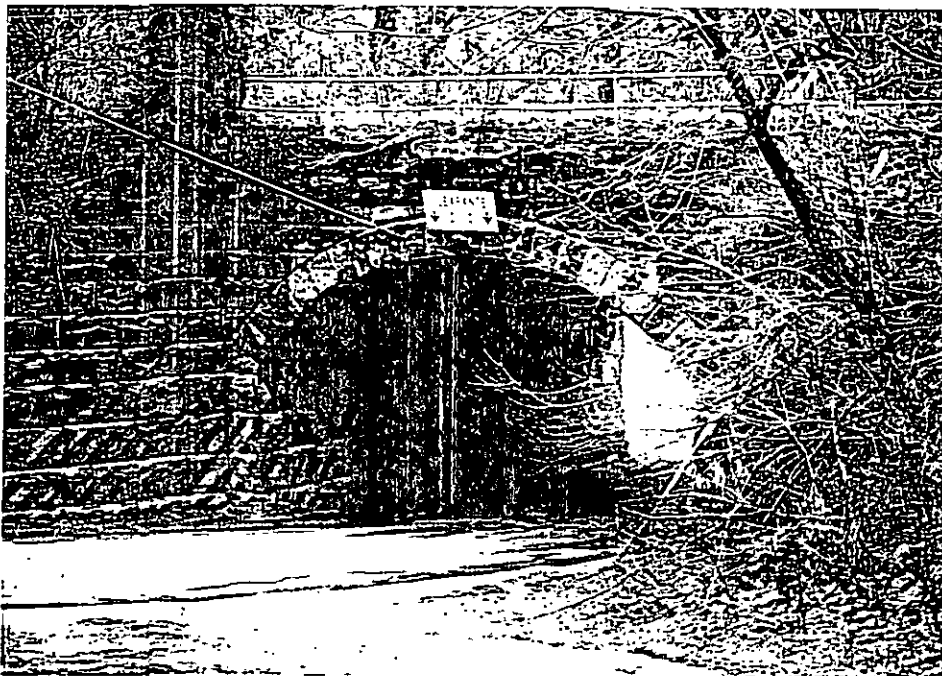
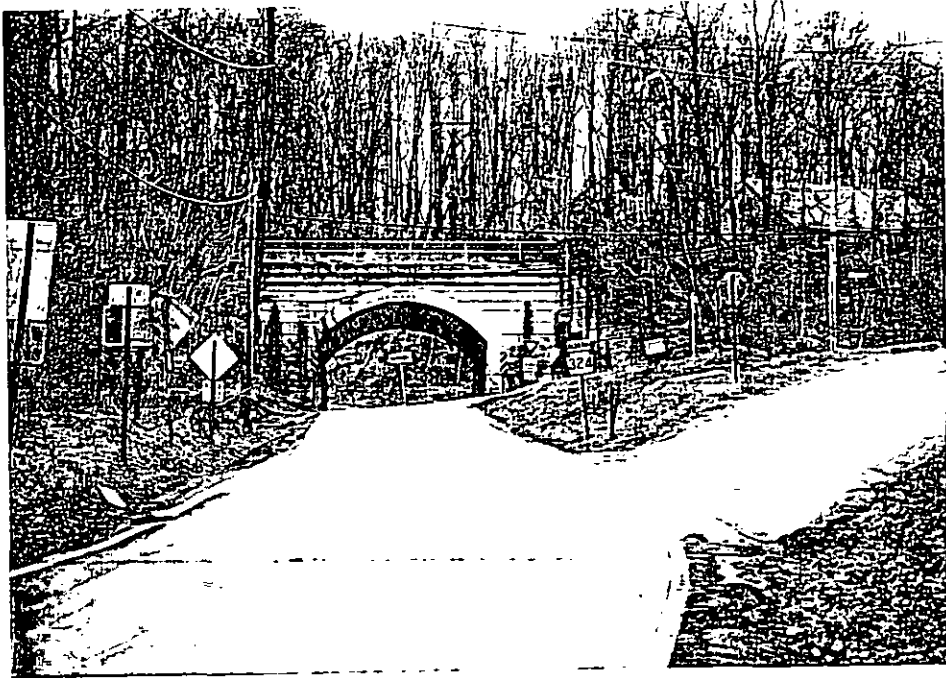
A-00111016
CROSSING #27
AAR 518 213V
PA 324, MARTICVILLE ROAD
MARTIC TOWNSHIP
BELOW GRADE
MILE POST 23.04

12 Q: Please describe the type of structure at Crossing No. 27 and
13 describe its condition.

14 A: The structure at Crossing No. 27 is a stone arch with
15 concrete extension on the south end and is in fair
16 condition.

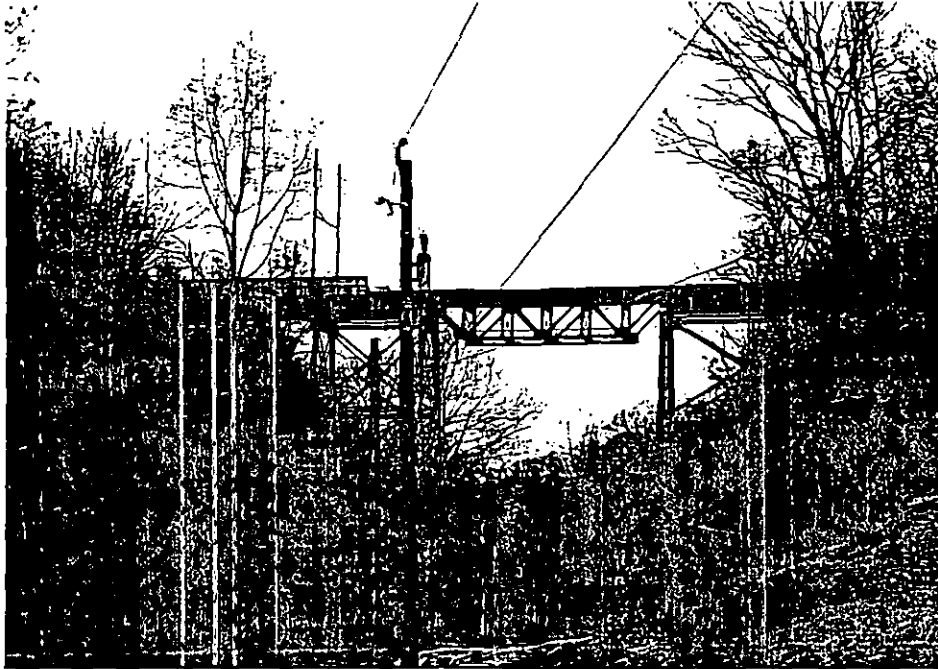
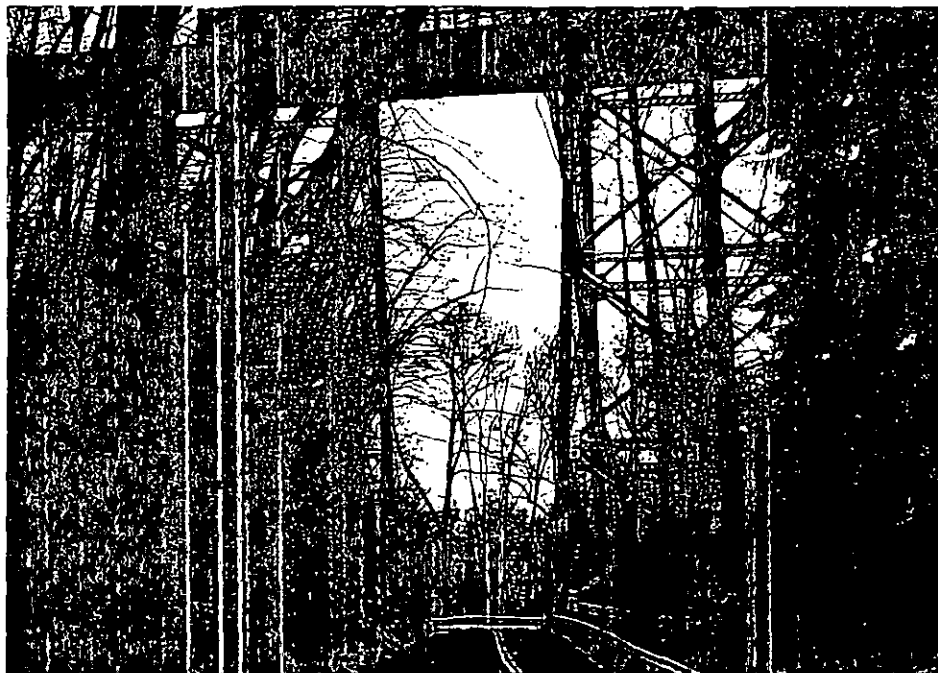
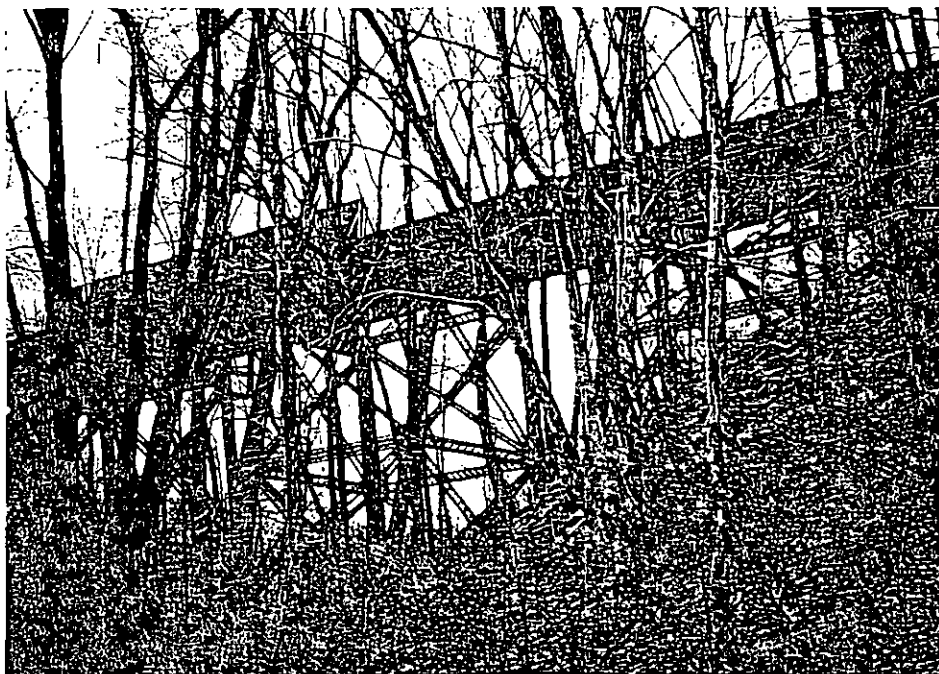
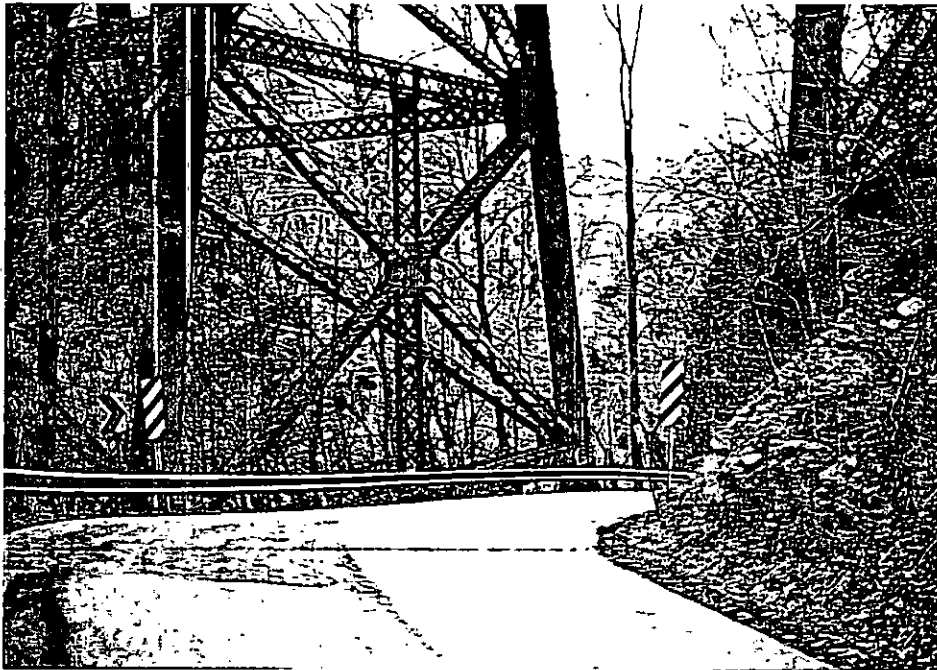
A-00111016
CROSSING #28
AAR 518 214C
T-440, RIVER ROAD
CONESTOGA TOWNSHIP
BELOW GRADE
MILE POST 23.76

11
12 Q: Please describe the type of structure at Crossing No. 28 and
13 describe its condition.

14 A: The structure at Crossing No. 28 consists of one simple span
15 steel deck truss and ten simple dual span steel deck girders
16 in fair to poor condition.
