CONSULTANT
REPORT ON *PRO*
6/7/01
STABILITY OF THE *A-00116257*
EAST BRADY TUNNEL *6-00981552*
OJL

Consolidated Rail Corporation Shared Assets
1000 Howard Boulevard, Suite 450
Mt. Laurel, NJ 08054

Gordon M. Elliott, Ph.D., P.E.
Wexford Consulting Group, Inc.

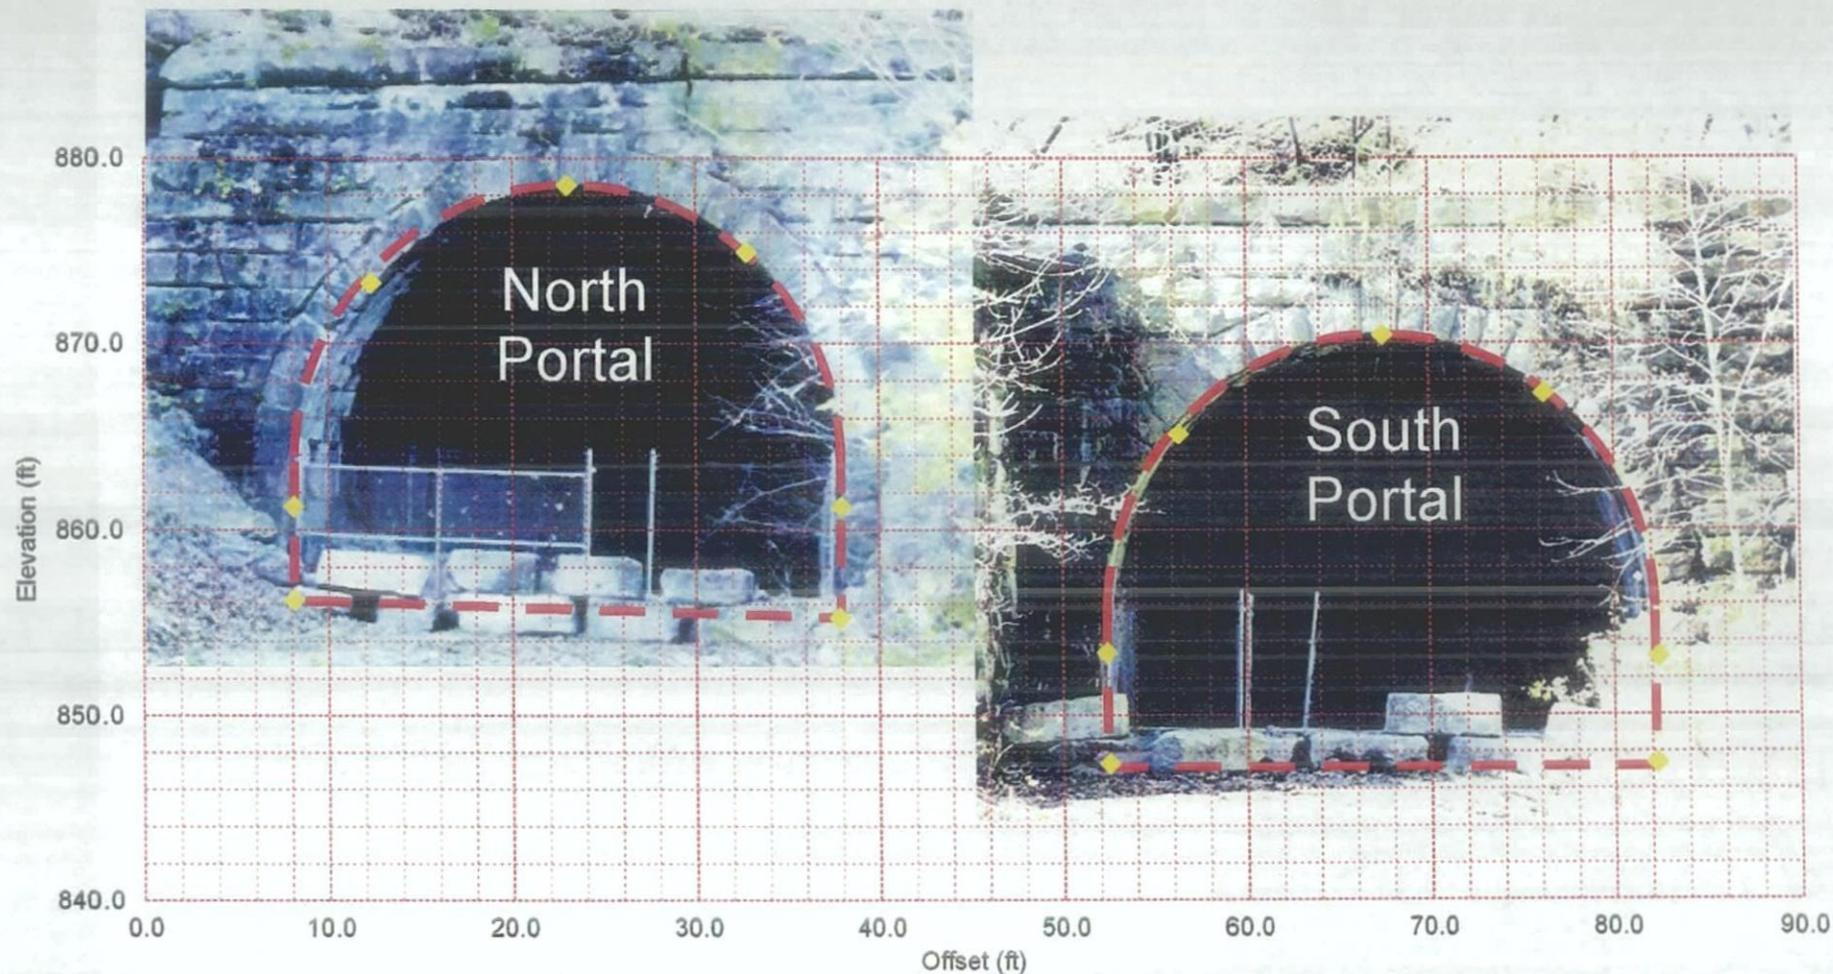
Figure 3
Scaled View of Each Portal
East Brady Tunnel, PA

The cross-section of the tunnel at each portal was surveyed as part of this investigation. The results are presented in Figure 3. The tunnel shape is referred to as an inverted-U because the arch is cylindrical, the walls are vertical, and the invert is approximately flat. The results indicate that the tunnel is approximately 29.8 ft wide, and approximately 23.3-ft high from center of crown to invert. The elevations of each portal shown in Figure 3 are approximate, and are estimated to be more accurately represented at the south portal than the north portal.

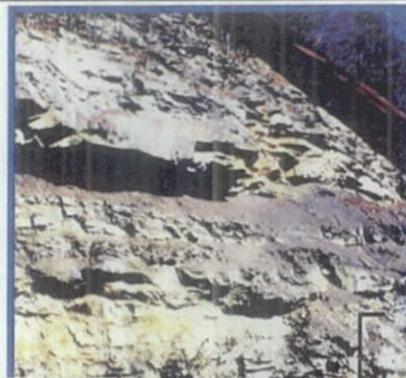
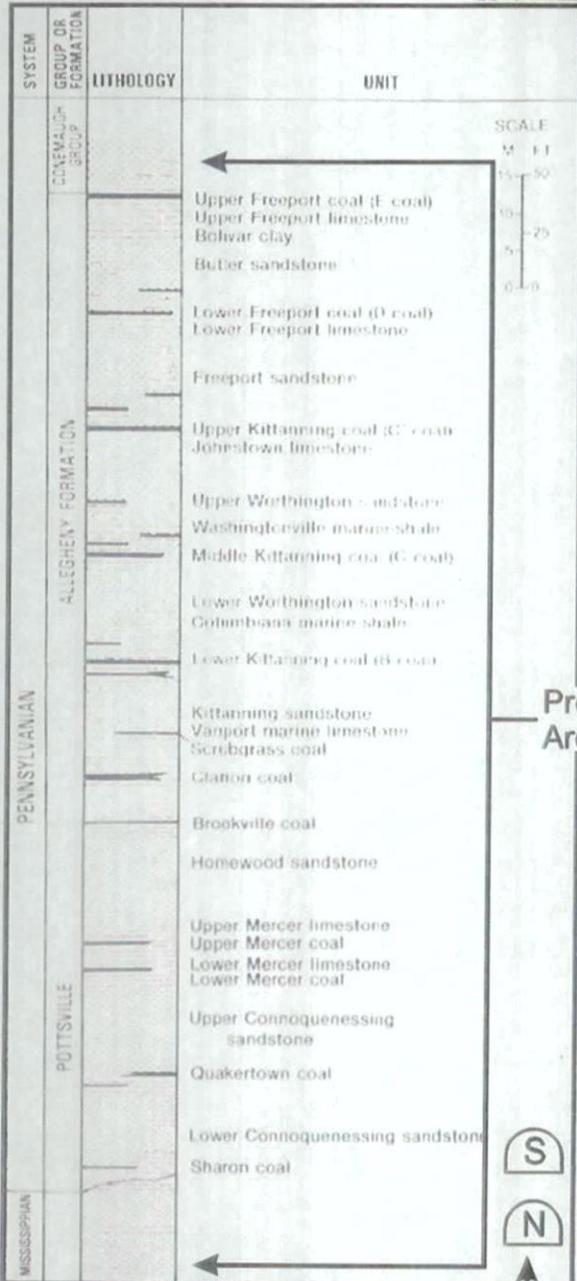
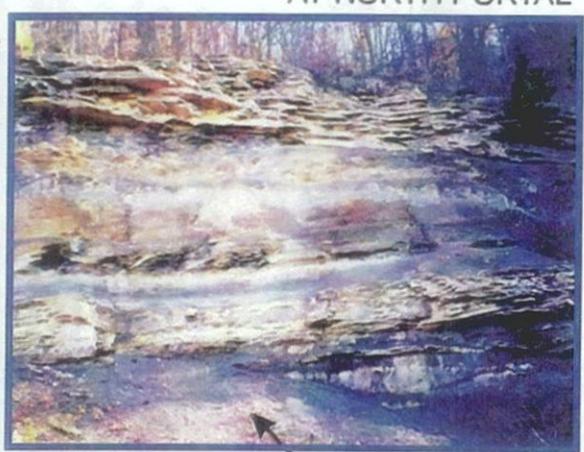
Figure 4
Geologic Setting
East Brady Tunnel, PA

Our own observations and geologic delineations suggest that the Lower Connoquenessing is the sandstone unit located immediately adjacent to the south portal, and the large overhang immediately above the portal is the base of the Upper Connoquenessing. The weathered shale and claystone bed immediately below the overhang is probably associated with the Quakertown Coal. These features are illustrated in the photographs included with the stratigraphic column in Figure 4. At the north portal, the rock types adjacent to the portal are largely claystone and shale, that we delineate to be part of the Mauch chunk formation. The overhangs high up on this

exposed rock face (see Figure 4) are considered to be at the base of the Lower Connoquenessing that was surveyed at approximately 915-ft MSL to 920-ft MSL. The bedding of the sandstone dips into the hillside at both portals suggesting that the stratigraphy takes the form of a shallow trough in section along the tunnel.

GEOLOGIC STRATA AT SOUTH PORTAL

GEOLOGIC STRATA AT NORTH PORTAL

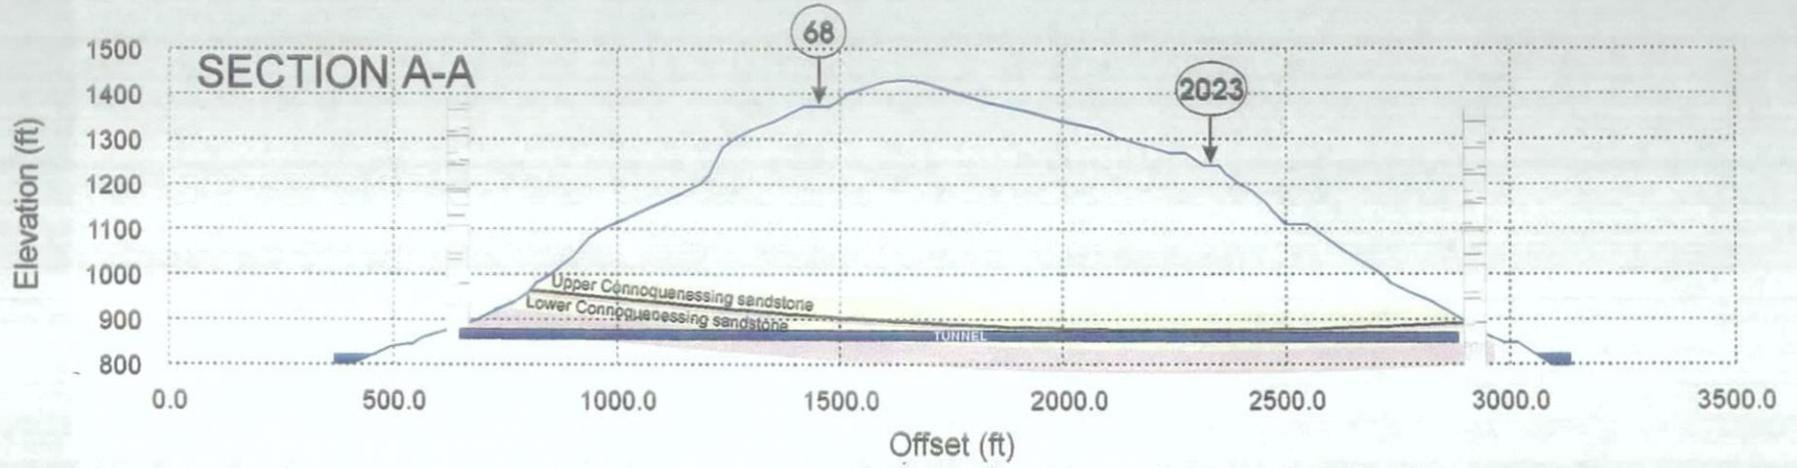
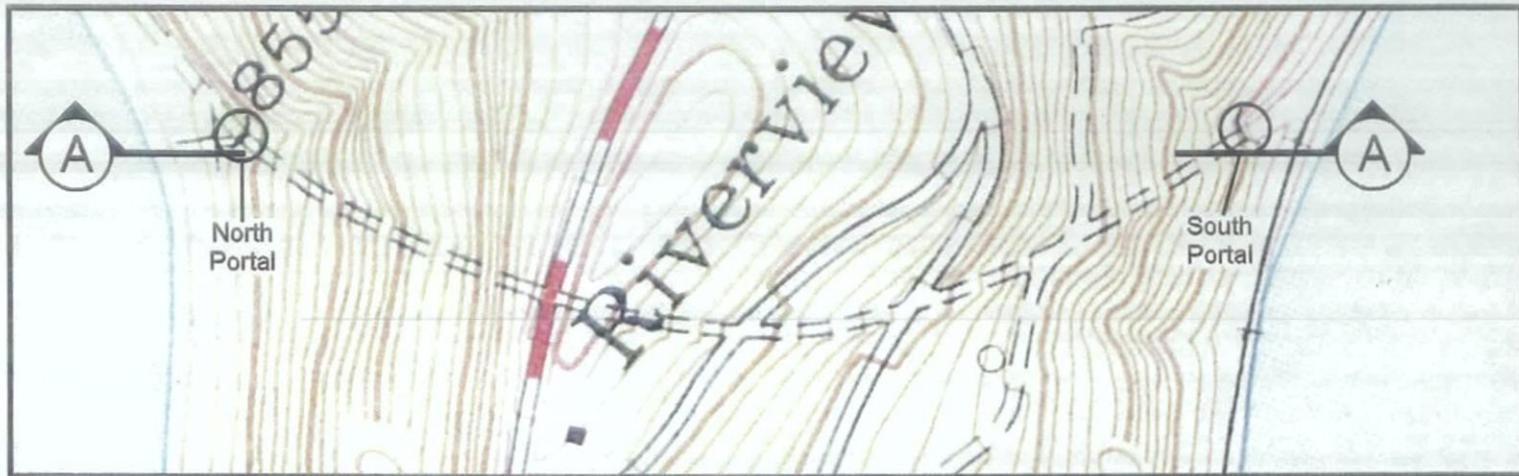
Figure 5
Geologic Section
East Brady Tunnel, PA

Our interpretation of these findings as they apply to a section through the hillside is shown in Figure 5. The assumed dip of the Upper and Lower Connoquenessing sandstones also takes into account the observations made in the probe hole drilling program described in the next section. It would appear that the tunnel was excavated under largely favorable conditions in blocky sandstone over much of its length, and in shale and claystone in the northern third. Bedding is almost horizontal, and joints are largely vertical, which is a favorable combination for stress-redistribution, and makes the existence of large, kinematically unstable, wedge shape blocks highly unlikely. Temporary support during construction would likely have had to address local instabilities of thin slabs of rock separating on bedding planes.

interpreted to be unweathered sandstone, or a softer weathered shale or claystone. At Station 8+14, beneath SR 2023, we observed what appeared to be bedding separation, and debris immediately outside the lining, particularly on the right side. At both locations, the variability of materials encountered, and the relatively small thickness of beds of different rock types suggests that the material in the arch of the tunnel is the Quakertown bed between the Upper and Lower Connequenessing Sandstone beds. A study of the photographs of the surface exposures of these materials in the rock face at the south portal (Figure 5.) supports this interpretation.

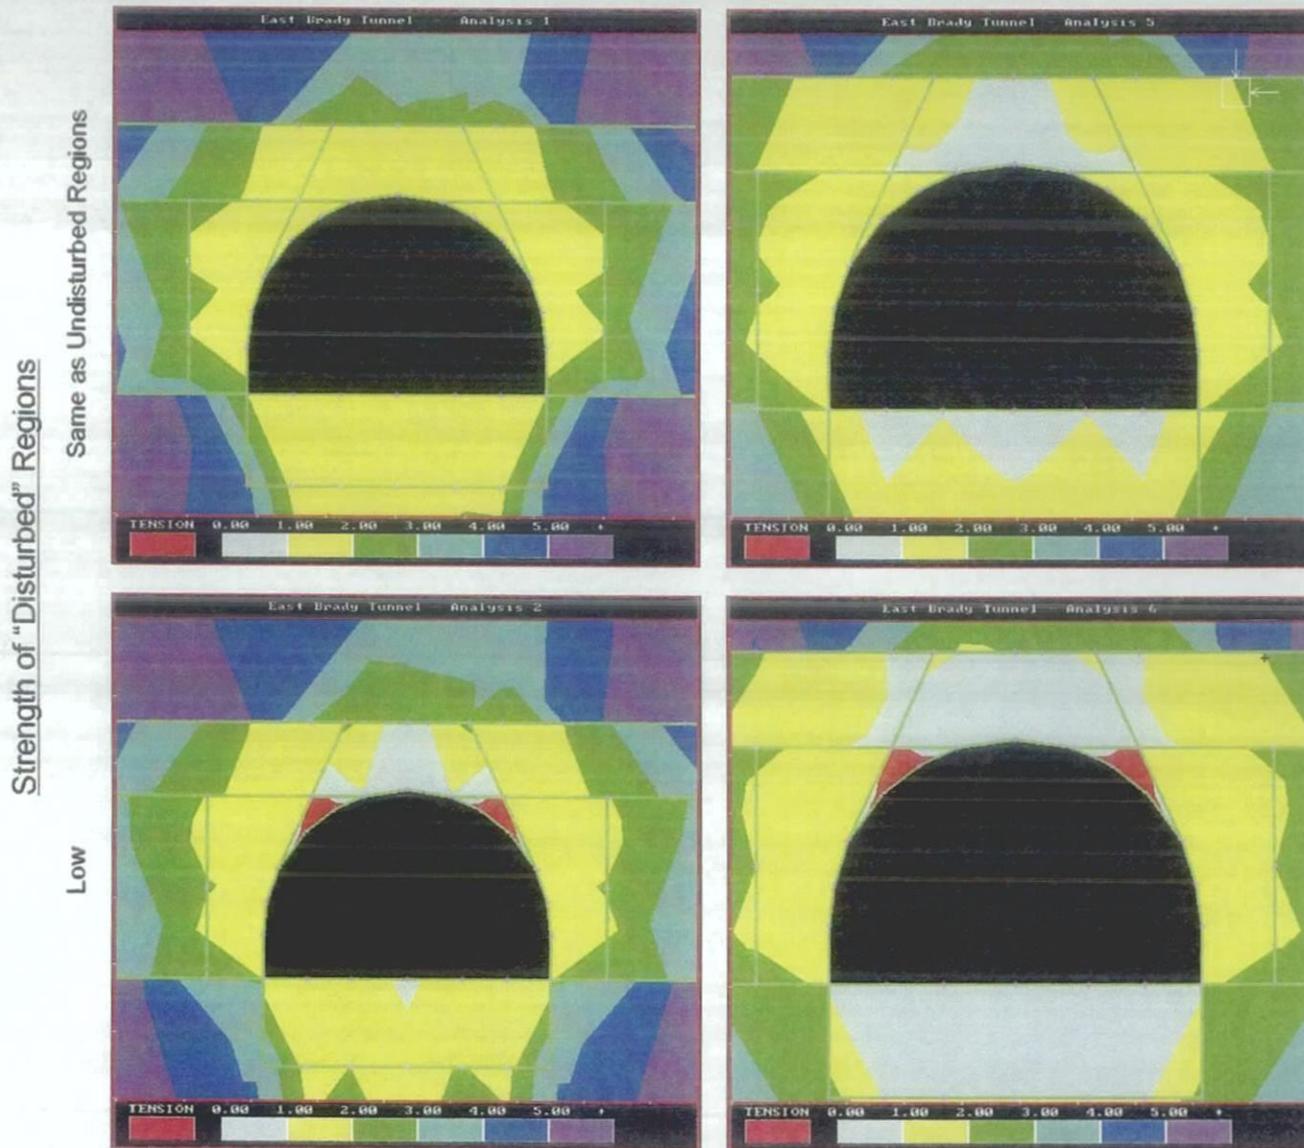
Figure 8
Strength Factor for Tunnel Excavation
East Brady Tunnel, PA

In the unlikely event that a collapse does occur, the initial volume of rock that would fall into the tunnel would be limited to the weathered claystones and shales immediately above the crown. Our calculations have shown that the strength factor of the sandstone overlying the disturbed claystone unit exceeds 5 even under the most conservative of assumptions. A collapse of the claystone materials would unlikely propagate immediately upward beyond the first competent sandstone unit since this would act as a stable beam that would "bridge" the collapse zone.

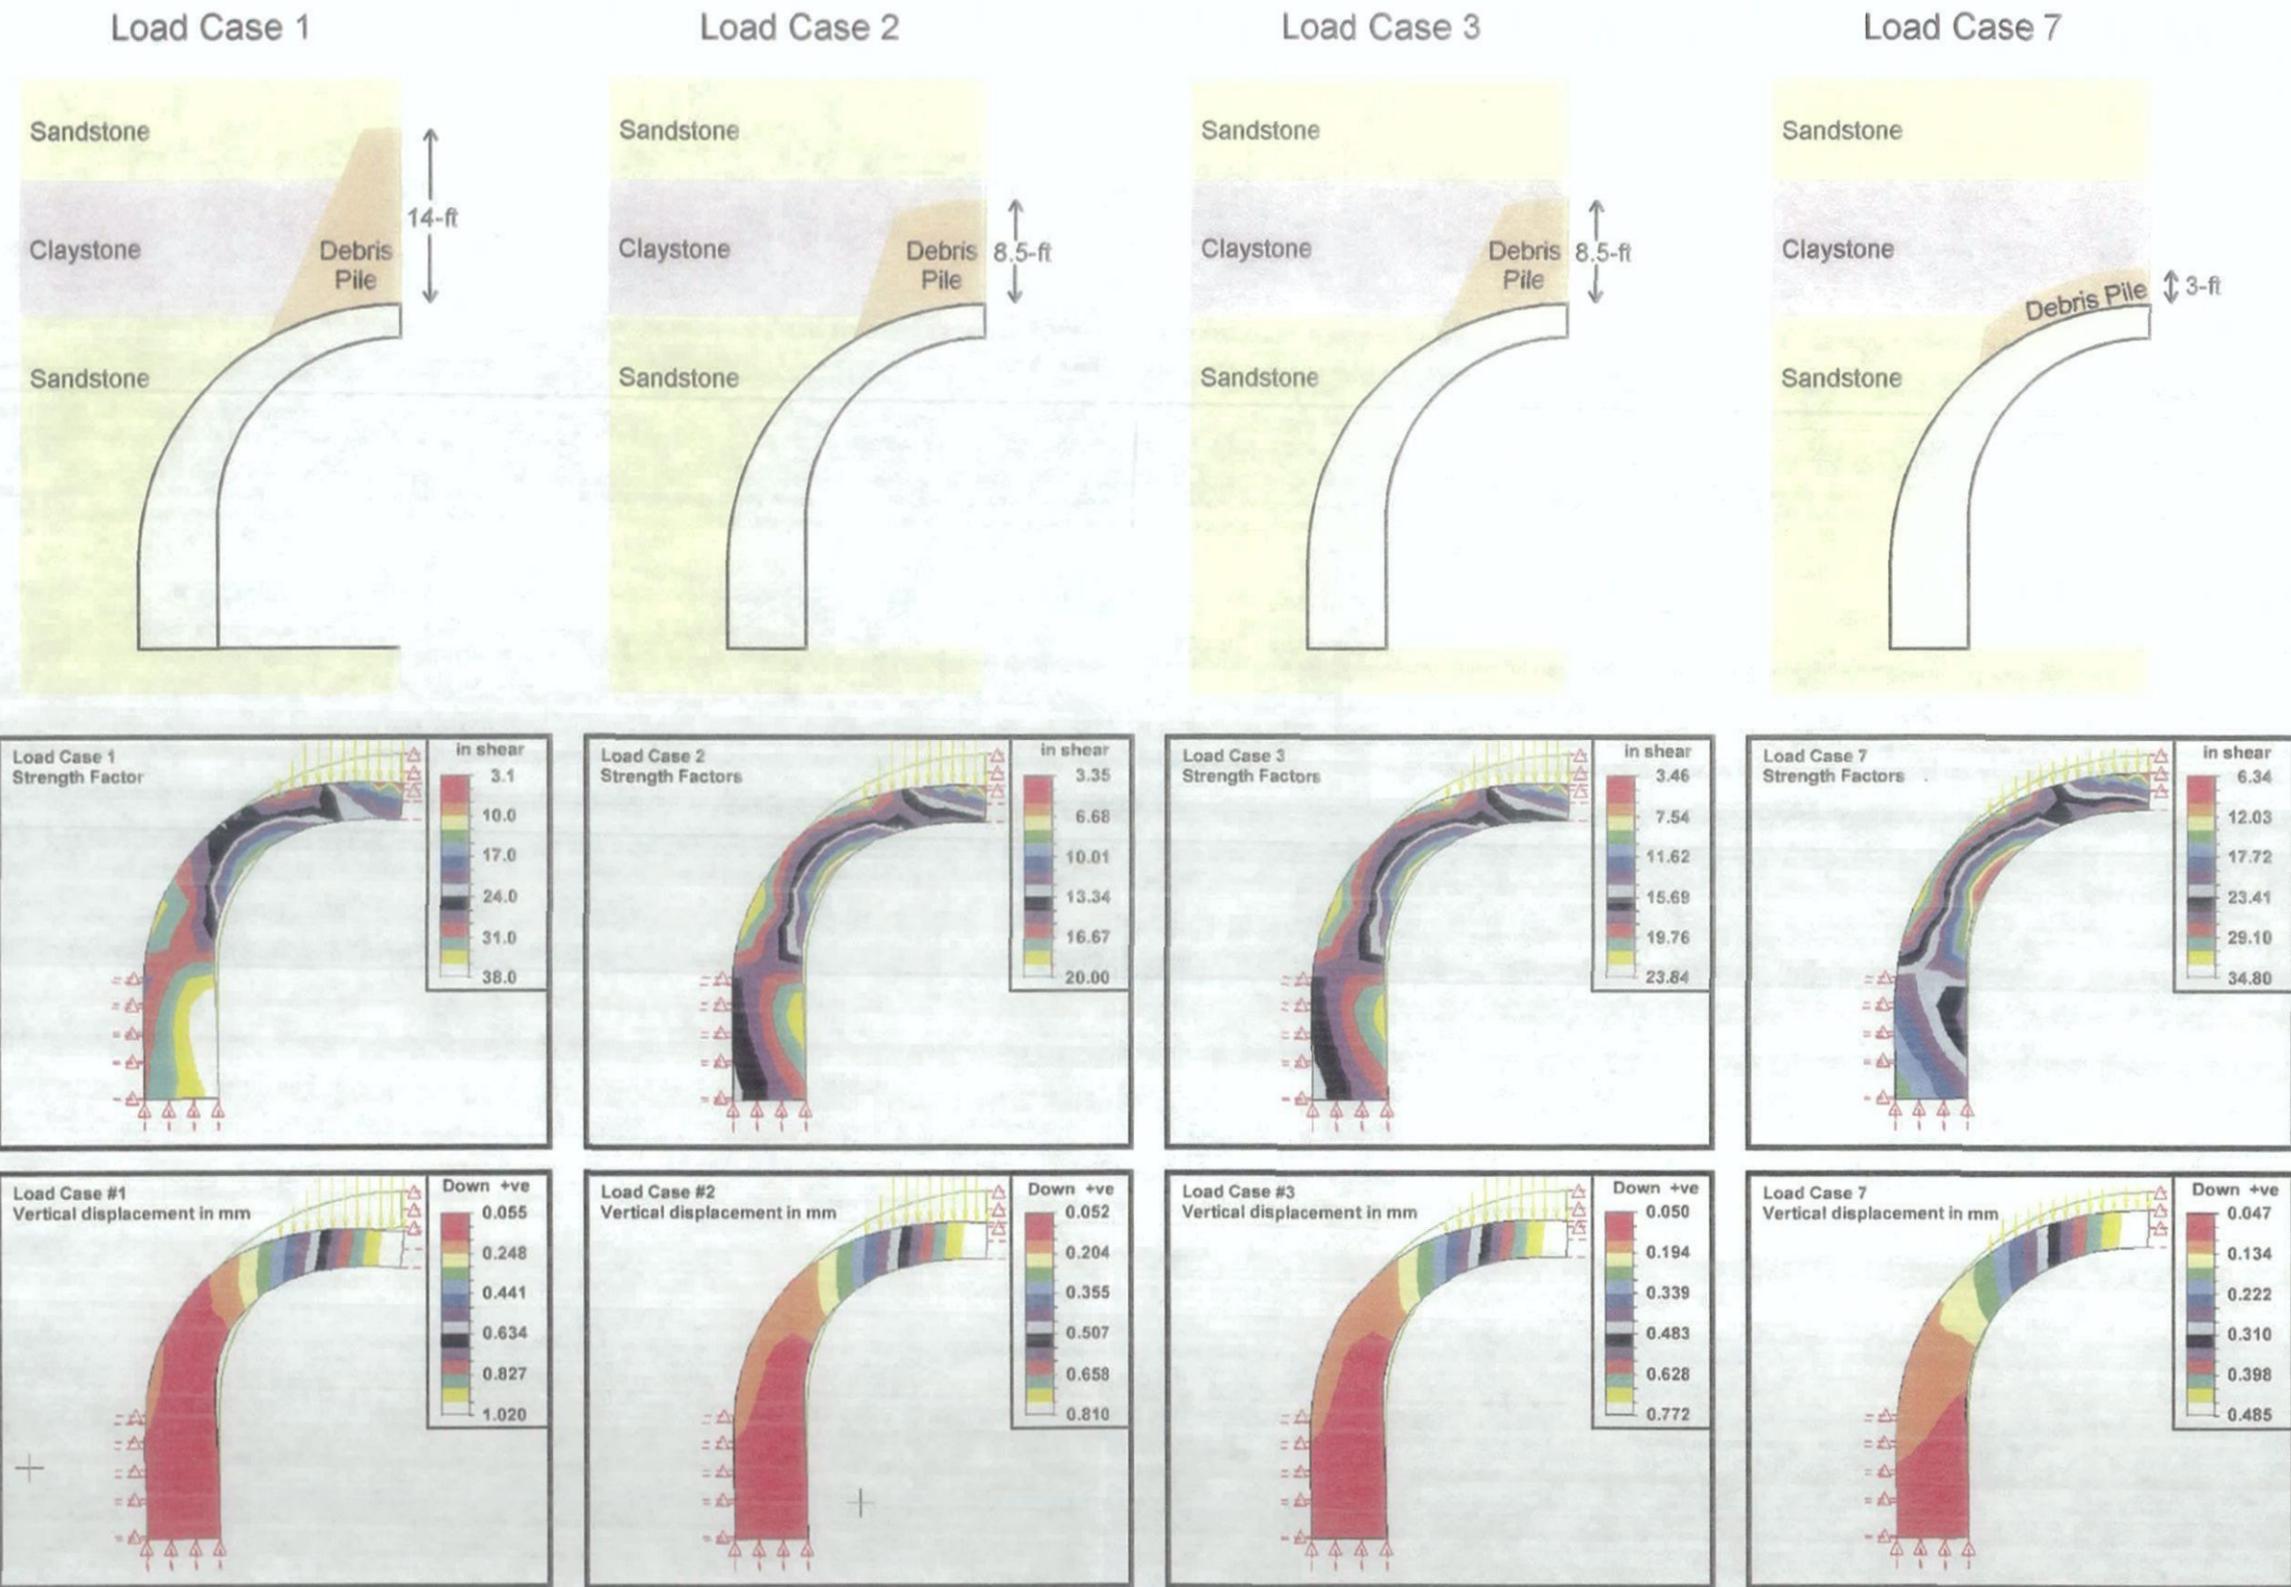
Figure 14
 Summary of Finite Element Results for Free-Standing Arch
 East Brady Tunnel, PA

NOTE
Analyses using "low" rock strength in
"disturbed" and "undisturbed" regions

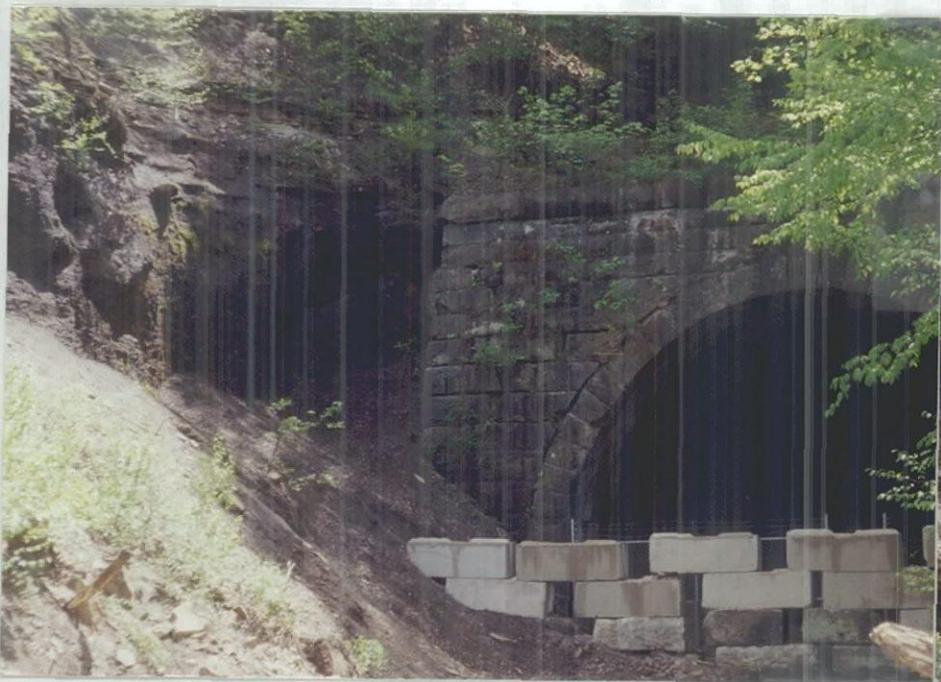
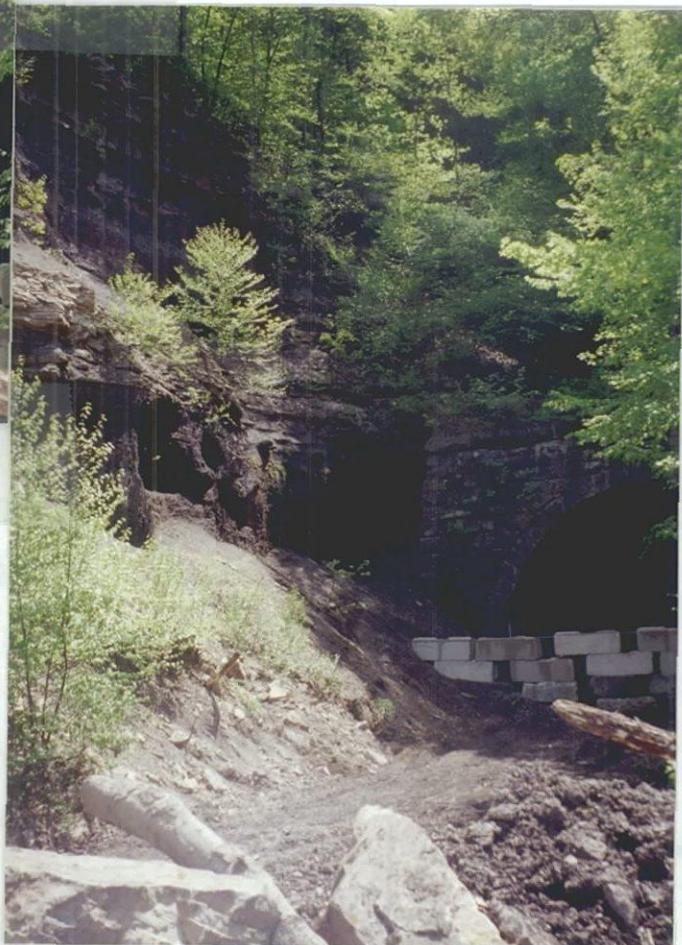
NORTH PORTAL
AREA OF CUT JUN 29 2001

NORTH PORTAL EXPANDED
AREA OF VIEW

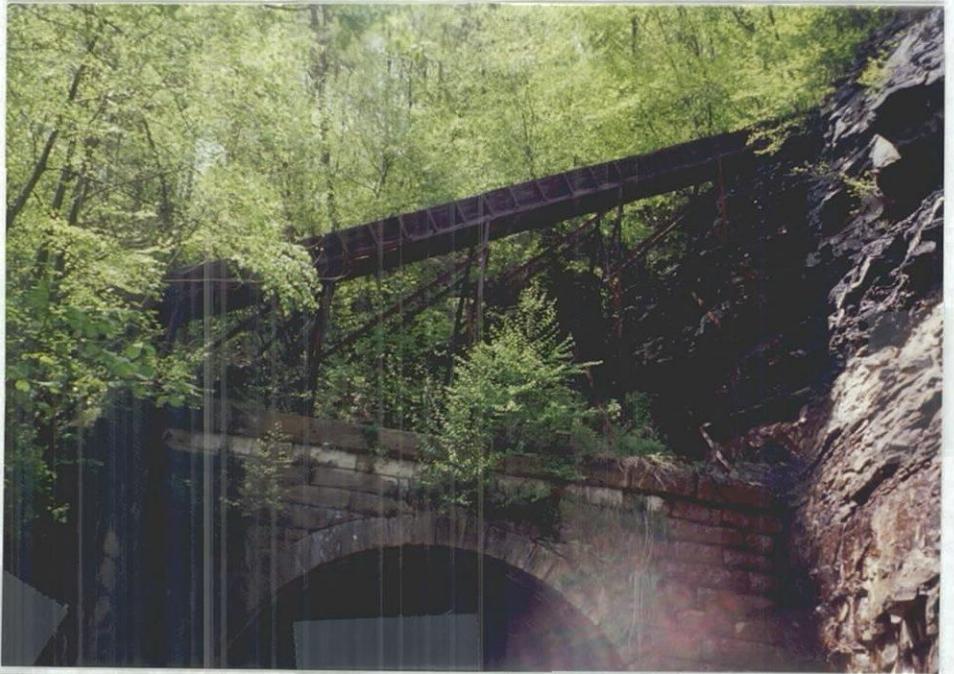
SOUTH PORTAL
VIEW FROM INSIDE

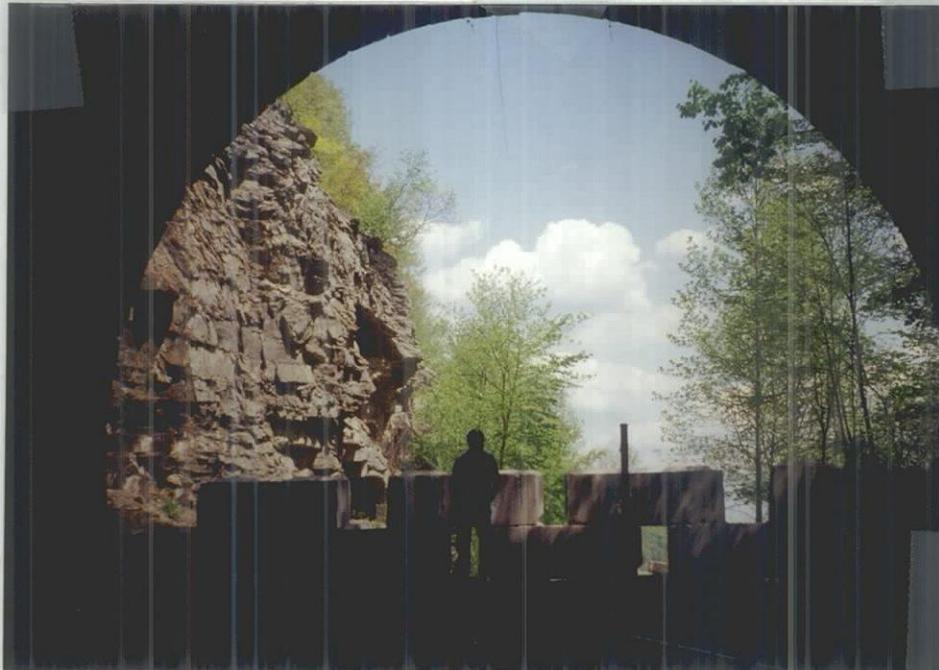
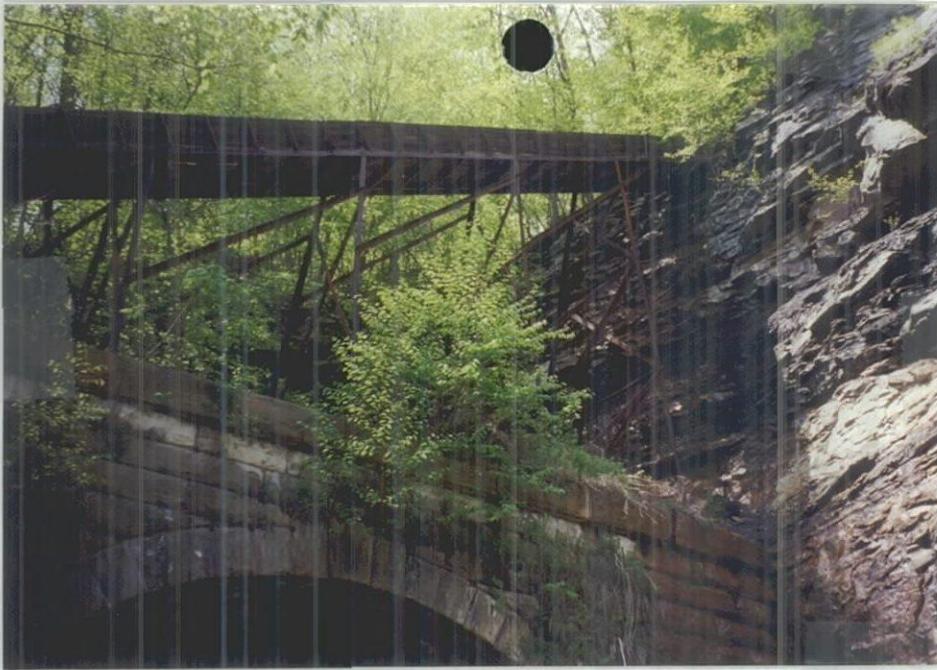
SOUTH PORTAL
SLUICE - STEEL SUPPORTS
ROCK CUT ABOVE TUNNEL
