REBUTTAL RESPONSE

FILED BY DAWNE SOHN AND
DIANE SOHN THROUGH THE
PENNSYLVANIA PUBLIC UTILITY COMMISSION

DOCKET NUMBER C-2016-2532799

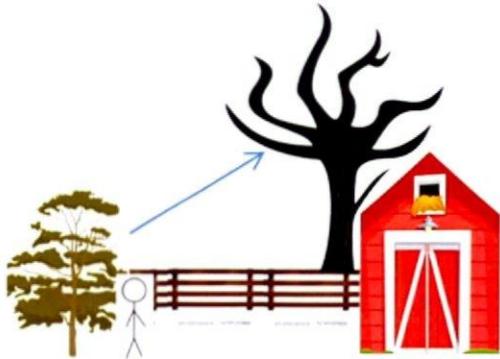
There was also a fence between the two trees, which was knocked down when the ash tree limbs were cut. The maple tree was the smaller tree. The ash tree was significantly taller and above the barn roof. Therefore, to “manually climbed an adjacent maple tree to perform the work”, the contractor had to literally leap over 20 feet backwards into the air from a little maple tree, navigate this leap over a fence, flip facing front from a backwards position in the maple tree, and land high up in the ash tree—all while carrying a chain saw. Here is a diagram of the only way that could have happened. Since both trees and the damaged rails are gone, no photographs can be provided:

Or if he did not make this leap and therefore cut the ash tree while balanced in the maple tree, then he would have to have a gigantic saw and be standing on a narrow little maple branch reaching over backwards to the top of an ash tree over 20 feet away in an upward projection. It is absurd.

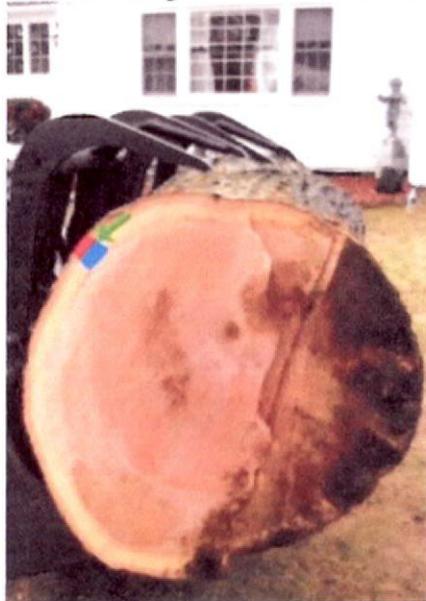
The photo to the right is that of a cross section of a Red Oak tree. I have highlighted three area's of the growth rings.

The RED area is the phloem. The ISA Arborists' Certification Study Guide defines Phloem as; plant vascular tissue that transports photosynthates and growth regulators. Situated on the inside of the bark, just outside the cambium. Is bidirectional (transports up and down). So in general terms the phloem transports sugars, carbohydrates, and growth regulators affecting the development of the plant.
