**HIDDEN VALLEY UTILITY SERVICES, L.P. – ENGINEER'S REPORTS (2) AND
REVISED BILL FORM**

HIDDEN VALLEY FOUR SEASONS RESORT SANITARY SEWER SYSTEM FACILITIES STUDY

APRIL 2018

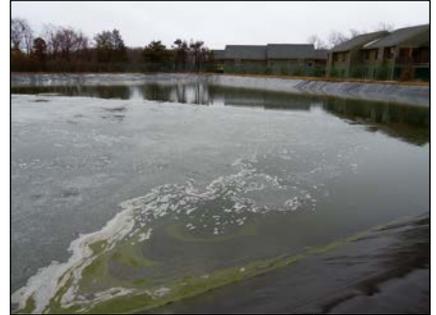
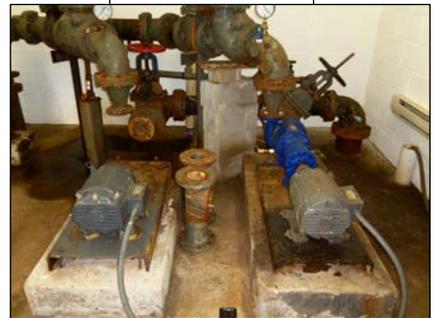
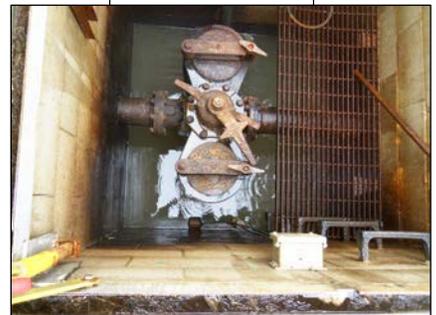
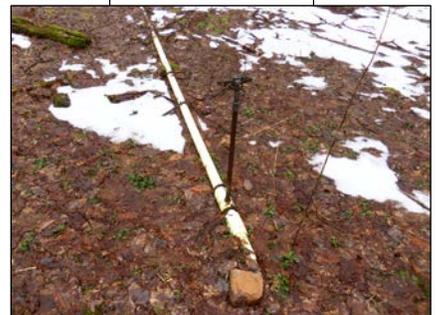
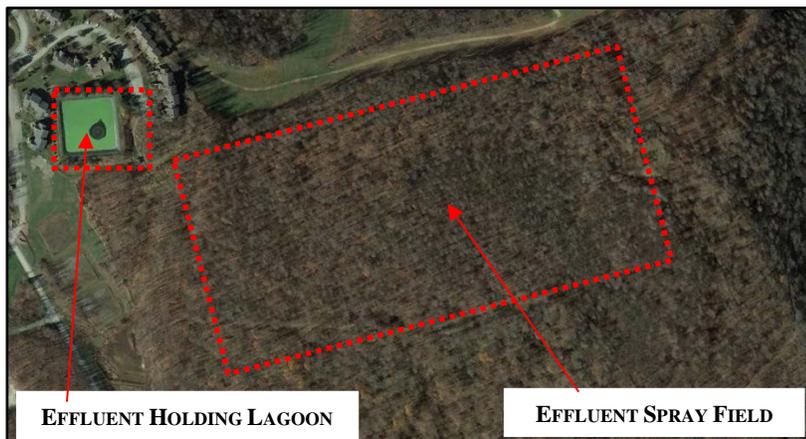
Effluent Pump Room Observations

- One (1) effluent pump operational.
- Second pump not operational. Needs replaced.
- Gate valve on suction line of non-operational pump is not operational. Needs replaced.

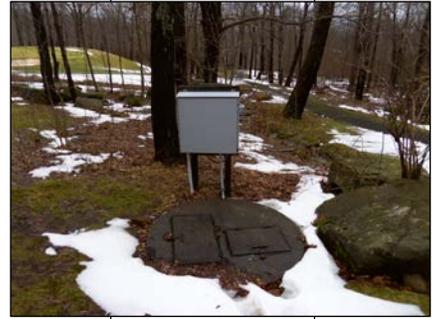
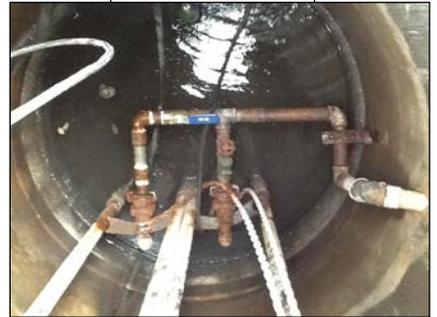
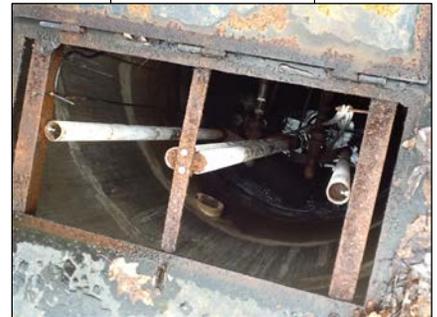
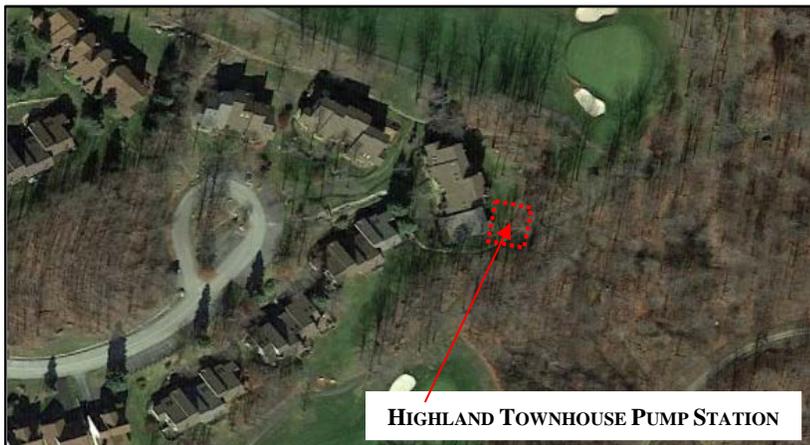
Electrical/Control Panel Observations

- Panel post/structure in good condition.
- Alarm buzzer and warning beacon in working order.
- Floats:
 - Lead Pump On Float operational
 - Pump Off Float operational
 - High Wetwell Level Alarm Float operational
 - Pump Lag Float operational
- Electrical disconnect situated on control panel board.
- Electrical junction box for pump power and controls located in wetwell. Limited access for junction box from wetwell steps.
- No method of influent or effluent flow measurement.
- No provisions for connecting portable emergency generator.
