**Re: Letter of Notification of PPL Electric Utilities Corporation, Filed Pursuant to 52 Pa. Code Chapter 57 Subchapter G, for Approval of the Siting and Construction of the Siegfried-East Palmerton #1 & #2 183/69 kV Transmission Lines and Associated Tap Lines Located in Lehigh and Carbon Counties, Pennsylvania  
Docket No. A-2018-3001477**

**PPL Electric Utilities Corporation  
Response to Data Requests of  
Bureau of Technical Utility Services  
Dated August 8, 2018  
Docket No. A-2018-3001477**

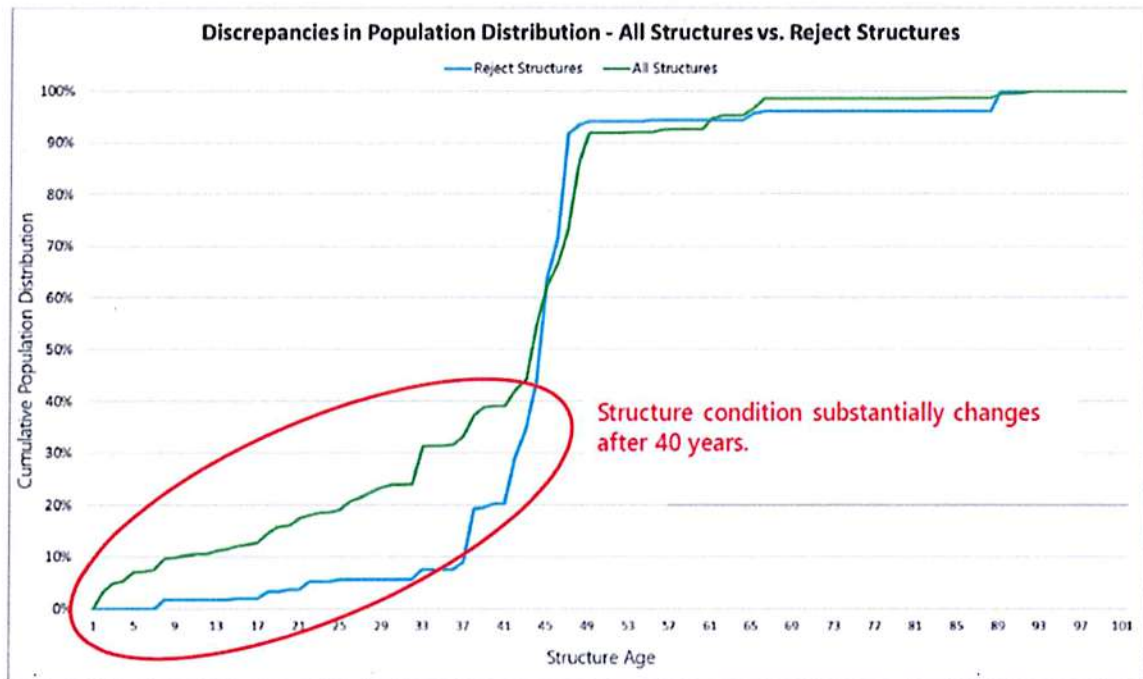
\*Industry data points to end of life for wood structures and steel structures separately. Based on research published by Osmose Utilities, the predicted service life of a wood pole in our decay zone (or deterioration zone) is approximately 44.5 years. A study published by Quanta Technology in 2012 calculates the average expected service life of a wood pole in the U.S. to be 53 years. The wood poles on these lines have exceeded both milestones. Osmose research also indicates that steel structures have an average estimated life span of 60 years or more, however the actual expected life can vary greatly based on structure type, material, design, environment, etc. Their analysis also notes that condition declines substantially at 40 years of age. Structures are at a much higher likelihood of being categorized as unserviceable ("reject") between the ages of 40 and 50.

*Based on a 10,000 structure sample of steel utility transmission structures geographically constrained to the mid-Atlantic region. Intentionally constrained to avoid macro effects of geography on data sample. Larger samples will be utilized in future analyses when additional variables (beyond age) are evaluated.*

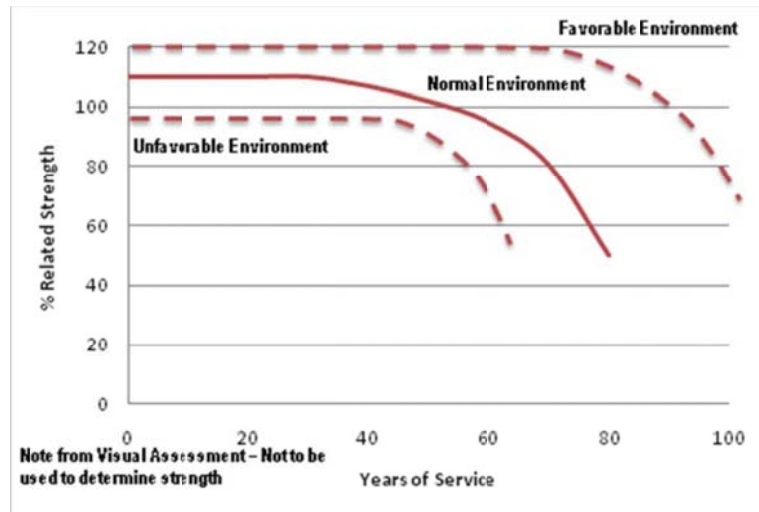
Figure 1 – Relation between Service Life and Rated Strength (Galvanized Steel) (from EPRI *Overhead Transmission Inspection and Assessment Guidelines – 2009*)

It is assumed that most insulators are original and approximately 60 years old. Insulators this old have several drawbacks. Due to their age, they can be contaminated with pollutants. This contamination greatly reduces the insulation levels intended to be provided by the insulators. Several insulator strings on the Siegfried-E. Palmerton lines have had entire insulator strings replaced with newer porcelain bells. Insulators were most likely replaced due to flashovers, contamination, mechanical damage or failure. This is indicative of poor insulation levels causing phase to ground faults. There is evidence of galvanizing left on the insulator caps, although corrosion is actively occurring on all hardware. Corrosion of both the caps and the pin and clevis end fittings will all contribute to a reduction in strength. See Figure 1 below for a plot of service life of hardware and galvanized steel versus rated strength. Galvanizing, when not painted can have a life expectancy of anywhere from 30 to 80 years, depending on the environment. The hardware on the Siegfried-E. Palmerton lines is over 60 years old and even in a favorable environment is

approaching the age marking the period in which rapid decline in strength begins. The useful life of all original insulators and hardware is approaching its end. In the area northeast of the Lehigh River, the insulators and hardware are especially corroded. This area is very industrial, or used to be very industrial. There is evidence of a zinc processing facility on the original plan and profiles. Other industries and the remnants of past industries can be seen in this area and this is believed to have significantly contributed to the accelerated corrosion on this side of the river.

The two towers inspected have fair paint conditions. There is still life left on the tower coatings. In the near future, the towers will require a thorough scraping, priming and repainting with quality zinc based tower paint. Galvanizing can also be observed on the base of the tower where the paint coatings have peeled off. Some corrosion can be seen up high in the tower. This is thought to be a result of the corrosive environment northeast of the Lehigh River. Most towers on the Siegfried-E. Palmerton lines are located primarily in this region. Moderate surface corrosion on tower steel is evident and with failing coatings and exposed galvanizing, corrosion will begin to increase at a more rapid rate. Reference Figure 1.
