PPL Electric Utilities
Steel Transmission Structure
Corrosion Inspection

Lines 577-578 (Face Rock – Five Forks 1 & 2)

Inspection Summary

September 2, 2016

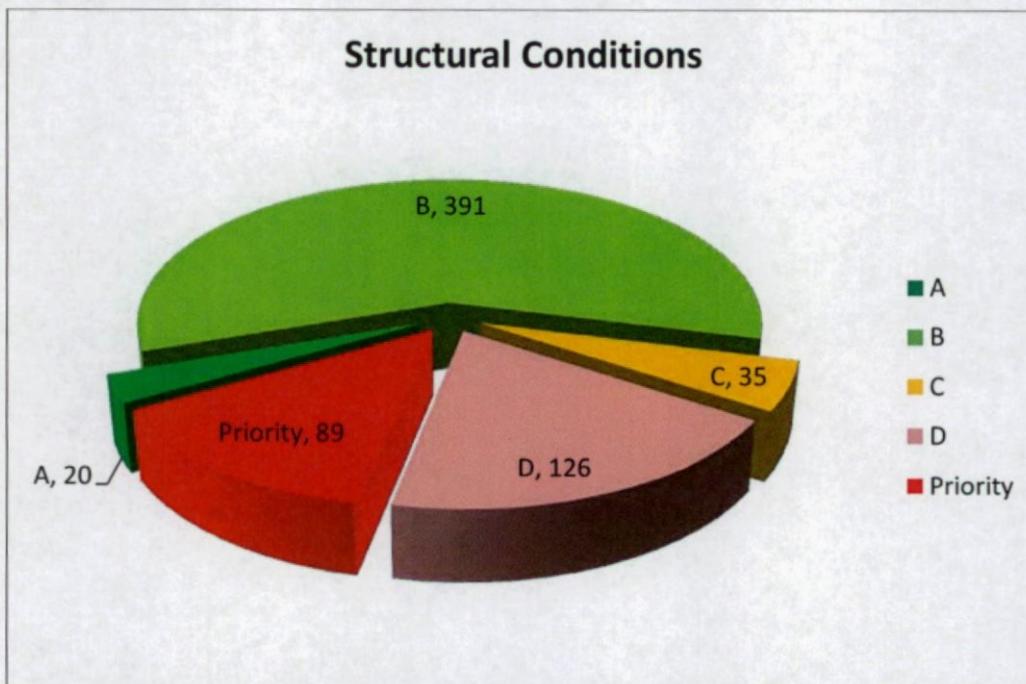
Figure 1: Structural Condition Breakdown for Lines 577-578

Condition D (Severe) Steel has experienced heavy corrosion activity consisting of significant thinning, pitting and/or edge loss. Corroded areas will typically have a large amount of section loss, with parts completely rusted through. To meet the definition of this condition category, the average section loss must be $> 20\%$. **There were (126) tower legs that rated "Condition D".**

Priority A structure in "Condition D", with $> 50\%$ average loss of cross section on any one pole wall or tower component or has had structural damage due to corrosion, mechanical damage, or acts of God, which may exceed the customer's allowable tolerance threshold. Poles that have two or more adjoining flats with $> 20\%$ (averaged reading on each affected adjoining flat) section loss will also be flagged as a "Priority." These will be communicated directly to the customer project manager for their immediate attention. **There were (88) tower legs that rated "Priority", along with the (1) steel pole.**

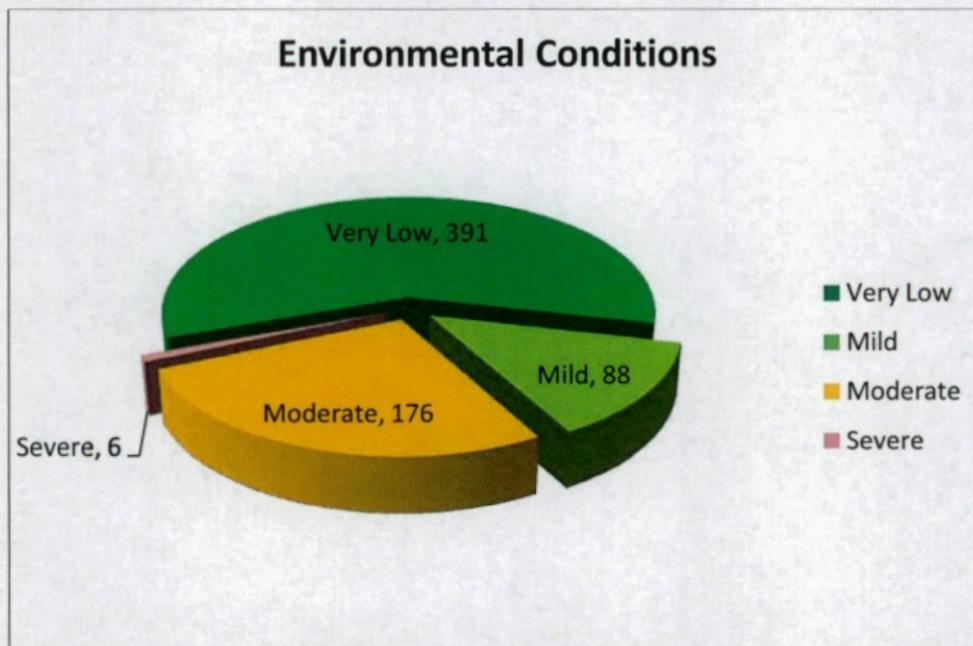
Figure 2: Environmental Condition Breakdown for Lines 577-578

- Very Low** Reported in the data as “Condition A”. These structures demonstrate a low potential for corrosion activity with low or neutral environmental indicators. Typically these structures are at low risk, show little or no outward signs of corrosion, and do not need further attention at the time of inspection. **There were (391) tower legs that rated “Very Low”.**

- Mild** Reported in the data as “Condition B”. These structures demonstrate a slightly elevated potential for corrosion, with environmental indicators showing minor corrosion activity. These structures may show some minor physical signs of corrosion and are at the threshold where they may require some type of mitigation to offset potential deterioration. **There were (87) tower legs that rated “Mild”, along with the (1) steel pole.**

- Moderate** Reported in the data as “Condition C”. These structures demonstrate a more serious potential for corrosion activity with moderate environmental indicators. These structures will likely show some physical corrosion taking place and should have some type of mitigation applied (likely in the form of coatings) to help prevent further deterioration. **There were (176) tower legs that rated “Moderate”.**

- Severe** Reported in the data as “Condition D”. These structures have environmental indicators that reflect a severe potential for corrosion. Structures in this condition likely have extensive corrosion present and may have structural deterioration requiring further evaluation. Structures in this condition should have mitigation applied in the forms of coatings at a minimum and be evaluated for cathodic protection. If no mitigative efforts are utilized on structures in this condition, the re-inspect interval should be significantly shortened. **There were (6) tower legs that rated “Severe”.**

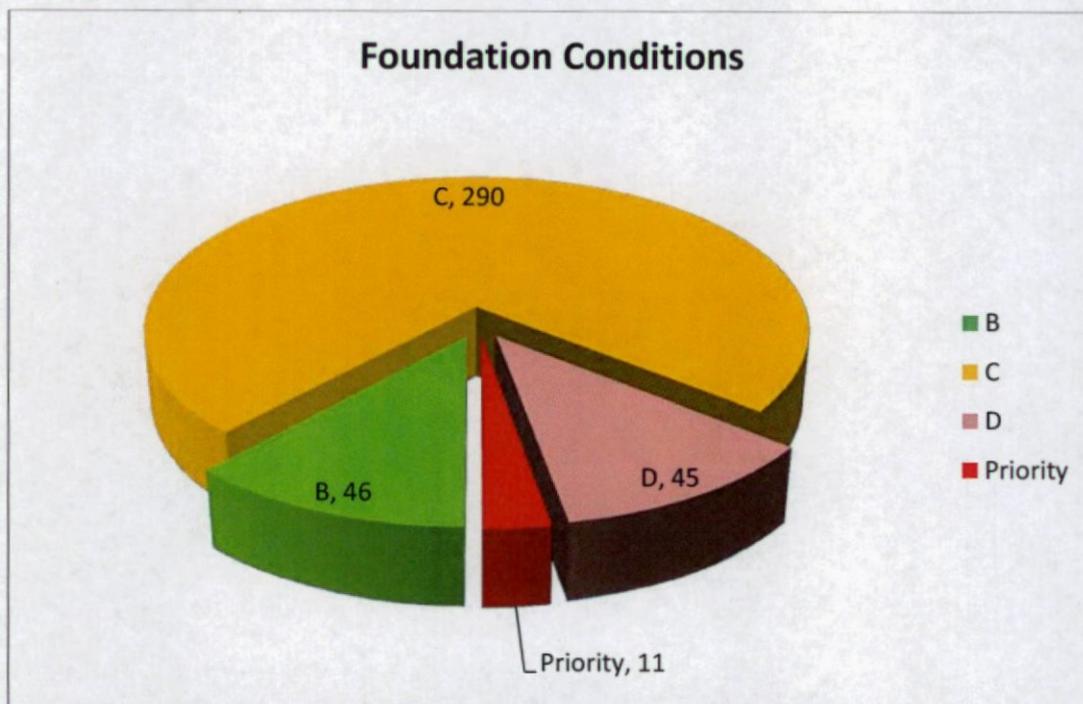
Figure 3: Foundation Condition Breakdown for Lines 577-578

Condition D (Reject) Cracks wider than 0.187" but less than 0.25", large spalls (> ~25% of total exposed area) with possible exposed reinforcing, and/or disintegration. Severe scaling (mortar loss between 0.50" and 0.75" deep with exposed aggregate) and/or medium spalls (between 25% and 50% of total exposed surface or edge, or 1" and 3" deep) may be present. **There were (45) tower legs that rated "Condition D".**

Priority Foundations flagged as "Priority" structures may exhibit one or more of the following: cracks 0.25" or wider, very severe scaling (mortar loss depth greater than 0.75"), large spalling (large sections of concrete missing, greater than ~50% of total exposed surface or edge, greater than 3" deep), or exposed corroded rebar. **There were (11) tower legs that rated "Priority".**
