September 1, 2011

Project 2009-149

Mr. Joseph Marhefka
PPL Electric Utilities
2 North Ninth Street
Allentown, PA 18101-1179
MS: GENN4

*Special Inspection Report for
Zone #1, Hauto-Siegfried #1 and #4 &
Siegfried-E. Palmerton #1 and #2 69kV Transmission Lines*

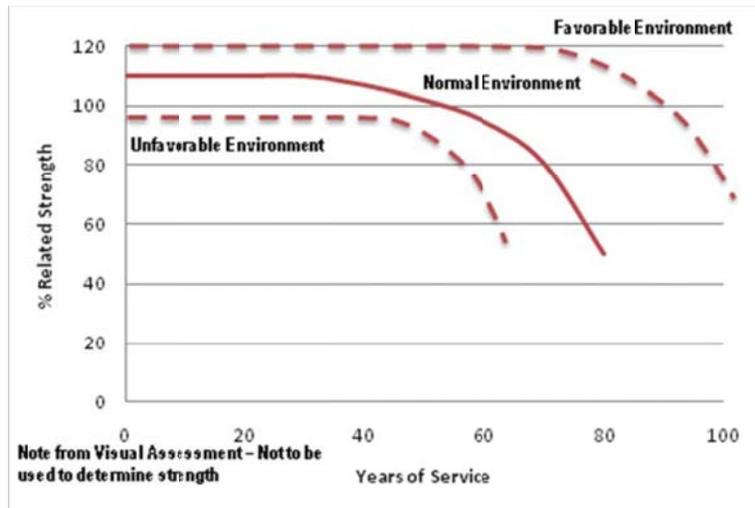
It is assumed that all insulators that have not been replaced are approximately 60 years old. Insulators this old have several drawbacks. Due to their age, they can be heavily contaminated with pollutants. This contamination greatly reduces the insulation levels intended to be provided by the insulators. There is a mixture of porcelain and polymer insulators on this line. Many of the insulator strings on the Hauto-Siegfried-E. Palmerton lines have either had entire insulator strings replaced with newer porcelain bells or with polymer insulators. Insulators were most likely replaced due to flashovers, contamination, mechanical damage or failure. This is indicative of poor insulation levels causing phase to ground faults. There is evidence of galvanizing left on the insulator caps, although corrosion is actively occurring on all hardware. Corrosion of both the caps and the pin and clevis end fittings will all contribute to a reduction in strength. See Figure 1 below for a plot of service life of hardware and galvanized steel versus rated strength. Galvanizing, when not painted can have a life expectancy of anywhere from 30 to 80 years, depending on the environment. The hardware on the Hauto-Siegfried-E. Palmerton lines is over 60 years old and even in a favorable environment is approaching the age marking the period in which rapid decline in strength begins. The useful life of all original insulators and hardware is approaching its end.

Figure 1 – Relation between Service Life and Rated Strength (Galvanized Steel) (from EPRI *Overhead Transmission Inspection and Assessment Guidelines – 2009*)

The paint coatings on towers are generally in poor condition. The current coatings are desiccated. The original paint can be seen on most towers. Galvanizing can also be observed where all remnants of tower paint are gone. Moderate surface corrosion on tower steel is evident and with failing coatings and exposed galvanizing, corrosion will begin to increase at a more rapid rate. Reference Figure 1.

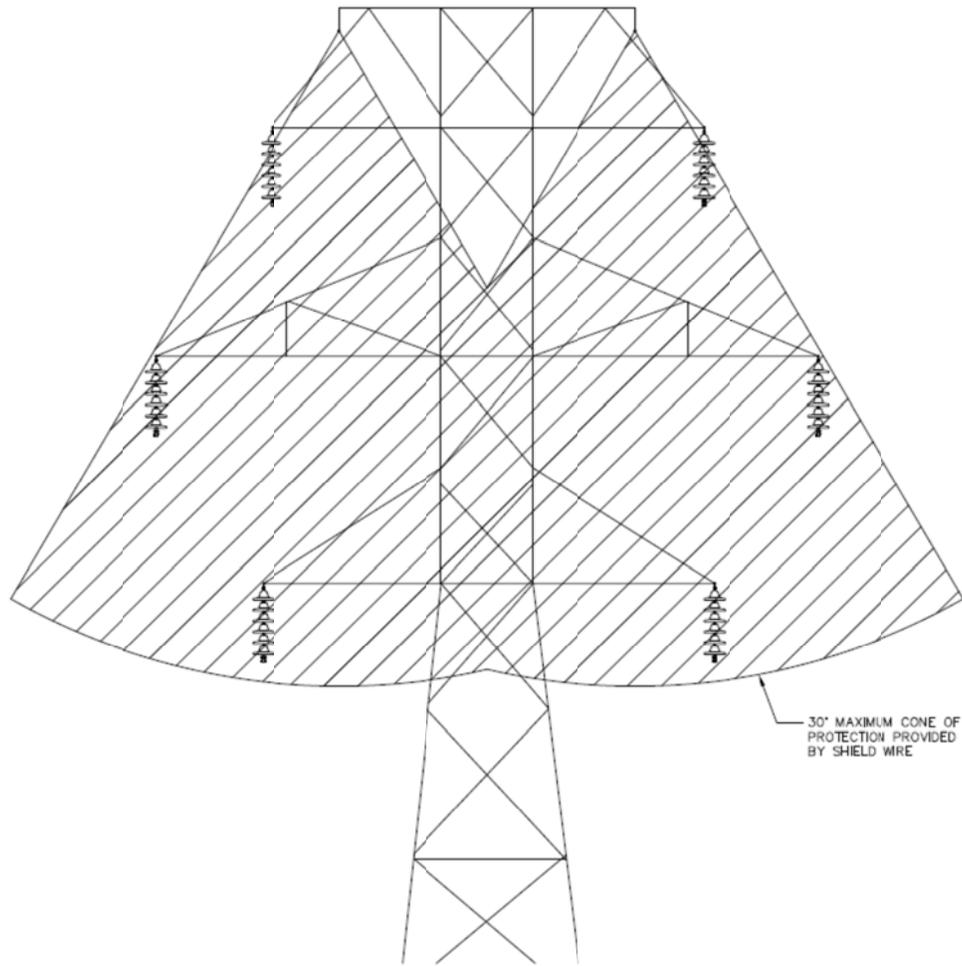
Lightning protection research was a work in progress when the Hauto-Siegfried structures were designed and built. In general, the shielding provided is adequate. Only at structures with strain shield wire connections does it appear to be inadequate. Historically, the maximum shielding afforded by an overhead shield wire is a 30 degree cone at tangent structures. The cone necessary to protect the conductors at strain structures on the Hauto-Siegfried-E. Palmerton lines is 41 degrees at a minimum. This is unrealistic. A more refined analysis was performed for the structures shown in Figures 2 and 3 using IEEE and EPRI guidelines. The refined shielding analysis yields the same conclusions of the 30 degree rule of thumb. In general, all structures except ones with strain shield wire connections were adequately shielded. Fortunately, most structures are connected using a suspension clamp, thus most structures are adequately shielded. Additionally, since the shield wires are connected to the structures using a suspension saddle clamp, there is not an adequate electrical connection to the structure. The lightning current is expected to follow a path along the shield wire, down the tower and through the tower footing resistance to the ground. With a saddle suspension clamp, this expected path cannot be relied upon. The shield wires should be physically bonded to select towers to provide the required electrical connection, without forming a closed loop for induced current to circulate, resulting in a resistance heating line loss. See Figure 2 and 3 below for schematics of the shielding angle for two structure types on the Hauto-Siegfried-E. Palmerton lines.

Figure 2 – Adequate shielding angle schematic for tangent Lattice Tower

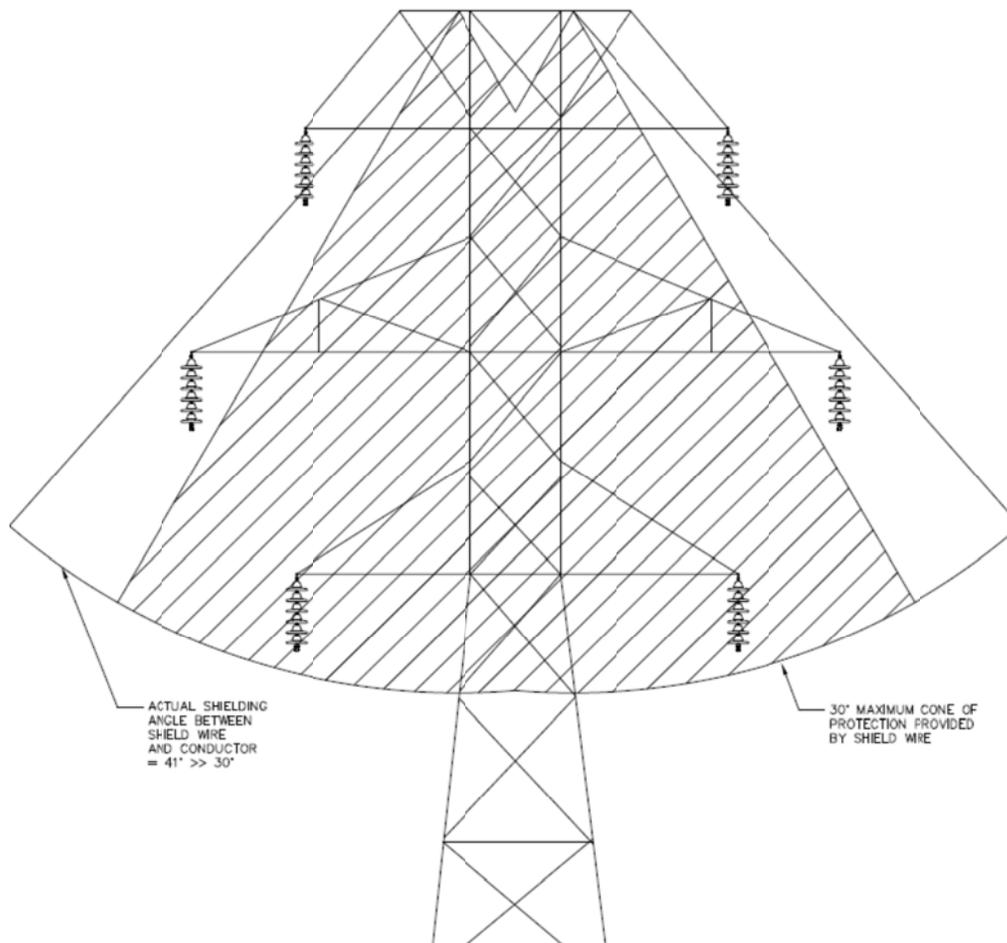
Figure 3 – Inadequate shielding angle schematic for structures with strain shield wire connection
