Project 2009-149

*Special Inspection Report for  
Zone #3 Hauto-Siegfried #1 and #4 69kV Transmission Lines*

Mr. Joseph Marhefka Zone #3, Line #449 & #452, Hauto-Siegfried 69kV Lines  
Project 2009-149  
September 1, 2011

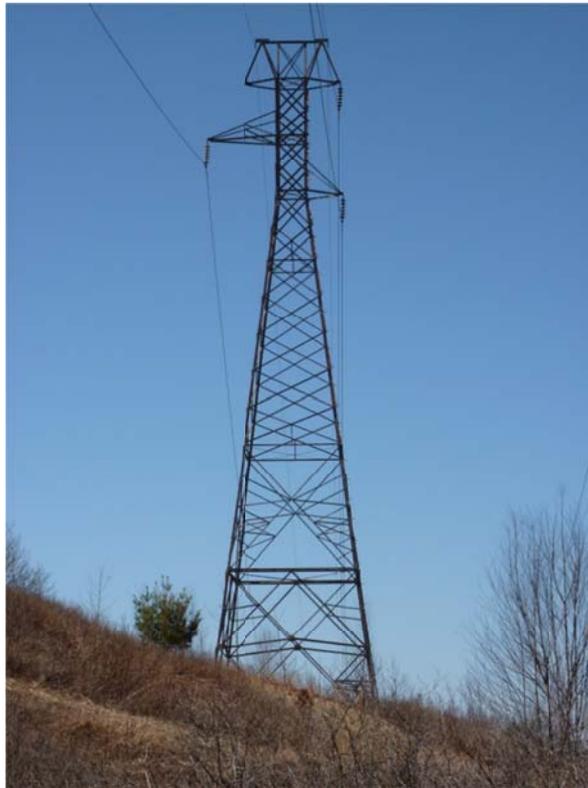
Photo 1 – Typical lattice tower

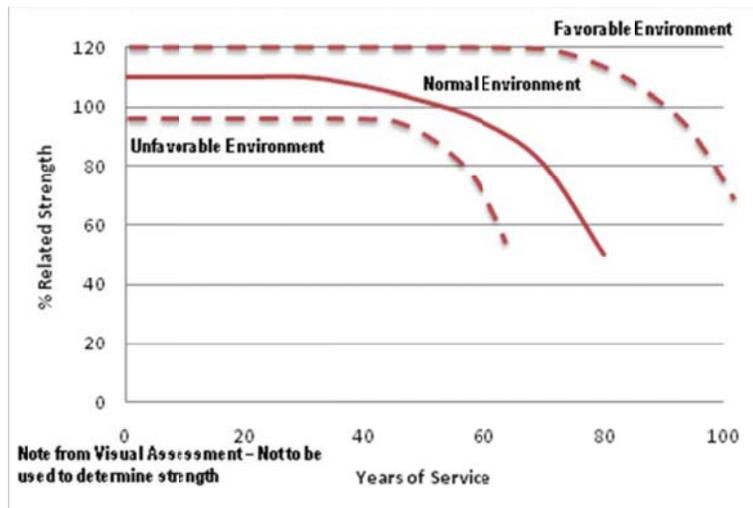
bells or with polymer insulators. Insulators were most likely replaced due to flashovers, contamination, mechanical damage or failure. This is indicative of poor insulation levels causing phase to ground faults. There is evidence of galvanizing left on the insulator caps, although corrosion is actively occurring on all hardware. Corrosion of both the caps and the pin and clevis end fittings will all contribute to a reduction in strength. See Figure 1 below for a plot of service life of hardware and galvanized steel versus rated strength. Galvanizing, when not painted can have a life expectancy of anywhere from 30 to 80 years, depending on the environment. The hardware on the Hauto-Siegfried lines is approximately 60 years old and even in a favorable environment is approaching the age marking the period in which rapid decline in strength begins. The useful life of all original insulators and hardware is approaching its end.

Figure 1 – Relation between Service Life and Rated Strength (Galvanized Steel) (from EPRI *Overhead Transmission Inspection and Assessment Guidelines – 2009*)

The paint coatings on towers are generally in poor condition. The current coatings are desiccated. The original paint can be seen on most towers. Galvanizing can also be observed where all remnants of tower paint are gone. Moderate surface corrosion on tower steel is evident and with failing coatings and exposed galvanizing, corrosion will begin to increase at a more rapid rate. Reference Figure 1.

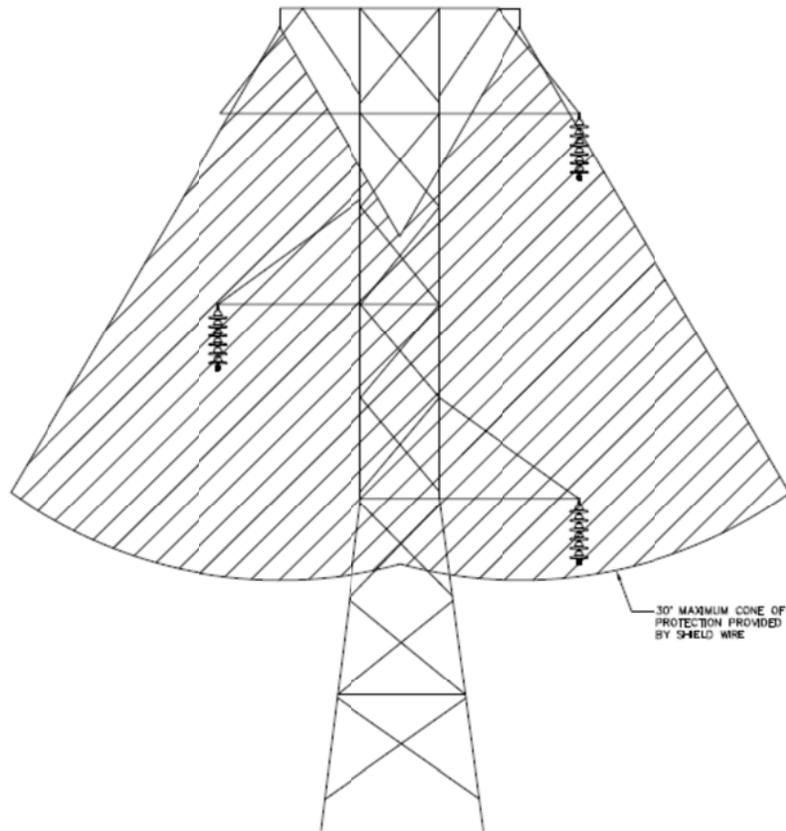
Lightning protection research was a work in progress when the Hauto-Siegfried structures were designed and built. In general, the shielding provided is adequate. Only at structures with strain shield wire connections does it appear to be inadequate. Historically, the maximum shielding afforded by an overhead shield wire is a 30 degree cone at tangent structures. The cone necessary to protect the conductors at strain structures on the Hauto-Siegfried lines is 41 degrees at a minimum. This is unrealistic. A more refined analysis was performed for the structures shown in Figures 2 and 3 using IEEE and EPRI guidelines. The refined shielding analysis yields the same conclusions of the 30 degree rule of thumb. In general, all structures except ones with strain shield wire connections were adequately shielded. Fortunately, most structures are connected using a suspension clamp, thus most structures are adequately shielded. Additionally, since the shield wires are connected to the structures using a suspension saddle clamp, there is not an adequate electrical connection to the structure. The lightning current is expected to follow a path along the shield wire, down the tower and through the tower footing resistance to the ground. With a saddle suspension clamp, this expected path cannot be relied upon. The shield wires should be physically bonded to select towers to provide the required electrical connection, without forming a closed loop for induced current to circulate, resulting in a resistance heating line loss. See Figure 2 and 3 below for schematics of the shielding angle for two structure types on the Hauto-Siegfried lines.

Figure 2 – Adequate shielding angle schematic for tangent Lattice Tower
