CHAPTER 94 MUNICIPAL WASTELOAD MANAGEMENT ANNUAL REPORT

For Calendar Year: 2018

GENERAL INFORMATION			
Permittee Name:	Radnor Township	Permit No.:	PA
Mailing Address:	301 Iven Avenue	Effective Date:	
City, State, Zip:	Wayne, PA 19087	Expiration Date:	
Contact Person:	Steve Norcini	Renewal Due Date:	
Title:	Township Engineer	Municipality:	Radnor Township
Phone:	610-688-5600	County:	Delaware
Email:	snorcini@radnor.org	Consultant Name:	Gannett Fleming, Inc.

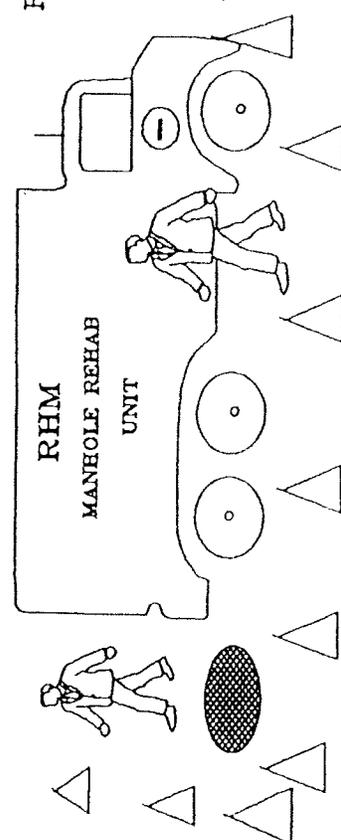
LOCATION Clermont Rd
 TOWNSHIP Tredyffrin Twp
 MANHOLE CONDITION Fair
 MANHOLE TYPE Block
 INFILTRATION NE
 MANHOLE DEPTH 9'7"
 BASE SIZE 4'
 INSPECTOR/OPERATOR Kyle Zuk

patched top under ring with concrete. To seal to finish with sealcrete.

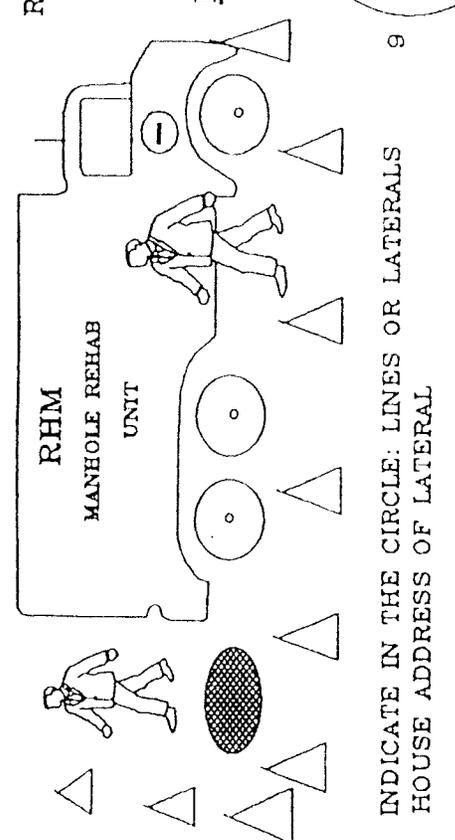
LOCATION School House Lane
 TOWNSHIP Tredyfflin Twp
 MANHOLE CONDITION POOR
 MANHOLE TYPE Brick
 INFILTRATION Ns
 MANHOLE DEPTH 11'
 BASE SIZE 4'
 INSPECTOR/OPERATOR Kyle Zalk

9-6-18 Patched top under ring with a concrete To seal to finish with sealcrete

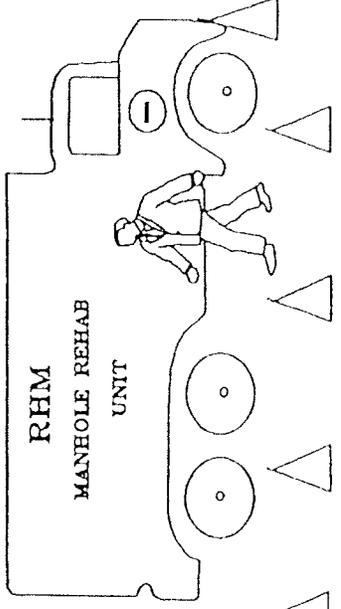
LOCATION Stroblechase Rd
 TOWNSHIP Wedgeton Twp
 MANHOLE CONDITION fair
 MANHOLE TYPE brick
 INFILTRATION no
 MANHOLE DEPTH 3.5'
 BASE SIZE 4
 INSPECTOR/OPERATOR Kyle Zuk

9-5-18 Patched top under ring with concrete. To seal to finish with sealant.

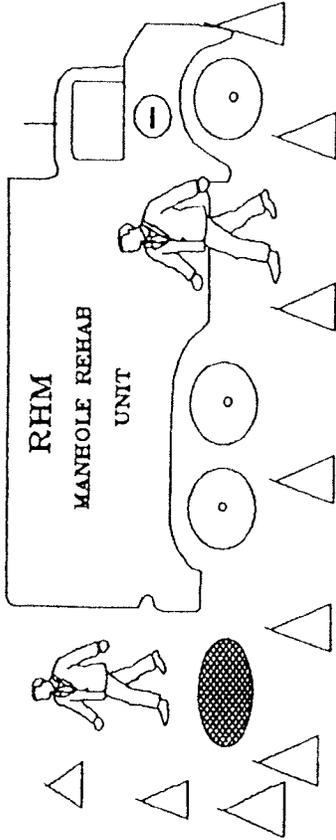
LOCATION Forest Lane
 TOWNSHIP Treddeford Twp
 MANHOLE CONDITION Fair
 MANHOLE TYPE Brick
 INFILTRATION No
 MANHOLE DEPTH 9'
 BASE SIZE 4'
 INSPECTOR/OPERATOR
 Kyle Chip

seal top of tower

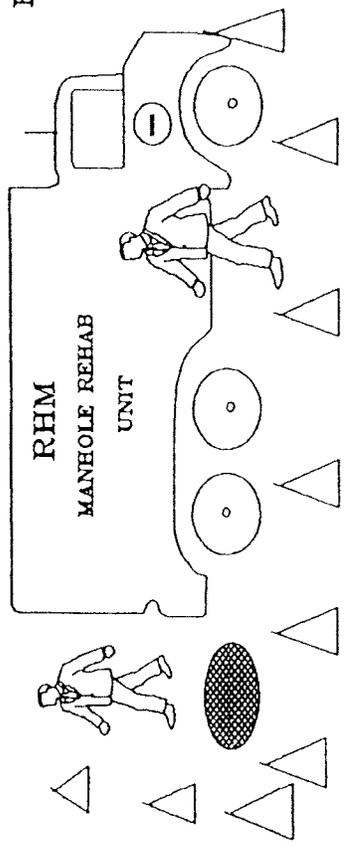
LOCATION Forest Lane
 TOWNSHIP Tredyffrin Twp
 MANHOLE CONDITION Fair
 MANHOLE TYPE Block
 INFILTRATION N3
 MANHOLE DEPTH 8.8'
 BASE SIZE 4
 INSPECTOR/OPERATOR Kyle Chip

2-21-18 Patched top under ring with sealer. To seal to finish with sealer.

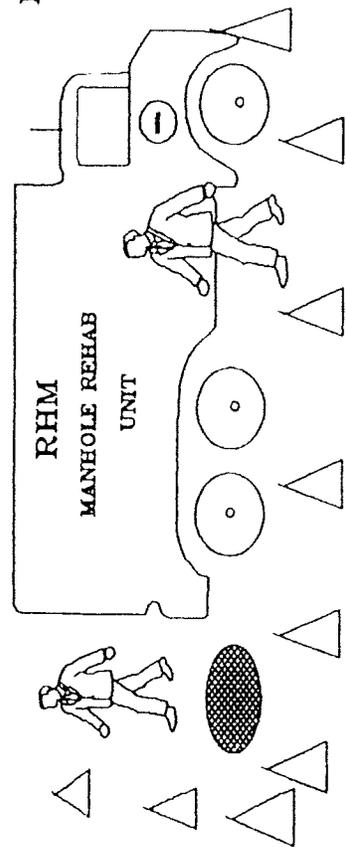
LOCATION Avon Rd
 TOWNSHIP Jordan Hill Twp
 MANHOLE CONDITION Fair
 MANHOLE TYPE Base
 INFILTRATION No
 MANHOLE DEPTH 4
 BASE SIZE 4
 INSPECTOR/OPERATOR Kyle Chip

2-21-18 Patched top under ring with concrete to seal to finish with sealant

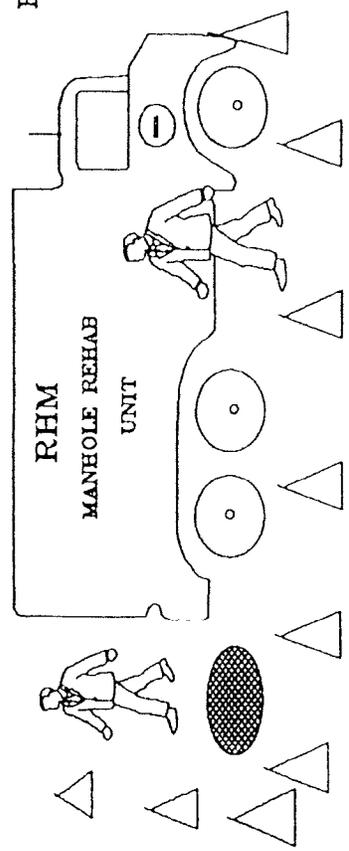
LOCATION Valley Forge Rd
 TOWNSHIP Rediffon Twp
 MANHOLE CONDITION Fair
 MANHOLE TYPE Pre-Cast
 INFILTRATION No
 MANHOLE DEPTH 3'
 BASE SIZE 4'
 INSPECTOR/OPERATOR Kyle Tom

6-4-18 Seal top of tower.

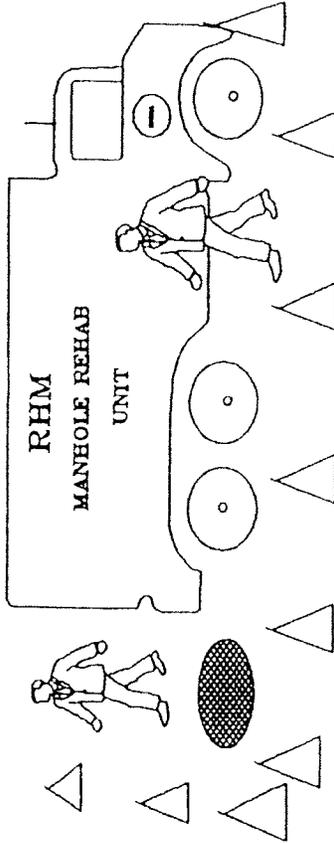
LOCATION Bell Vista Rd
 TOWNSHIP Islandton
 MANHOLE CONDITION FCIF
 MANHOLE TYPE Re-lin
 INFILTRATION No
 MANHOLE DEPTH 5'6"
 BASE SIZE 4'
 INSPECTOR/OPERATOR Kyle Tim

6-4-18 Jacked up Frozen lid. Patched top under ring with concrete To seal to finish with sealcrete.

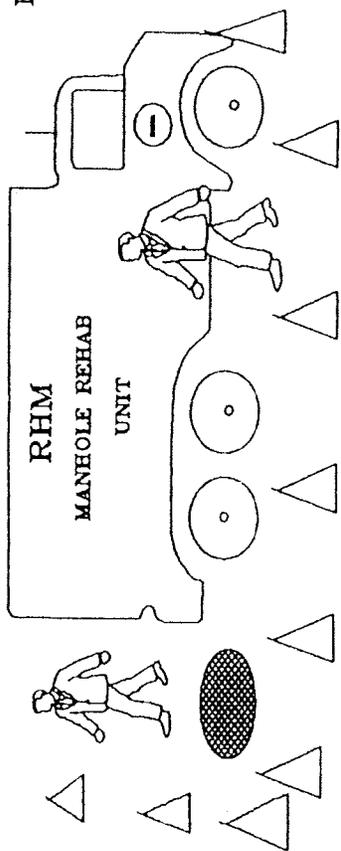
3 MANHOLE # 357

LOCATION School Lane
TOWNSHIP Tredahon Twp
MANHOLE CONDITION Fair
MANHOLE TYPE brick
INFILTRATION As
MANHOLE DEPTH 7.5'
BASE SIZE 4'
INSPECTOR/OPERATOR Kyle Timm

Seal top of tower.

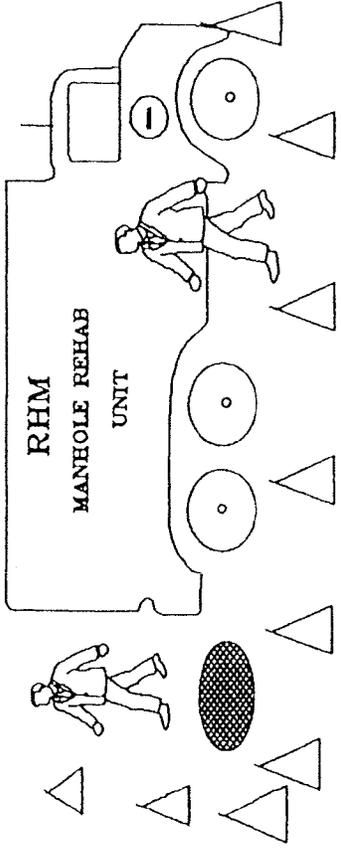
LOCATION Storford Ave
 TOWNSHIP Troyton Twp
 MANHOLE CONDITION fair
 MANHOLE TYPE PK-60
 INFILTRATION No _____
 MANHOLE DEPTH 8 ft
 BASE SIZE 4'
 INSPECTOR/OPERATOR Kyle Tim

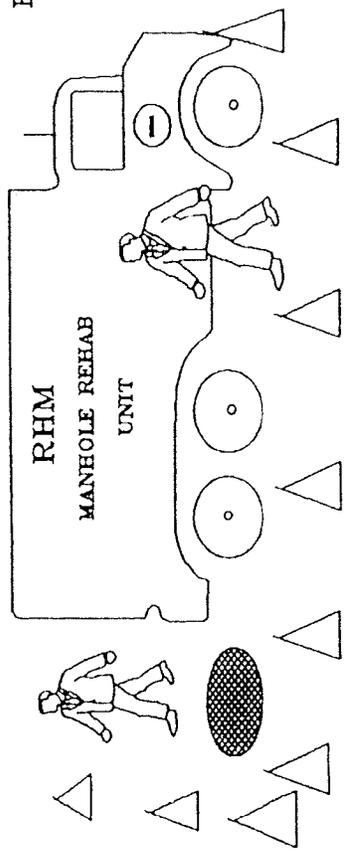
LOCATION Quincy Rd
TOWNSHIP Wedgeville Twp
MANHOLE CONDITION Fair
MANHOLE TYPE WV-40
INFILTRATION No
MANHOLE DEPTH 14' 3"
BASE SIZE 4
INSPECTOR/OPERATOR Kyle Tim

Seal top of tower

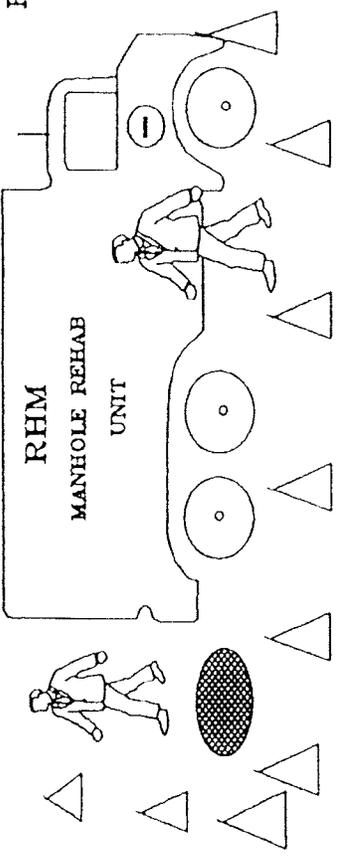
LOCATION GREEN AVE
 TOWNSHIP Tredyffrin Twp
 MANHOLE CONDITION fair
 MANHOLE TYPE 18-18b
 INFILTRATION NO. _____
 MANHOLE DEPTH 0'
 BASE SIZE 4'
 INSPECTOR/OPERATOR Kyle Tom

6-10-18 Jacked up frozen lid. & seal top of tower. *

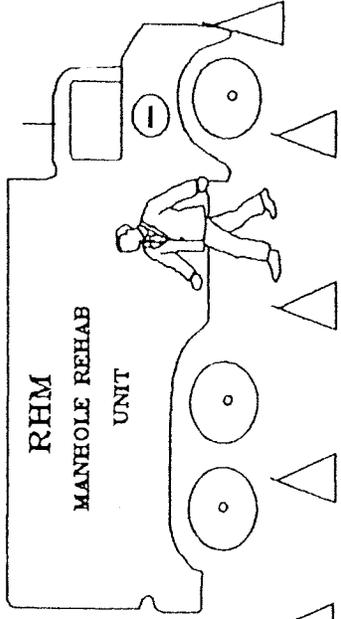
LOCATION Valley Forge
 TOWNSHIP Tredyffrin Twp
 MANHOLE CONDITION Fair
 MANHOLE TYPE 18" dia
 INFILTRATION No
 MANHOLE DEPTH 13'
 BASE SIZE 4'
 INSPECTOR/OPERATOR Kyle/Tim

6-7-18 Seal top of tower

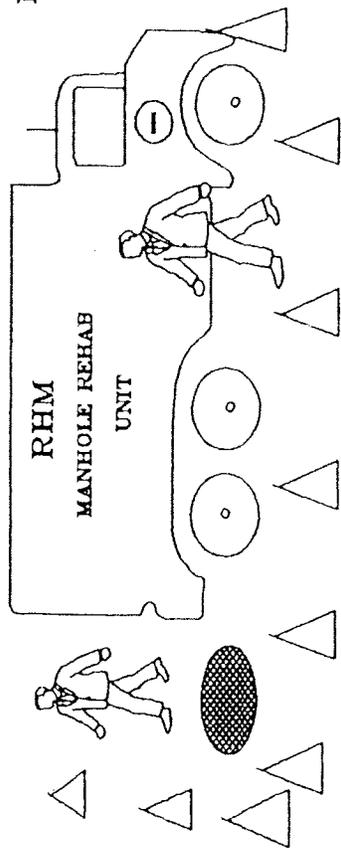
LOCATION STERIOR CHUR RD
 TOWNSHIP Tredyfflow Twp
 MANHOLE CONDITION Fair
 MANHOLE TYPE brick
 INFILTRATION no
 MANHOLE DEPTH 4'
 BASE SIZE 4'
 INSPECTOR/OPERATOR KSK/ZAK

6-8-18 Patched top under ring with concrete & seal to finish with sealcrete.

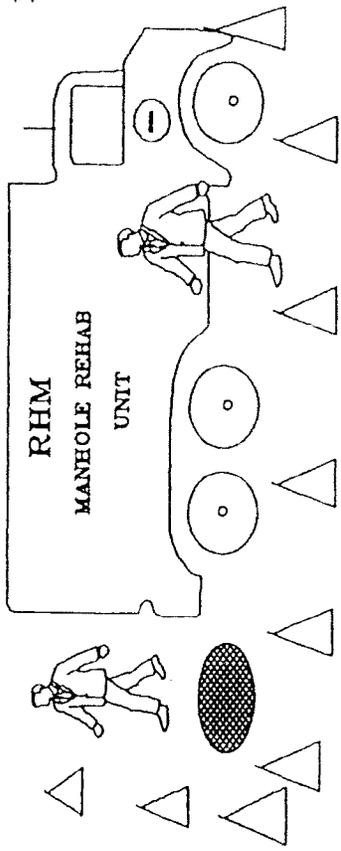
LOCATION Steele Chase Rd
 TOWNSHIP Tredahon Twp
 MANHOLE CONDITION fair
 MANHOLE TYPE brick
 INFILTRATION no
 MANHOLE DEPTH 8'
 BASE SIZE 4'
 INSPECTOR/OPERATOR Kyler Zink

6-8-18 Patched top under ring with concrete to seal to finish with sealcrete.

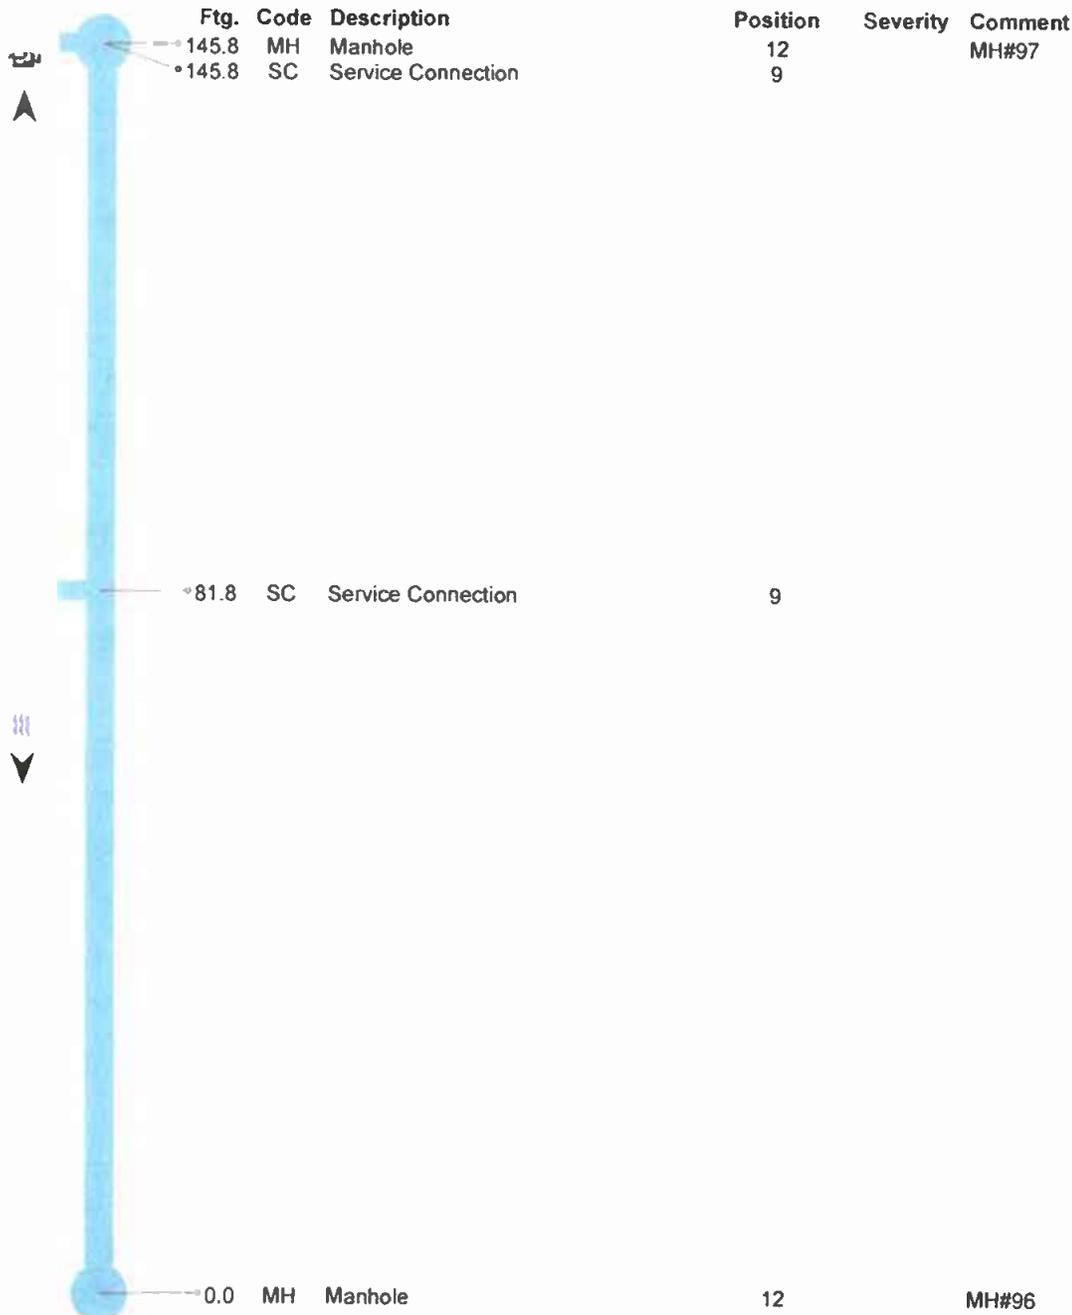
Owner TREDYFFRIN TWP.	Customer TREDYFFRIN TWP.	Upstream MH 97	Downstream MH 96	Date 03-Oct-2018
Surveyor PATRICK	Street STEEPLECHASE RD.		City	Weather Dry
Size 8	Material Transite Pipe	Sewer Use Sanitary	Purpose Routine Assessment	Length
Comments SEWER MAIN IN GOOD CONDITION			Pre-Cleaning No Pre-Cleaning	TV Length 145.8

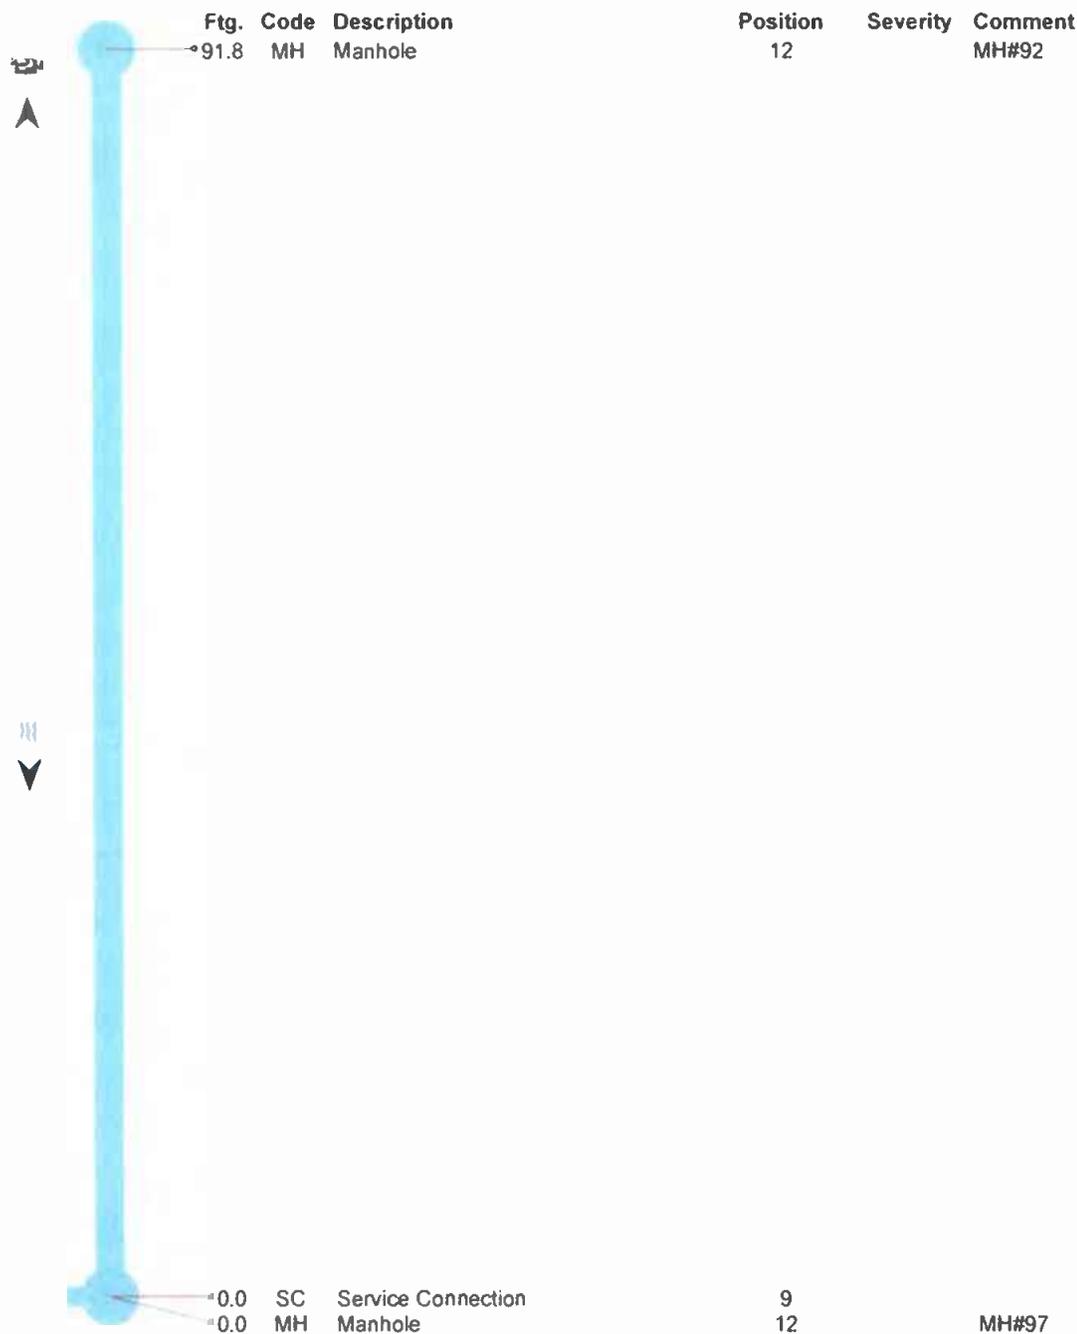
Owner TREDYFFRIN TWP.	Customer TREDYFFRIN TWP.	Upstream MH 92	Downstream MH 97	Date 03-Oct-2018
Surveyor PATRICK	Street STEEPLECHASE RD.		City	Weather Dry
Size 8	Material Transite Pipe	Sewer Use Sanitary	Purpose Routine Assessment	Length
Comments SEWER MAIN IN GOOD CONDITION			Pre-Cleaning No Pre-Cleaning	TV Length 91.8

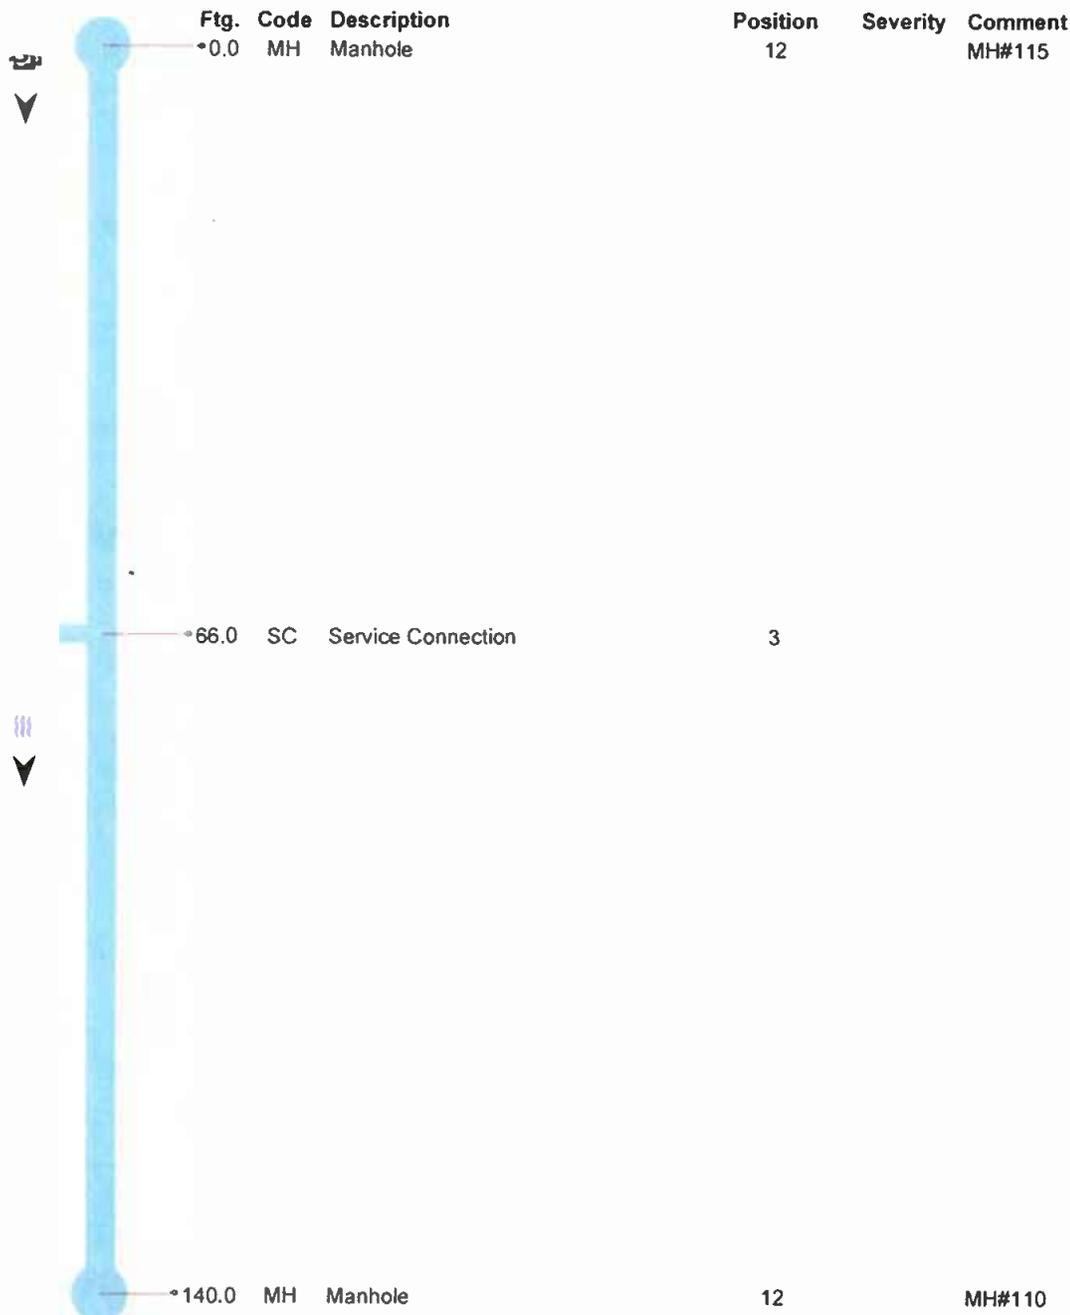
Owner TREDYFFRIN TWP.	Customer TREDYFFRIN TWP.	Upstream MH 115	Downstream MH 110	Date 04-Oct-2018
Surveyor PATRICK	Street SUNSET RD.		City	Weather Dry
Size 8	Material Transite Pipe	Sewer Use Sanitary	Purpose Routine Assessment	Length
Comments SEWER MAIN IN GOOD CONDITION			Pre-Cleaning No Pre-Cleaning	TV Length 140

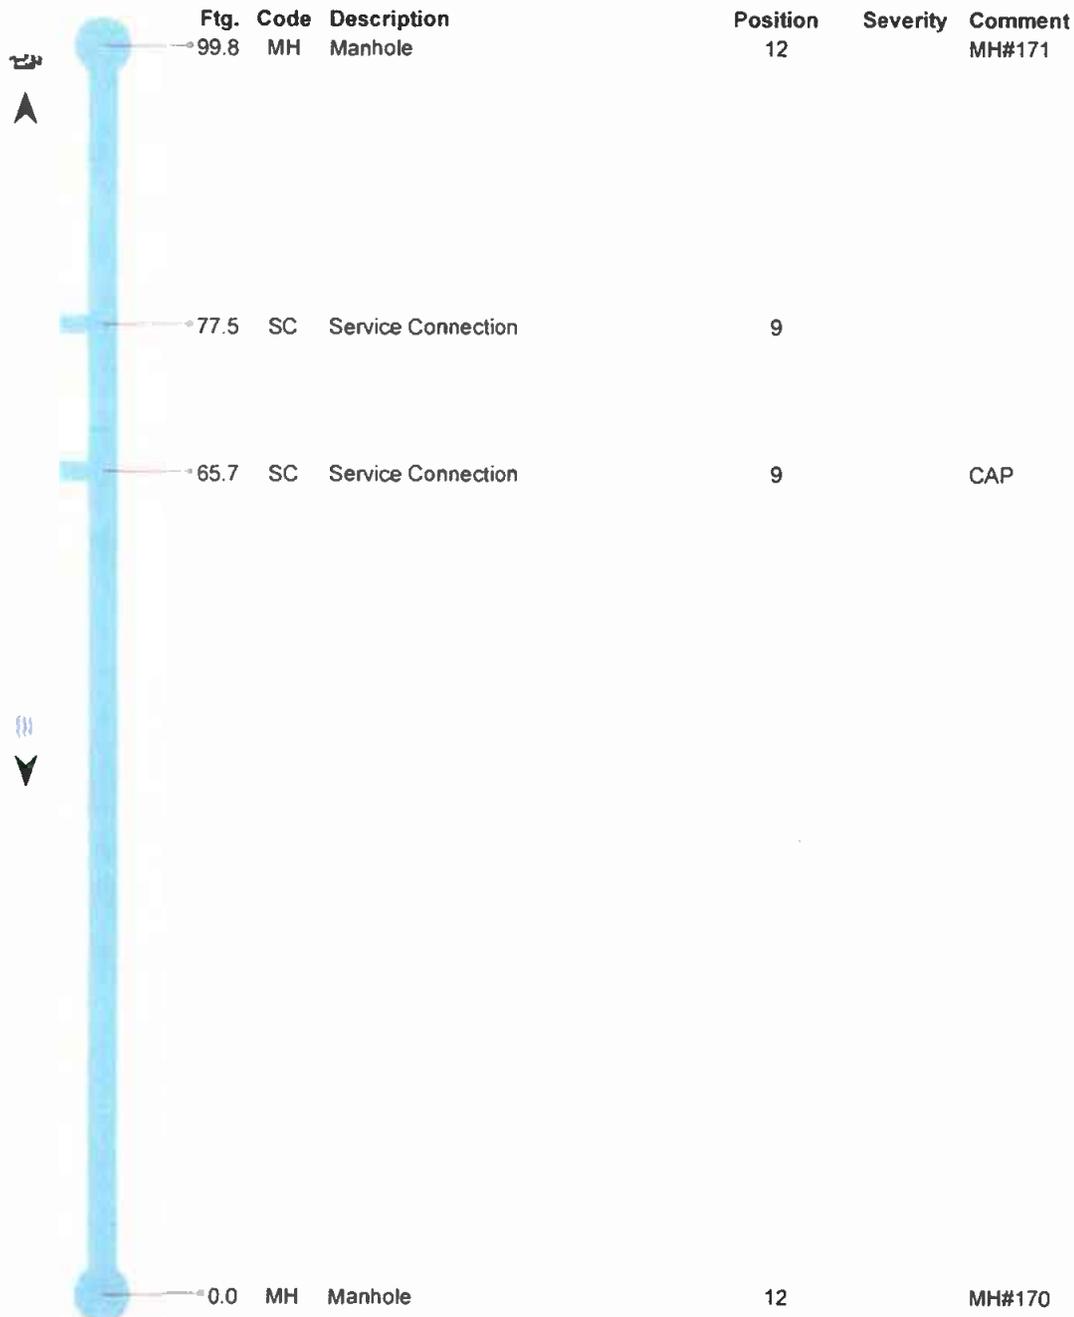
Owner TREDYFFRIN TWP.	Customer TREDYFFRIN TWP.	Upstream MH 171	Downstream MH 170	Date 04-Oct-2018
Surveyor PATRICK	Street HOMESTEAD RD.		City	Weather Dry
Size 8	Material Transite Pipe	Sewer Use Sanitary	Purpose Routine Assessment	Length
Comments SEWER MAIN IN GOOD CONDITION			Pre-Cleaning No Pre-Cleaning	TV Length 99.8

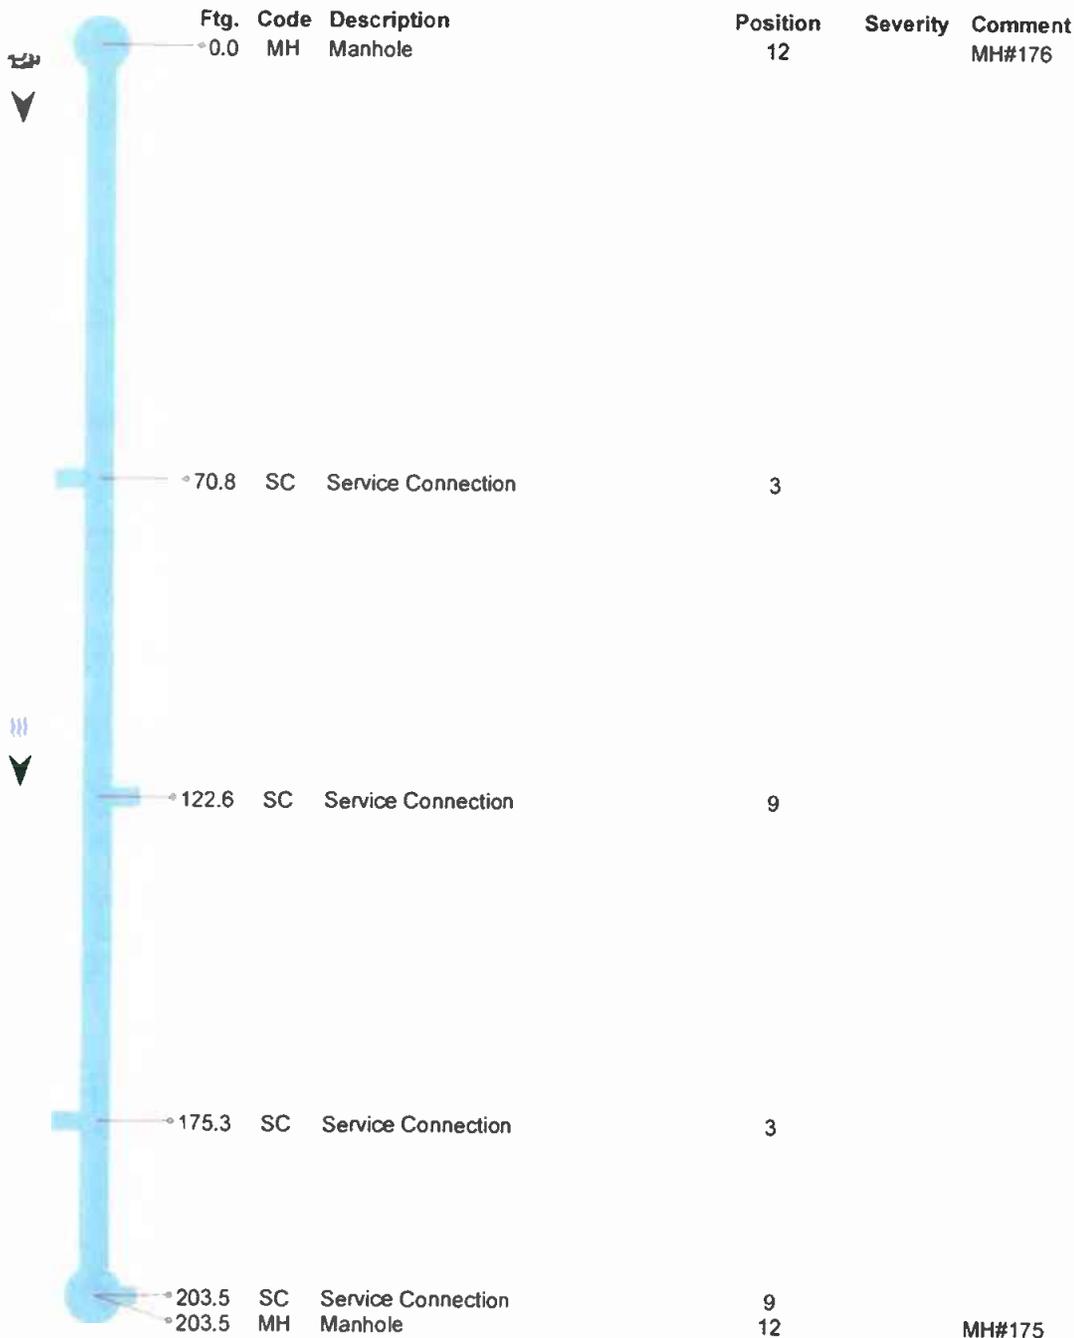
Owner TREDYFFRIN TWP.	Customer TREDYFFRIN TWP.	Upstream MH 176	Downstream MH 175	Date 05-Oct-2018
Surveyor PATRICK	Street HOMESTEAD RD.		City	Weather Dry
Size 8	Material Transite Pipe	Sewer Use Sanitary	Purpose Routine Assessment	Length
Comments SEWER MAIN IN GOOD CONDITION			Pre-Cleaning No Pre-Cleaning	TV Length 203.5

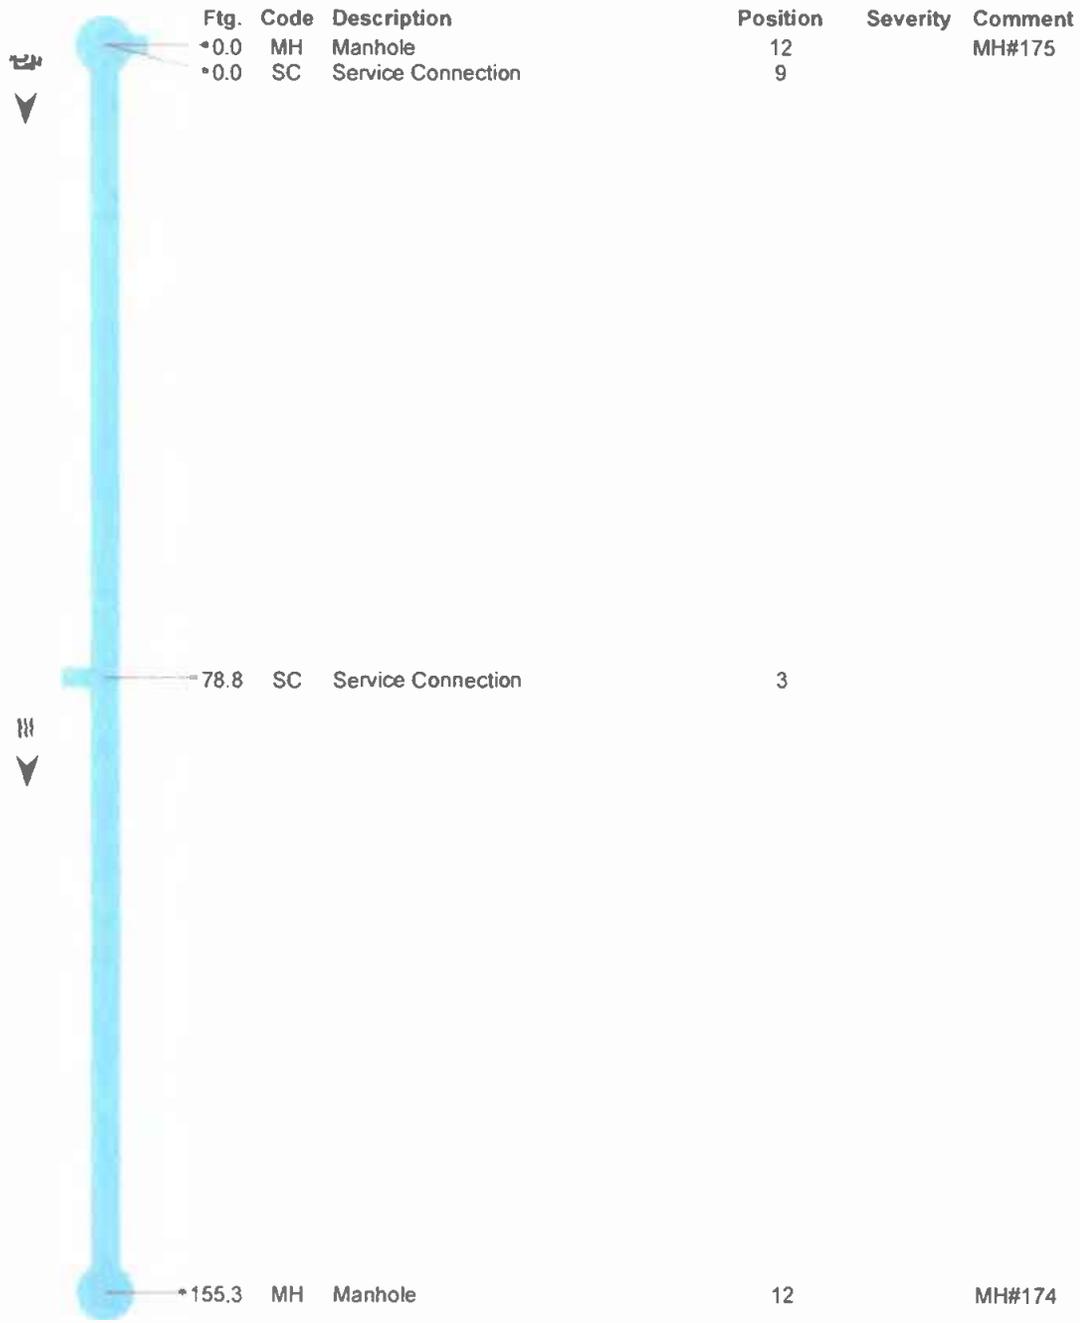
Owner TREDYFFRIN TWP.	Customer TREDYFFRIN TWP.	Upstream MH 175	Downstream MH 174	Date 05-Oct-2018
Surveyor PATRICK	Street HOMESTEAD RD.		City	Weather Dry
Size 8	Material Transite Pipe	Sewer Use Sanitary	Purpose Routine Assessment	Length
Comments SEWER MAIN IN GOOD CONDITION			Pre-Cleaning No Pre-Cleaning	TV Length 155.3

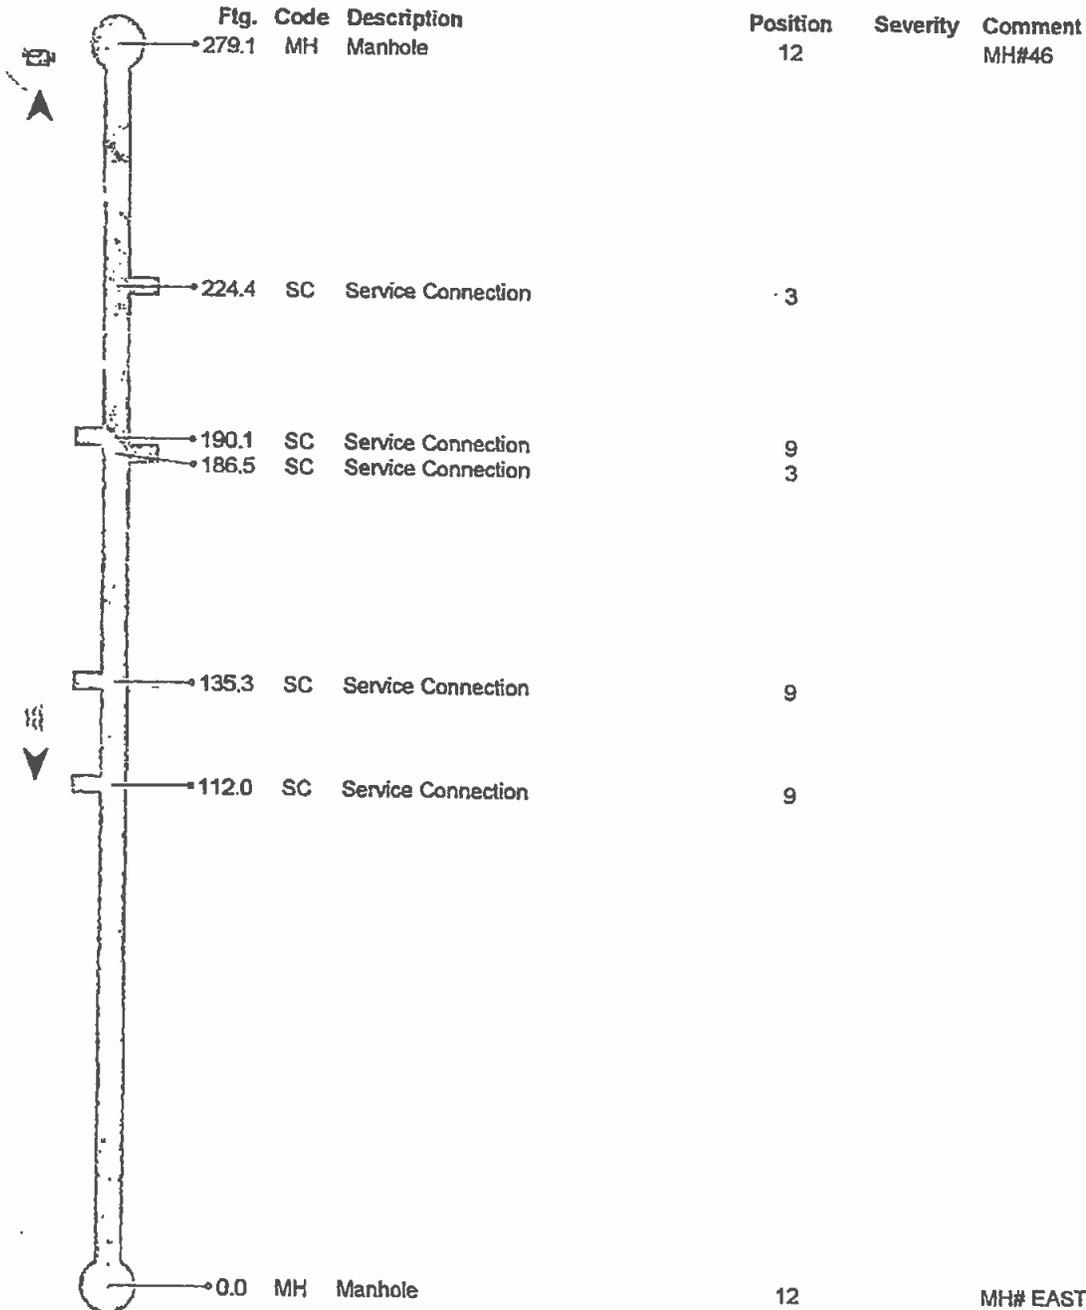
Owner TREDYFFRIN TWP.	Customer TREDYFFRIN TWP.	Upstream MH 46	Downstream MH EAST 8	Date 30-Mar-2018
Surveyor PATRICK	Street SOUTH VALLEY FORGE RD.		City	Weather Dry
Size 8	Material Transite Pipe	Sewer Use Sanitary	Purpose Routine Assessment	Length
Comments SEWER MAIN IN GOOD CONDITION				Pre-Cleaning No Pre-Cleaning
				TV Length 279.1

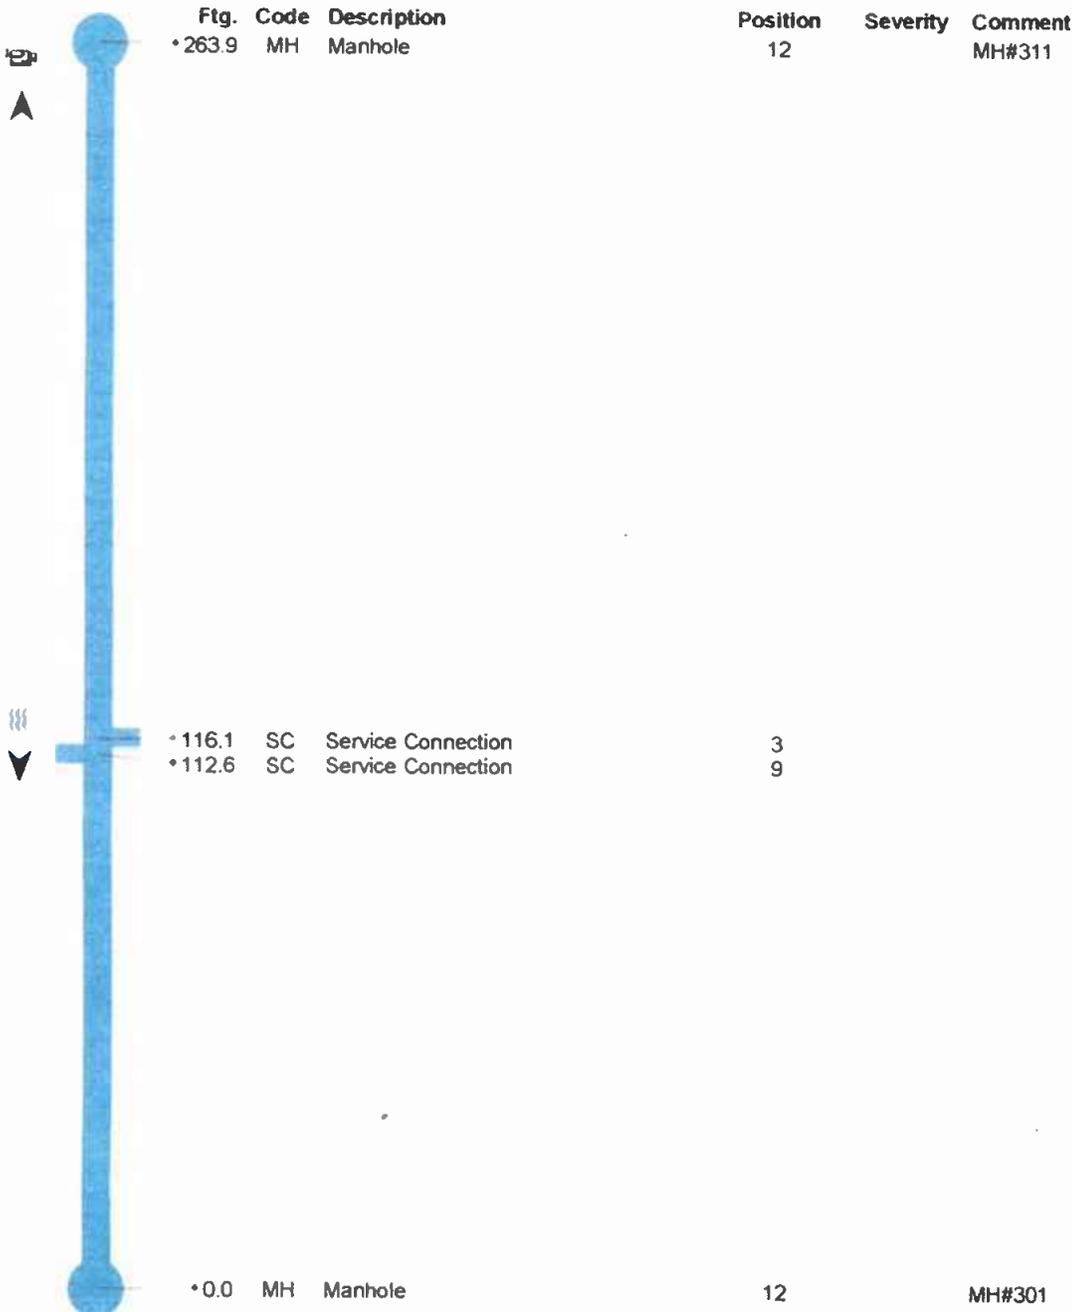
Comments SEWER MAIN IN GOOD CONDITION	Pre-Cleaning No Pre-Cleaning	TV Length 263.9
---	--	---------------------------

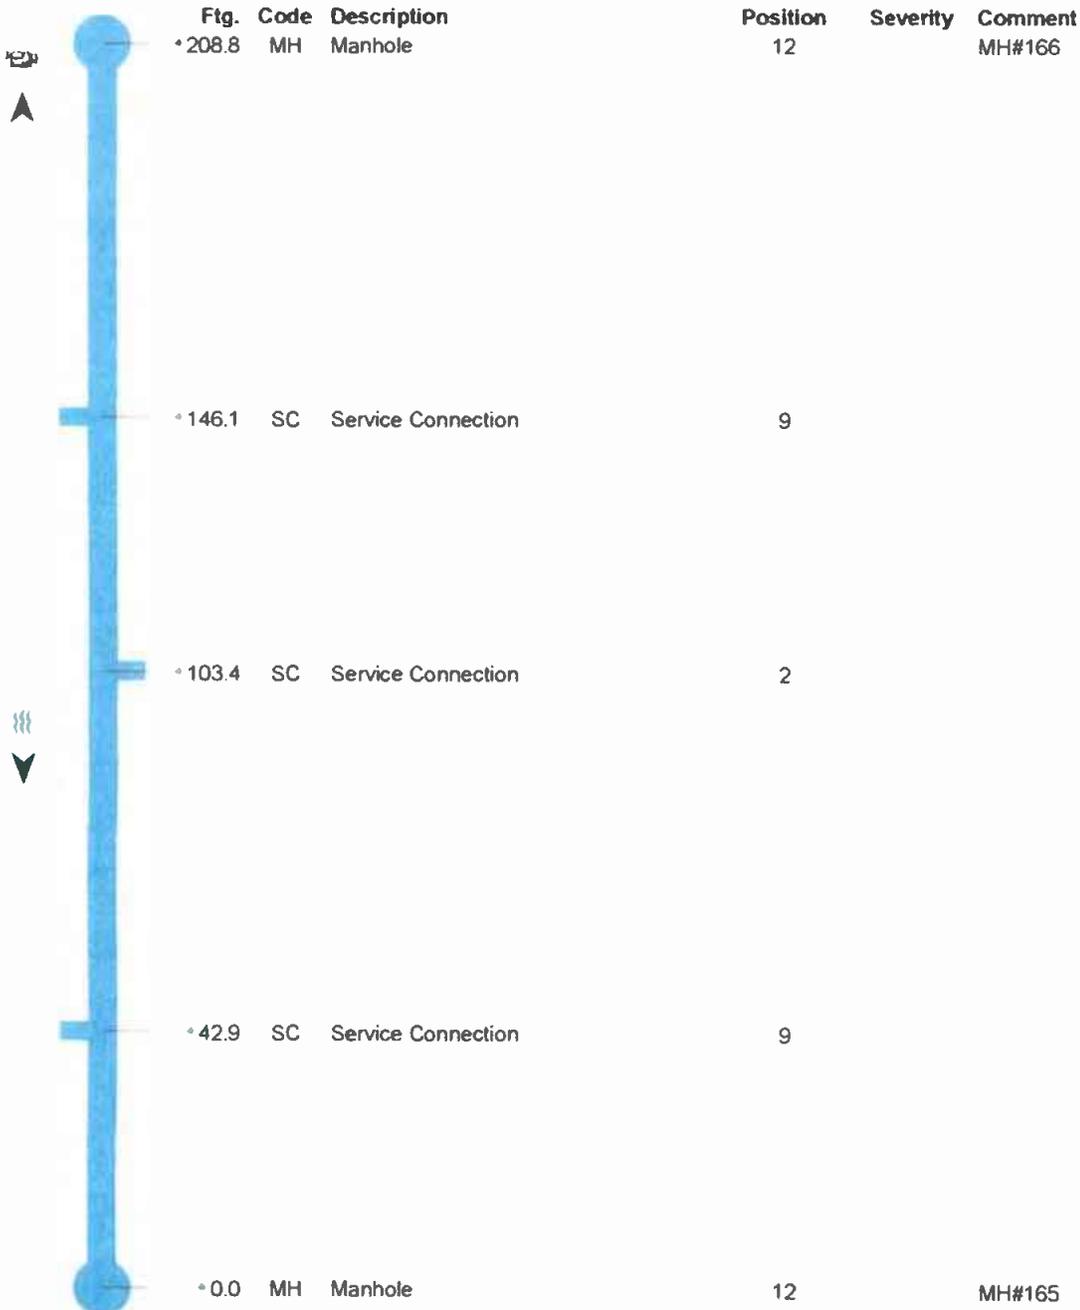
Owner TREDYFFRIN TWP.	Customer TREDYFFRIN TWP.	Upstream MH 166	Downstream MH 165	Date 26-Mar-2018
Surveyor PATRICK	Street WOODLAND RD.		City	Weather Dry
Size 8	Material Transite Pipe	Sewer Use Sanitary	Purpose Routine Assessment	Length
Comments SEWER MAIN IN GOOD CONDITION				Pre-Cleaning No Pre-Cleaning
				TV Length 208.8

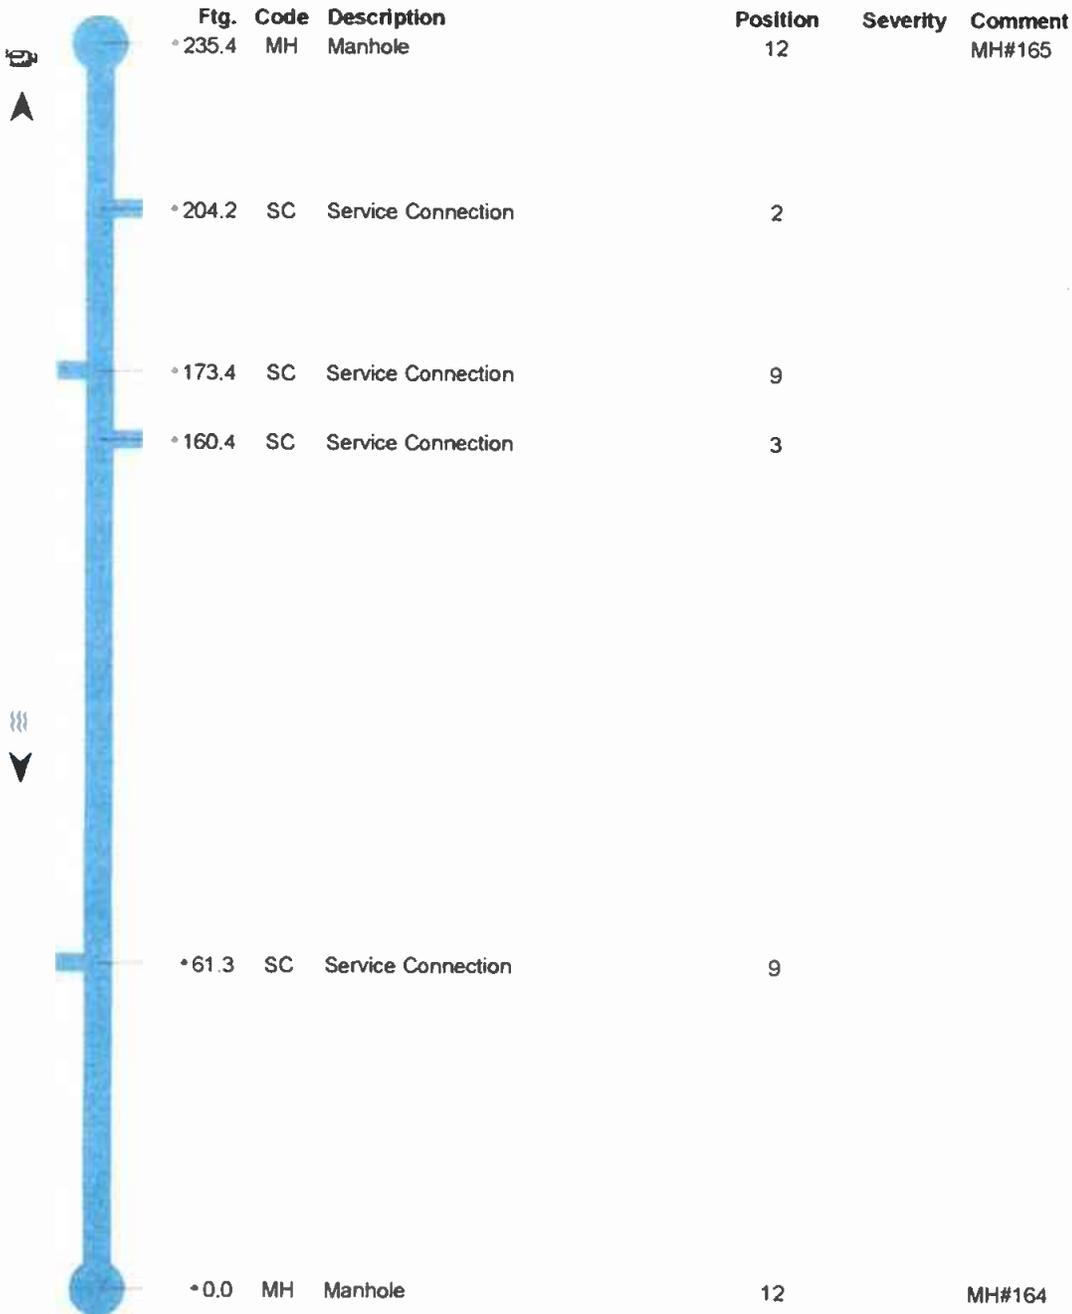
Owner TREDYFFRIN TWP.	Customer TREDYFFRIN TWP.	Upstream MH 165	Downstream MH 164	Date 26-Mar-2018
Surveyor PATRICK	Street WOODLAND RD.		City	Weather Dry
Size 8	Material Transite Pipe	Sewer Use Sanitary	Purpose Routine Assessment	Length
Comments SEWER MAIN IN GOOD CONDITION			Pre-Cleaning No Pre-Cleaning	TV Length 235.4

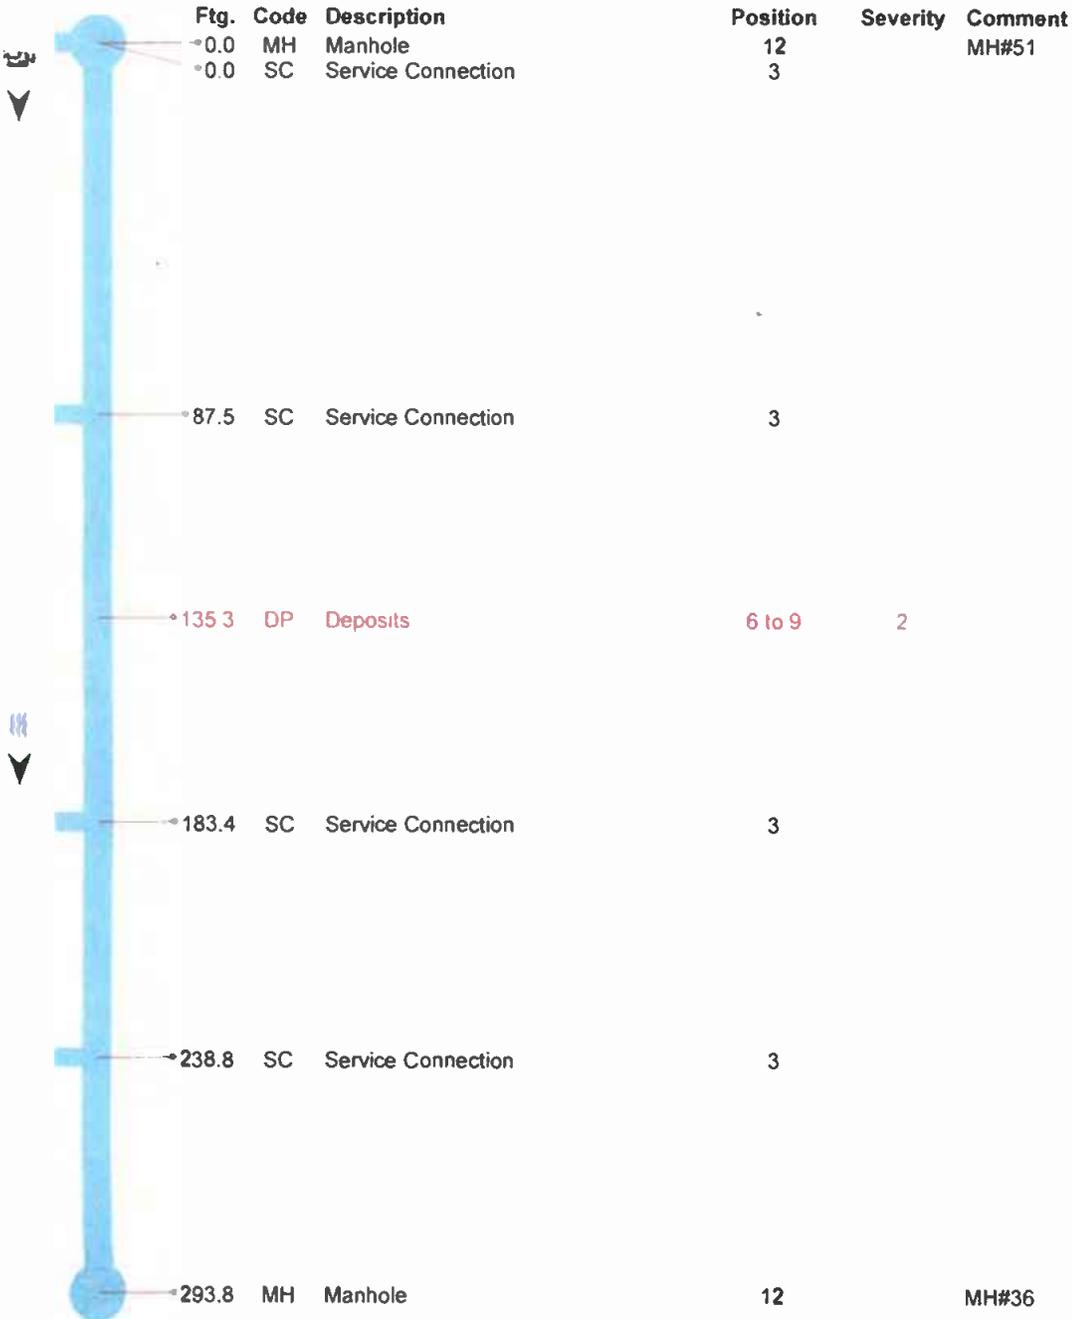
Owner TREDYFFRIN TWP.	Customer TREDYFFRIN TWP.	Upstream MH 51	Downstream MH 36	Date 7/6/2018
Surveyor PATRICK	Street CHESTNUT RD.		City	Weather Dry
Size 8	Material Transite Pipe	Sewer Use Sanitary	Purpose Routine Assessment	Length
Comments MAIN IN GOOD CONDITION			Pre-Cleaning No Pre-Cleaning	TV Length 293.8
