CHAPTER 94 MUNICIPAL WASTELOAD MANAGEMENT ANNUAL REPORT

For Calendar Year: 2018

GENERAL INFORMATION			
Permittee Name:	Radnor Township	Permit No.:	PA
Mailing Address:	301 Iven Avenue	Effective Date:	
City, State, Zip:	Wayne, PA 19087	Expiration Date:	
Contact Person:	Steve Norcini	Renewal Due Date:	
Title:	Township Engineer	Municipality:	Radnor Township
Phone:	610-688-5600	County:	Delaware
Email:	snorcini@radnor.org	Consultant Name:	Gannett Fleming, Inc.

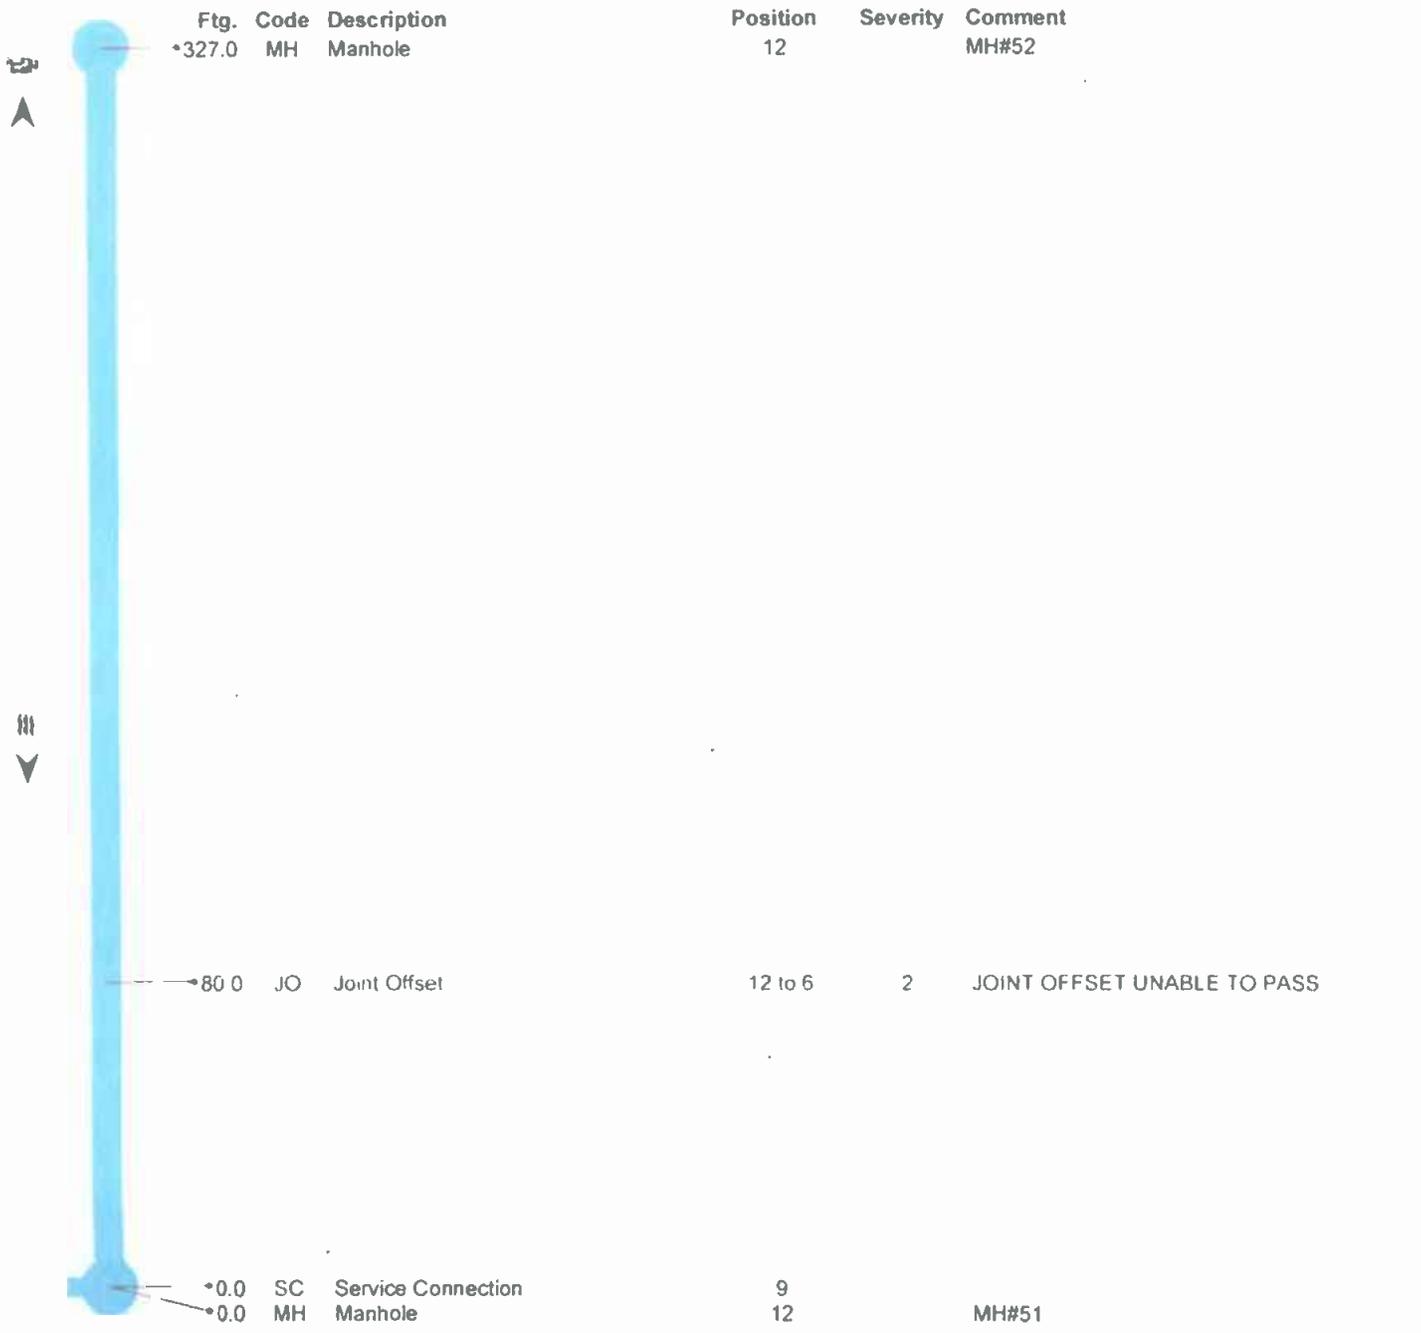
Owner TREDYFFRIN TWP.	Customer TREDYFFRIN TWP.	Upstream MH 52	Downstream MH 51	Date 7/6/2018
Surveyor PATRICK	Street CHESTNUT RD.		City	Weather Dry
Size 8	Material Transite Pipe	Sewer Use Sanitary	Purpose Routine Assessment	Length 327
Comments REPAIR:OFF-SET JOINT			Pre-Cleaning No Pre-Cleaning	TV Length 80

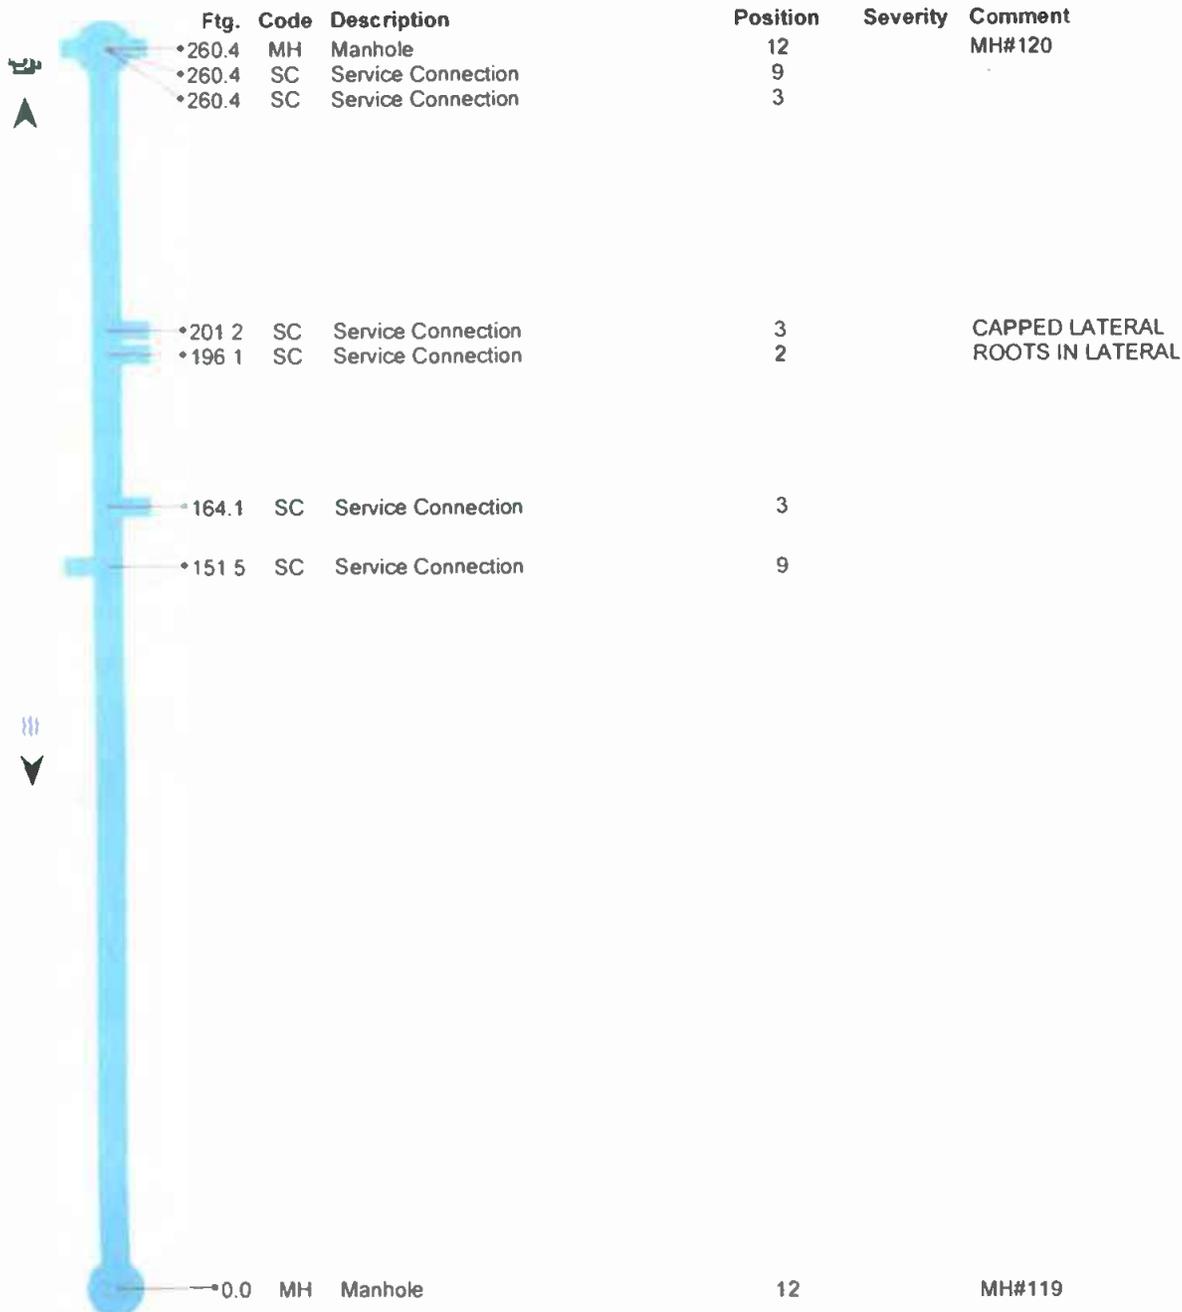
Owner TREDYFFRIN TWP.	Customer TREDYFFRIN TWP.	Upstream MH 120	Downstream MH 119	Date 05-Jul-2018
Surveyor PATRICK	Street WENTWORTH RD.		City	Weather Dry
Size 8	Material Transite Pipe	Sewer Use Sanitary	Purpose Routine Assessment	Length
Comments SEWER MAIN IN GOOD CONDITION			Pre-Cleaning No Pre-Cleaning	TV Length 260.4
