RE: Ronald and Sheila Derian vs. Pennsylvania American Water Company
Docket # c-2023-3041252

Included please find Exhibits 1 thru 7 to be entered concerning the above case # c-2023-3041252.

G:\Projects\41000\41370 Travelers - Derian Property\Docs\Report.docx

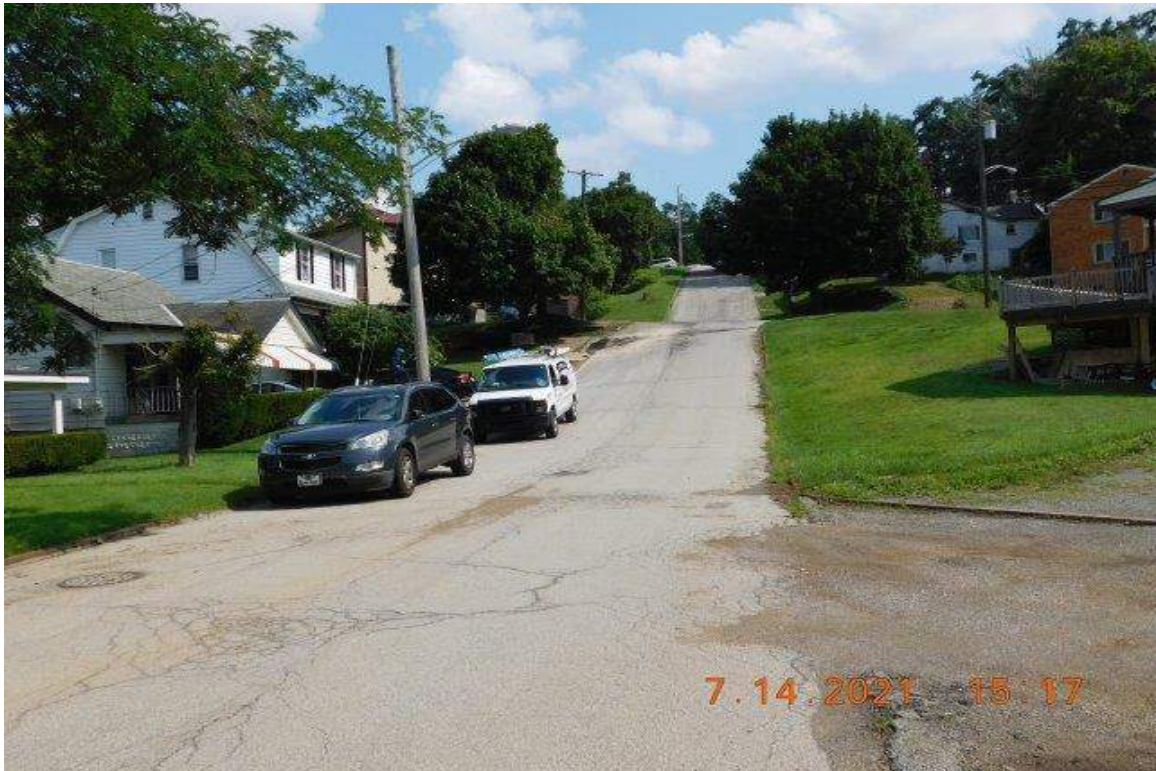
Photo 1 shows the Derian property looking east from the intersection of E. Miller Avenue and Hill Street. Photos 2 and 3 show Hill Street looking southeast. The water main break occurred in the area of the dark pavement patch in the center background of Photo 3. Photos 4, 5, and 6 show the south portion of the Derian property, the area where runoff from the water main break reportedly flowed. Photo 7 shows the upper retaining wall in the rear (south) limit of the left (east) yard. Photo 8 shows E. Miller Avenue looking east from Hill Street, while Photo 9 shows the dwelling front (north) wall.

PHOTO 3 - AREA SOUTHEAST OF PHOTO 2

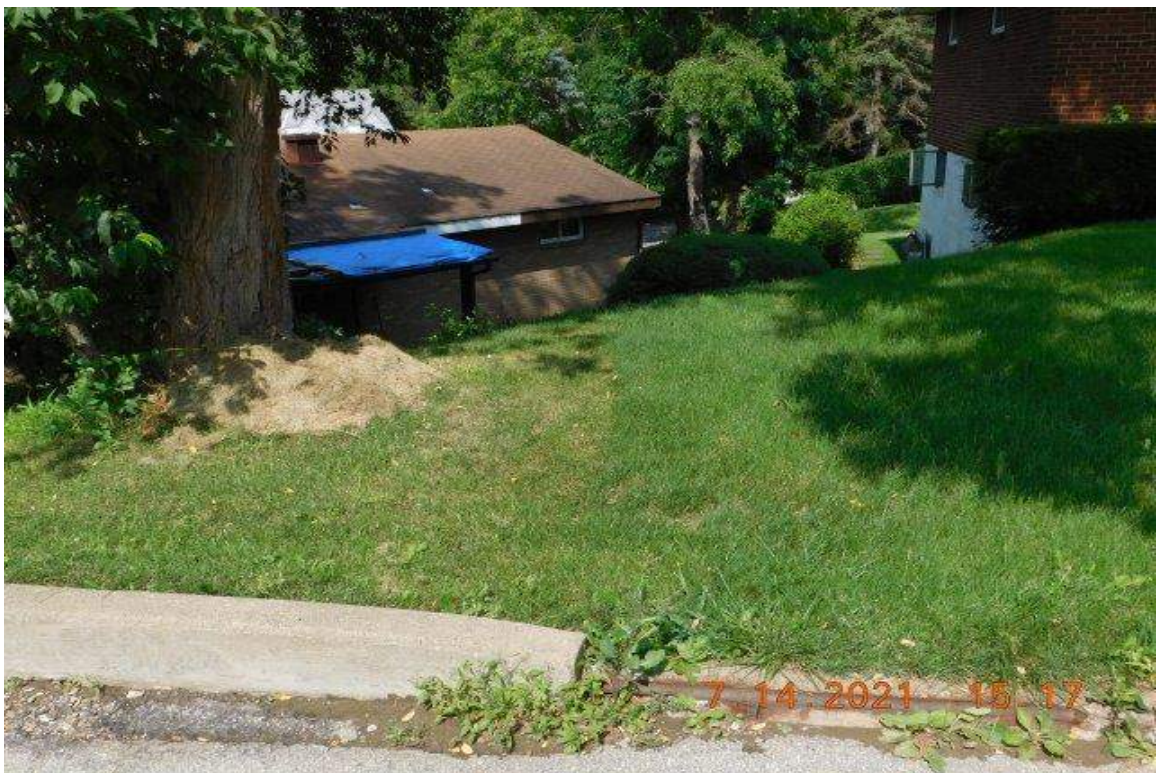
PHOTO 4 - SOUTHEAST PORTION OF DERIAN PROPERTY VIEWED FROM HILL STREET

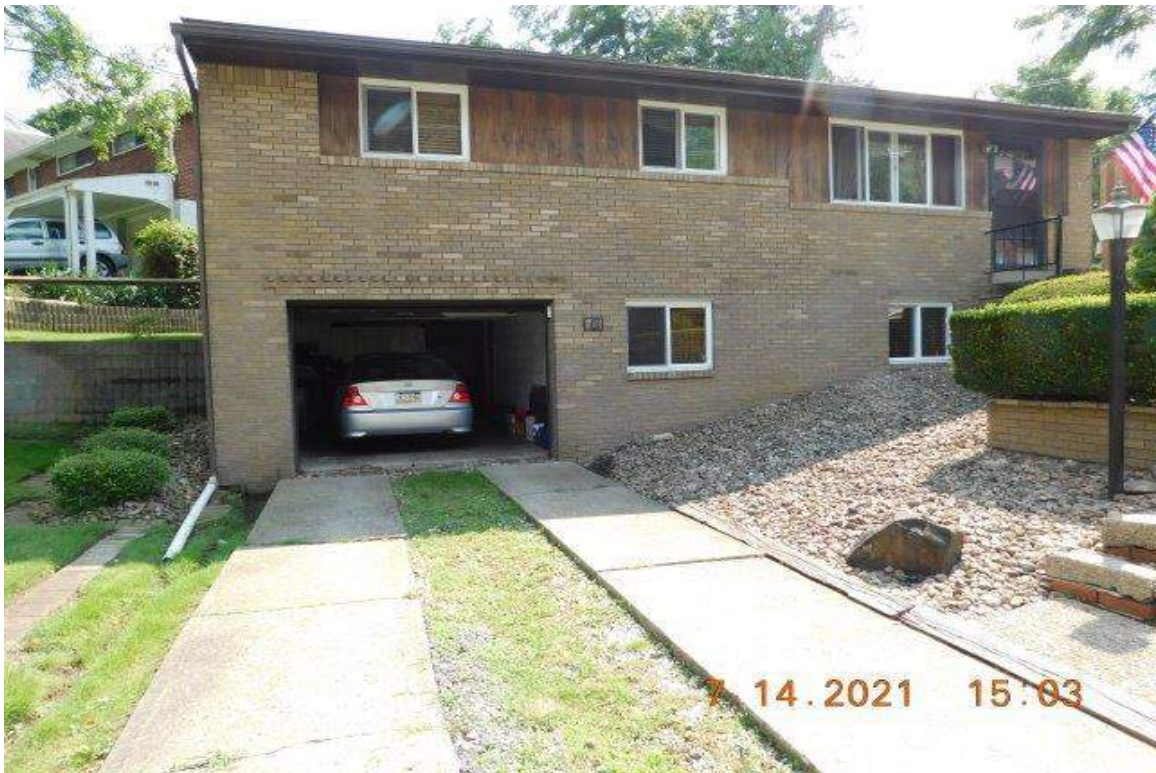
PHOTO 9 - DERIAN DWELLING FRONT (NORTH) WALL

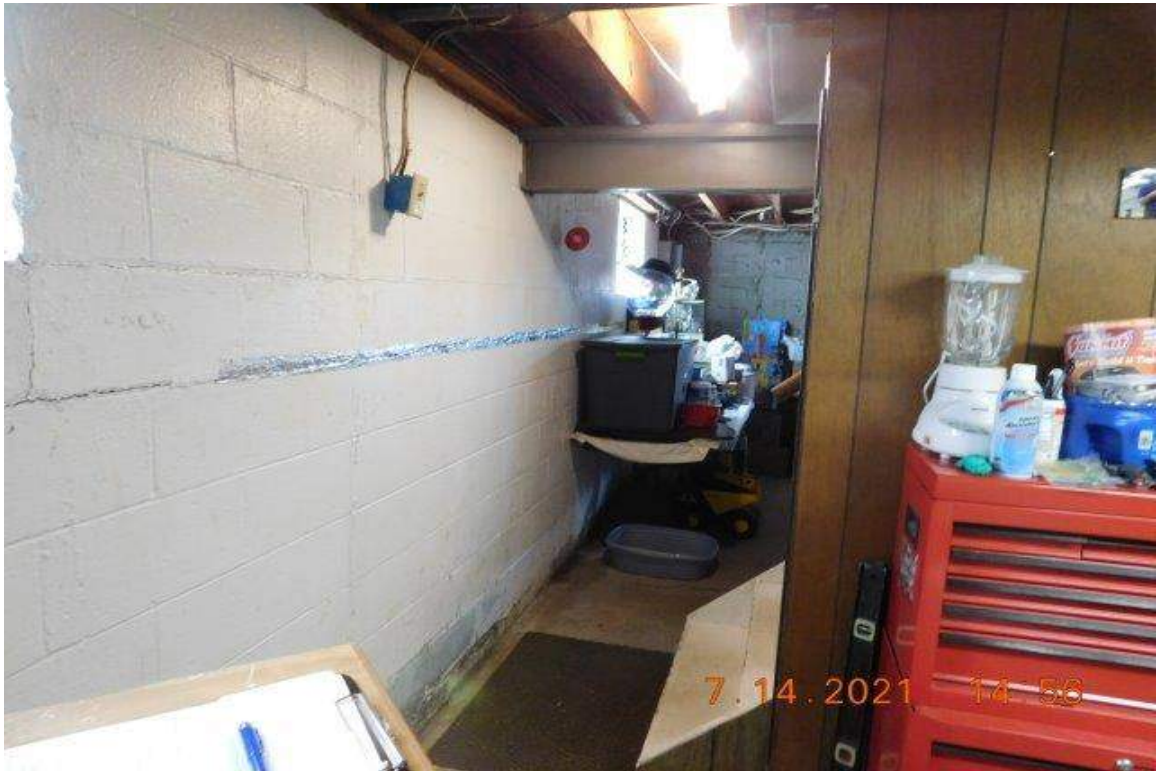
Interior Photo 10 shows the right (west) rear corner of the basement. Photo 11 shows the basement right wall right of Photo 10. Photos 12, 13, and 14 show a step crack in the blockwork mortar joints below the basement right wall rear window, reportedly repaired by Mr. Derian after the water main break in 2020. As noted in those photos, flexible caulking was installed in these cracks. However, the cracks have since recurred. Photos 15, 16, and 17 show horizontal cracks in the basement right wall blockwork mortar joints three courses and four courses below the top of the wall, some of which were covered with metallic paint. Photos 18 and 19 show the basement right wall front window and horizontal and step cracks in the blockwork mortar joints below the window opening. Photo 20 shows the basement right front corner and significant staining as well as areas where the paint has

PHOTO 11 - BASEMENT RIGHT WALL RIGHT OF PHOTO 10

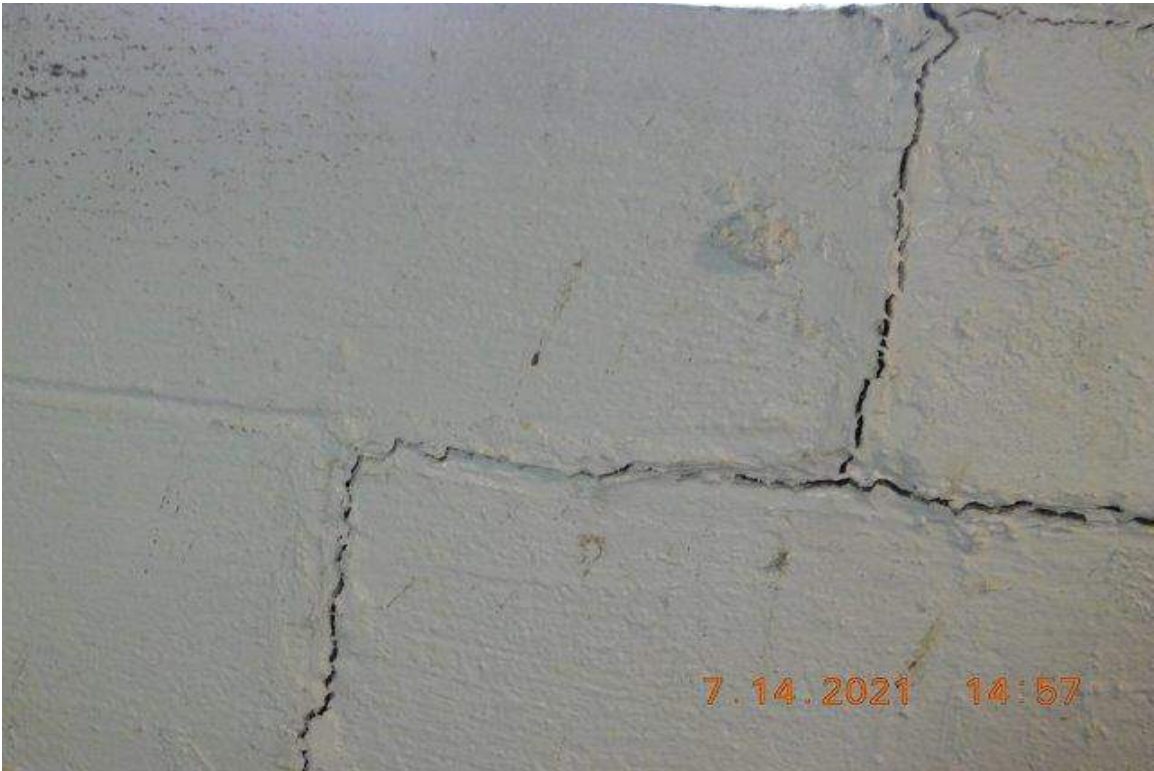
PHOTO 13 - CLOSE-UP OF AREA ON PHOTO 12

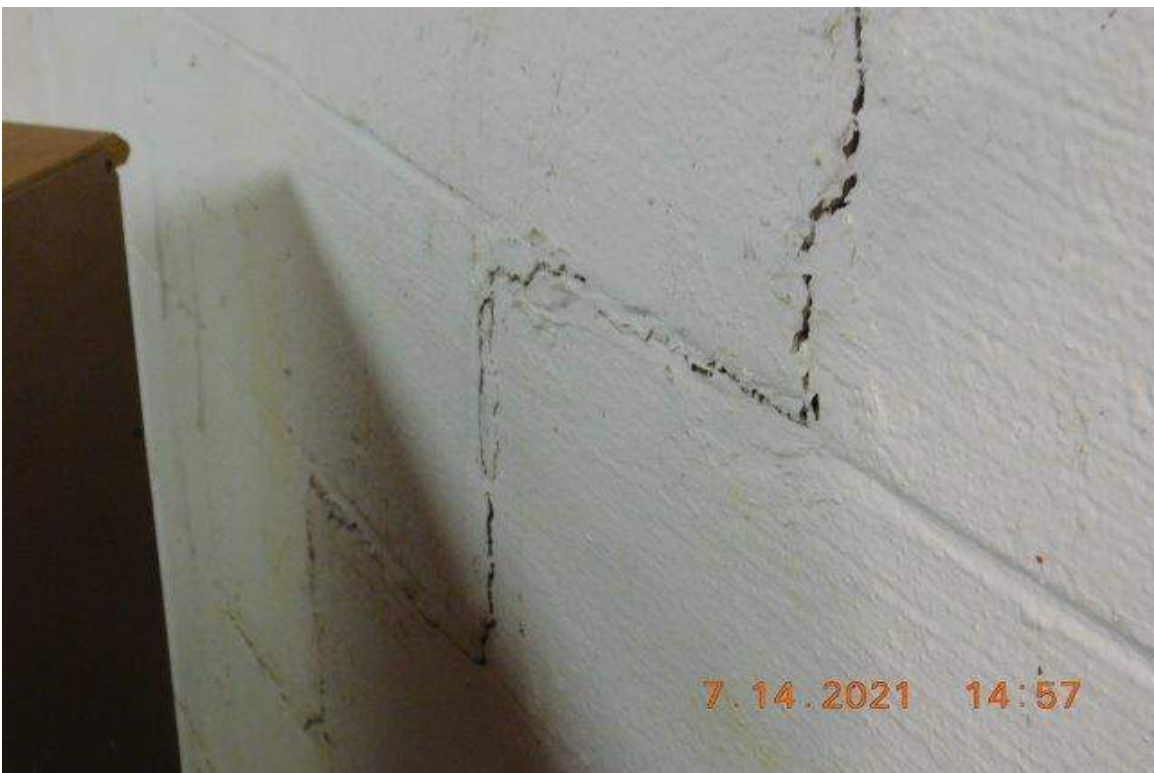
PHOTO 14 - AREA BELOW PHOTO 13

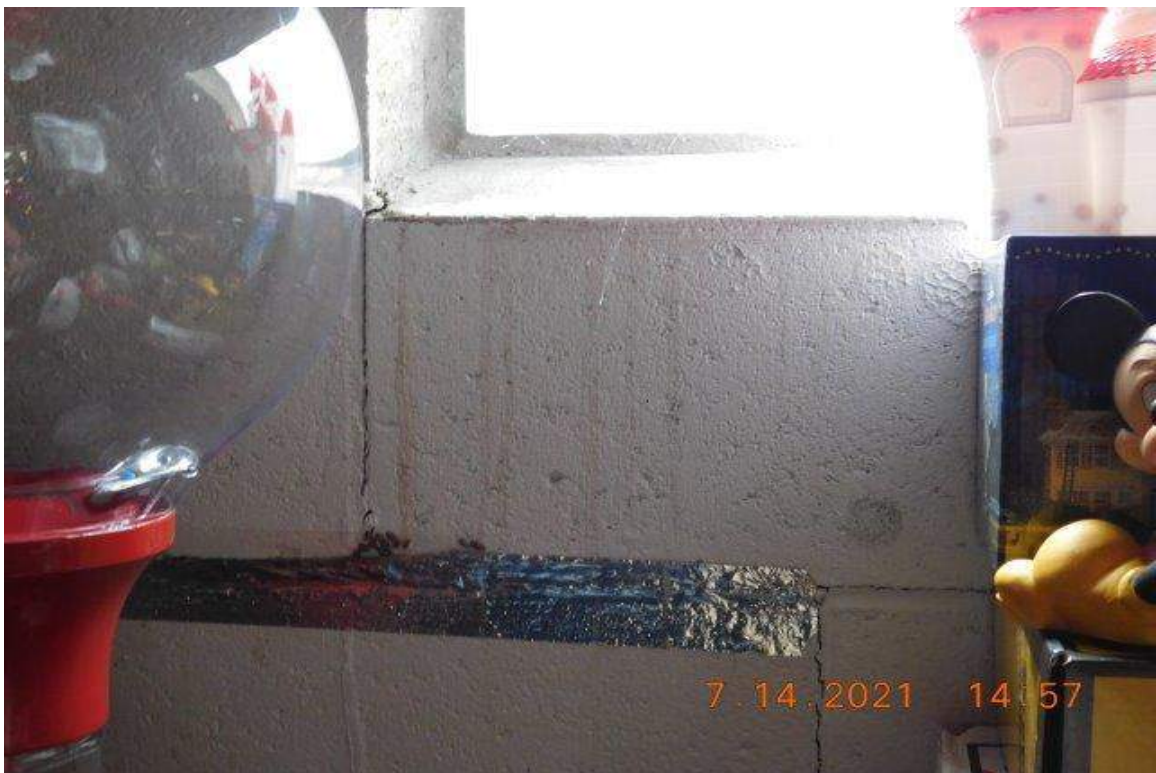
PHOTO 18 - BASEMENT RIGHT WALL FRONT WINDOW

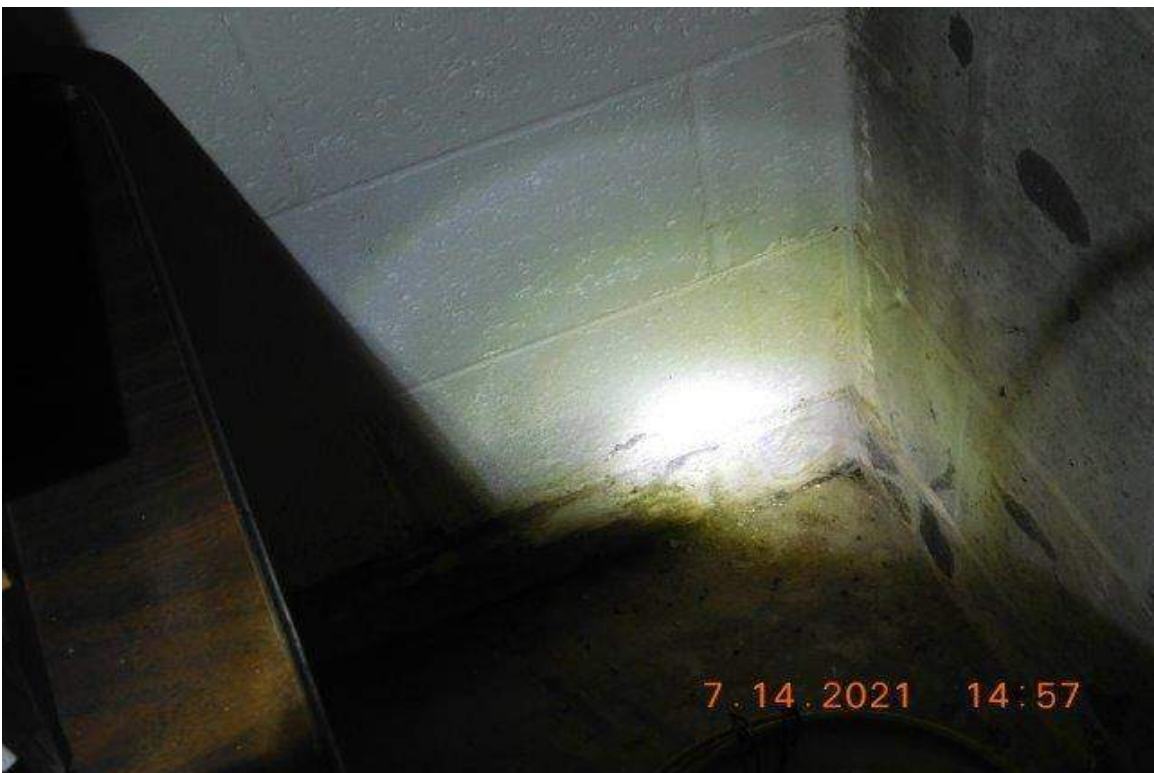
PHOTO 20 - BASEMENT RIGHT FRONT CORNER

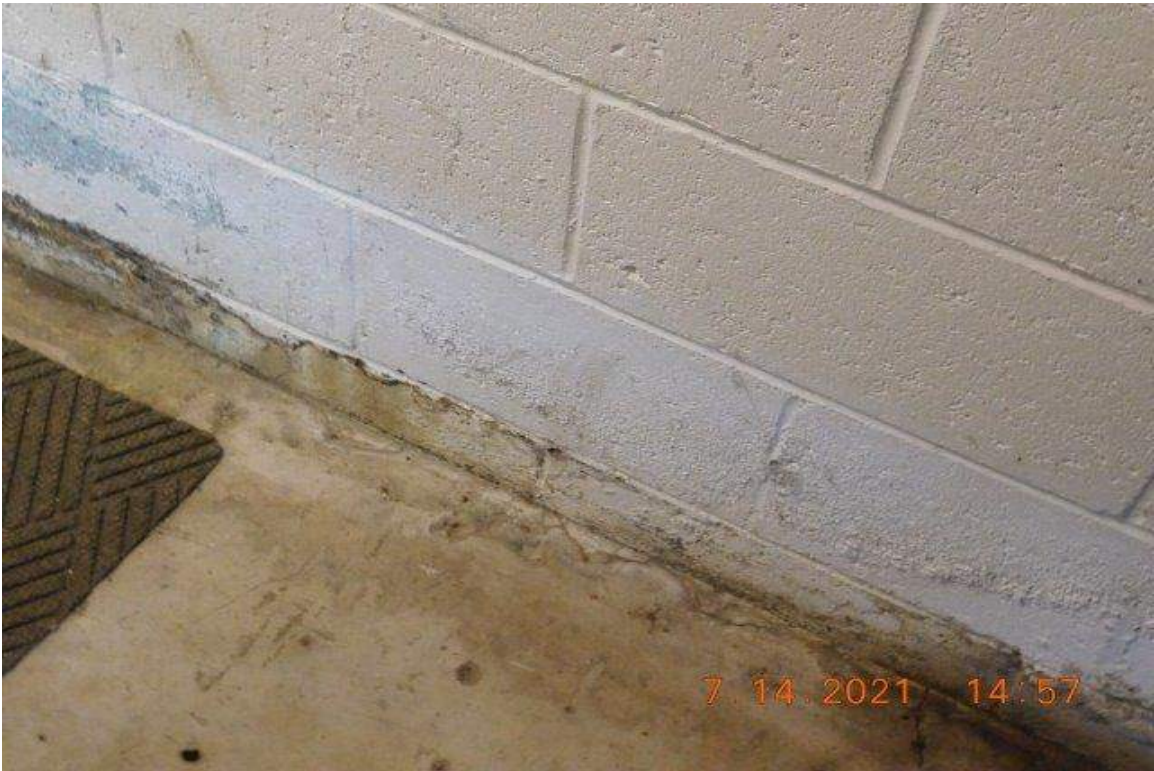
been displaced. Photos 21, 22, and 23 show similar staining and displaced paint at the base of the center and rear portions of the right wall. Photo 23 also shows the north limit of the trench drain installed along the right wall in 2018.

PHOTO 21 - CENTER OF BASEMENT RIGHT WALL AT FLOOR

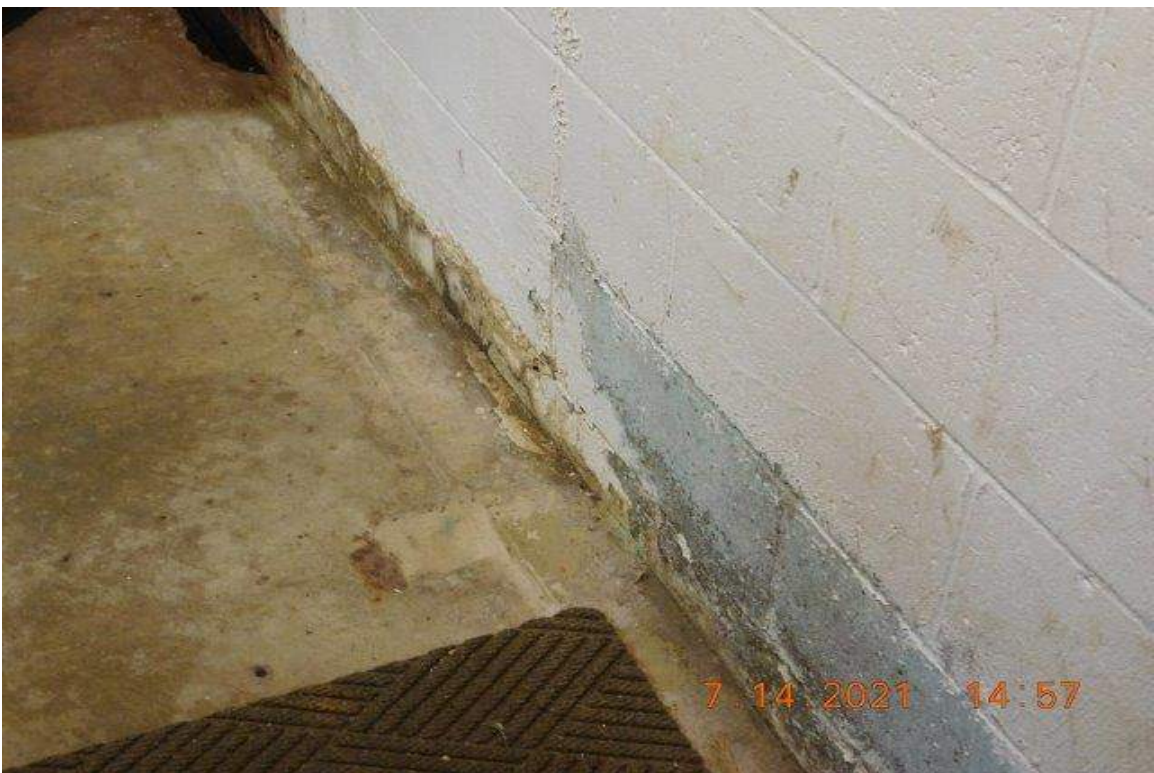
PHOTO 22 - AREA LEFT OF PHOTO 21

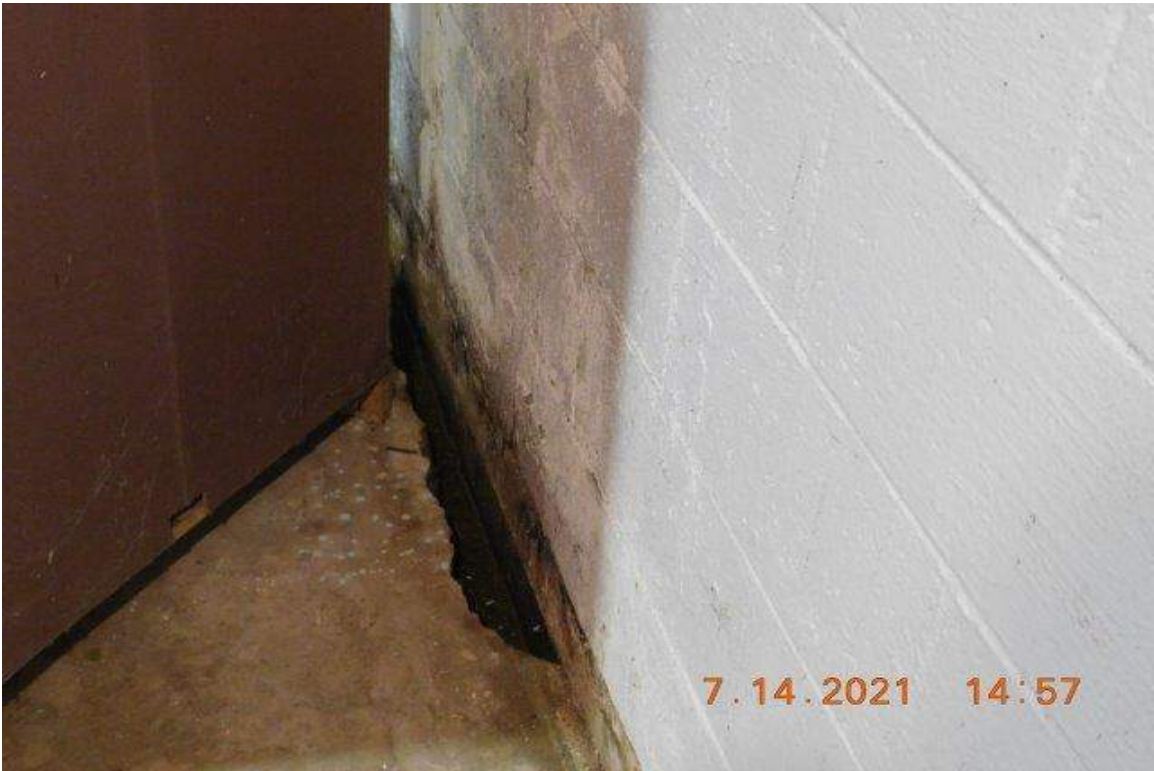
PHOTO 23 - AREA LEFT OF PHOTO 22

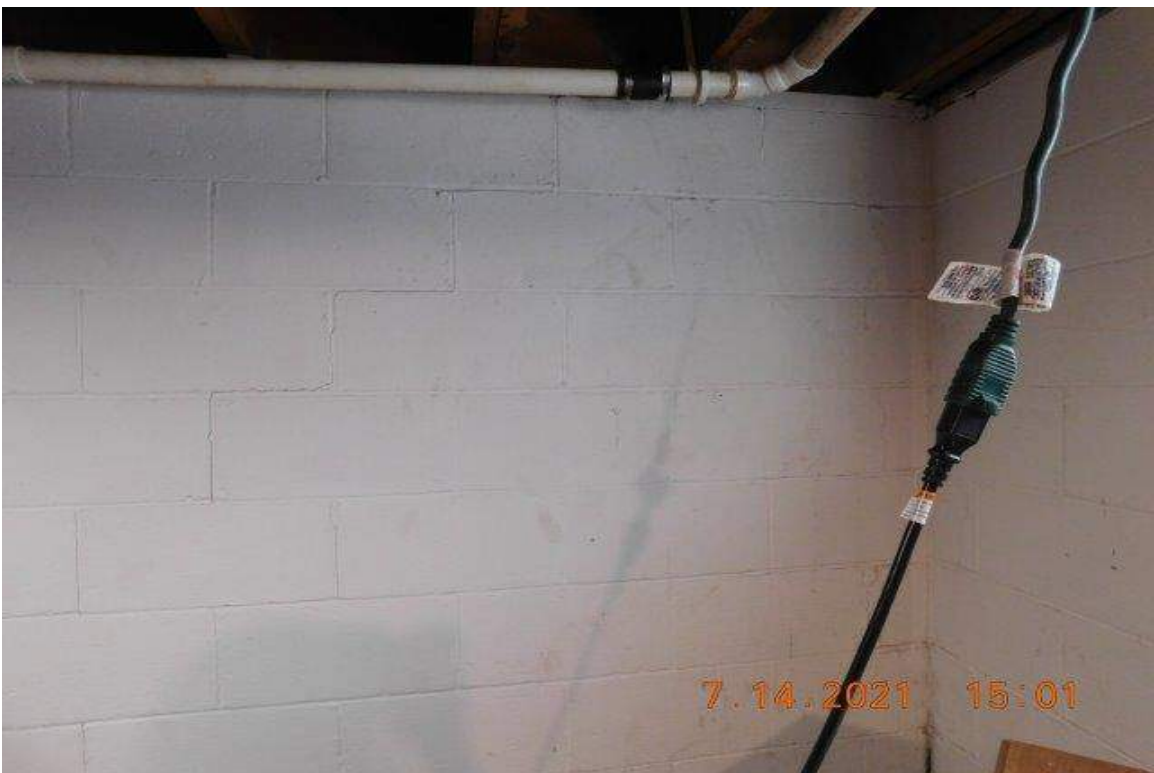
Photo 24 shows a step crack in the blockwork mortar joints in the right limit of the basement rear wall. Photo 25 shows significant staining and paint displacement, as well as the trench drain, in the right rear corner of the basement. Photo 26 is a close-up of the above-mentioned step crack. Photos 27 and 28 show the continued staining along the basement rear wall and a significant gap in the mortar joint in this area. Photo 29 shows the above-described blockwork mortar joint step crack continuing to the left. Photos 30 thru 35 show the left portion of the basement rear wall, continued staining and paint displacement, and water in the trench drain. Photos 34 and 35 show the sump pit for the drain in the left rear portion of the basement.

PHOTO 24 - RIGHT REAR CORNER OF BASEMENT

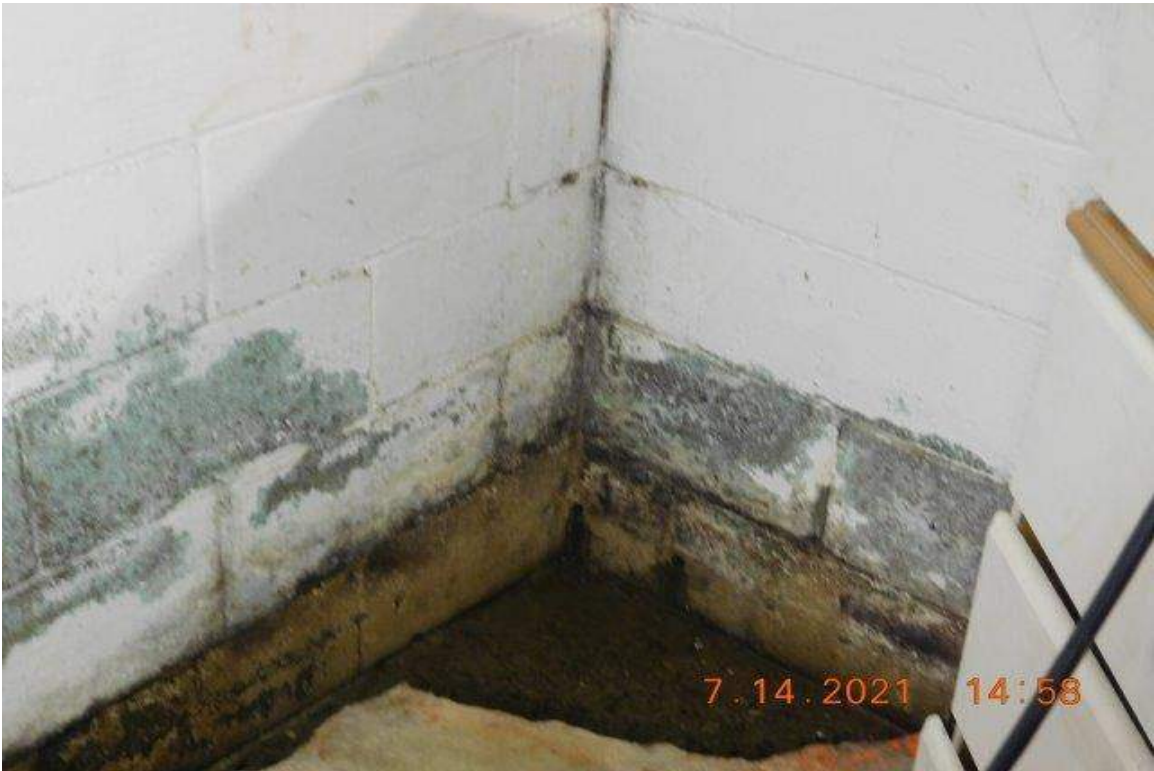
PHOTO 25 - AREA BELOW PHOTO 24

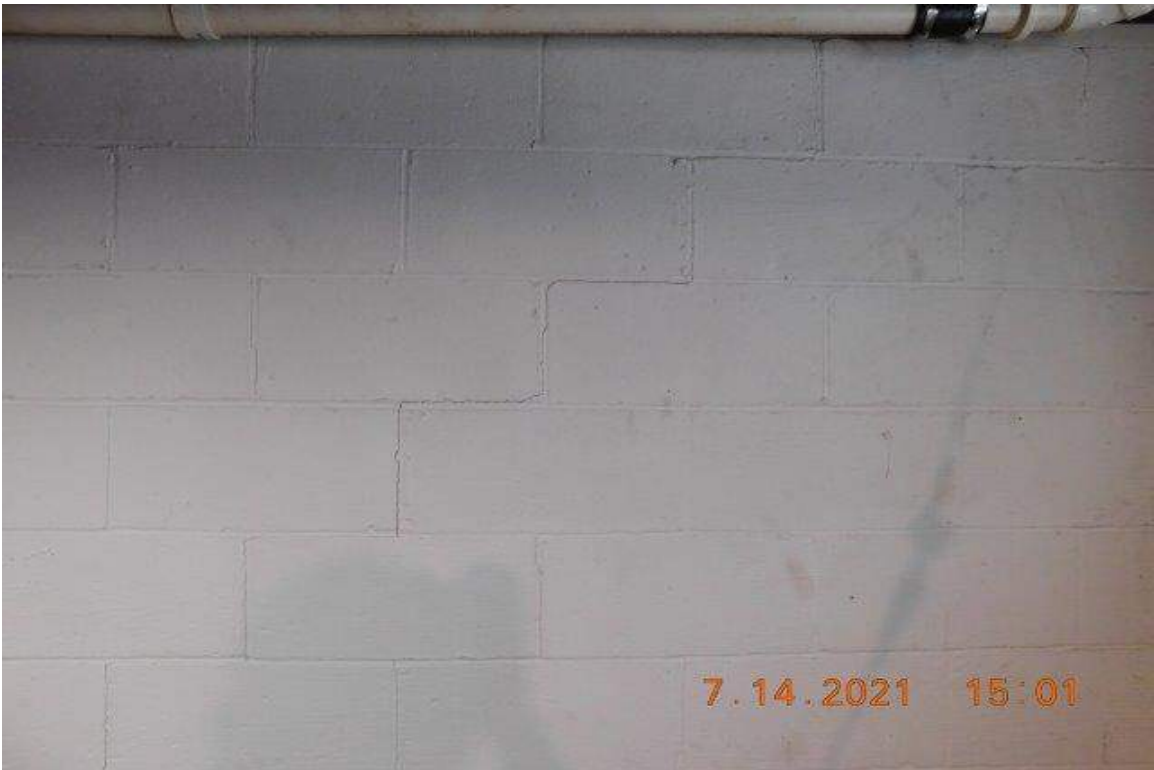
PHOTO 26 - AREA LEFT OF PHOTO 24

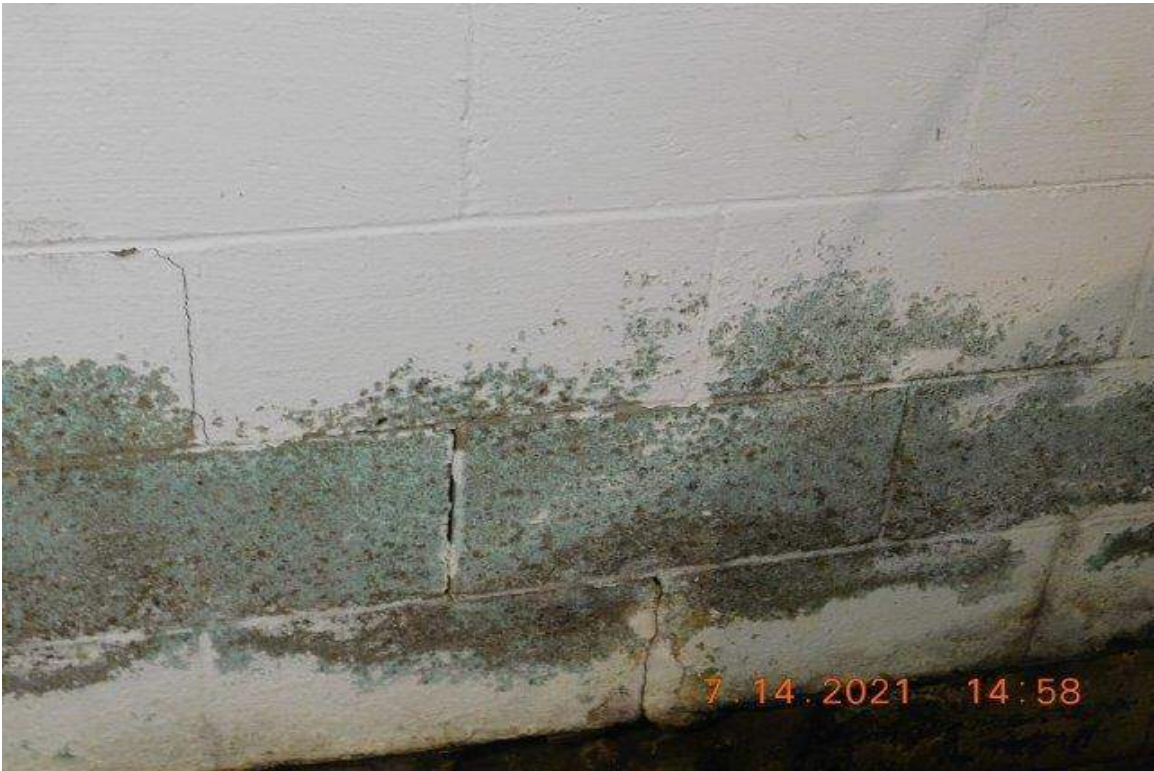
PHOTO 27 - AREA BELOW PHOTO 26

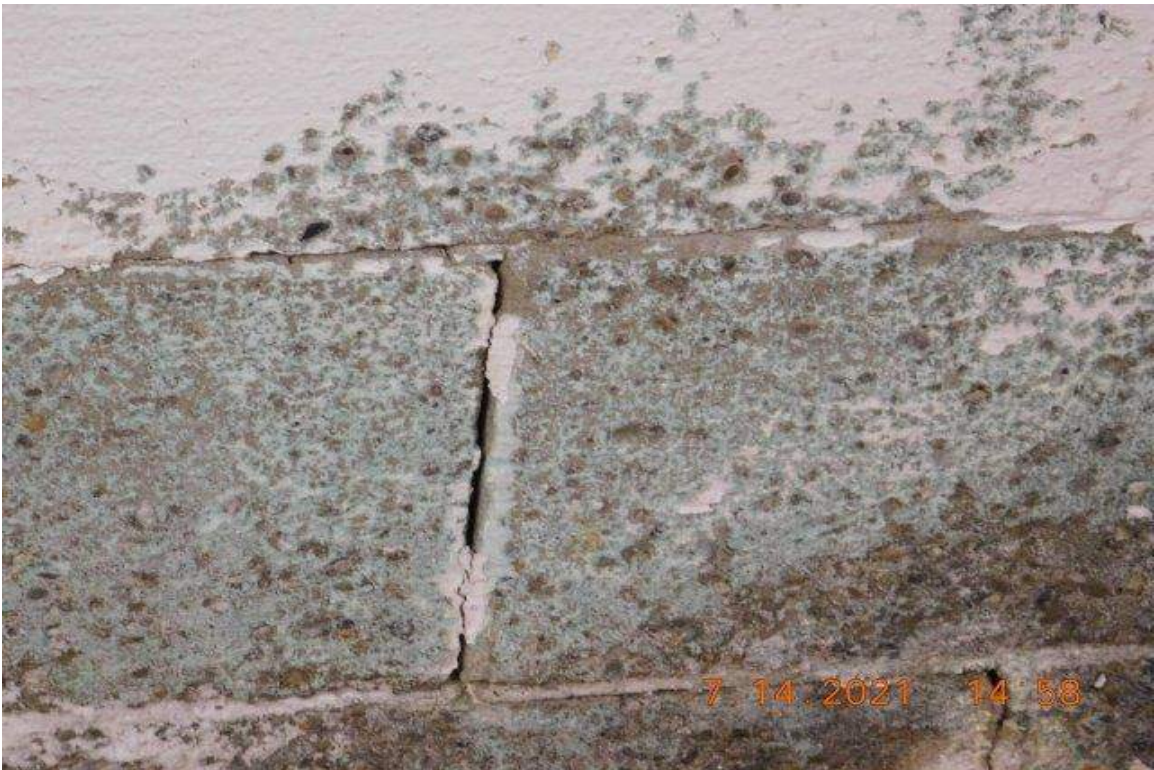
PHOTO 28 - CLOSE-UP OF AREA ON PHOTO 27

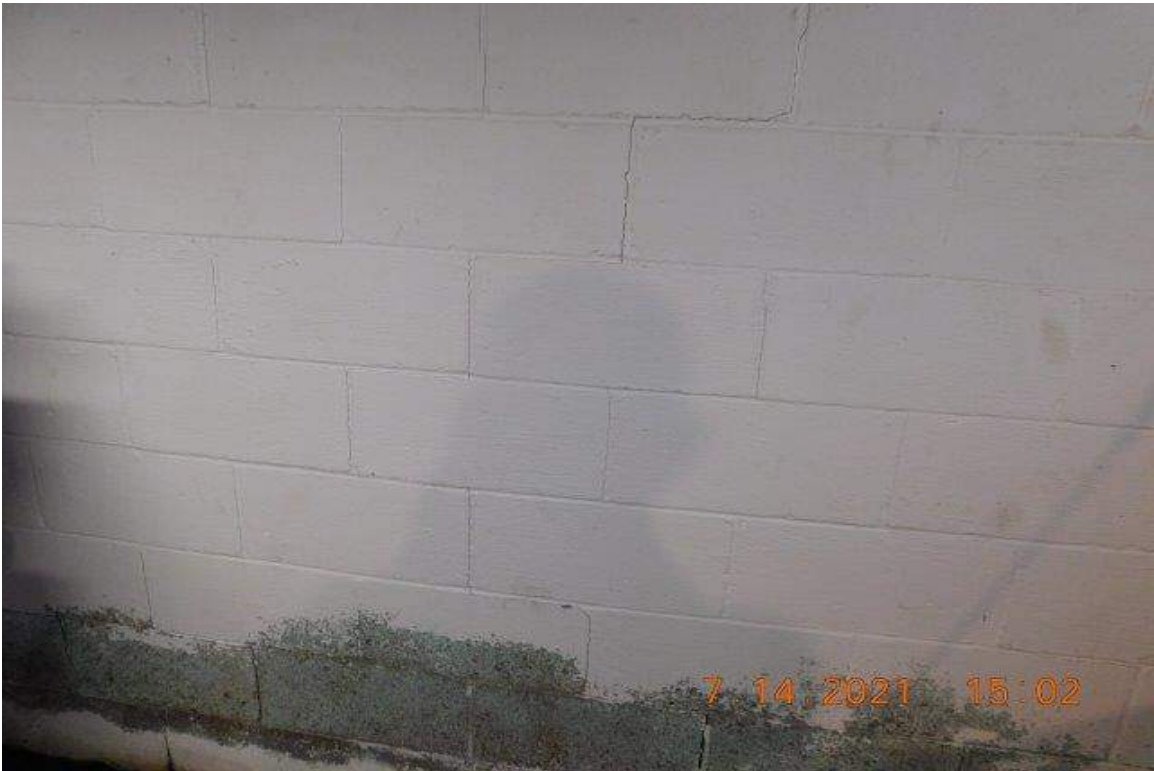
PHOTO 29 - AREA LEFT OF PHOTO 26

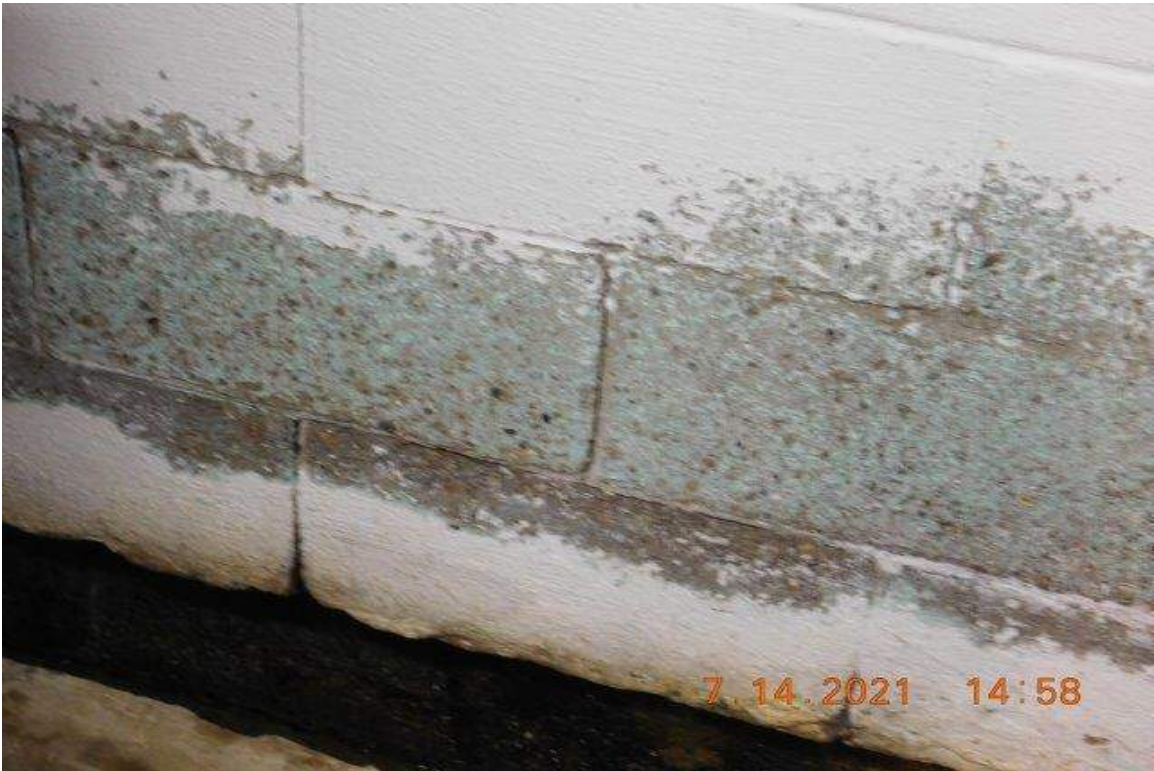
PHOTO 31 - CLOSE-UP OF AREA ON PHOTO 30

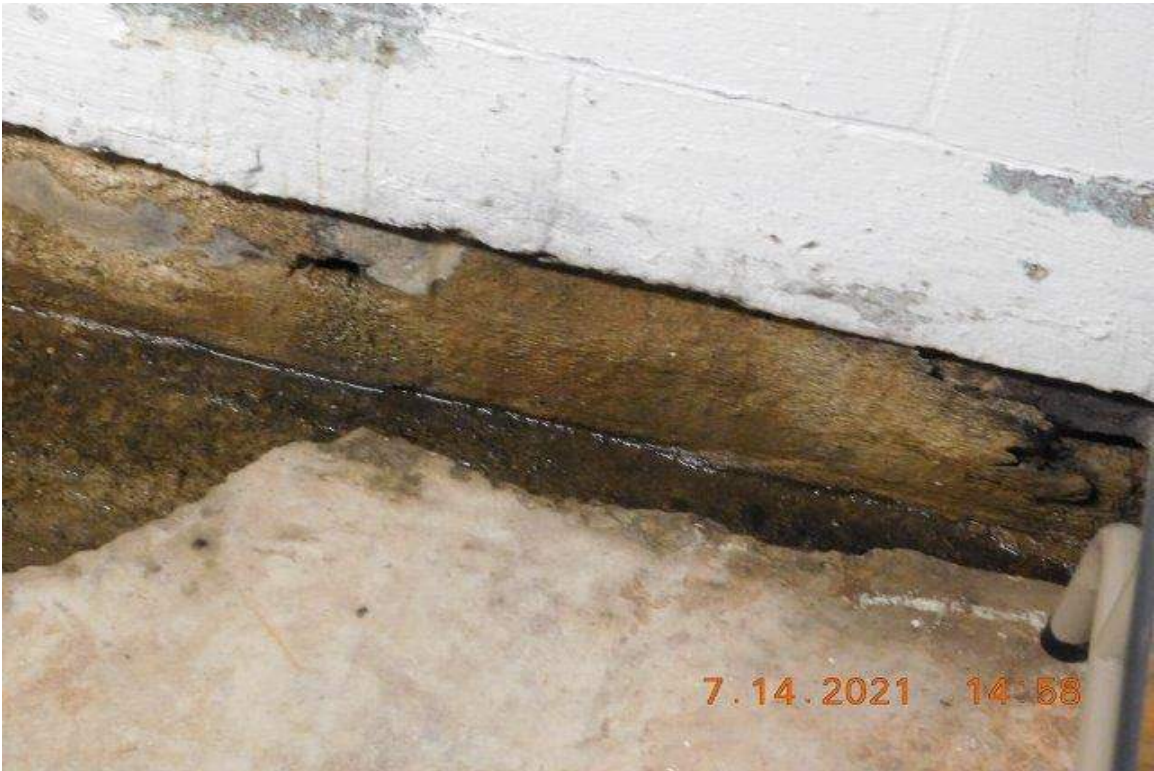
PHOTO 33 - AREA LEFT OF PHOTO 32

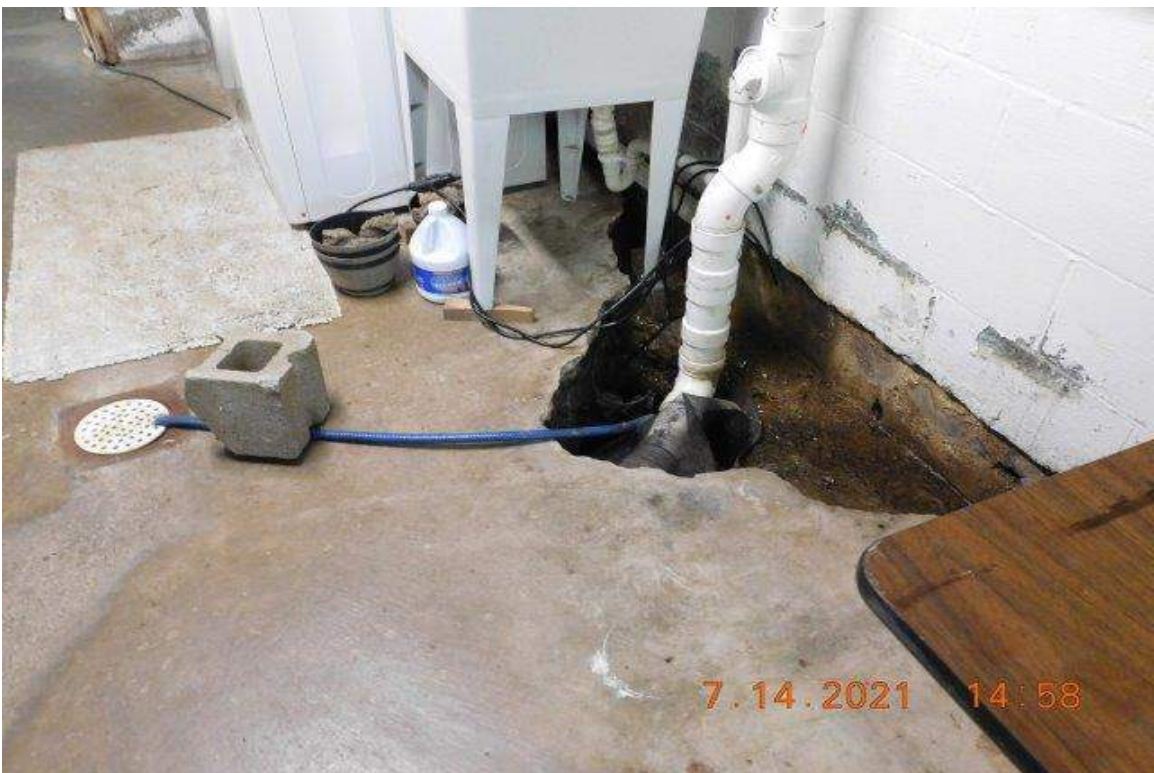
PHOTO 34 - LEFT REAR PORTION OF BASEMENT

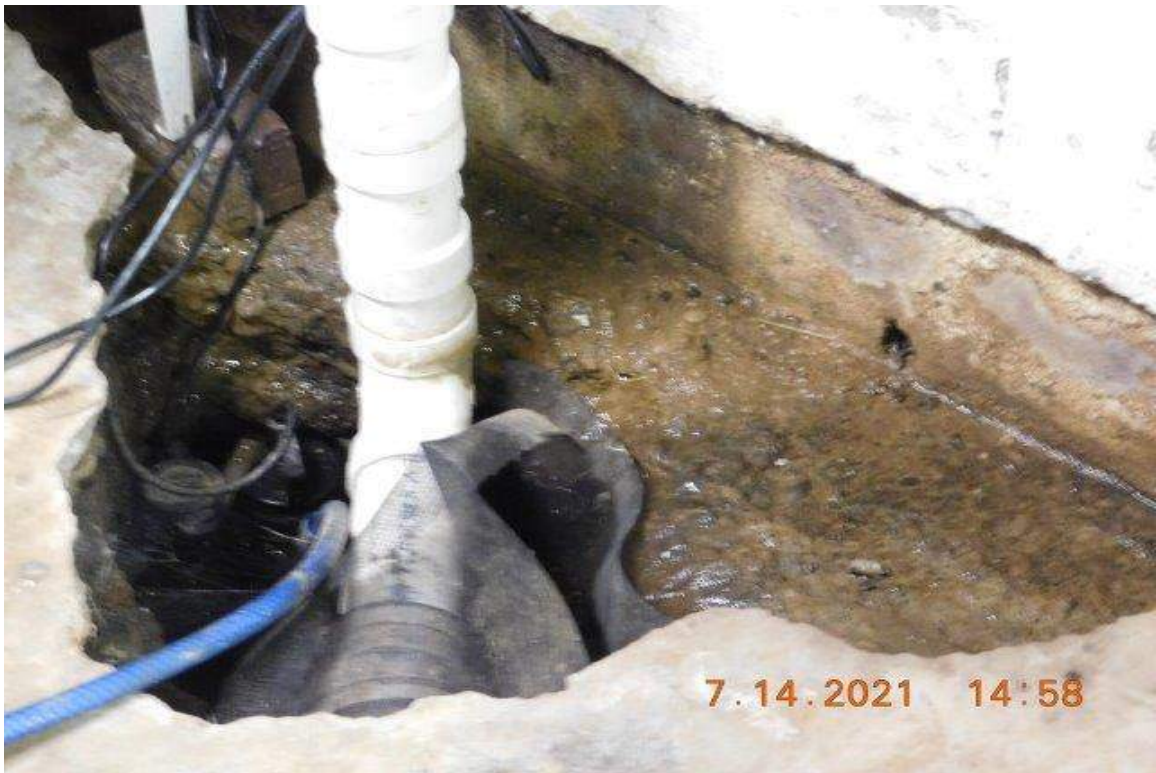
PHOTO 35 - CLOSE-UP OF AREA ON PHOTO 34

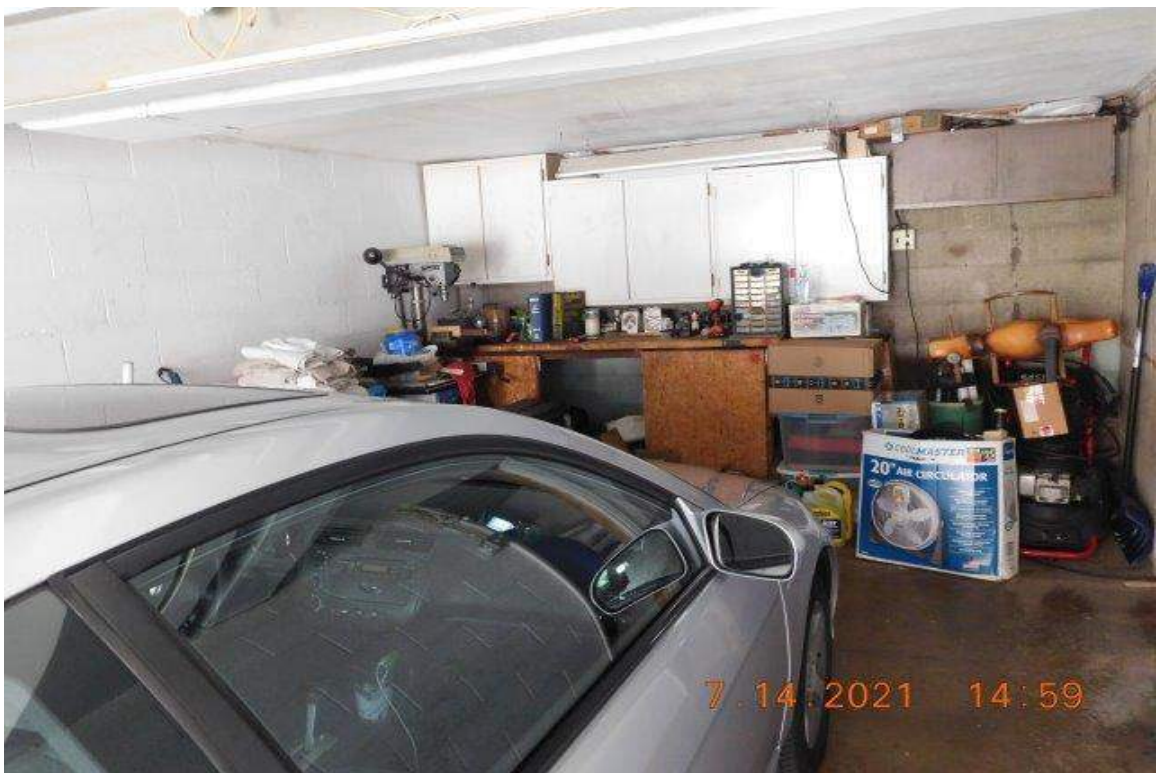
Photo 36 shows the garage rear wall, while Photo 37 shows significant water staining and displaced paint along that wall. Photos 38 and 39 show similar conditions along the garage left wall.

PHOTO 36 - GARAGE REAR WALL

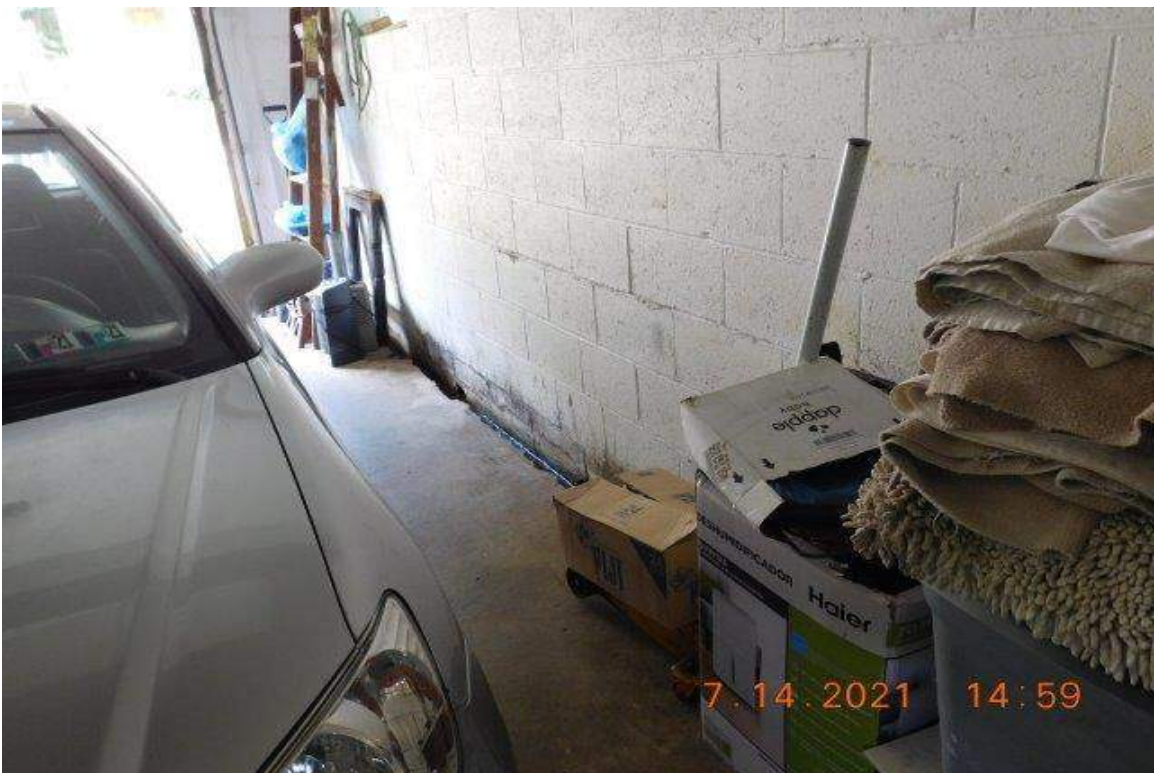
PHOTO 38 - GARAGE LEFT WALL

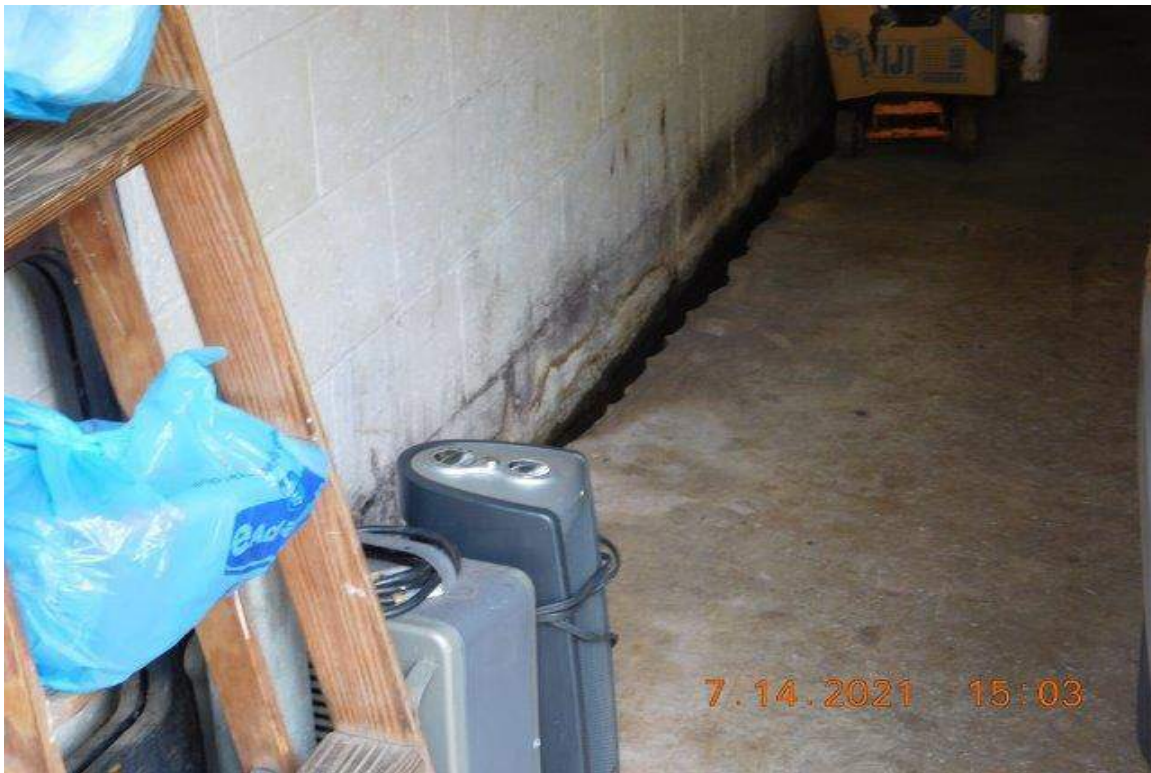
PHOTO 39 - CLOSE-UP OF GARAGE LEFT WALL

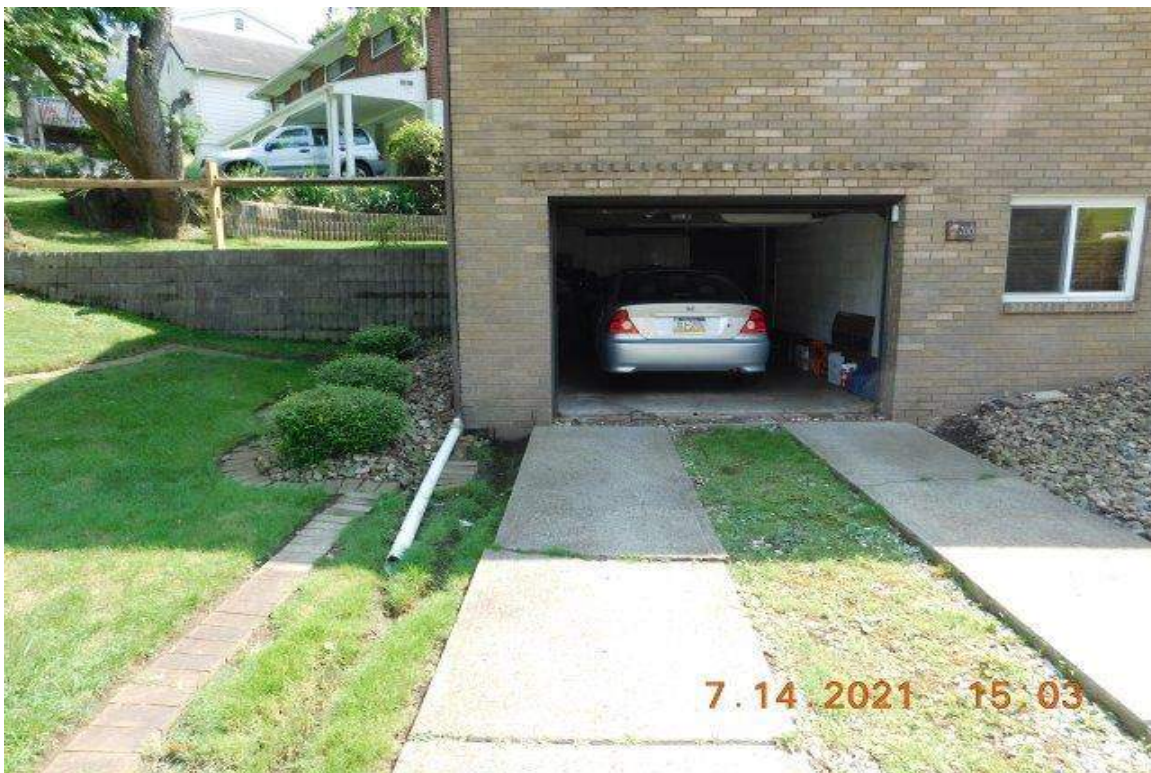
PHOTO 40 - DWELLING FRONT WALL GARAGE ENTRANCE
