RE: Ronald and Sheila Derian vs. Pennsylvania American Water Company
Docket # c-2023-3041252

Included please find Exhibits 1 thru 7 to be entered concerning the above case # c-2023-3041252.

G:\Projects\41000\41370 Travelers - Derian Property\Docs\Report.docx

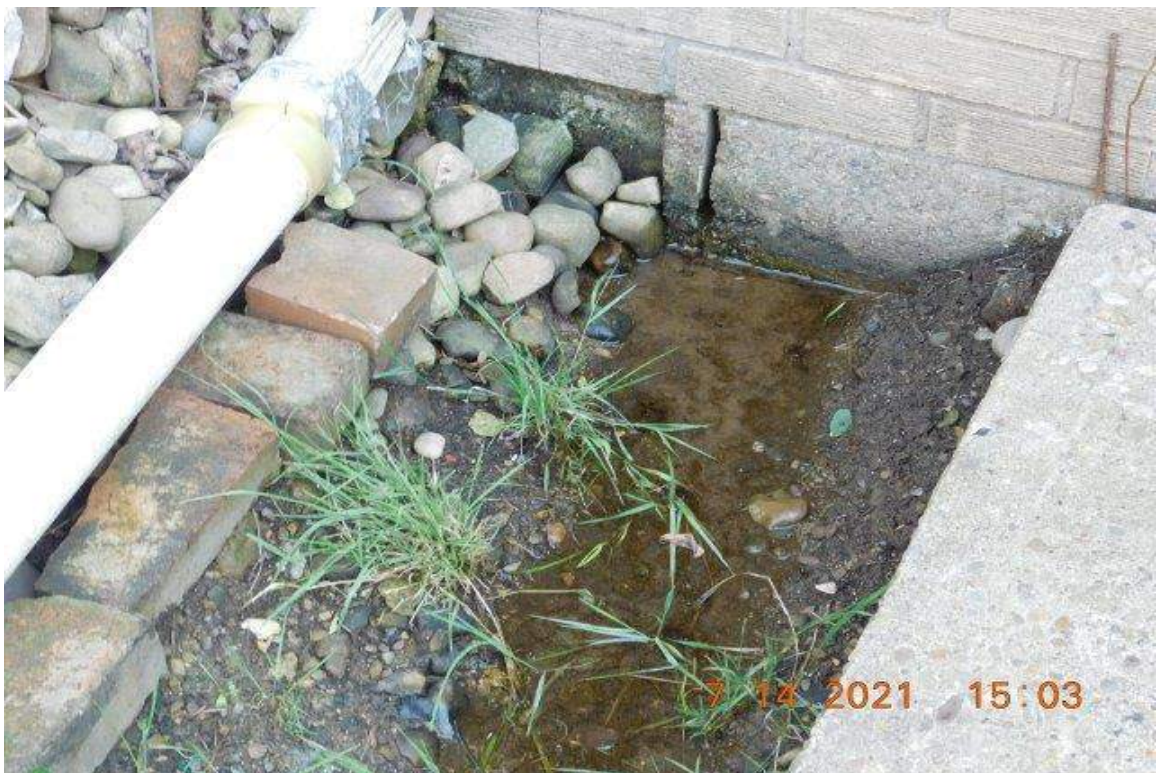
PHOTO 42 - CLOSE-UP OF AREA ON PHOTO 41

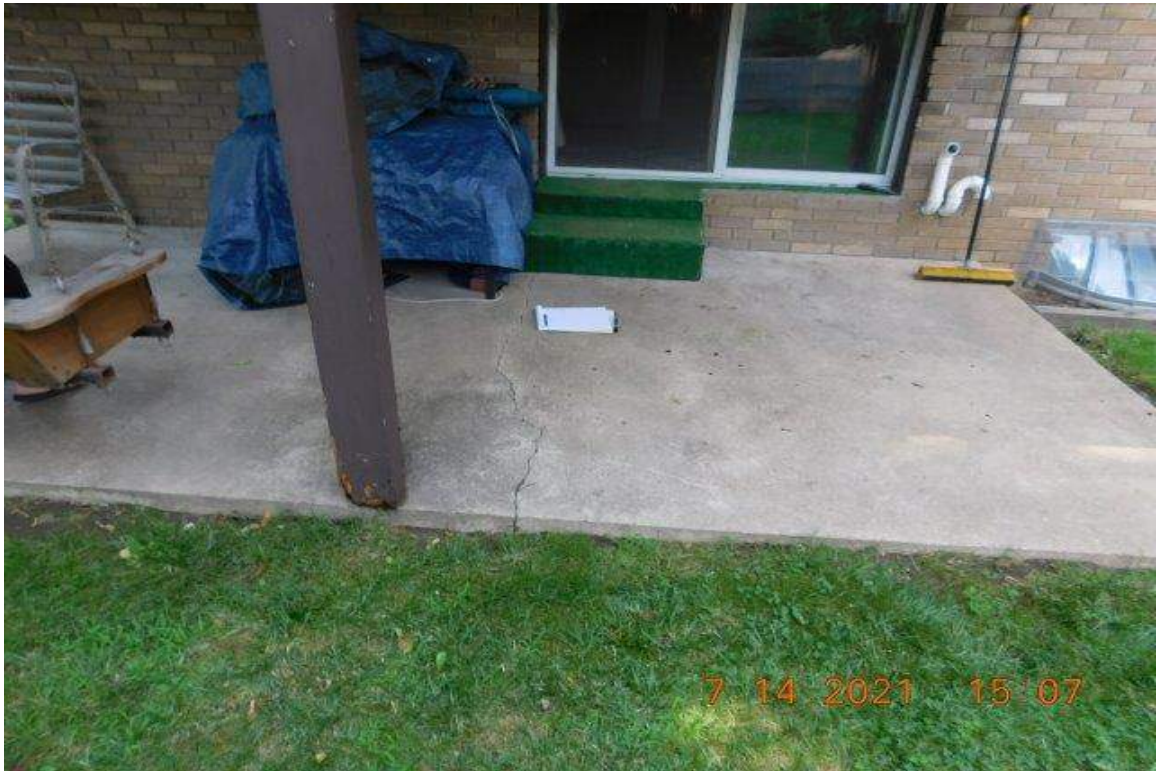
PHOTO 43 - DWELLING REAR WALL PATIO SLAB

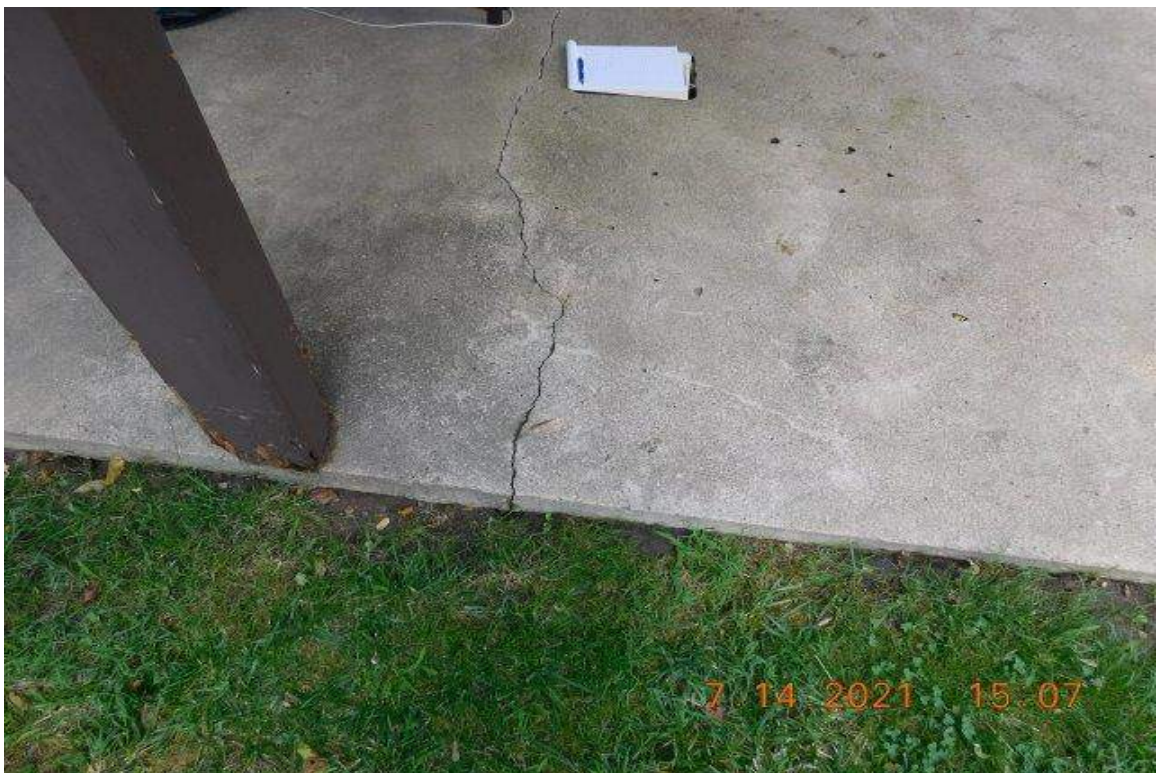
PHOTO 44 - CLOSE-UP OF AREA ON PHOTO 43

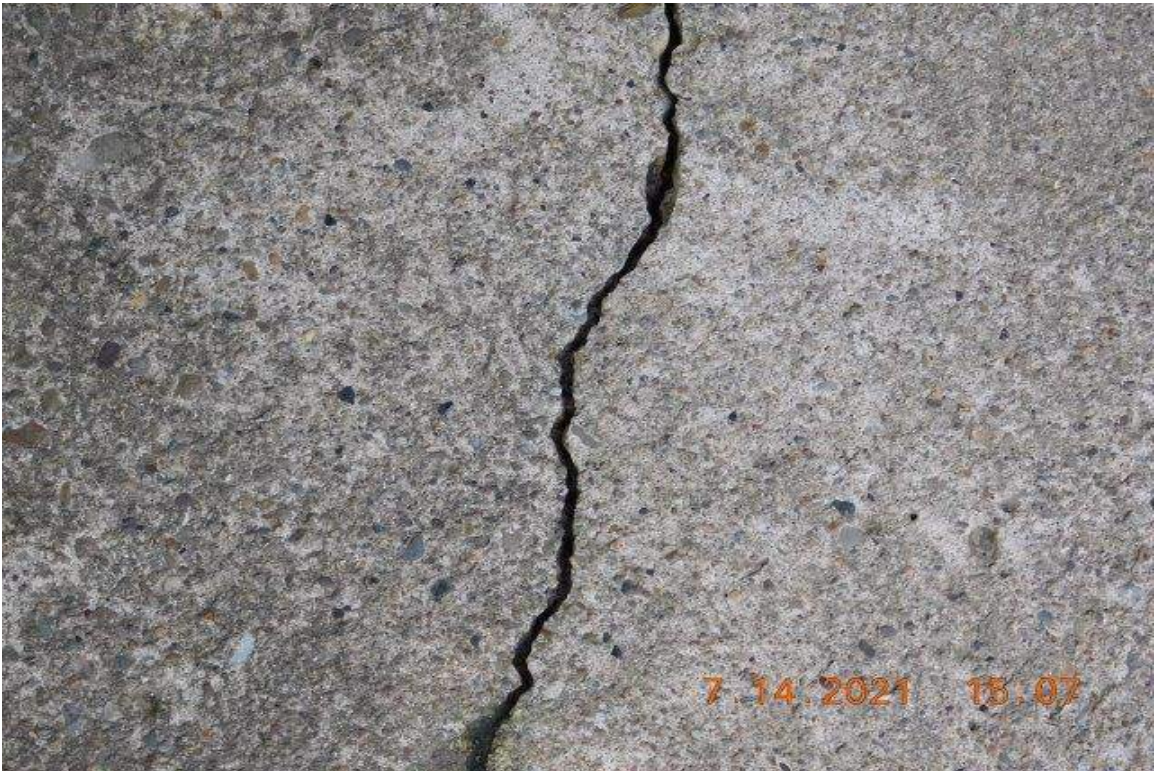
PHOTO 45 - CLOSE-UP OF AREA ON PHOTO 44

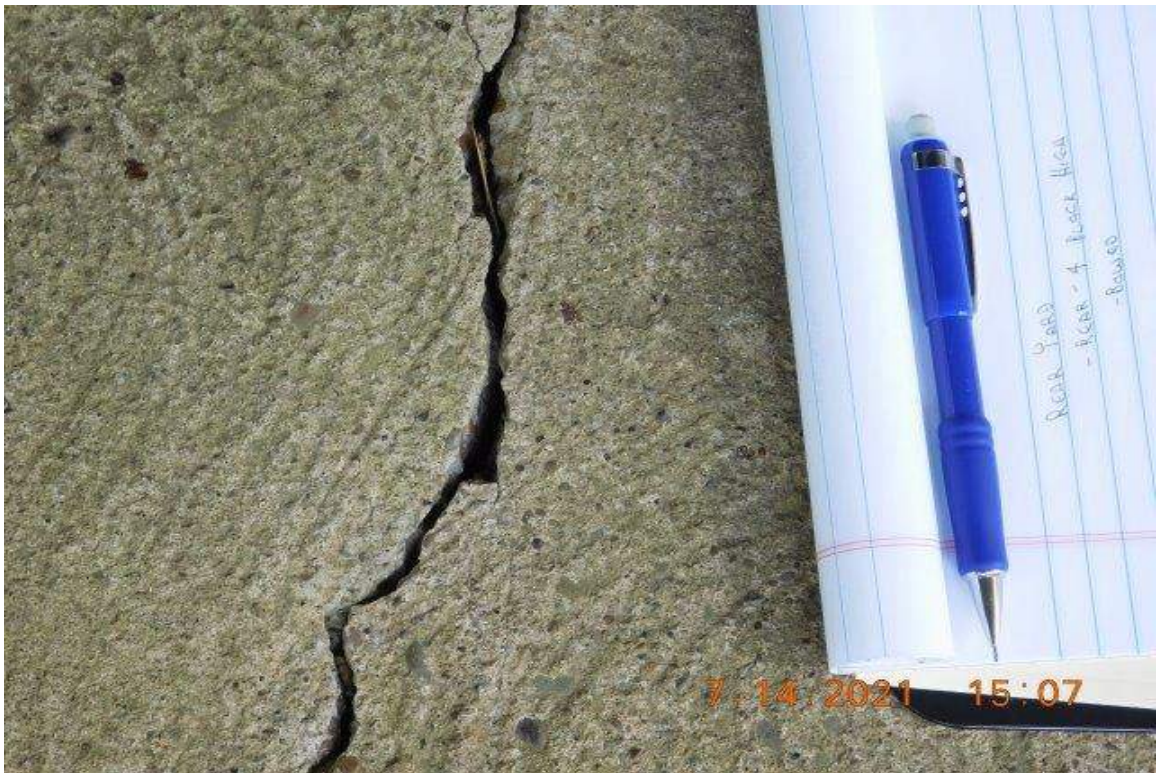
PHOTO 47 - CLOSE-UP OF AREA ON PHOTO 46

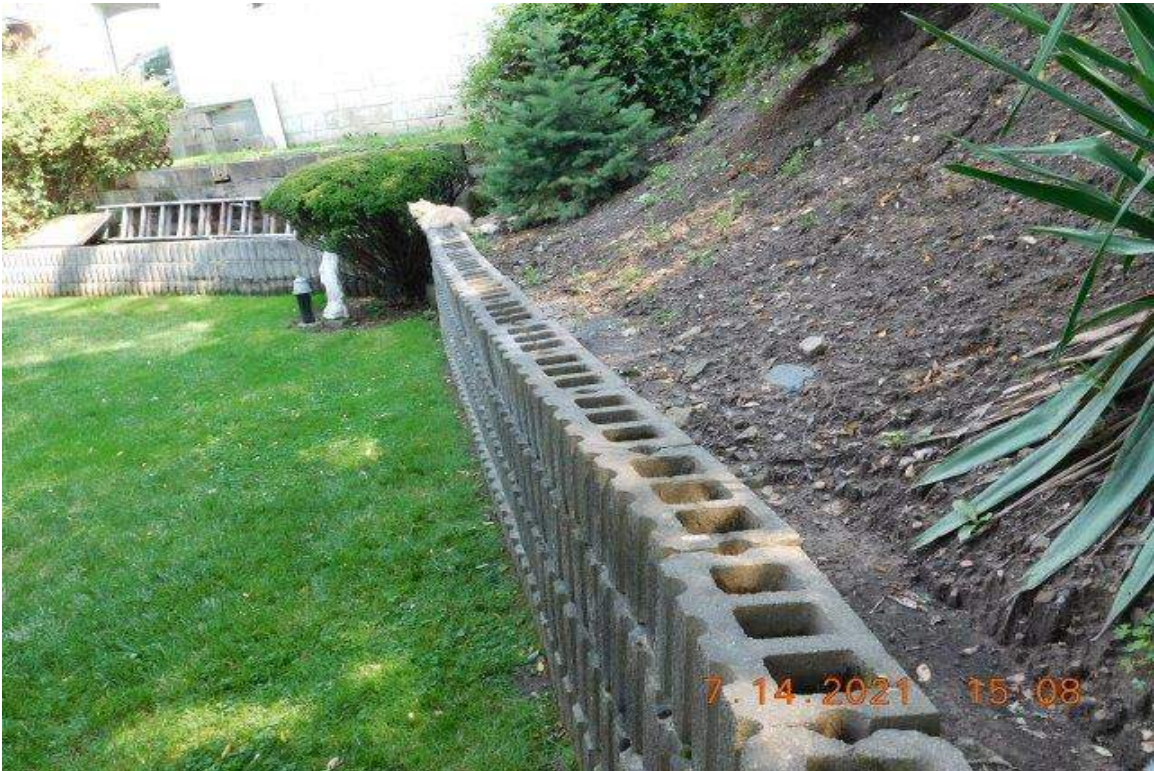
Photo 50 shows the four-course-high dry-stack (non-mortared) retaining wall in the rear portion of the right yard. Photos 51, 52, and 53 show the four-course-high rear yard retaining wall, which evidences bowing in the eastern portion where the most significant erosion of the slope above and deposition of material behind the wall had occurred.

PHOTO 51 - REAR YARD RETAINING WALL LOOKING EAST

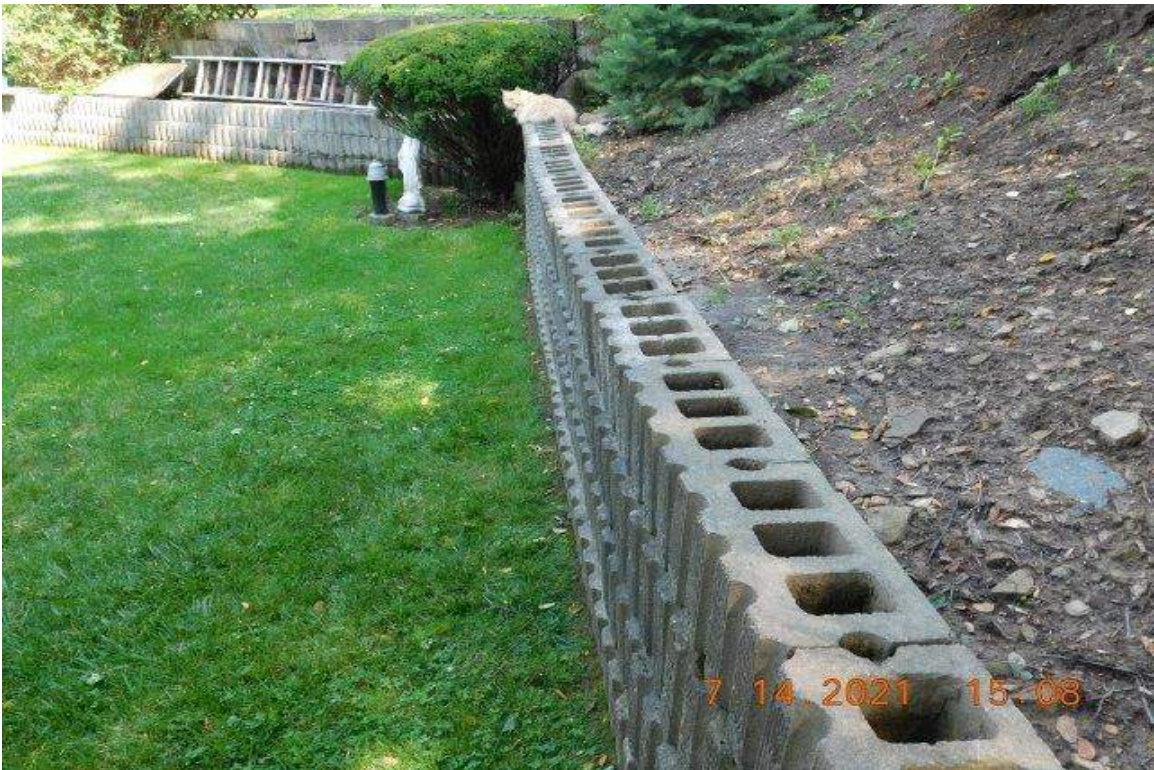
PHOTO 52 - CLOSE-UP OF AREA ON PHOTO 51

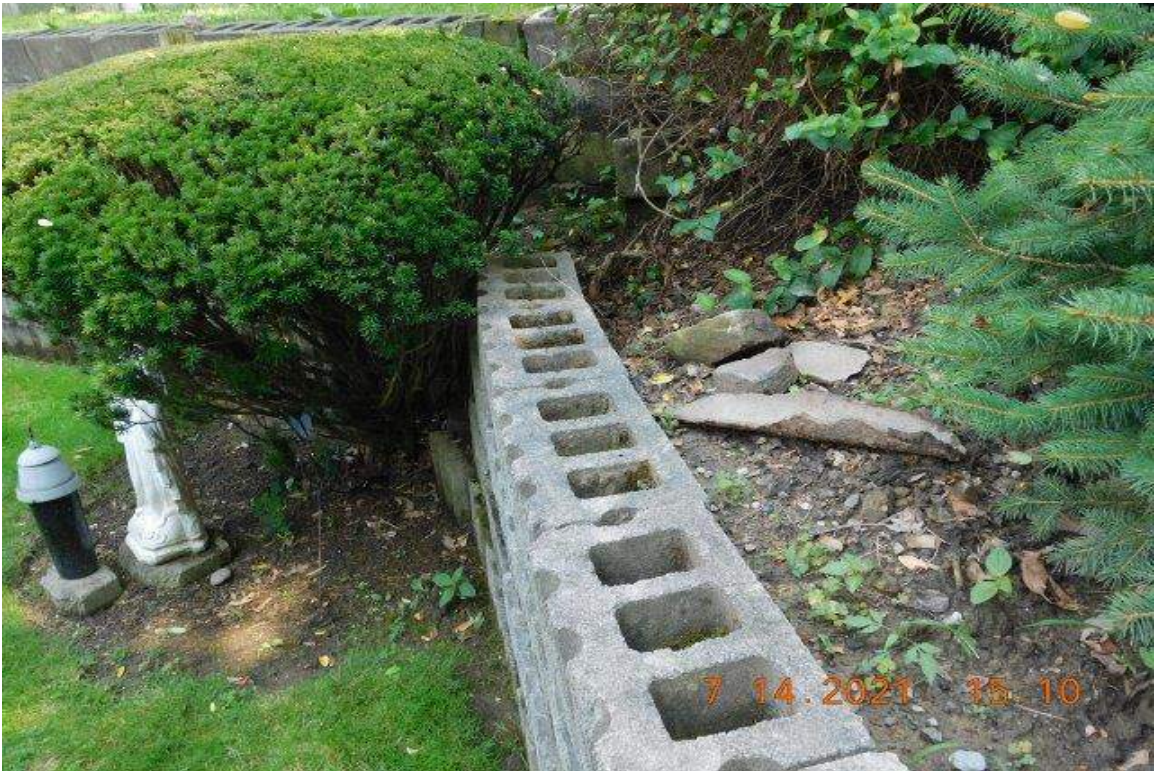
PHOTO 53 - CLOSE-UP OF AREA ON PHOTO 52

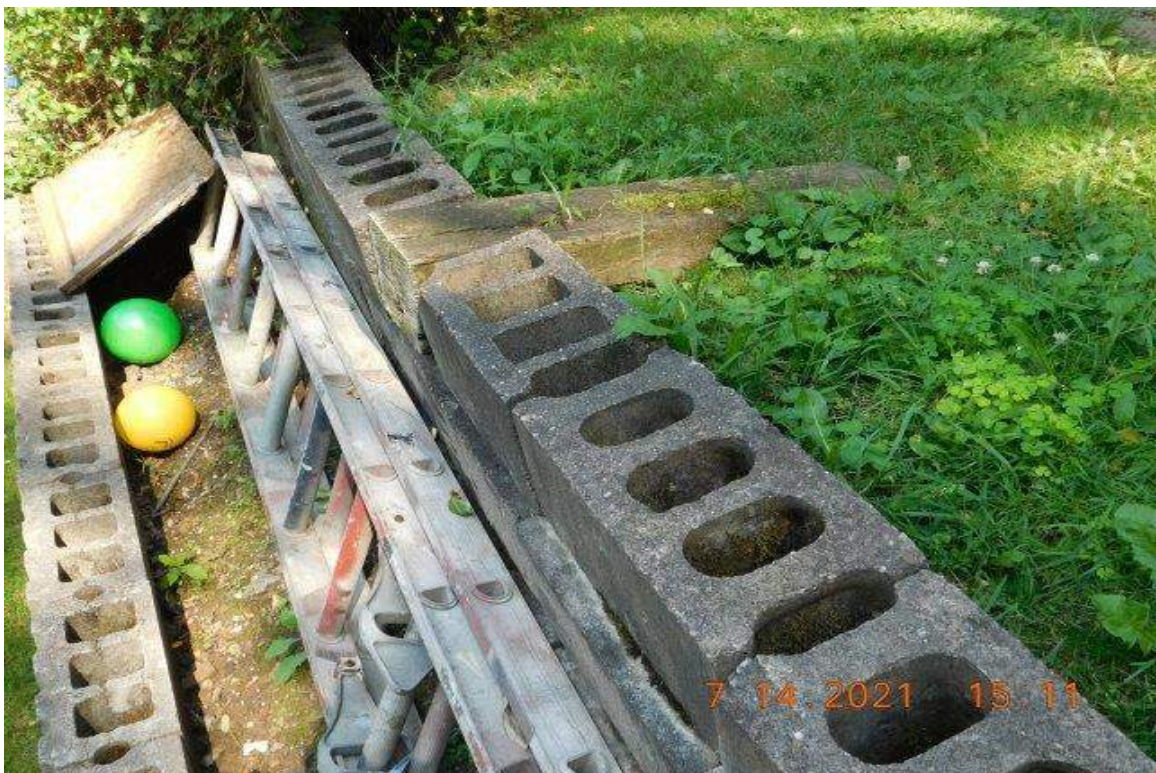
Photo 54 shows the left yard three-course-high retaining wall looking south. Photos 55 thru 58 show the two-tiered block retaining wall in the rear portion of the left yard. The upper wall includes occasional wooden perpendicular support members. Although both of these walls exhibit minor rotation, it does not appear that these walls experienced significant erosion or silt deposition behind them due to the runoff water. Therefore, this rotation pre-dated the water main break.

PHOTO 56 - UPPER LEFT YARD RETAINING WALL

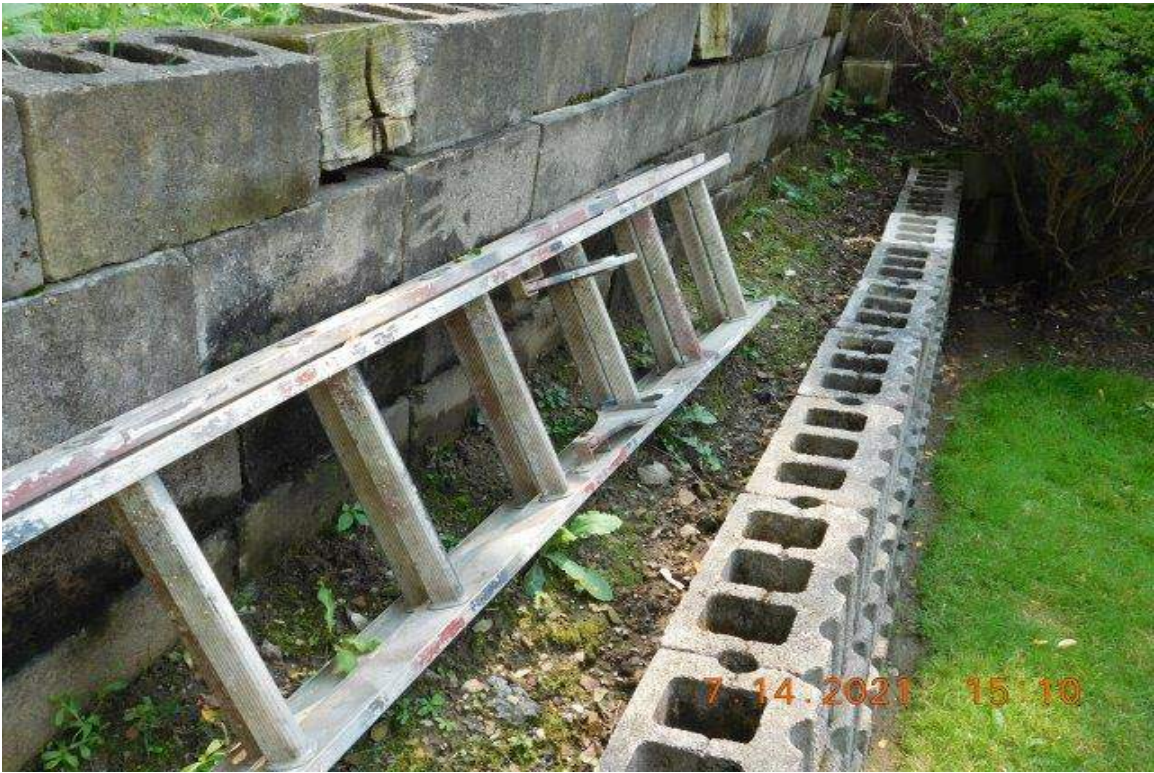
PHOTO 57 - REAR PORTION OF UPPER LEFT YARD RETAINING WALL LOOKING SOUTH

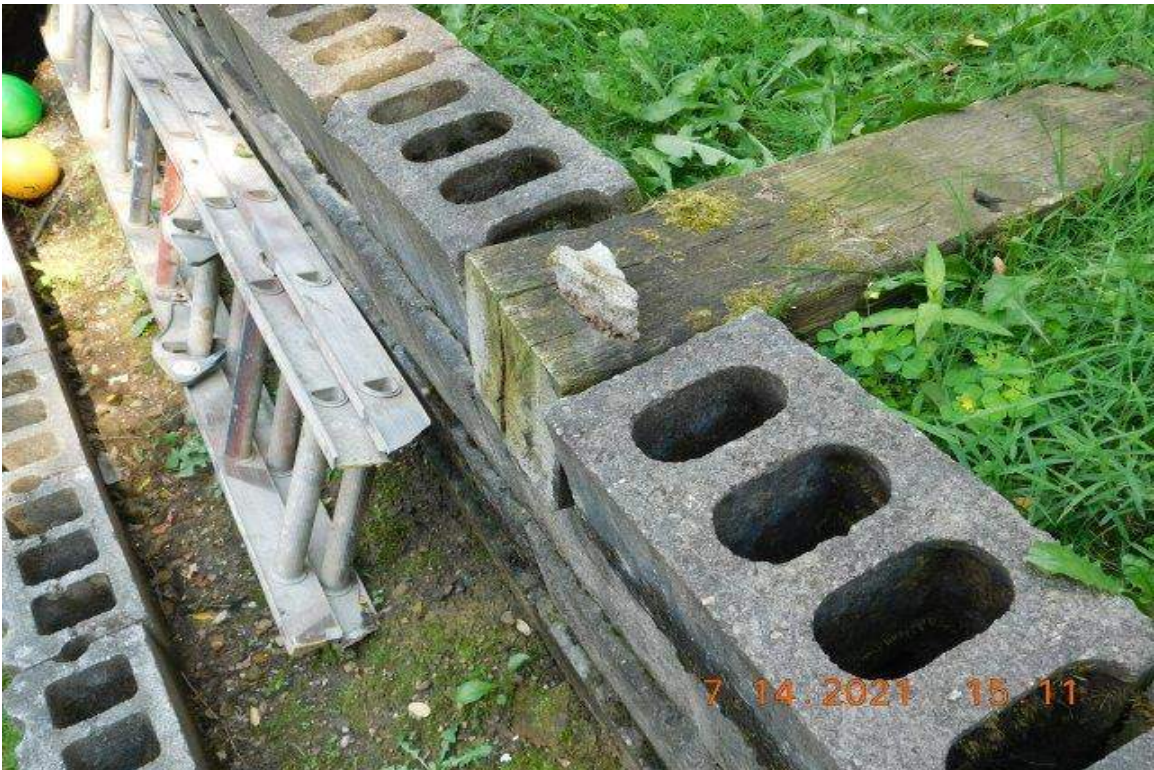
PHOTO 58 - CLOSE-UP OF AREA ON PHOTO 57

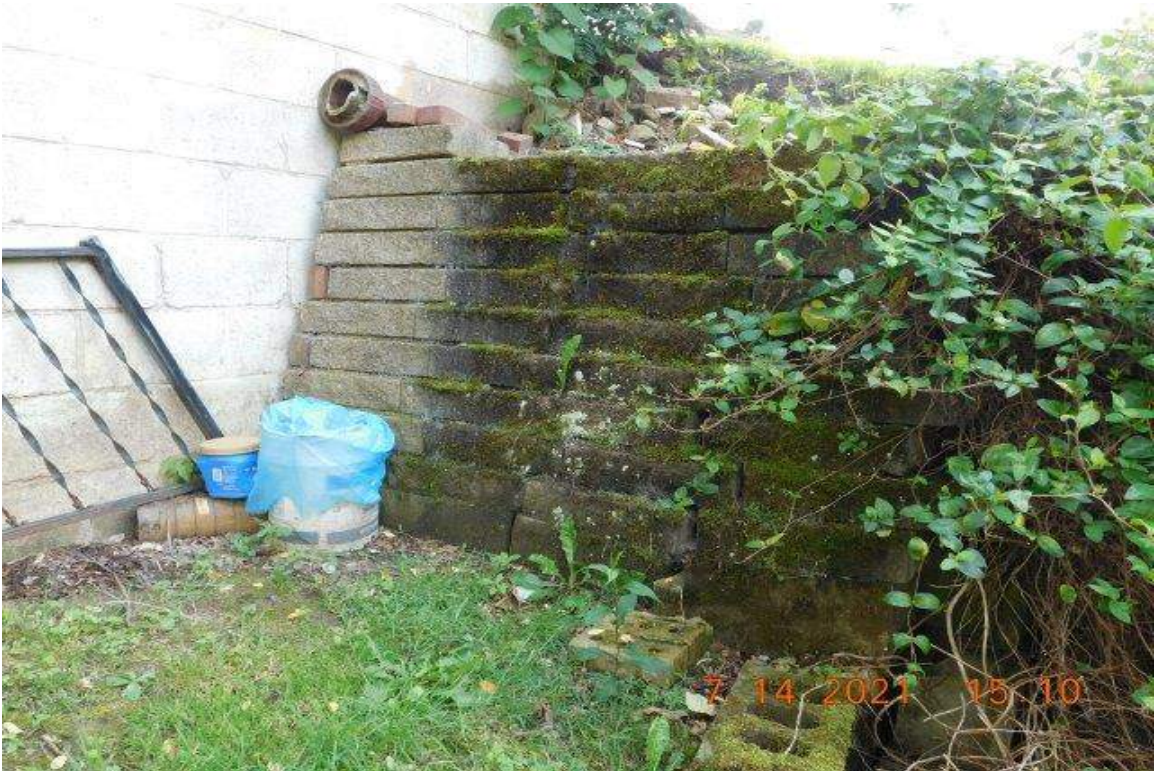
Photo 59 shows the retaining wall on the adjacent property to the east.

PHOTO 59 - REAR YARD RETAINING WALL ON PROPERTY TO THE EAST

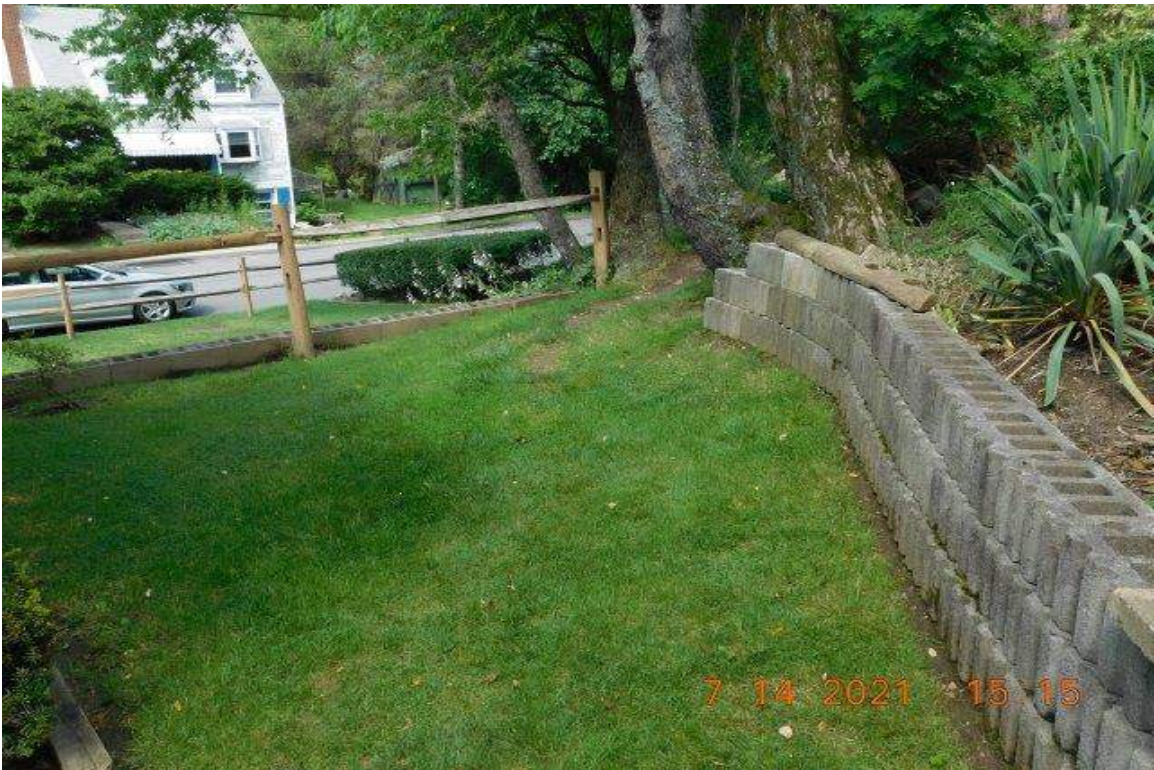
Photos 60 and 61 show the front portion of the lower left yard retaining wall and the dwelling left wall, respectively.

PHOTO 60 - FRONT PORTION OF LOWER LEFT YARD RETAINING WALL

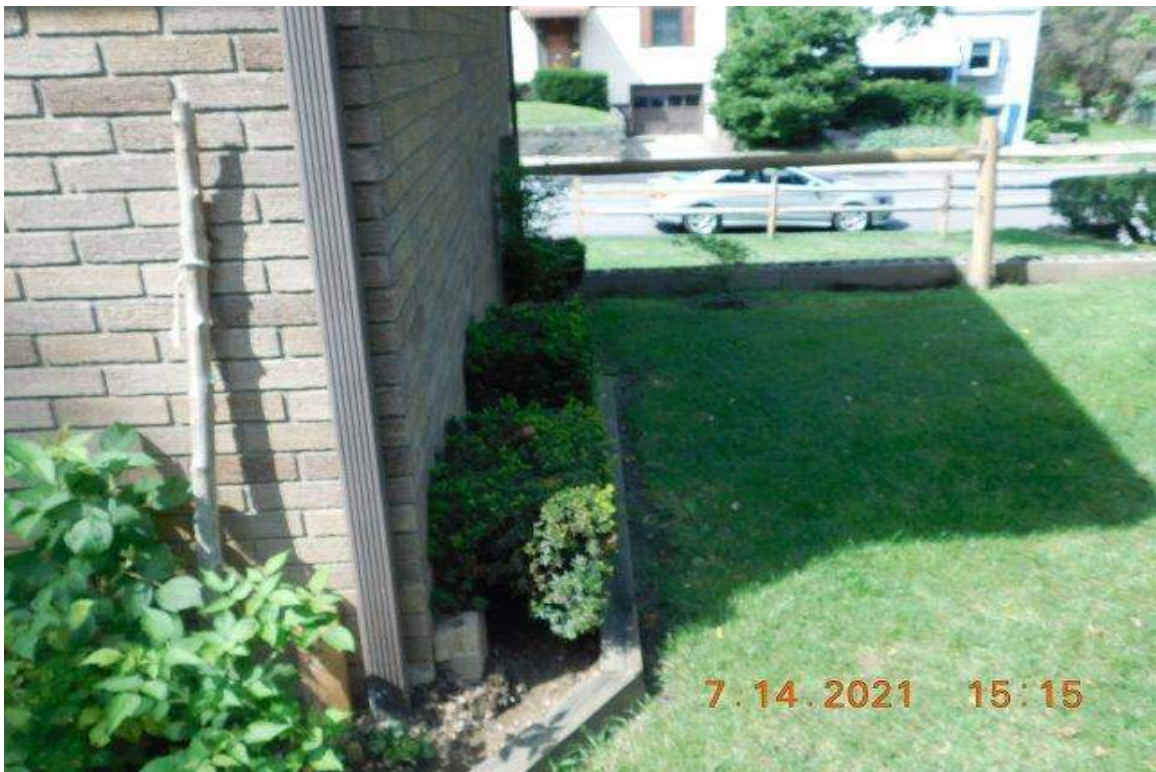
PHOTO 61 - AREA LEFT OF PHOTO 60

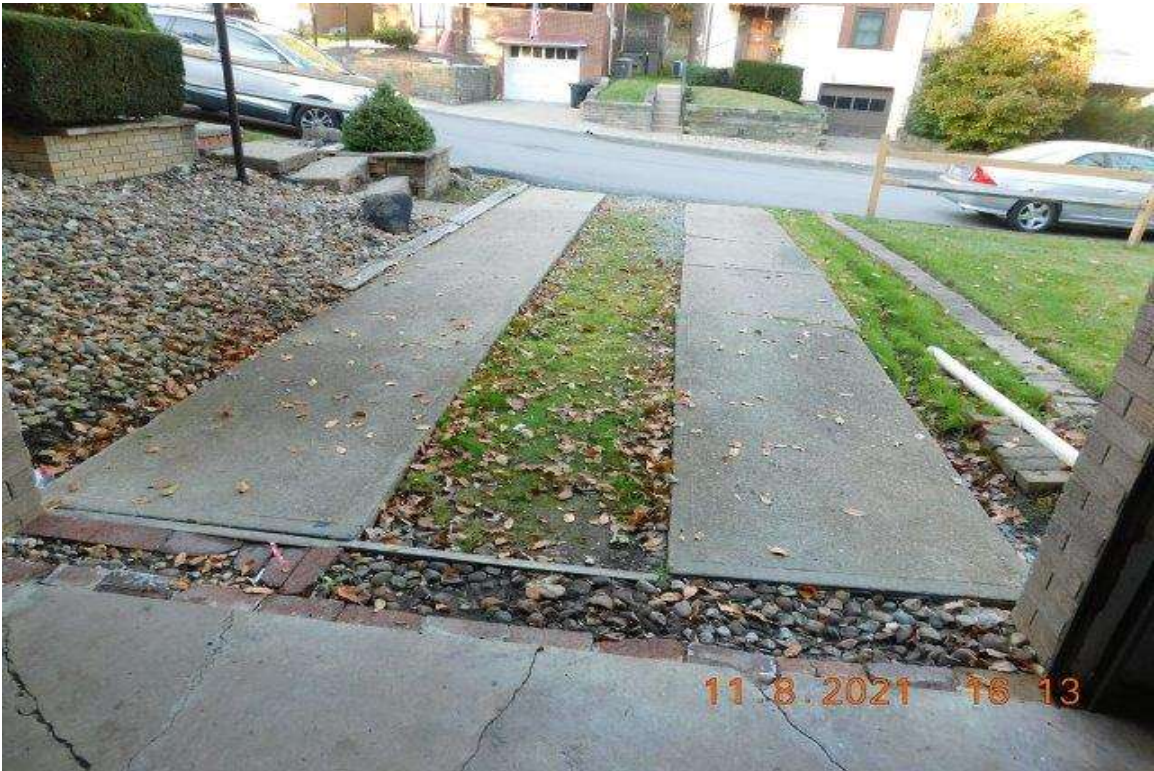
Photo 1 shows the Derian driveway looking north while Photo 2 shows a crack in the east side slab that Mrs. Derian claims is new (IGSV). Photos 3 thru 8 show the front (north) yard sidewalk and steps, which are uneven throughout. Photo 9 shows the blocks and slabs supporting the front stoop, which are not uniformly distributed. Mrs. Derian alleges that all of the unevenness is recent (IGSV).

PHOTO 1 - DERIAN DRIVEWAY LOOKING NORTH

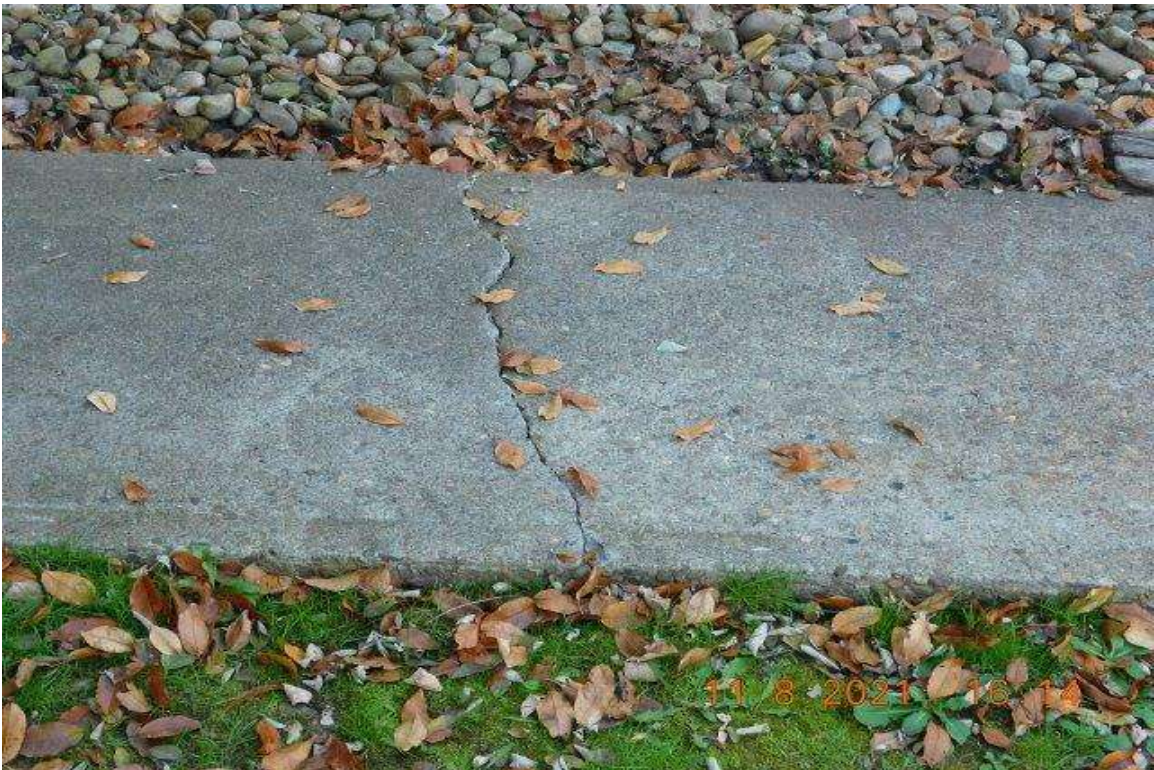
PHOTO 2 - CLOSE-UP OF AREA ON PHOTO 1

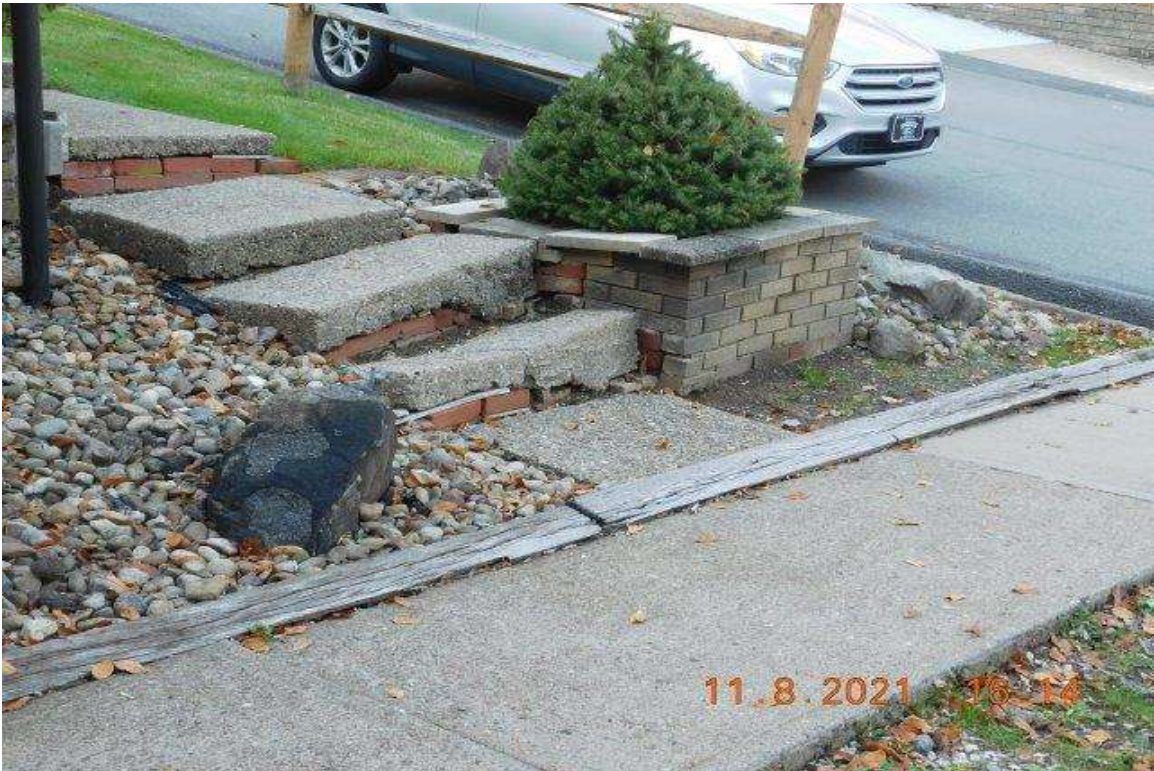
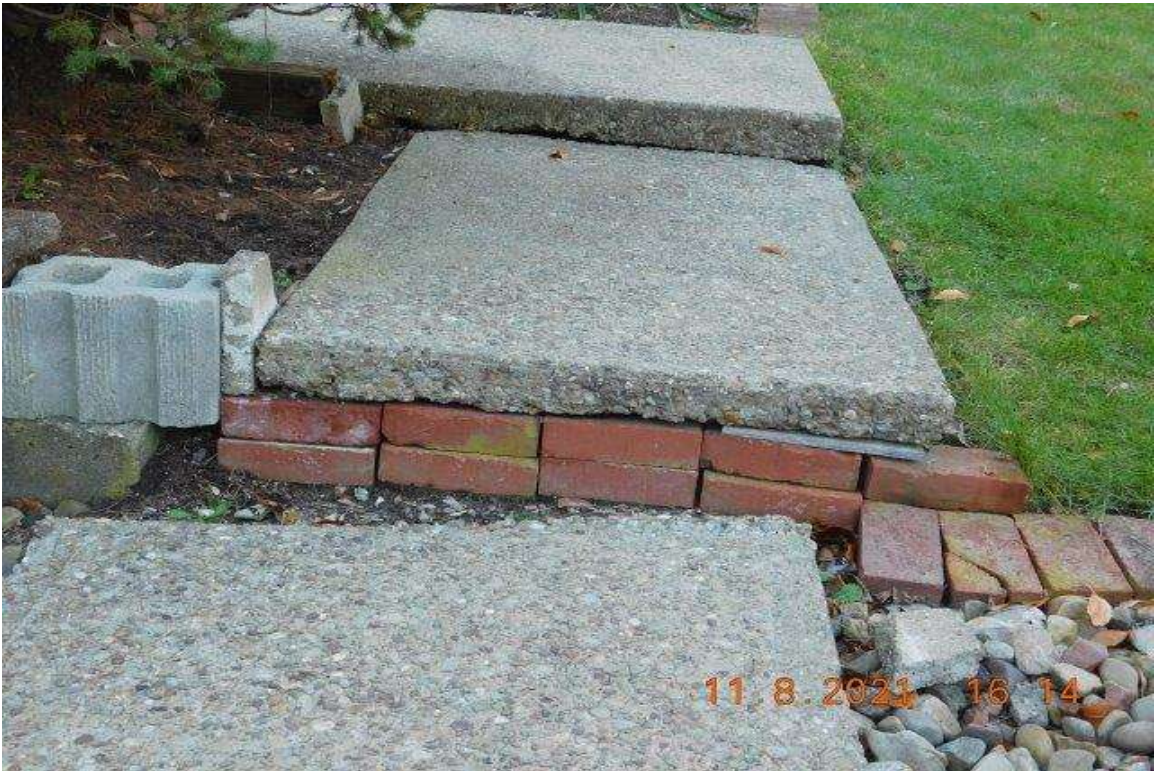
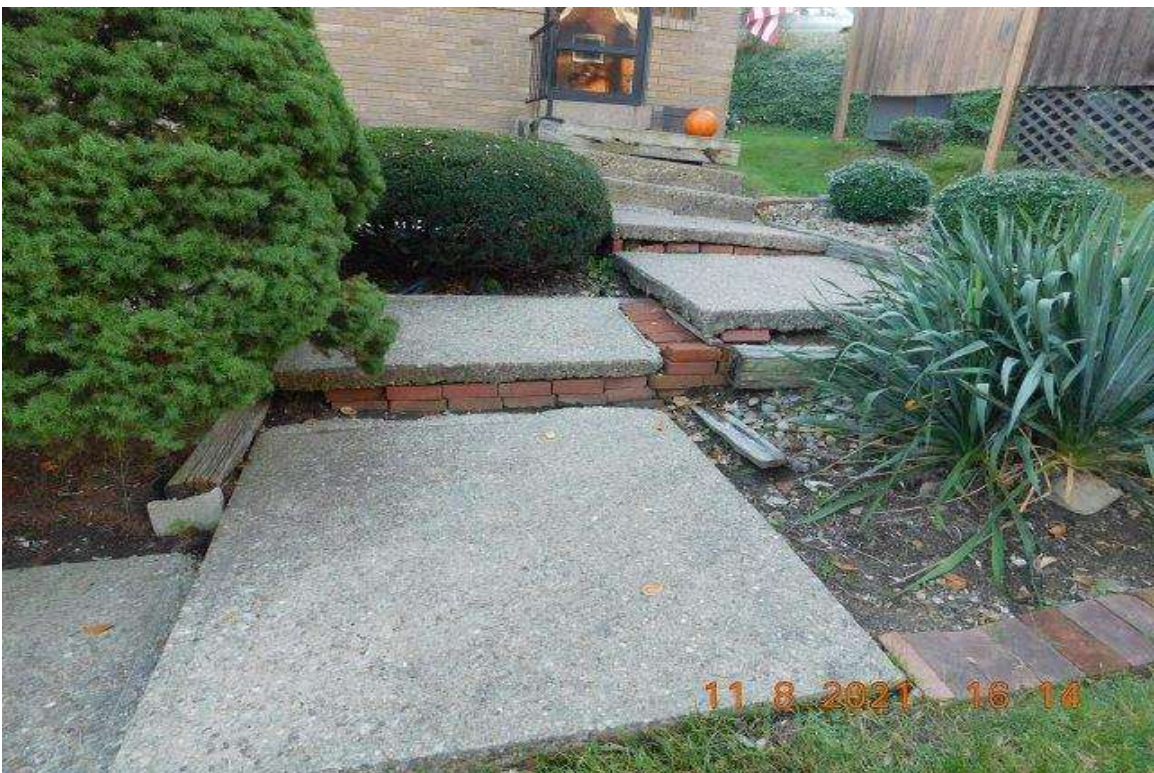
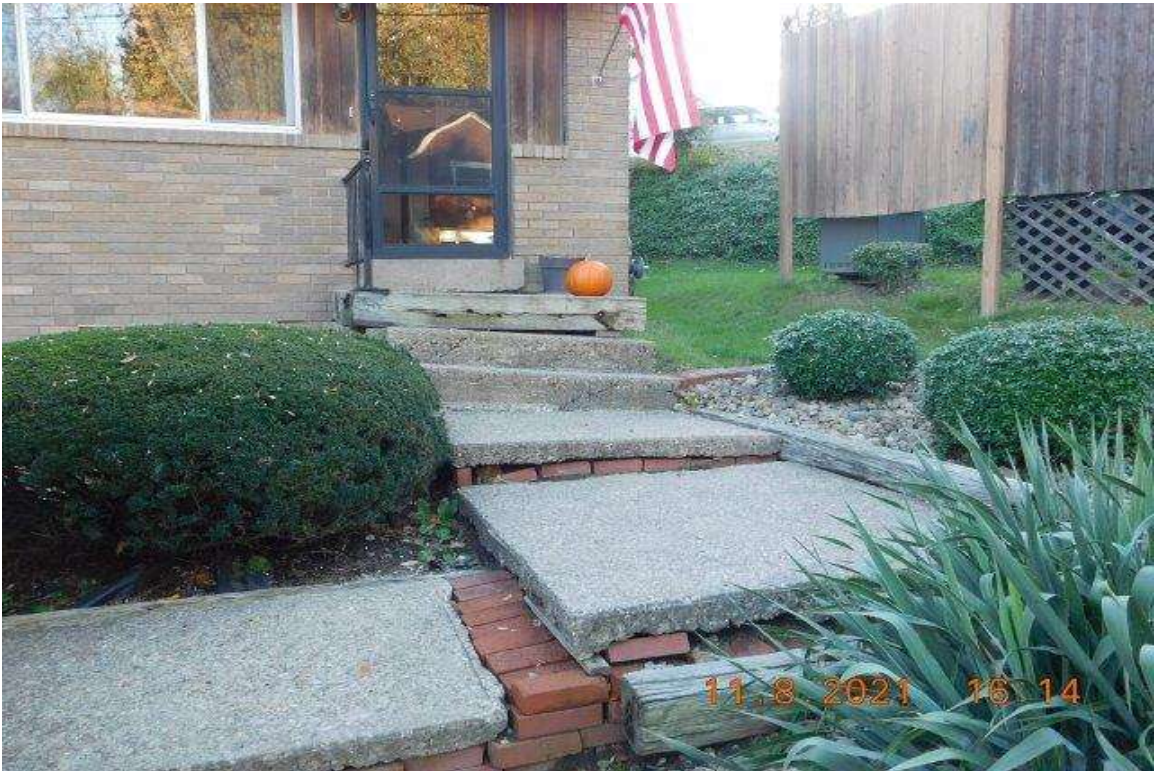
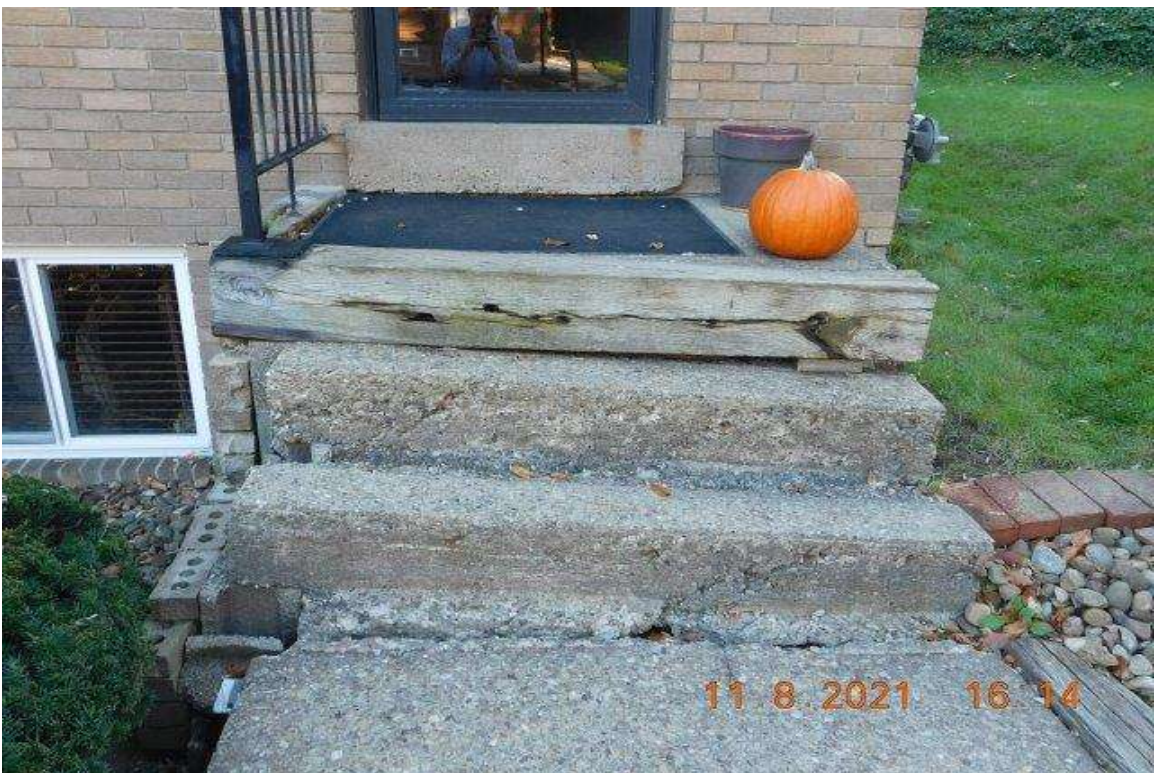
PHOTO 3 - FRONT (NORTH) YARD SIDEWALK LOOKING NORTHWEST

PHOTO 4 - ANOTHER VIEW OF AREA ON PHOTO 3

PHOTO 5 - CLOSE-UP OF AREA ON PHOTO 4

PHOTO 6 - SIDEWALK WEST OF PHOTO 5

PHOTO 7 - CLOSE-UP OF AREA ON PHOTO 6

PHOTO 8 - CLOSE-UP OF AREA ON PHOTO 7

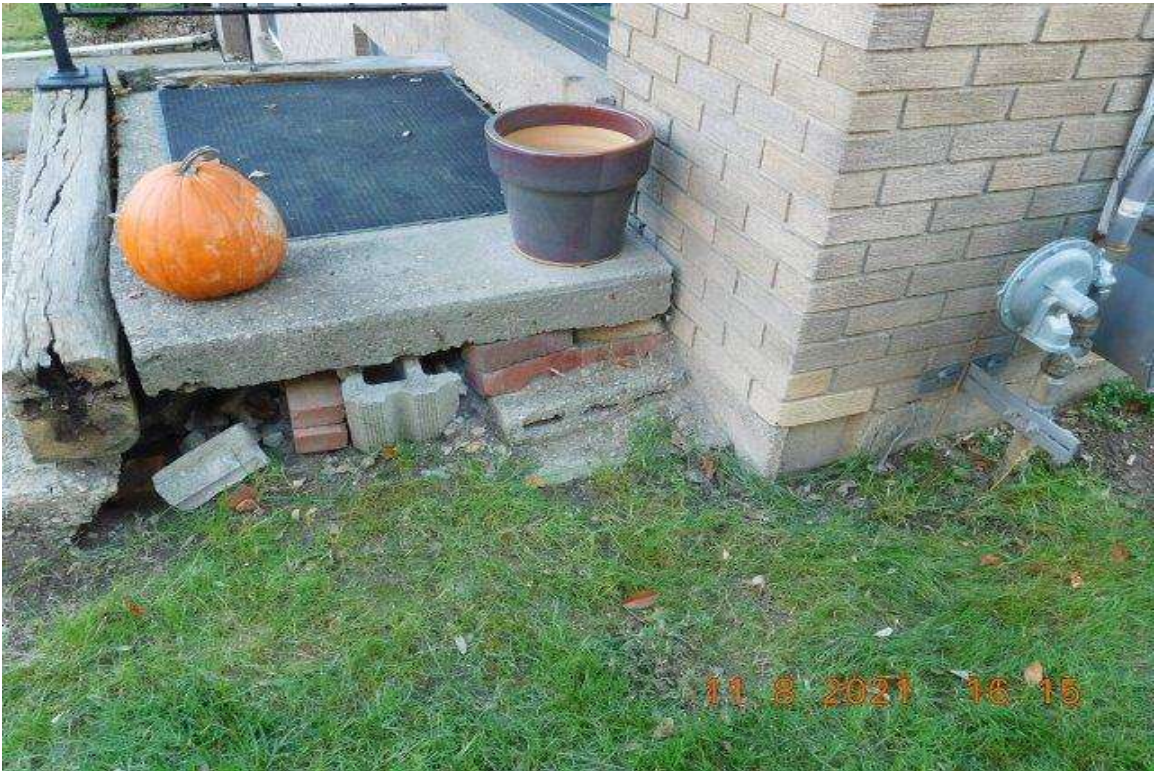
PHOTO 9 - FRONT ENTRY STOOP LOOKING EAST

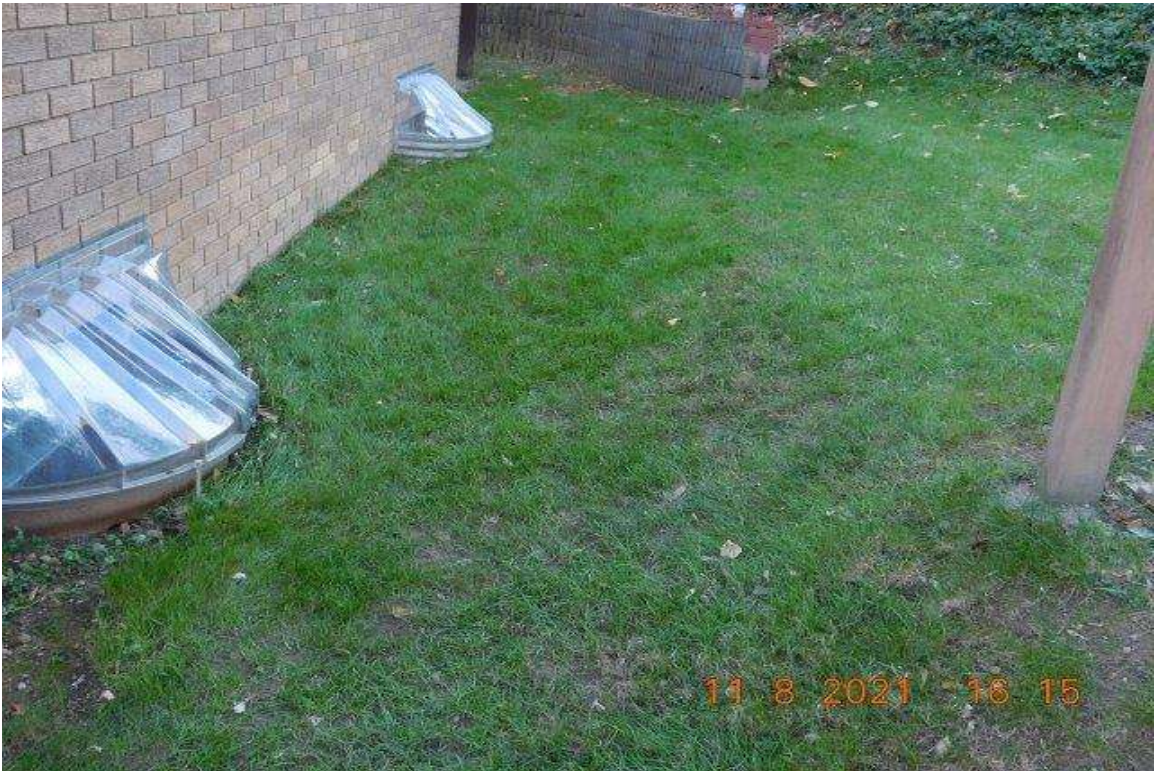
Photos 10, 11, and 12 show the Derian right (west) side yard. Mrs. Derian identified this as one of the areas that have become uneven recently due to “subsidence”. It should be noted that when I compared photos taken for my July 22, 2021, report the area appears to be the same. However, the grass was more lush in July than it was in November. It is my opinion that the areas of alleged subsidence are the paths that the Derians follow when walking through the yard. Since the grass is thinner and the ground is wetter in the Fall of the year, the paths are getting slightly more compressed when being walked on, creating the shallow depressed area.

PHOTO 10 - RIGHT (WEST) SIDE YARD

PHOTO 11 - CLOSE-UP OF AREA ON PHOTO 12

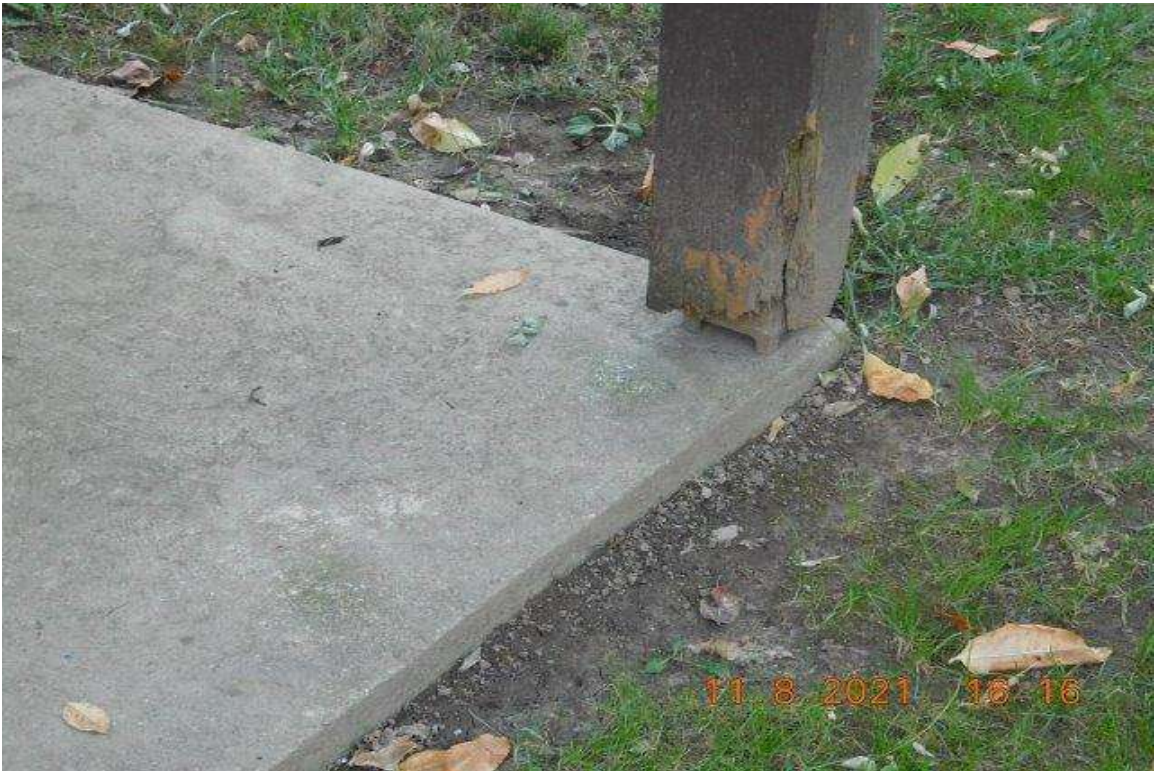
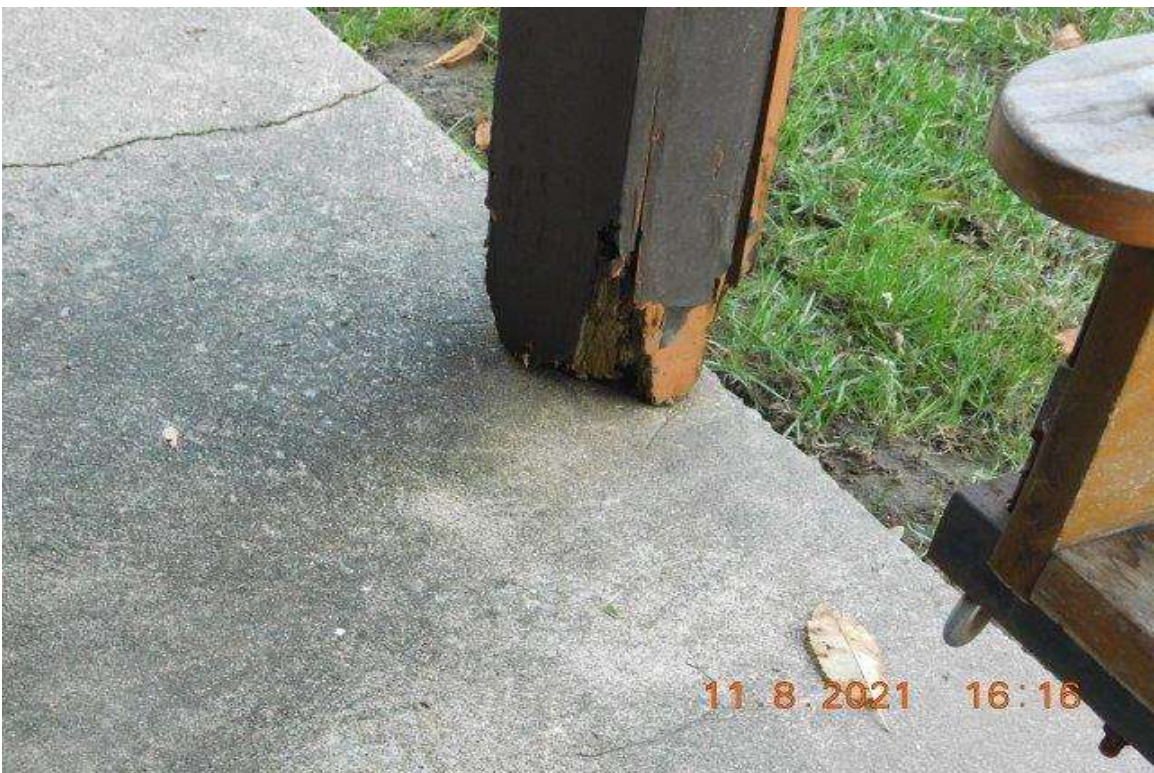
Photos 12, 13, and 14 show the significantly rotted bases of the posts supporting the porch roof. Photos 15, 16, and 17 show the roof of the porch which is very deteriorated in some areas and previously repaired in others. Photos 18 thru 21 show the crack in the rear patio slab, which does not appear to have changed since my July 14, 2021, inspection.

PHOTO 13 - CLOSE-UP OF REAR (SOUTH) PATIO RIGHT ROOF SUPPORT POST

PHOTO 14 - CLOSE-UP OF REAR PATIO CENTER ROOF SUPPORT POST
