RE: Ronald and Sheila Derian vs. Pennsylvania American Water Company
Docket # c-2023-3041252

Included please find Exhibits 1 thru 7 to be entered concerning the above case # c-2023-3041252.

G:\Projects\41000\41370 Travelers - Derian Property\Docs\Report.docx

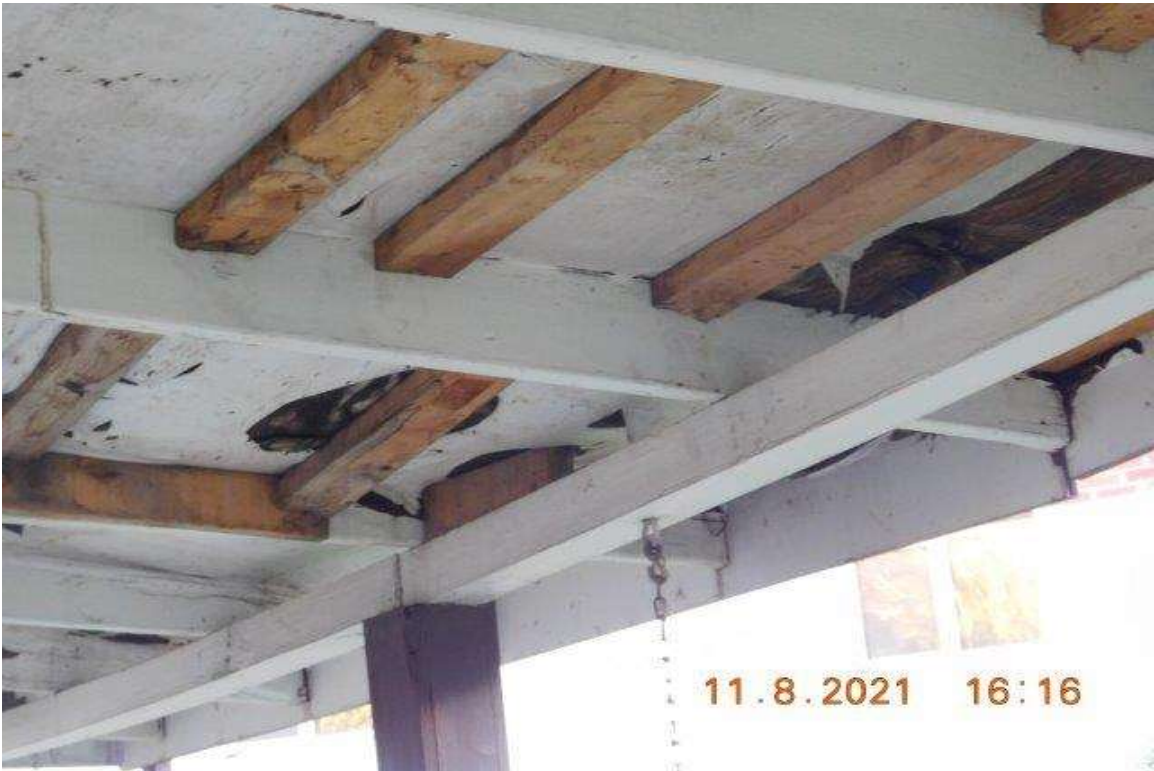
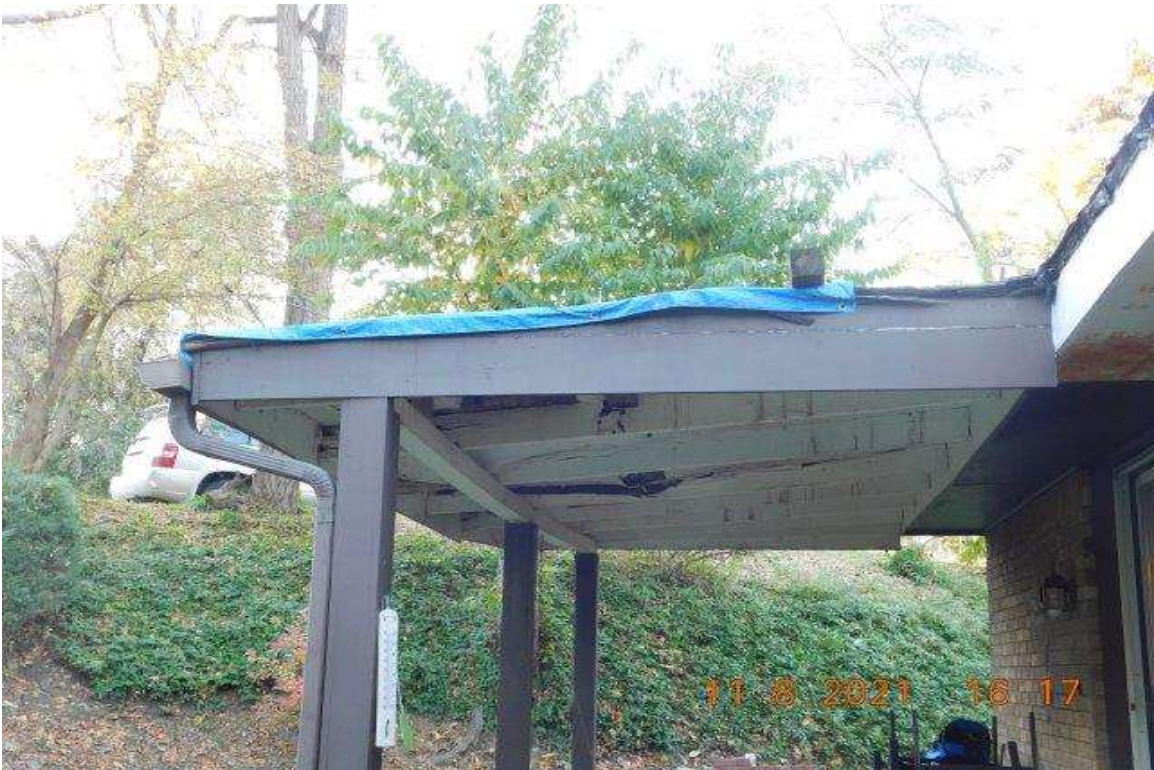
Photos 12, 13, and 14 show the significantly rotted bases of the posts supporting the porch roof. Photos 15, 16, and 17 show the roof of the porch which is very deteriorated in some areas and previously repaired in others. Photos 18 thru 21 show the crack in the rear patio slab, which does not appear to have changed since my July 14, 2021, inspection.

PHOTO 15 - AREA ABOVE PHOTO 14

PHOTO 16 - REAR PATIO ROOF LOOKING WEST

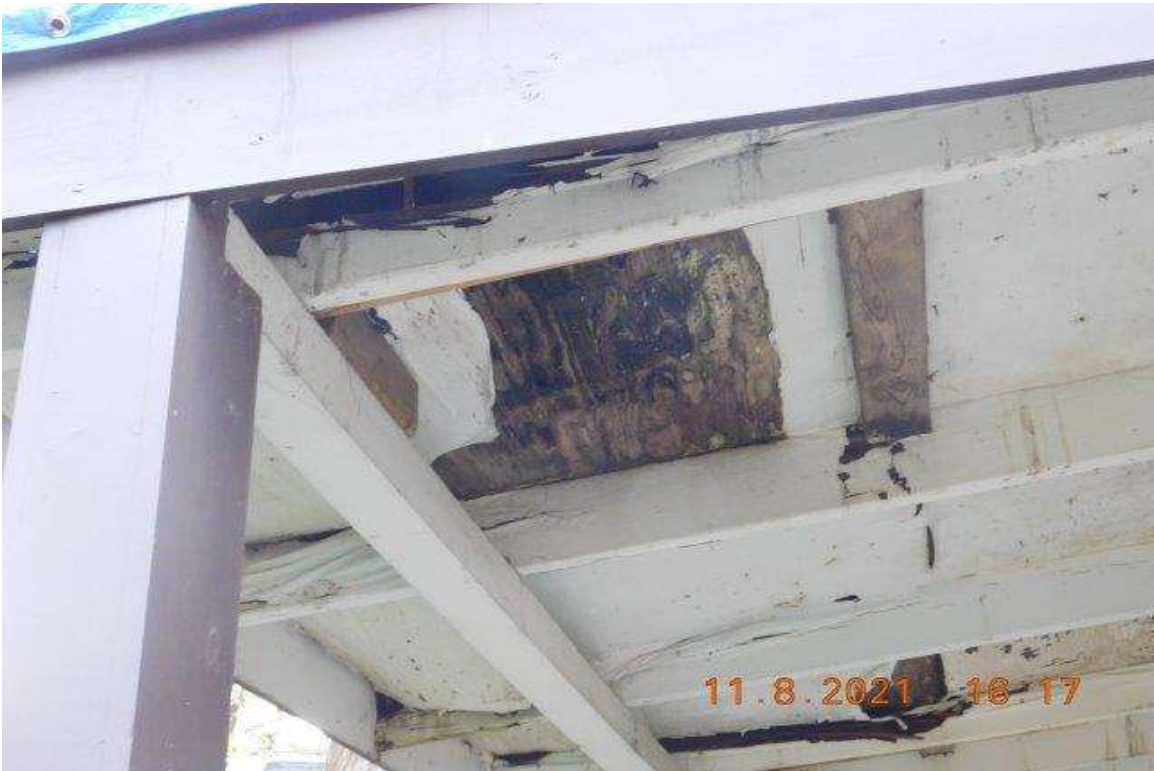
PHOTO 17 - CLOSE-UP OF AREA ON PHOTO 16

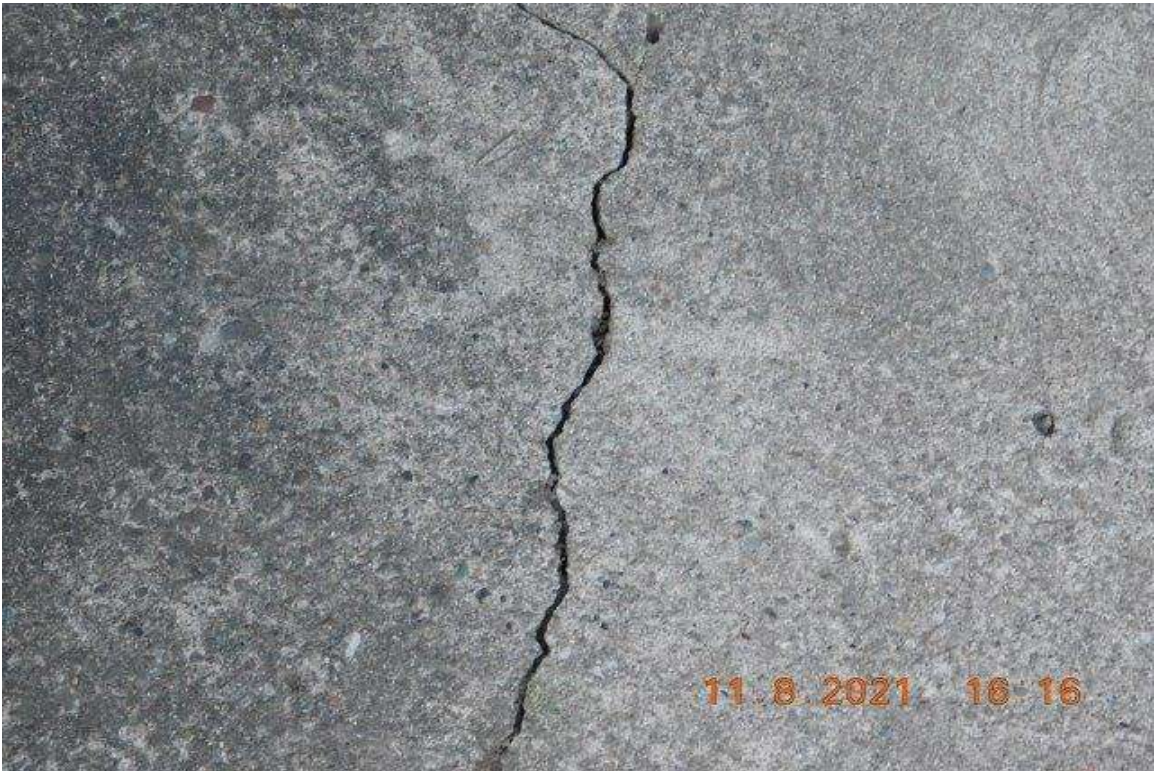
PHOTO 19 - CLOSE-UP OF AREA ON PHOTO 18

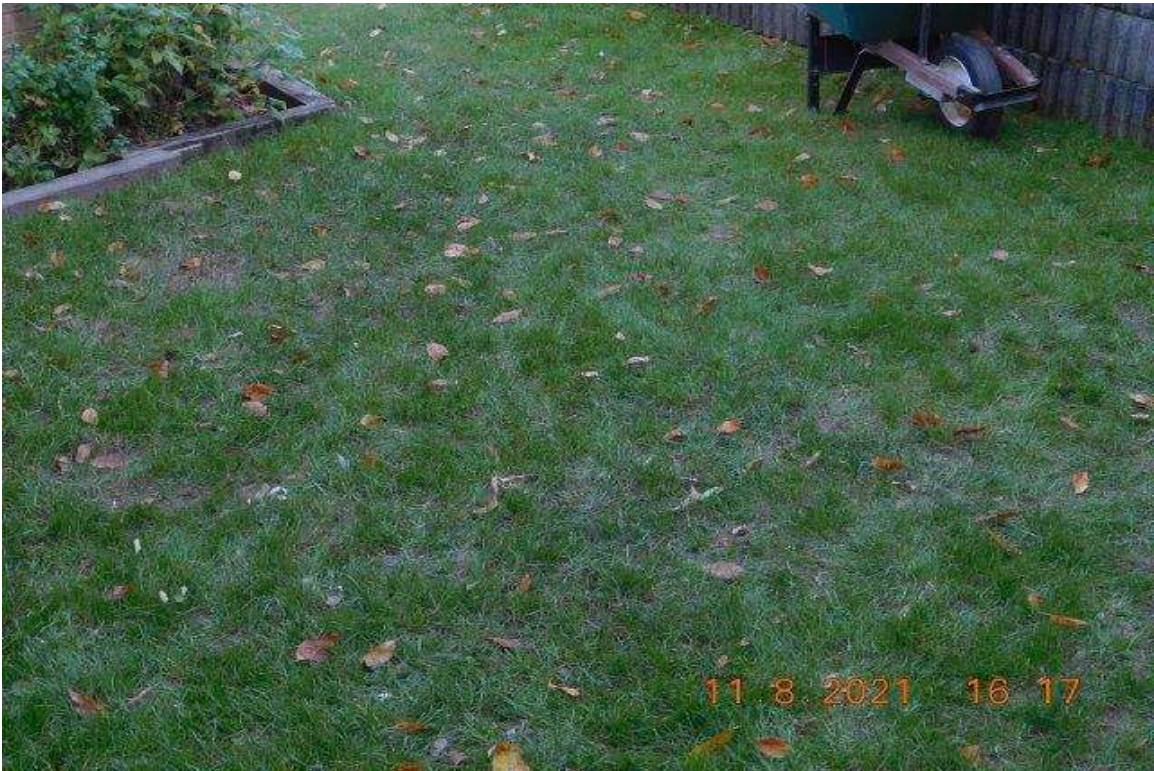
Photos 22, 23, and 24 show the left portion of the rear yard, the second area identified by Mrs. Derian as having become uneven recently due to “subsidence”. This area was not reviewed during my July

PHOTO 23 - CLOSE-UP OF AREA ON PHOTO 22

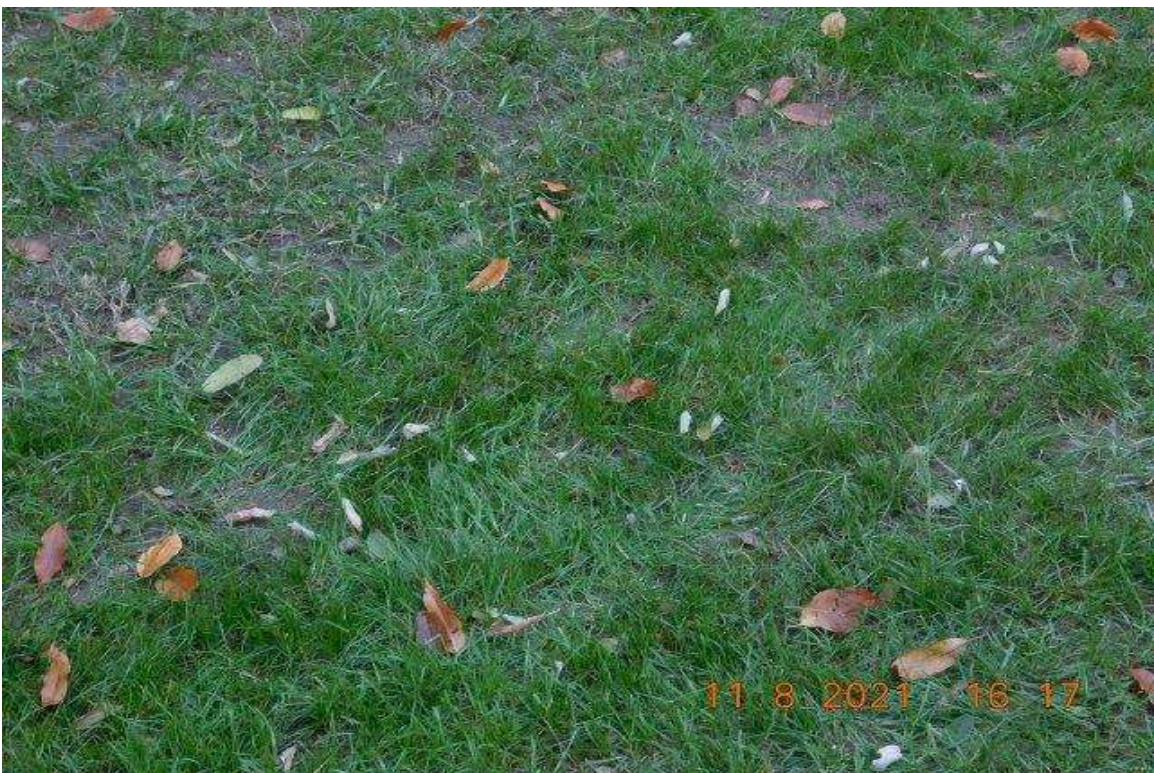
PHOTO 24 - CLOSE-UP OF AREA ON PHOTO 23

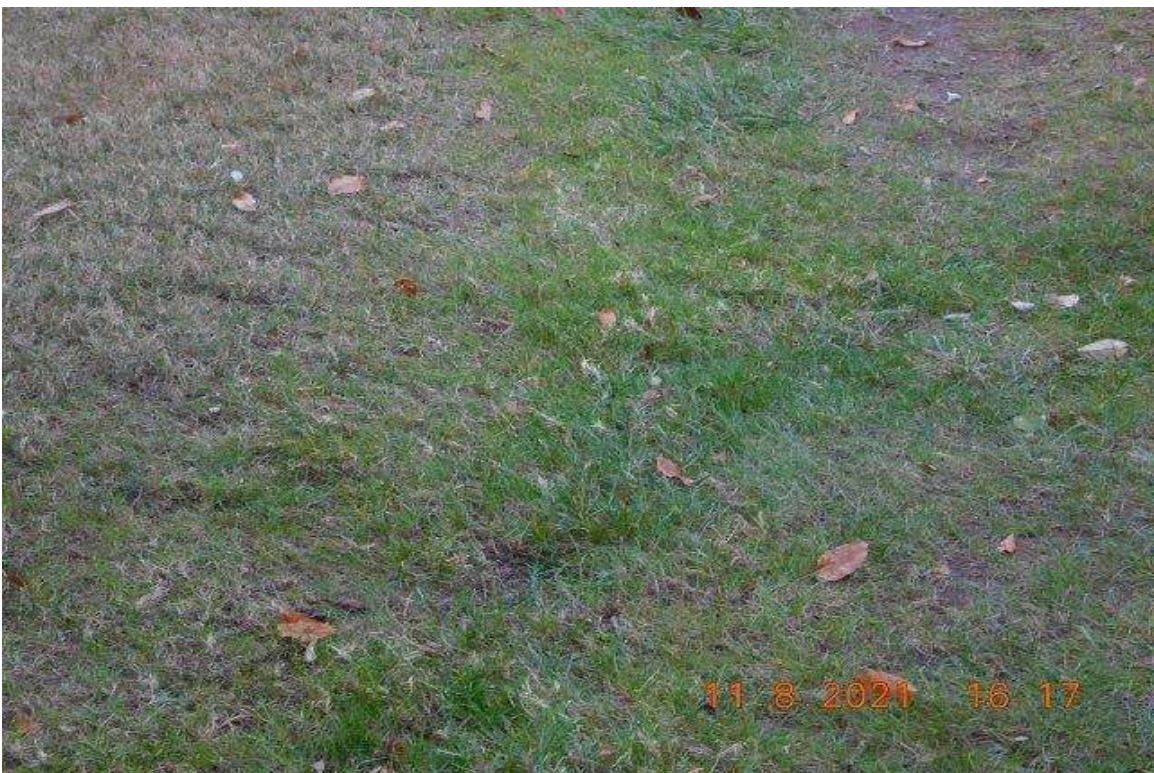
Photos 25 and 26 show the Derian left (east) side yard. Mrs. Derian identified this as the third area that has become uneven recently due to subsidence. It should be noted that when I compared photos taken for my July 22, 2021, report, the area's condition appears to be the same. However, the grass was more lush in July than it was in November. It is again my opinion that the areas of alleged subsidence are the paths that the Derians follow. Since the grass is thinner and the ground is wetter in the Fall, the paths are getting slightly more compressed when being walked on, creating the shallow depressed area.

PHOTO 26 - CLOSE-UP OF AREA ON PHOTO 25

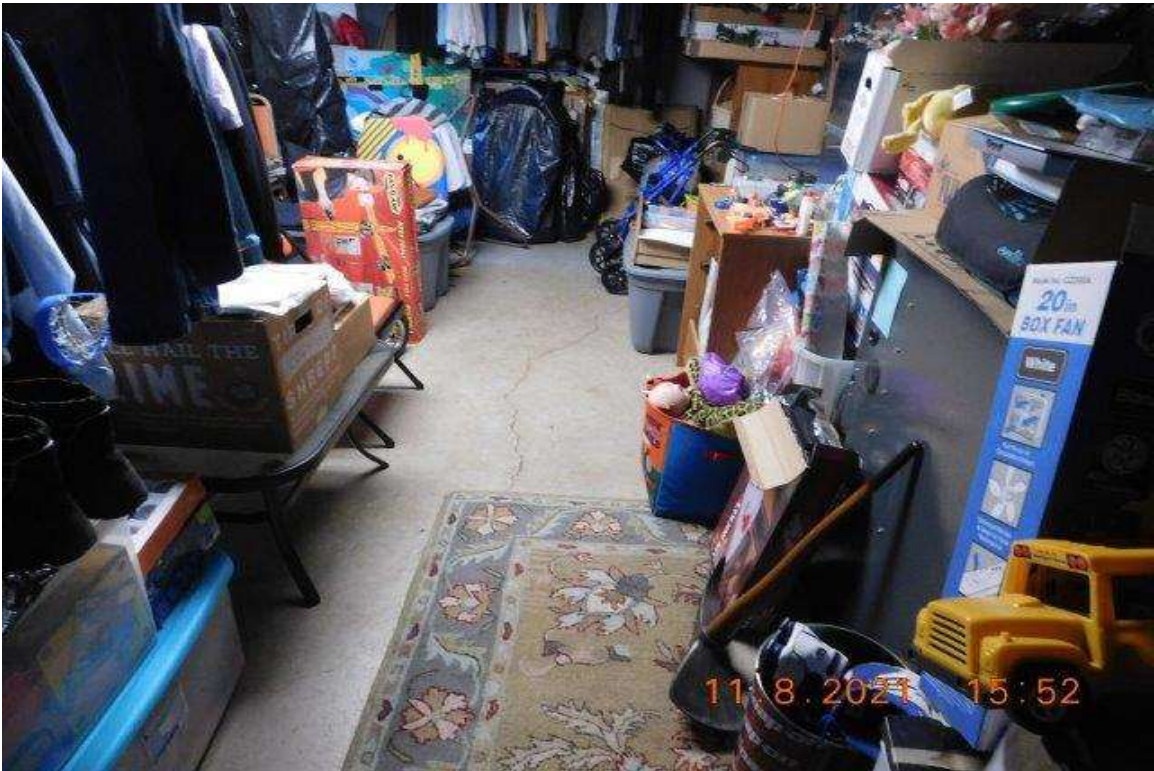
Interior Photos 27 thru 30 show a crack in the basement front room floor slab that Mrs. Derian opined is new and due to runoff from the water main break. This area was not claimed during my July inspection. The crack is old as it exhibits rounded and polished edges.

PHOTO 27 - BASEMENT FRONT ROOM LOOKING NORTH

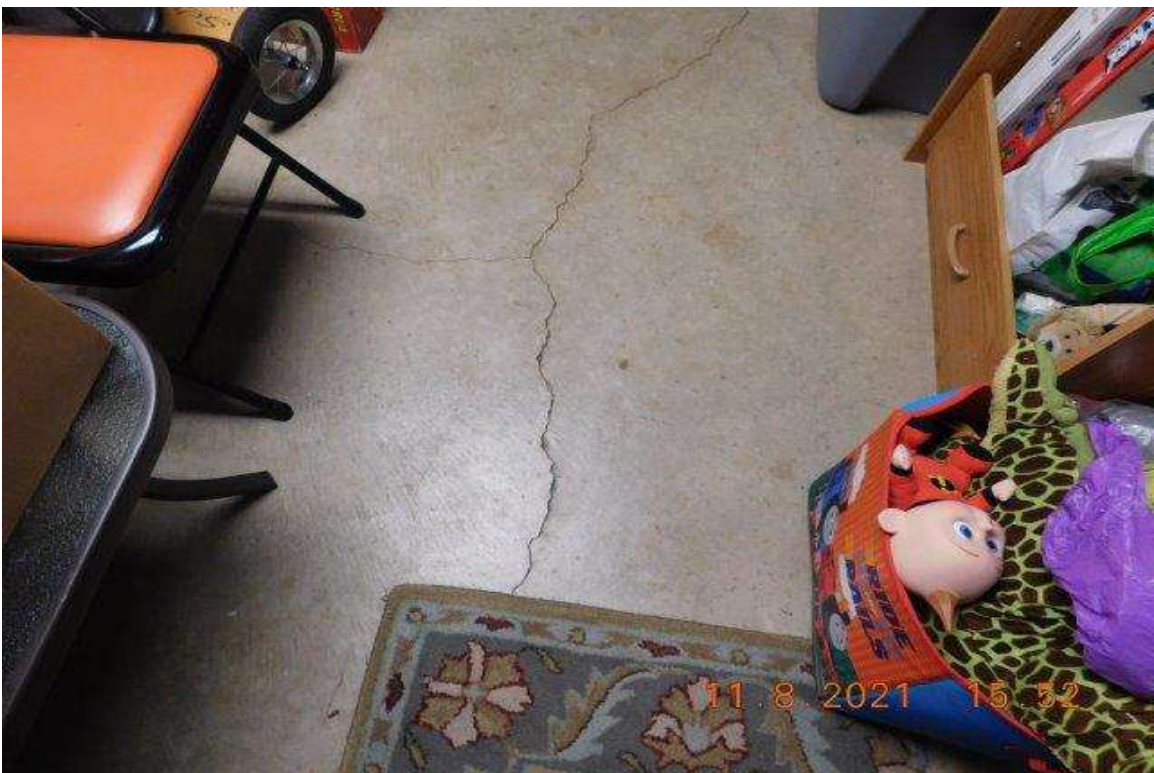
PHOTO 28 - CLOSE-UP OF AREA ON PHOTO 27

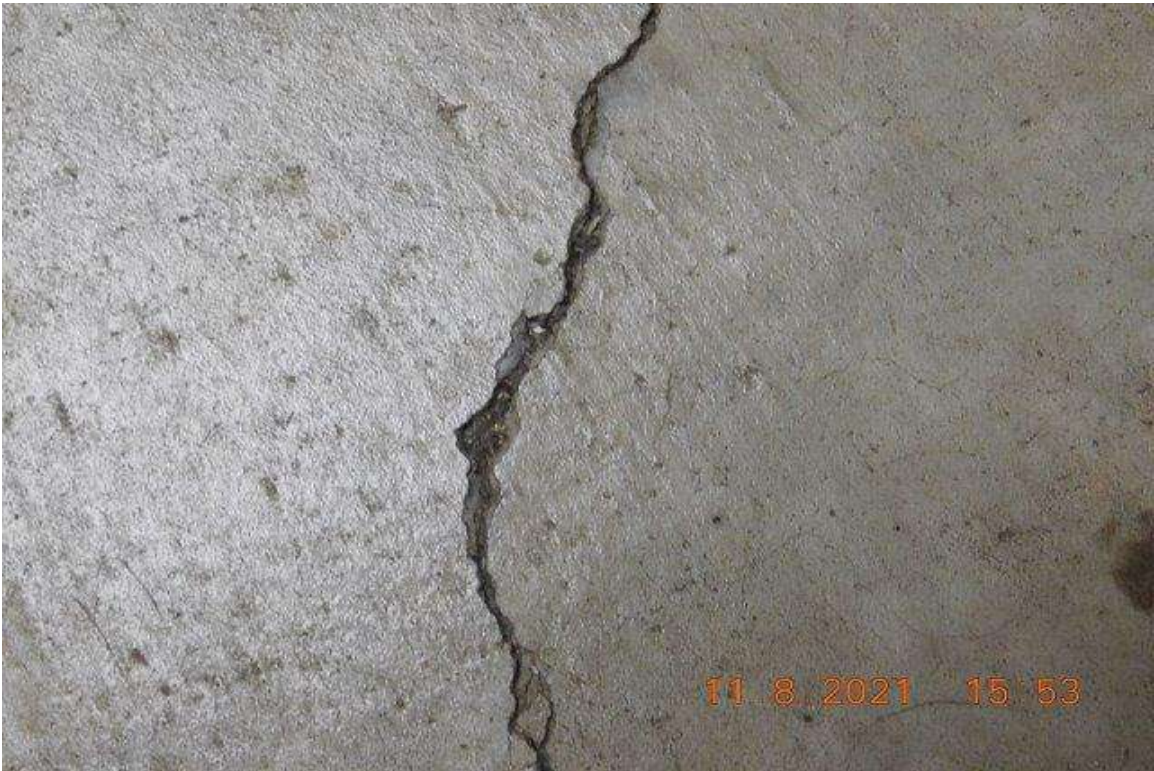
PHOTO 29 - CLOSE-UP OF AREA ON PHOTO 28

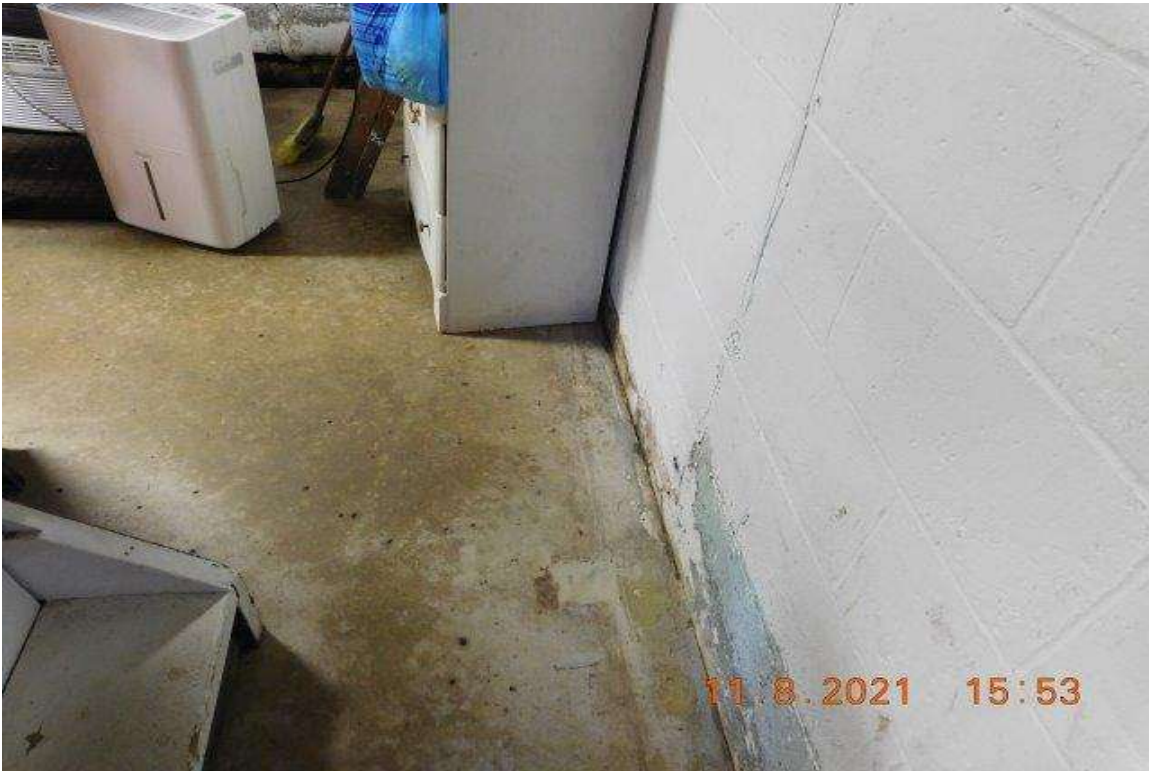
Photos 31 and 32 show the right wall of the basement rear room. Mrs. Derian opined that the floor has dropped since my first inspection. Photos 33, 34, and 35 show the cracks in the blockwork below the window in the right wall of the basement rear room, which Mrs. Derian opined had widened since my previous inspection. I reviewed the photos in my July 22, 2021, report, and there does not appear to be any changes in these areas. Photos 36 and 37 show the right rear corner of the basement rear room. Mrs. Derian stated that the basement wall has shifted since my last inspection. Again, I reviewed the photos in my July 22, 2021, report, and there does not appear to be any changes in this area.

PHOTO 31 - RIGHT WALL OF BASEMENT REAR ROOM

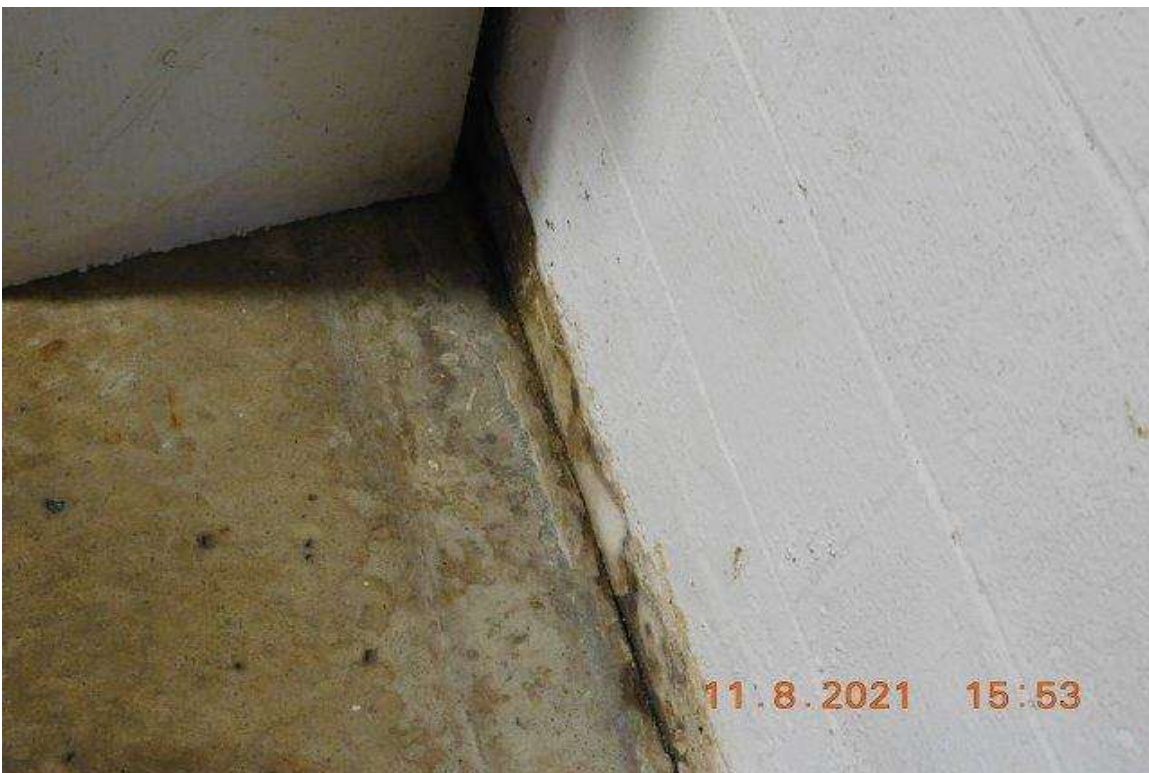
PHOTO 32 - CLOSE-UP OF AREA ON PHOTO 31

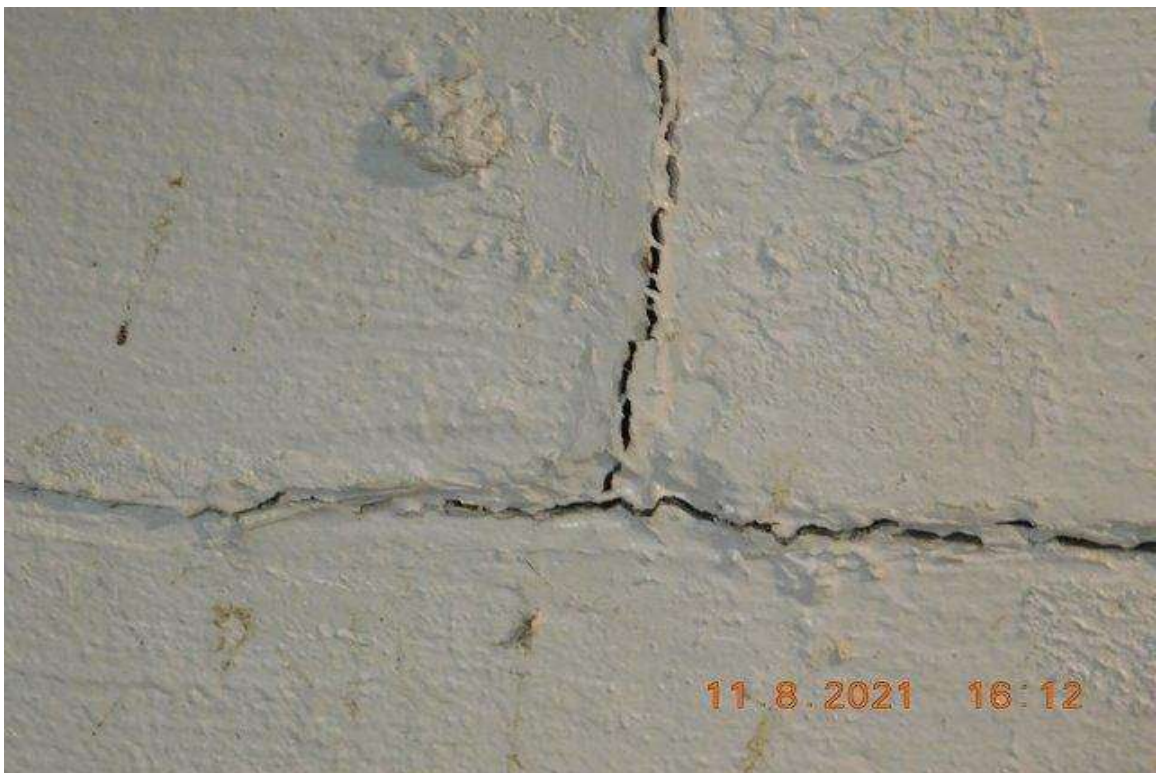
PHOTO 34 - CLOSE-UP OF AREA ON PHOTO 33

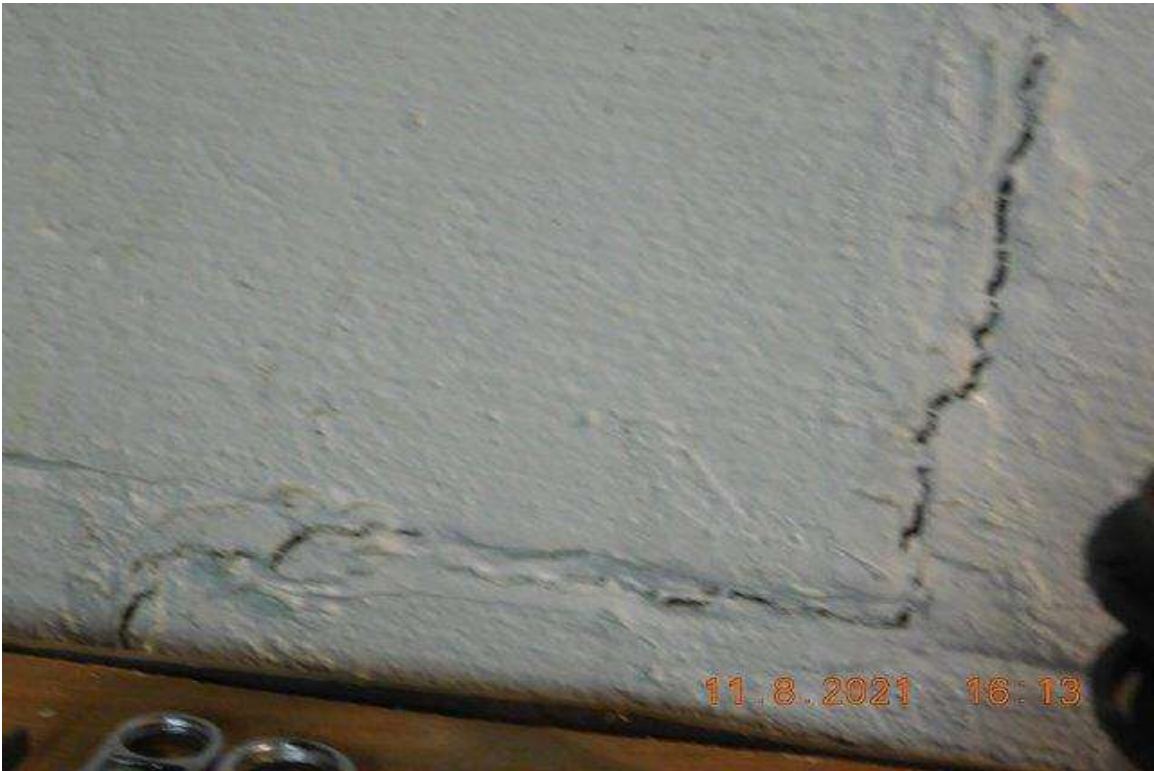
PHOTO 35 - AREA BELOW PHOTO 34

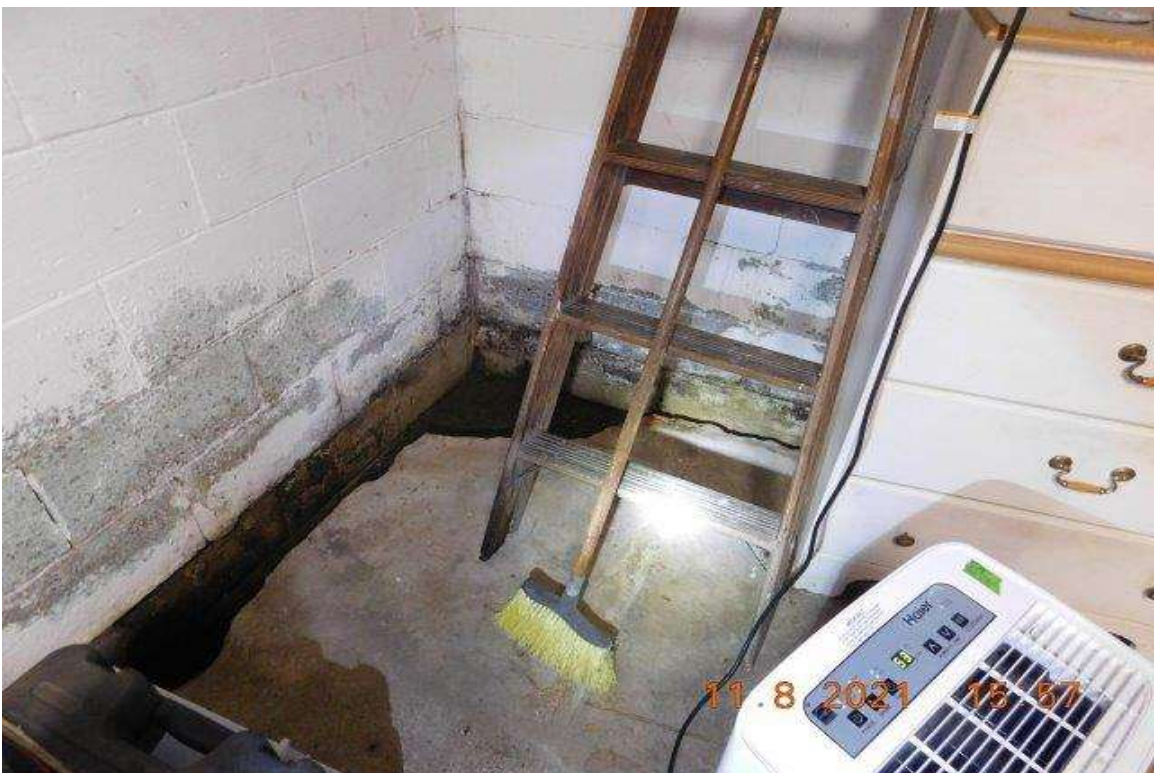
PHOTO 36 - RIGHT REAR CORNER OF BASEMENT REAR ROOM

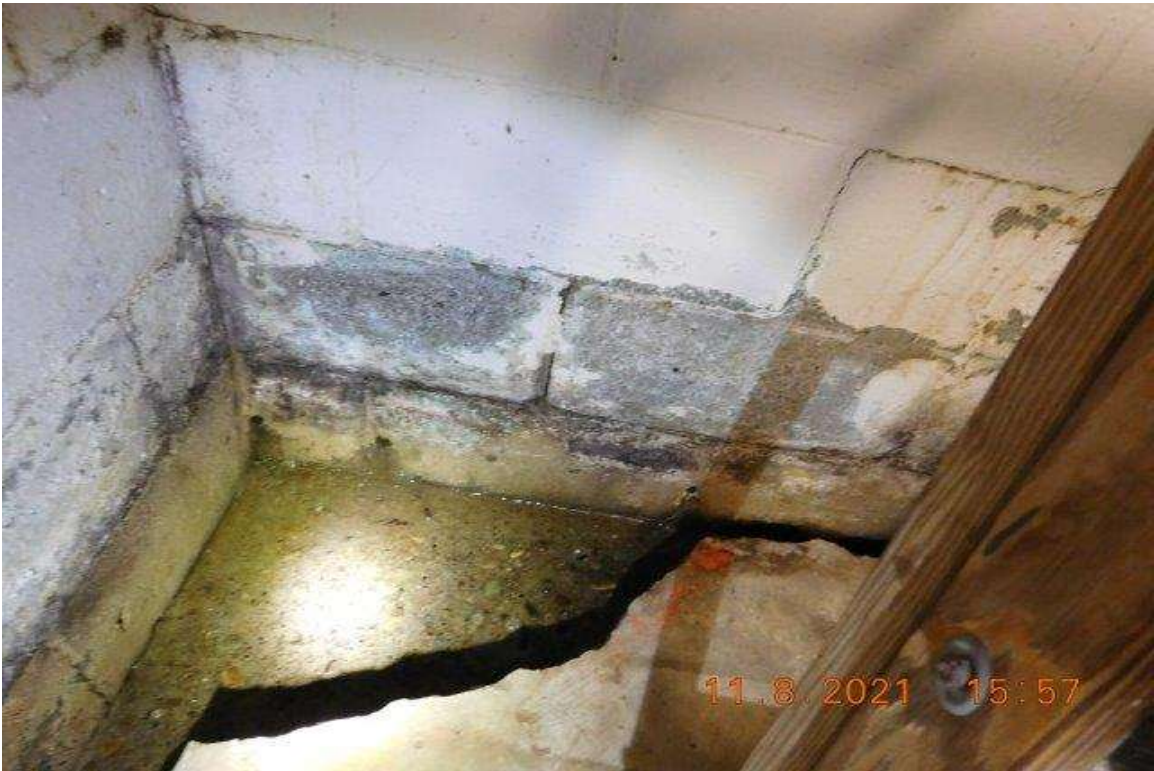
PHOTO 37 - CLOSE-UP OF AREA ON PHOTO 36

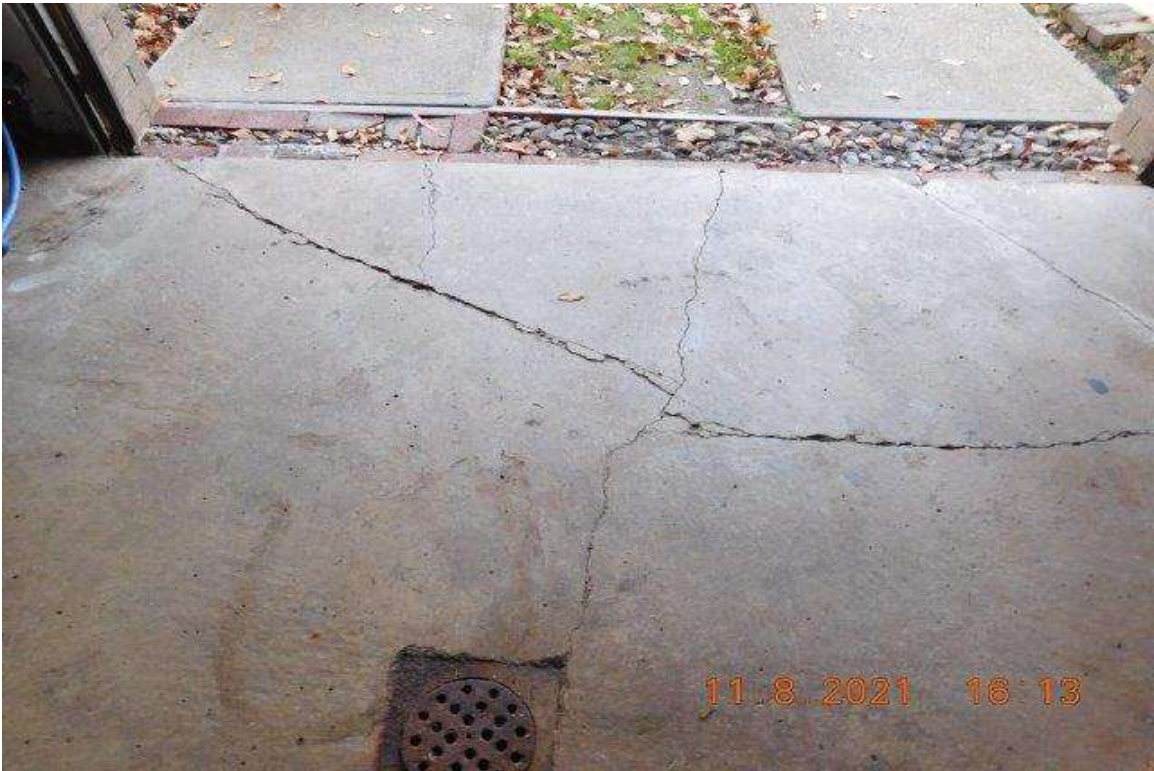
Photos 38, 39, and 40 show cracks in the garage floor slab, which Mrs. Derian opined are new. As noted in the photos, the cracks exhibit rounded and polished edges indicating that they are not new.

PHOTO 39 - CLOSE-UP OF AREA ON PHOTO 38

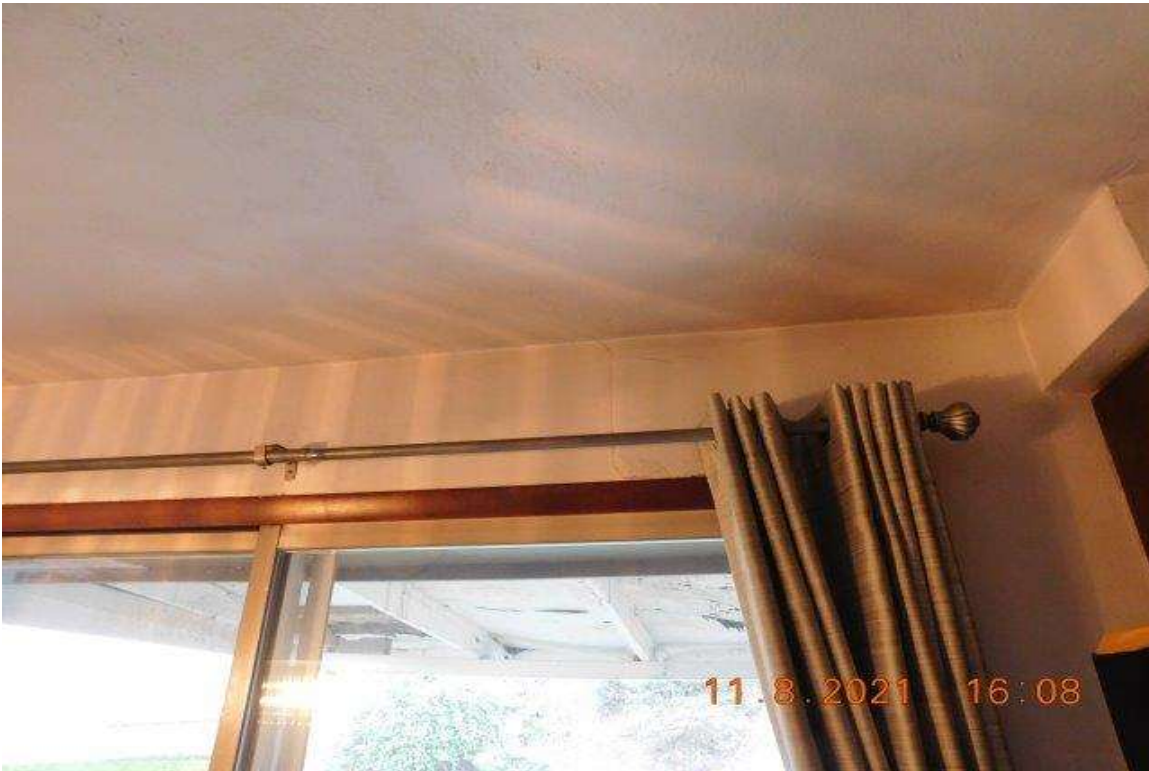
Photos 41, 42, and 43, show a crack in the rear wall of the first floor kitchen above the exit to the patio, which Mrs. Derian opined was new. The crack had significant dust in it, therefore, it is not new.

PHOTO 41 - AREA ABOVE REAR WALL EXIT TO PATIO

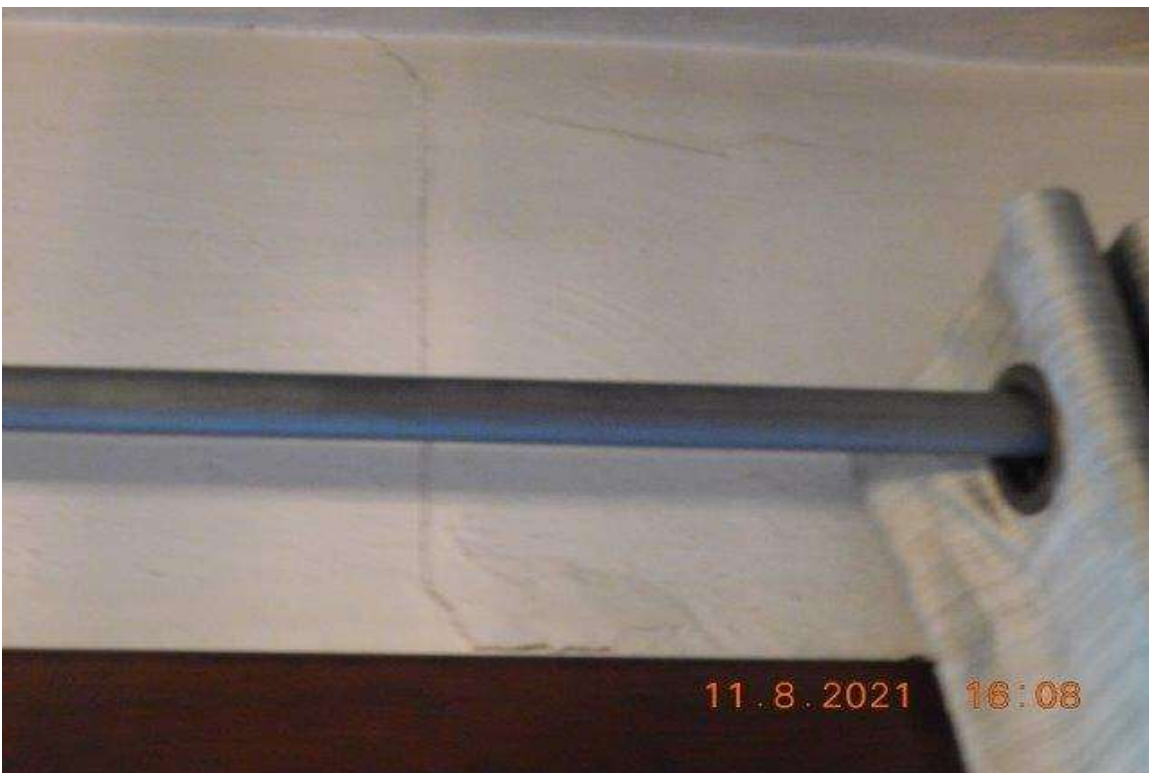
PHOTO 42 - CLOSE-UP OF AREA ON PHOTO 41

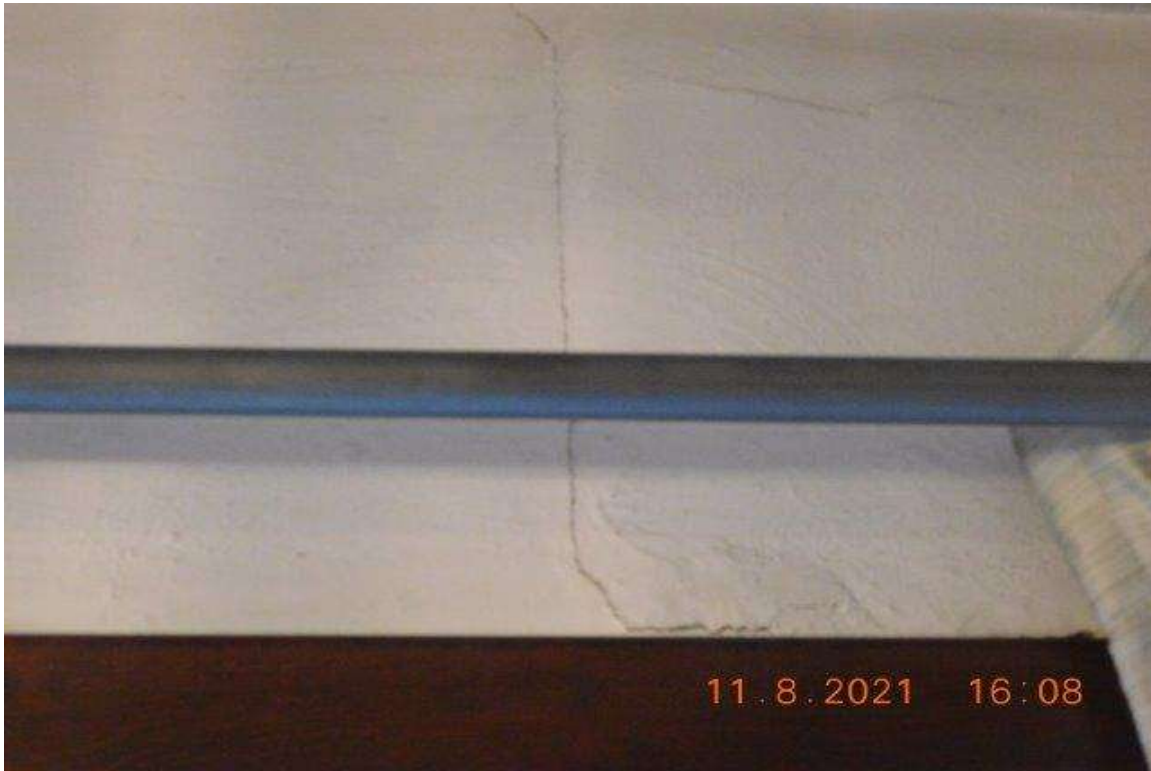
PHOTO 43 - CLOSE-UP OF AREA ON PHOTO 42

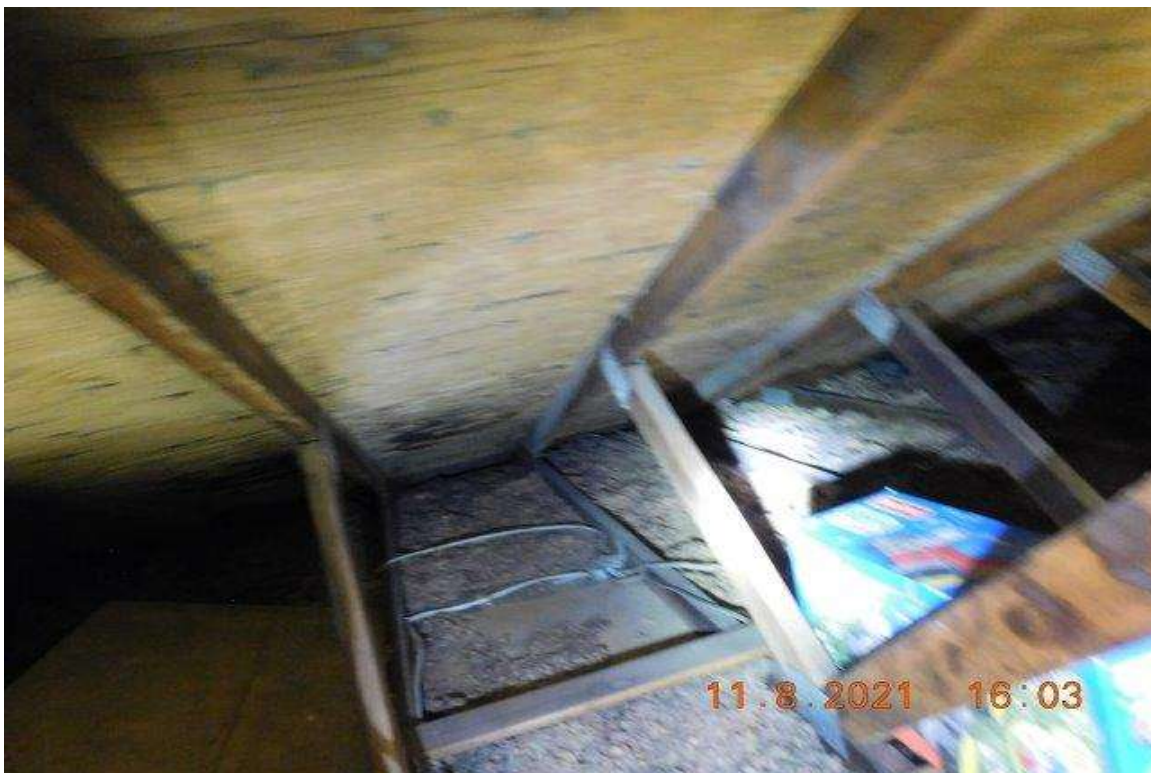
Photos 44, 45, and 46 are views of the attic roof framing. I saw no evidence of any recent movement in the framing.

PHOTO 44 - ATTIC ROOF FRAMING

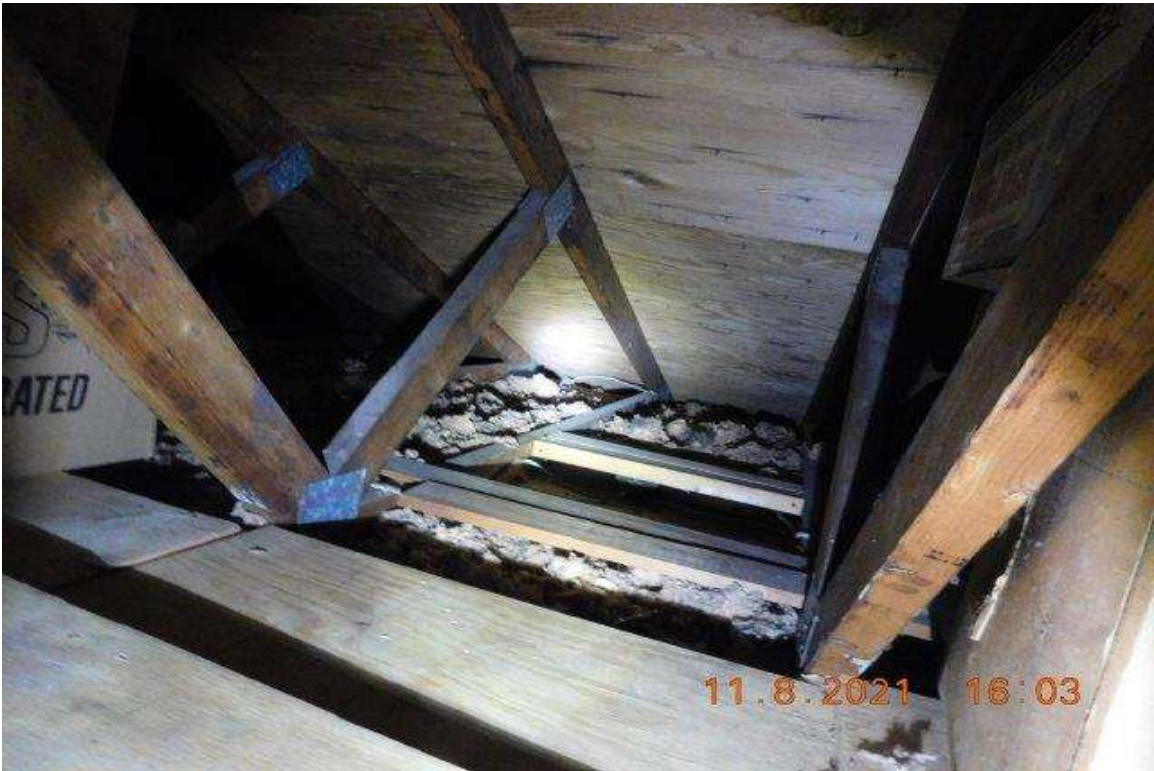
PHOTO 45 - ATTIC ROOF FRAMING

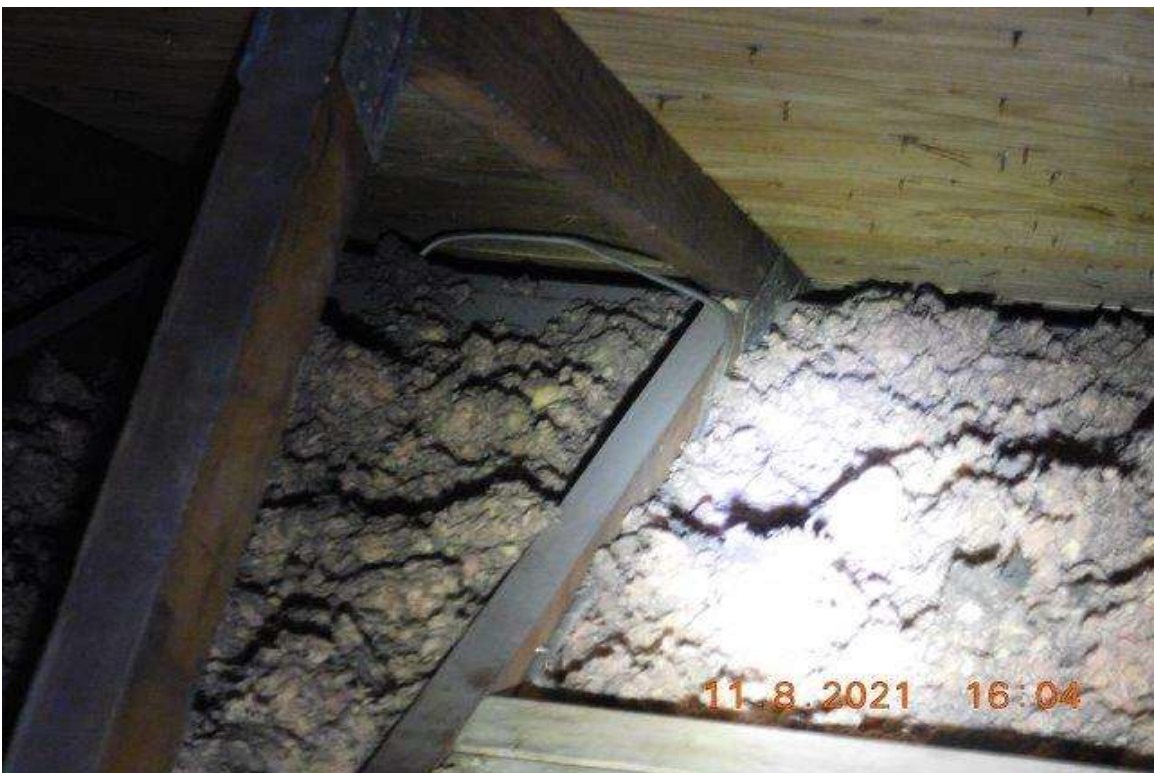
PHOTO 46 - CLOSE-UP OF AREA ON PHOTO 45

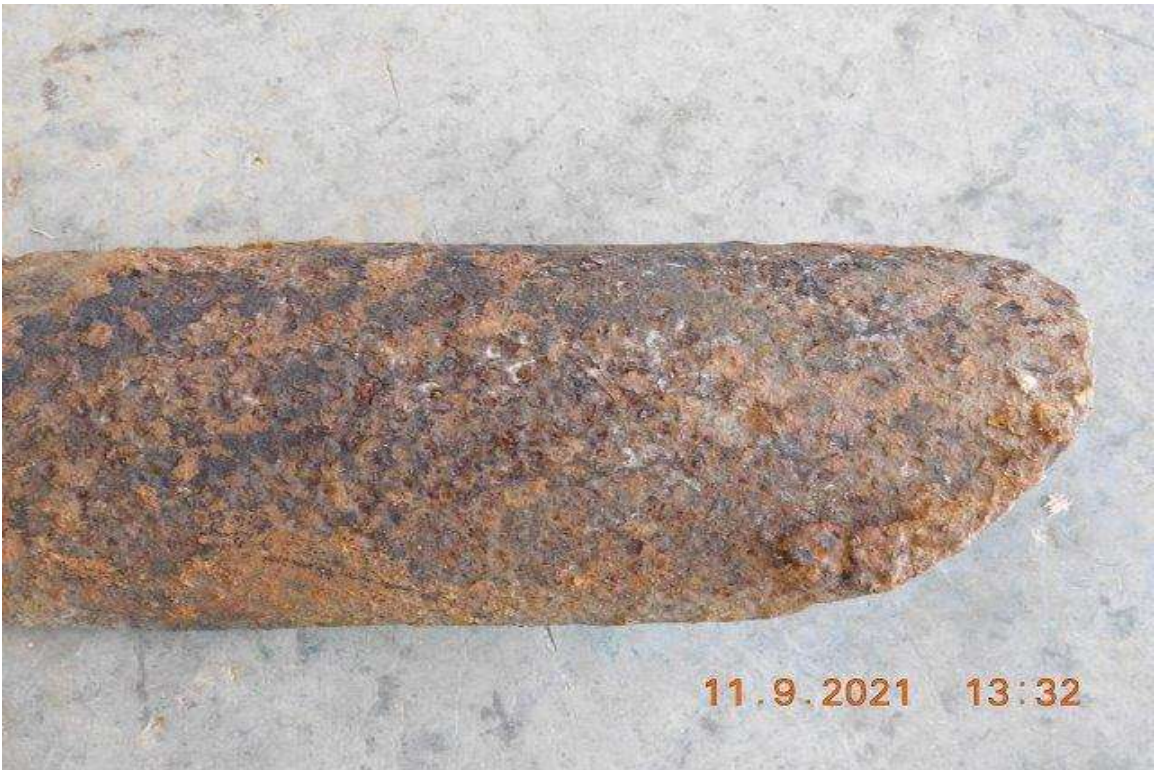
Photos 47, 48, and 49 show the exterior face of the piece of the broken water line cast iron pipe retrieved from the Derian property, while Photos 50, 51, and 52 show its interior face. As noted, there are no holes in the pipe that would be indicative of pitting.

PHOTO 48 - CLOSE-UP OF AREA ON PHOTO 47
