RE: Ronald and Sheila Derian vs. Pennsylvania American Water Company
Docket # c-2023-3041252

Included please find Exhibits 1 thru 7 to be entered concerning the above case # c-2023-3041252.

G:\Projects\41000\41370 Travelers - Derian Property\Docs\Report.docx

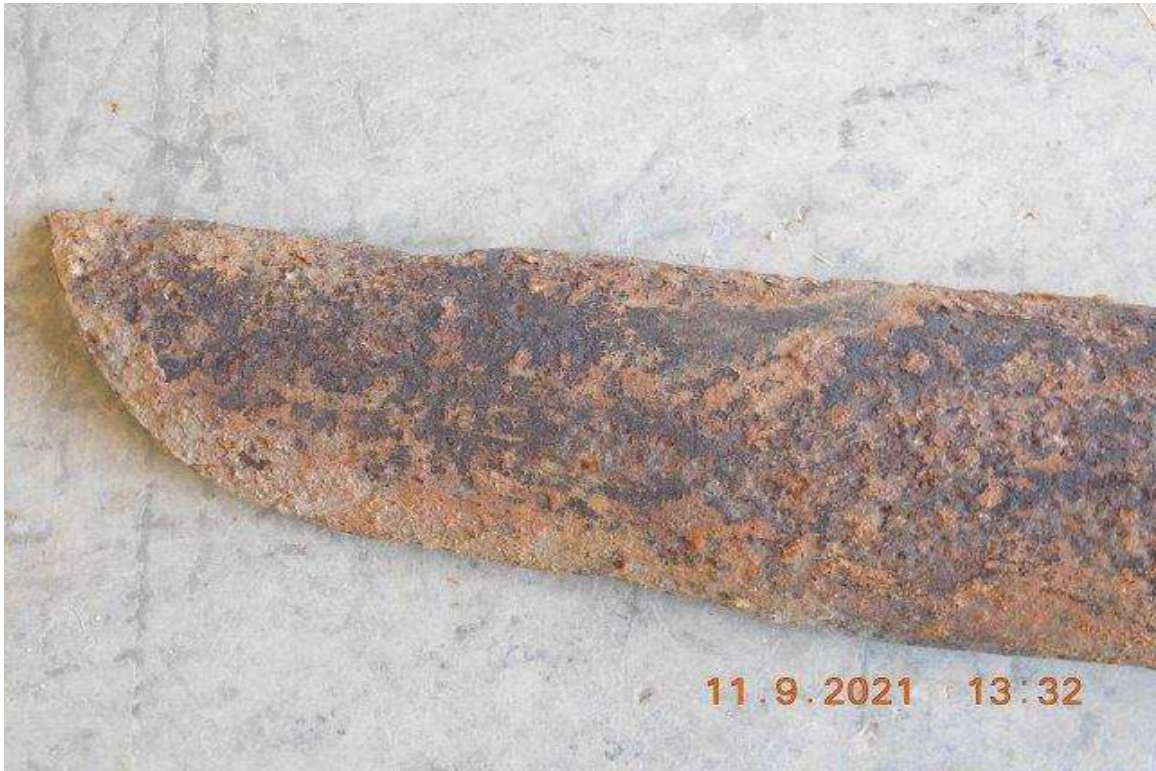
Photos 47, 48, and 49 show the exterior face of the piece of the broken water line cast iron pipe retrieved from the Derian property, while Photos 50, 51, and 52 show its interior face. As noted, there are no holes in the pipe that would be indicative of pitting.

PHOTO 49 - AREA LEFT OF PHOTO 48

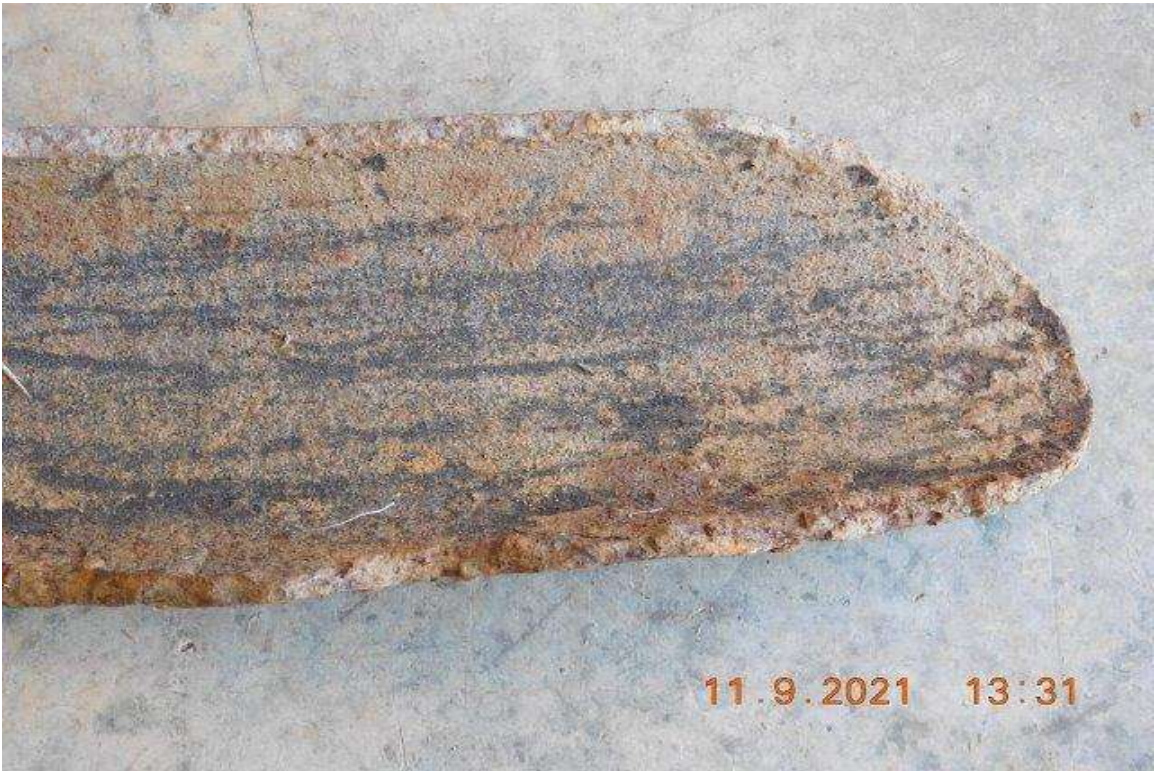
PHOTO 51 - CLOSE-UP OF AREA ON PHOTO 50

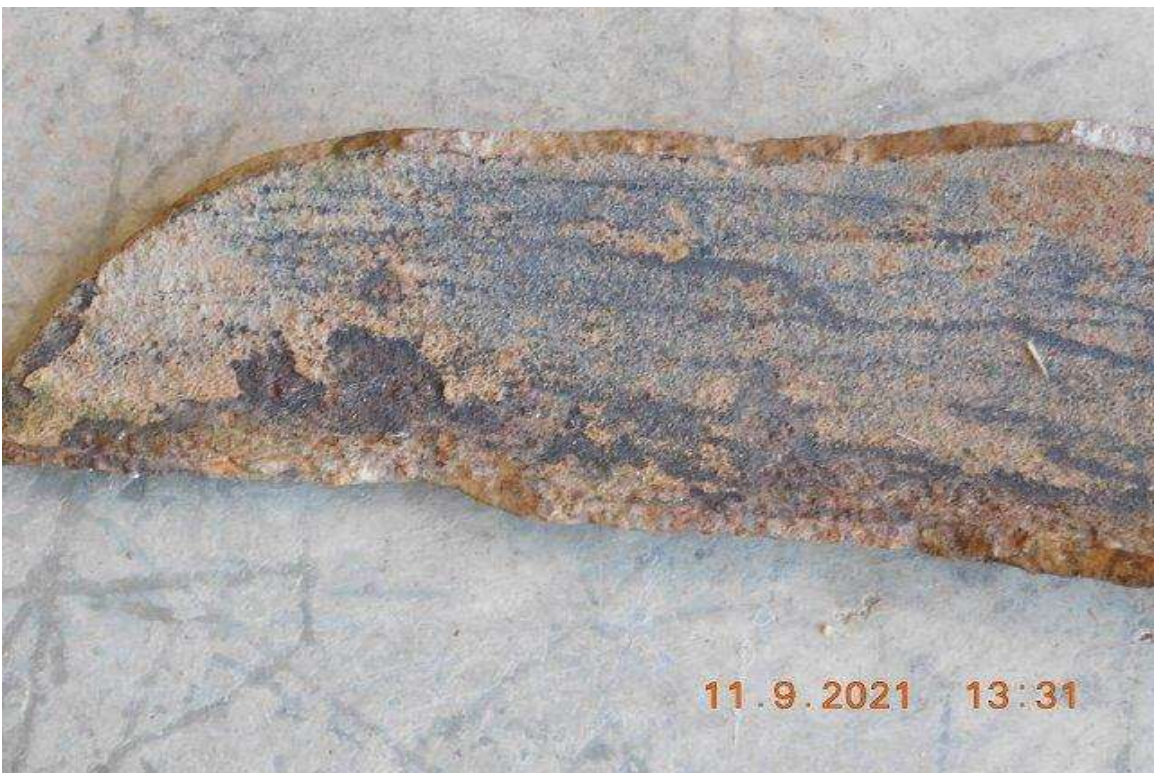
PHOTO 52 - AREA LEFT OF PHOTO 51
