RE: Petition of the Borough of Royersford, Pennsylvania for Emergency Order  
Docket No. P-2025-XXXXXXX

PETITION OF THE BOROUGH OF  
ROYERSFORD, PENNSYLVANIA FOR  
EMERGENCY ORDER

3. This petition concerns two defective railroad crossings within the Borough that are part of the "Harrisburg Line" owned and operated by NS.

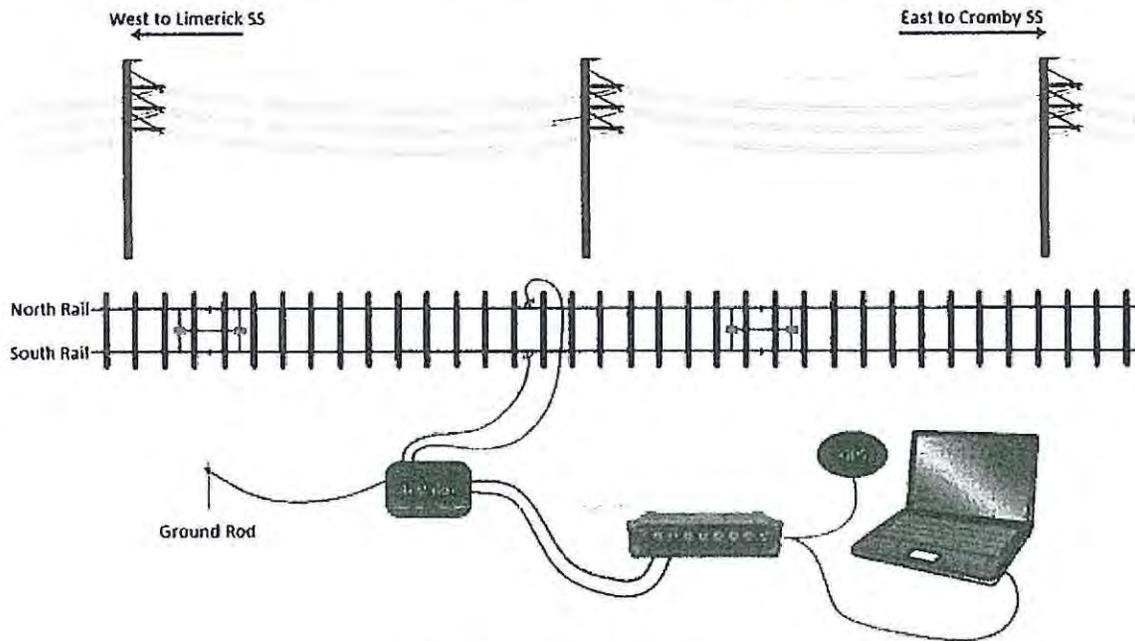
Figure 1: Rail Profile Test Setup

This section gives a brief description and objective for each test or data set that was collected as part of this investigation. During follow up measurements, the Fluke 117 DMM was substituted for the DEWESoft data acquisition unit in the interest of time. The test configuration which was used to profile the rails including rail to ground, rail to rail, and frequency spectrum measurements is shown in Figure 1.

Measuring the rail to ground voltage identifies the potential between the rails and the earth in close proximity. In addition to high impedance rail voltage measurements, touch potential for humans was also tested with the same setup. The test box shown in Figure 1 between the data acquisition unit and the rail connections allows measurements to be made with a series connected  $500\Omega$  or  $1000\Omega$  resistor in addition

to the high impedance measurement from rail to ground. The ground reference is a temporary ground rod driven about one foot into the ballast. The voltage across the resistor is measured and current through the resistor is calculated in order to identify the human touch potential. The measured current values are compared against known levels to make an assessment on personnel hazards.

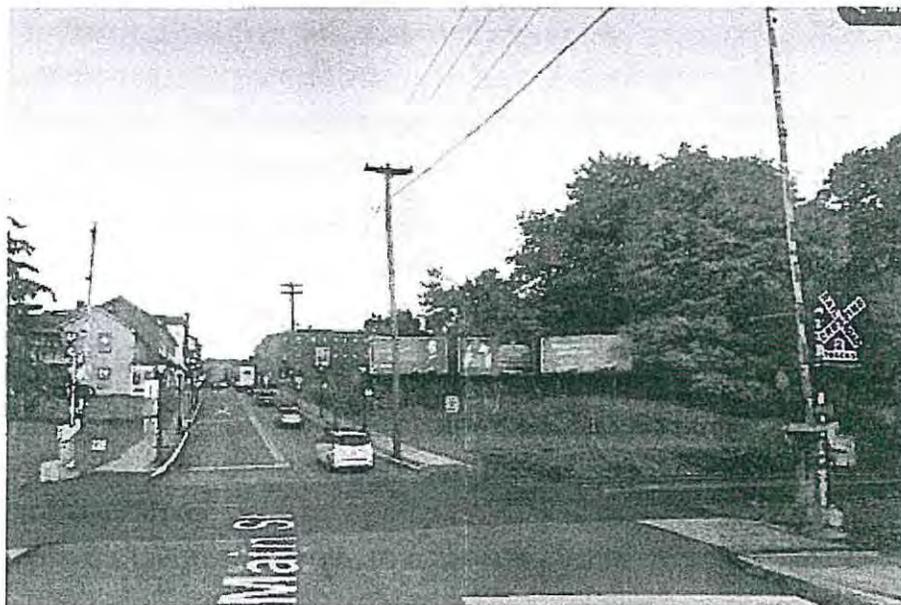
Looking north on Main Street at NS crossing
