Pursuant to your request, the writer conducted a metallurgical evaluation on the submitted section of cast iron gas piping pertaining to the above referenced matter. On November 30, 2021, a gas explosion reportedly occurred at 815 Jackson Street, Philadelphia, Pennsylvania. Subsequently, Philadelphia Gas Works (PGW) launched an investigation for the source of a potential gas leak. As a result of the investigation, PGW's response team located a breach in a 4-inch diameter cast iron pipe located at/near the residence located at 815 Jackson Street (between S. 8th Street and S. Mildred Street) and attributed it to the gas leak (**Figure 1**). The breached section was excavated near the subject residence and stored at the facilities of PGW (**Figures 2 – 3**). It was understood that the Pennsylvania Public Utility Commission (PA PUC) is investigating the incident and, per Federal Pipeline Safety Regulations 49 CFR 192.617, requires that the incident pipe section be evaluated for the cause of failure. Upon which, the undersigned was retained to perform a metallurgical evaluation per the request of the PA PUC and PGW.

Re: Philadelphia Gas Works
July 15, 2022
Page 2 of 29

ITEM A – Extern

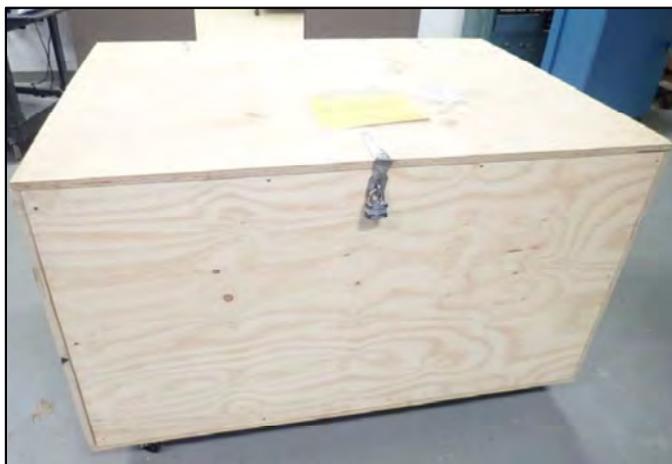
Photo No. 1 (W-6491-D-005.JPG – cropped)

The subject pipe section and corresponding pipe segment were supplied inside a padlocked wooden crate whereby a key was provided to gain access (**Photo No. 1**). Two pipe sections were contained inside the crate and were identified as **ITEM A** and **ITEM B** (**Photo Nos. 2 – 3**). The pipe sections and corresponding cut/removed samples were returned to the respective crate and locked at the end of each work day, except for the samples that were shipped to an independent testing laboratory while maintaining chain of custody, which were eventually returned to the respective crate upon completion of mechanical testing and chemical analysis as per the March 7, 2022 protocol. As noted above, **ITEM B** was reserved for sampling should **ITEM A** not have sufficient length for testing per the protocol. The following testing was performed on **ITEM A** only.

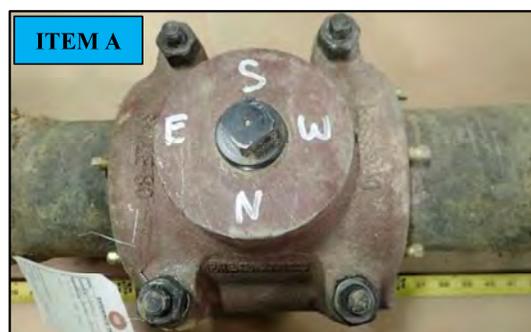
Photo No. 5 (W-6491-D-077.JPG – cropped)

ITEM A consisted of a 49-inch long, 4-inch diameter cast iron pipe with a metal pipe repair clamp (Dresser® Style 80 Repair Clamp) located in the approximate middle of the pipe section (**Photo Nos. 4 – 5**). A paper tag attached to the pipe section was marked “*DATE: 12/1/2021; LOCATION: 815 Jackson Street; DESCRIPTION: 4" CIOC gas main.*” Handwritten markings found on the surface of the clamp identified the TOP of the pipe and North (N), South (S), East (E), and West (W) directions denoting orientation as installed in the ground. It was understood that during the investigation process PGW workers installed a repair clamp across the breach, which was attributed to the reported incident, to secure the damaged region.

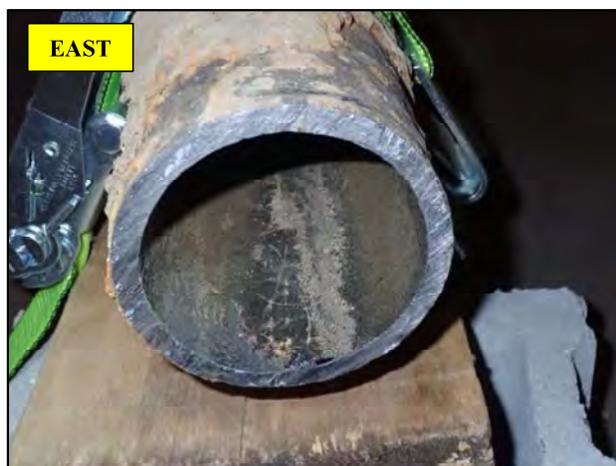
Photo No. 6 (W-6491-076.JPG)

Both the EAST and WEST ends exhibited circumferential cuts (**Photo Nos. 6 – 7**, respectively). Visual examination of the EAST and WEST ends of **ITEM A** revealed the presence of darkened regions along cut surfaces, suggesting graphitization, which reduces the effective wall thickness by corrosion process. Due to the roughness of the cut surfaces and the fact that the breach did not occur at these ends, these ends were not ground planar for further examination. However, it may be noted that visual examination of the cut surfaces of both ends showed notably sized porosity and voids, which formed at the time of manufacturing (**Photo Nos. 8 – 9**).

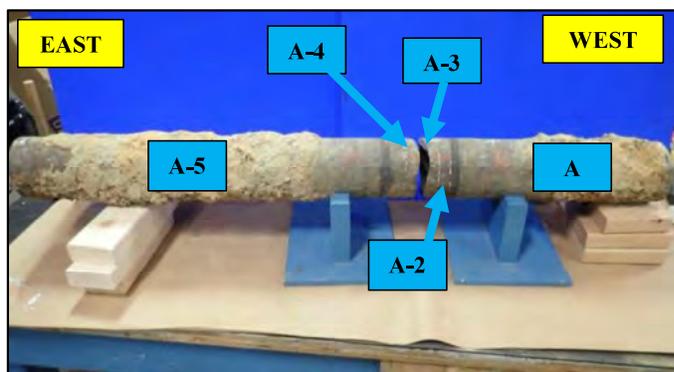
Photo No. 15 (W-6491-D-115.JPG – cropped)

In order to document the sections to be cut/removed from **ITEM A**, the sections of the mating fracture surfaces were subsequently marked and identified as follows (**Photo Nos. 15 – 16**):

- A WEST end remained as “parent” item
- A-1 Soil sample removed from A
- A-2 Ring section removed from the WEST end adjacent to A-3 for hardness and chemistry
- A-3 Mating fracture surface on the WEST end associated with the breach
- A-4 Mating fracture surface on the EAST end associated with the breach
- A-5 EAST end after A-4 was removed – reserved for mechanical testing

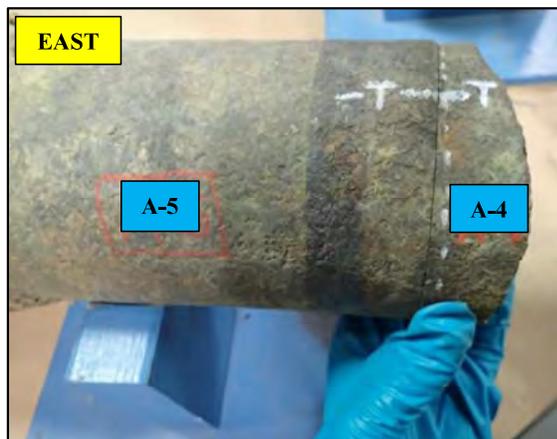
Photo No. 17 (W-6491-D-233.JPG – cropped)

The ring sections identified above were subsequently dry cut using a horizontal band saw (**Photo Nos. 17 – 18**).

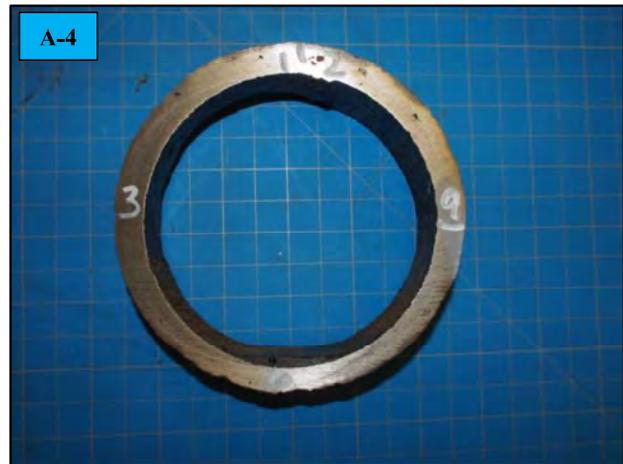
Photo No. 20 (W-6491-E-053.JPG)

Varying degrees of graphitization were observed on the cut edges of ring segments **ITEM A-3** and **ITEM A-4 (Photo Nos. 19 – 20)**. There was no indication of any through-wall penetrations formed by graphitization or any other type of corrosion or mechanical damage as intersected by the cuts. The effective wall thickness of the pipe in those two cross-sections was slightly reduced (up to 15%) as a result of graphitization (**TABLE A**). Notable casting voids were observed distributed along the cut edges of both rings, thereby further reducing the effective wall thickness (**Photo No. 21**).

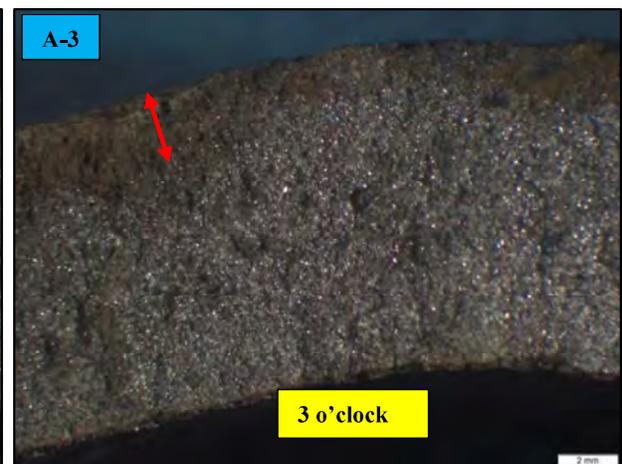
Photo No. 36 (W-6491-B-007.jpg)

The fracture surface was then examined via stereomicroscopy (**Photo Nos. 35 – 38**). Microscopic examination of the fracture surface showed brittle mode fracture of typical gray cast iron. Varying degrees of graphitization were noted along the OD surface. A notable amount of voids was observed near the 6 o'clock position.

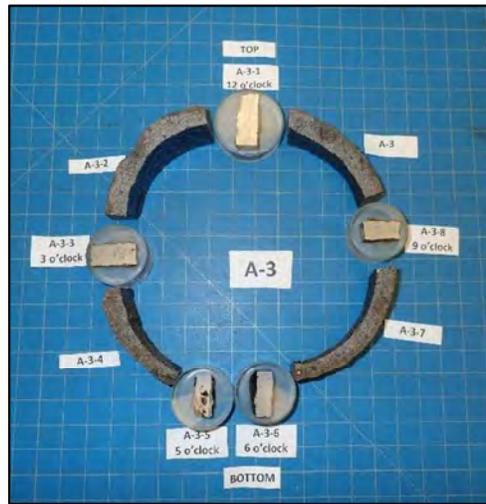
Photo No. 39 (W-6491-G-001.JPG - cropped)

Microspecimens intersecting ring section **A-3** were prepared using standard metallographic procedure as per ASTM E3-11(2017) "*Standard Guide for Preparation of Metallographic Specimens*" (**Photo Nos. 39 – 44**). As per the protocol, a minimum of four microspecimens were taken for microstructural studies, along the circumference at the 12, 3, 6, and 9 o'clock positions and the samples were identified as **A-3-1**, **A-3-3**, **A-3-6**, **A-3-8**, respectively. In addition to the originally proposed microspecimens for ring section **A-3**, a fifth microspecimen (**A-3-5**) was prepared intersecting suspected porosity based on visual examination and radiographic studies at the 5 o'clock position. The microspecimens were then examined via Light Optical Microscopy (LOM) in both the unetched and etched conditions.

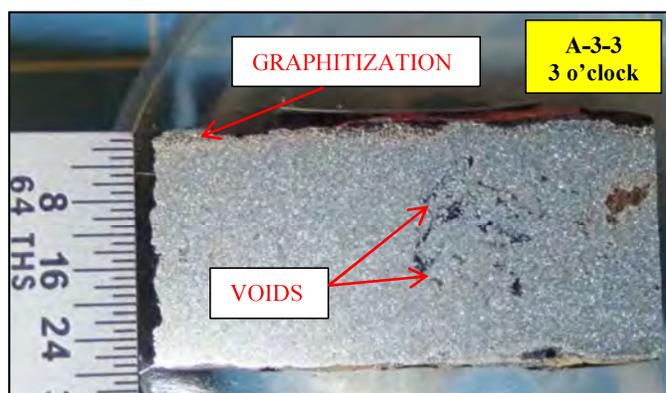
Photo No. 46 (W-6491-G-045.JPG – cropped)

Examination of the as-polished surfaces of the five microspecimens intersecting the fracture surface confirmed and documented the extent of graphitization that occurred over the 123 years of service (**Photo Nos. 45 – 49**). **TABLE B** contains the wall thickness measurements taken at the fracture. The 5 o'clock position (**A-3-5**) showed the most severe amount of corrosion damage resulting in an approximate 43% wall loss that reduced the effective wall thickness of the pipe to 57% of its original wall thickness at the fracture plane. Large-sized voids were also present in this region of the fracture, which further reduces the structural integrity of the gas main to approximately 30%. The 12 o'clock position (**A-3-1**) exhibited graphitization 20% (wall loss) of the original wall thickness while the 6 o'clock position (**A-3-6**) and 9 o'clock position (**A-3-8**) were both 13% (wall loss) at the fracture plane. The 3 o'clock position (**A-3-3**) was 11% wall loss. None of the microspecimens exhibited through-wall graphitic corrosion.

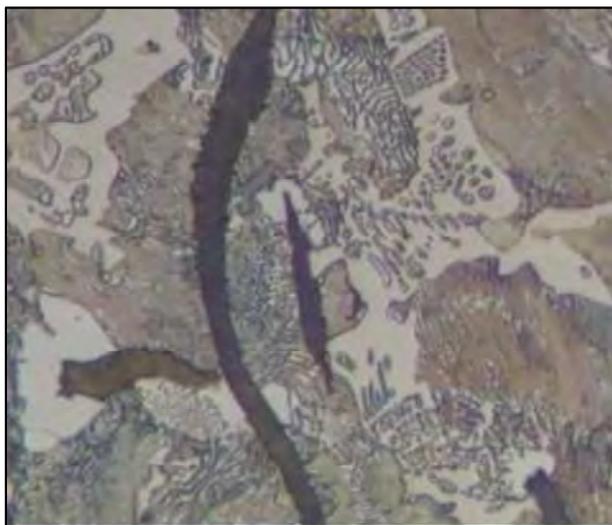
Photo No. 54 (W-6491-H-IMG_101.jpg – cropped)

Random distributions of iron-phosphide eutectic (Fe-P), also known as steadite phase, within a predominately Pearlite phase with some ferrite were also observed throughout the microstructure of all the specimens (**Photo No. 54 / Figure 4**). Steadite has a low melting point (1705°F) and is typically the last microstructural constituent to form upon solidification, which generally occurs at the grain boundaries.

The microstructure, comprised mostly of Pearlite phase with some residual ferrite, was consistent with Class 60 type gray cast iron. However, the presence of steadite phase is a hard constituent that makes the cast iron more brittle and can decrease the mechanical properties of the casting.

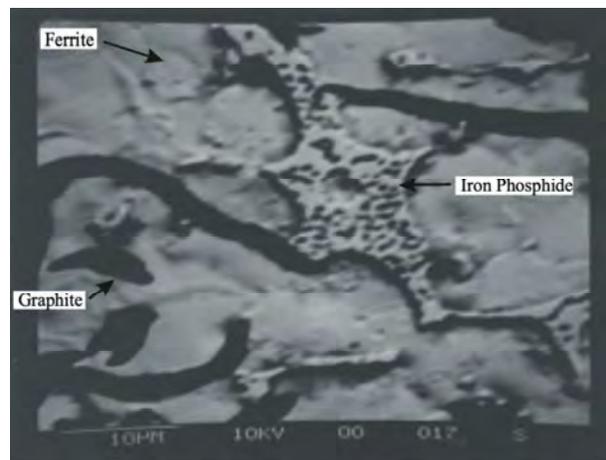
Figure 4 – Example of Steadite (Iron Phosphide)²

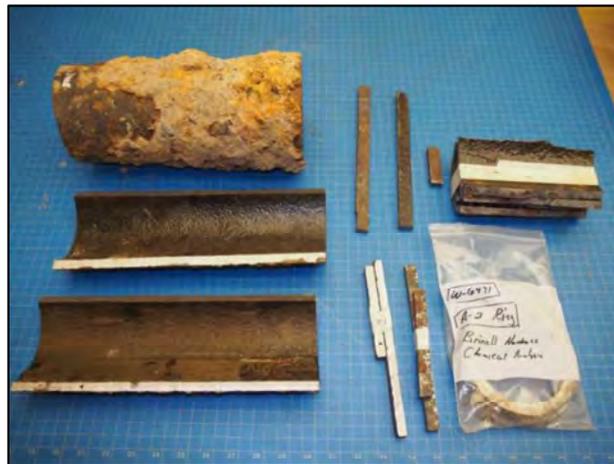
Photo No. 55 (W-6491-F-002.JPG)

As part of the mechanical testing and chemical analysis, **ITEM A-2** and **ITEM A-5** were submitted to AEIS for testing by an independent testing facility (**ATTACHMENT G** – Hardness, Ring, Talbot Strip Test Report, Chemical Analysis, and associated Chain of Custody Form).³ Hardness testing was performed as per the appropriate ASTM standards (see below) while the Ring and Talbot Strip Testing was performed as per ASA Specification A-21.3 “*Cast Iron Pit Cast Pipe for Gas*” (**ATTACHMENT H**). The samples from the mechanical testing were documented and photographed after being returned from AEIS (**Photo No. 55**).

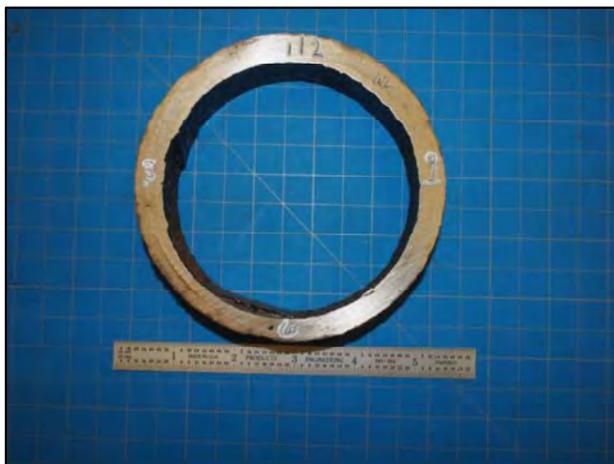
Photo No. 56 (W-6491-E-033.JPG)

Hardness testing was performed on ring segment **ITEM A-2** using Brinell scale with 3000-kg load as per ASTM E10-17 “*Standard Test Method for Brinell Hardness of Metallic Materials*” (**Photo No. 56**). Examination of the ring revealed a large-sized void at the 6 o’clock position (**Photo No. 57**). The following table contains the Brinell hardness values and equivalent Rockwell value (based on published conversion charts):

Reading No.	Brinell (HBW)
1	185
2	159
3	171
Average	172 HBW
Equivalent Rockwell	87 HRB
Required	95 HRB max

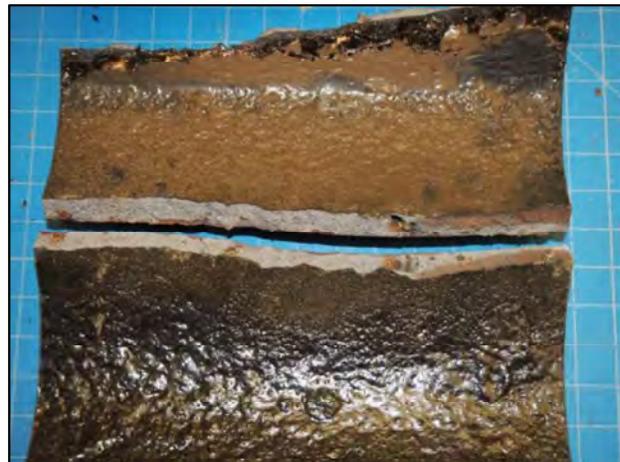
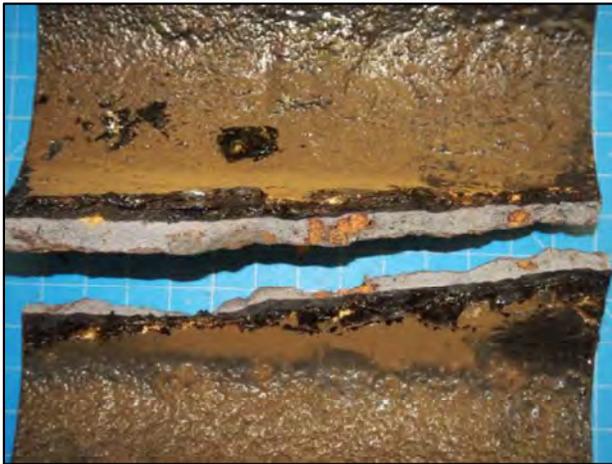
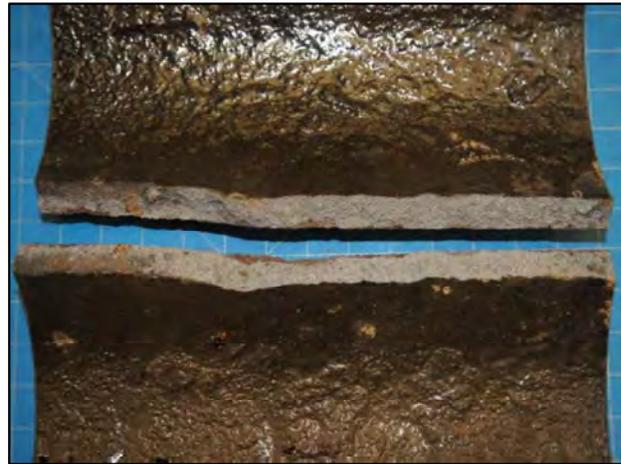
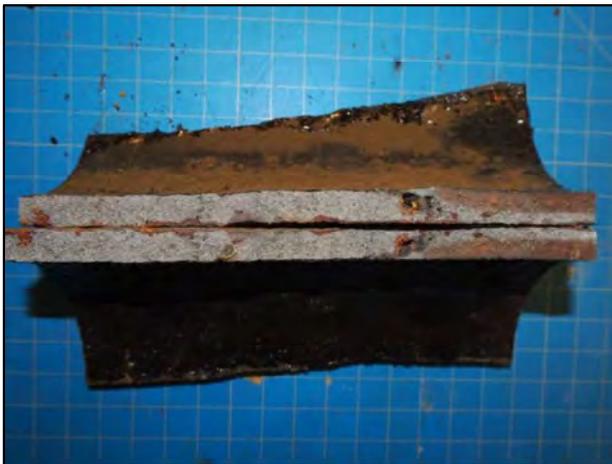
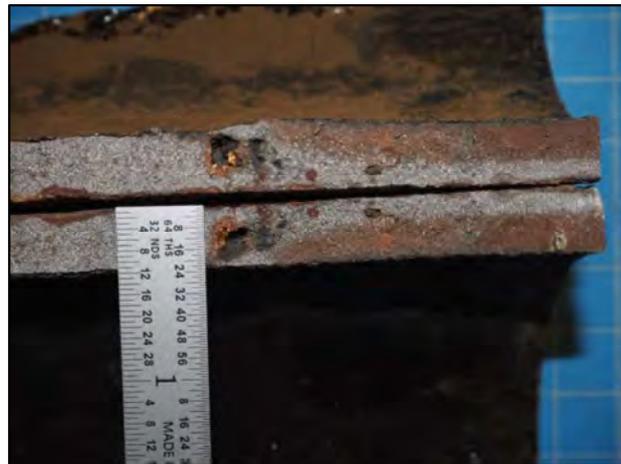
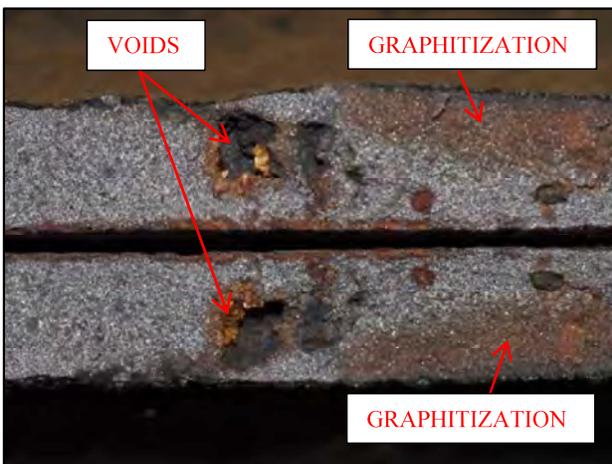
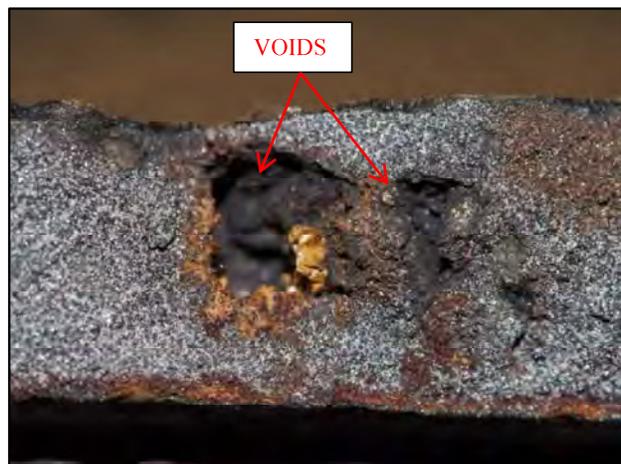
The calculated values from the ring testing indicated that the Modulus of Rupture was **NOT** acceptable or in compliance with the requirements of ASA Specification A-21.3 but the Secant Modulus of Elasticity was considered to be acceptable and in compliance with the requirements of ASA Specification A-21.3.

Examination of the induced fracture surfaces of the Ring Test Sample revealed varying degrees of graphitization and casting voids, similar to that of previously examined and above described ring samples from the cast iron main (**Photo Nos. 58 – 65**).

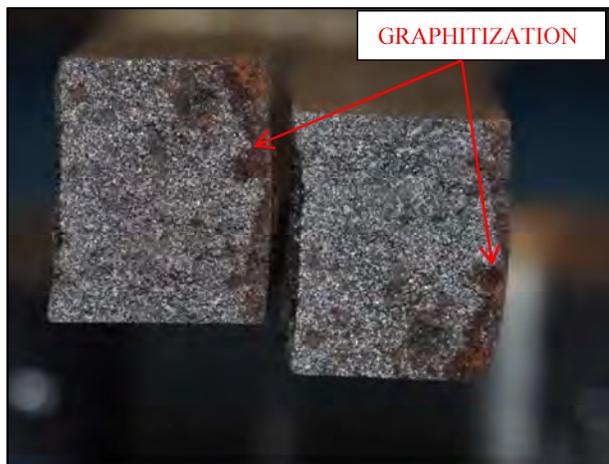
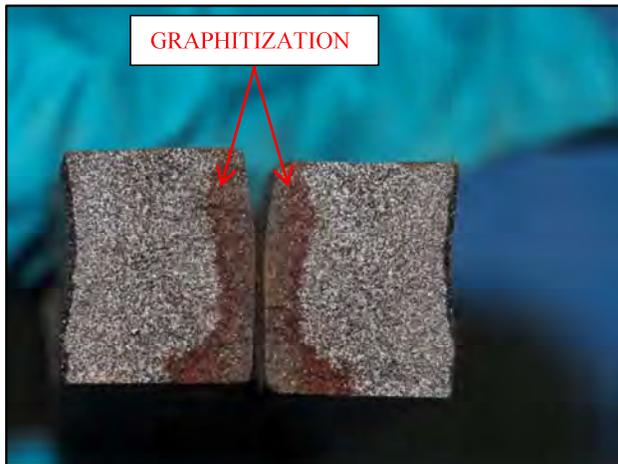
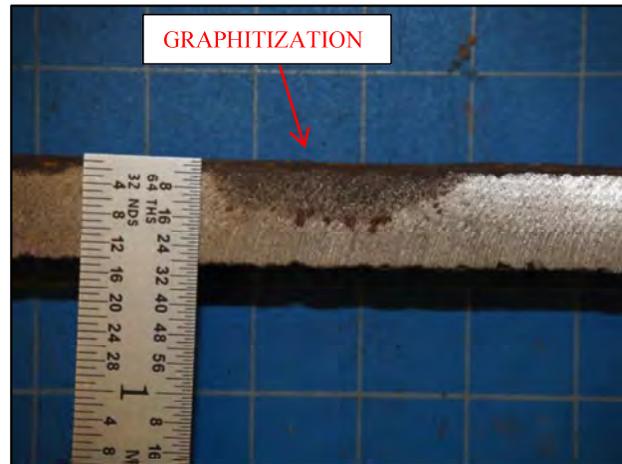
The Modulus of Rupture values of both Talbot strip specimens were **NOT** acceptable (less than 30,000 psi minimum while the Secant Modulus of Elasticity for one of the Talbot strip specimens (No. 2) met the requirement of 10,000,000 psi maximum, respectively).

Examination of the Talbot strip samples after testing revealed a reduction in effective wall thickness due to graphitization (**Photo Nos. 66 – 69**). In addition to the presence of graphitization in the cross-sections of the specimens, the low values may also be attributed to the presence of steadite phase in the microstructure, as observed in the microspecimens prepared from the cast iron main.

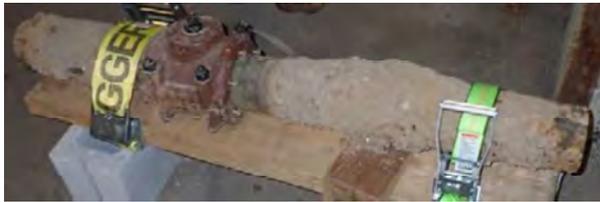
Photo No. 1 (ITEM A)

- A. 49-inch long 4-inch diameter cast iron pipe with pipe clamp spanning fracture location
- B. 47-inch long 4-inch diameter cast iron pipe with service tap

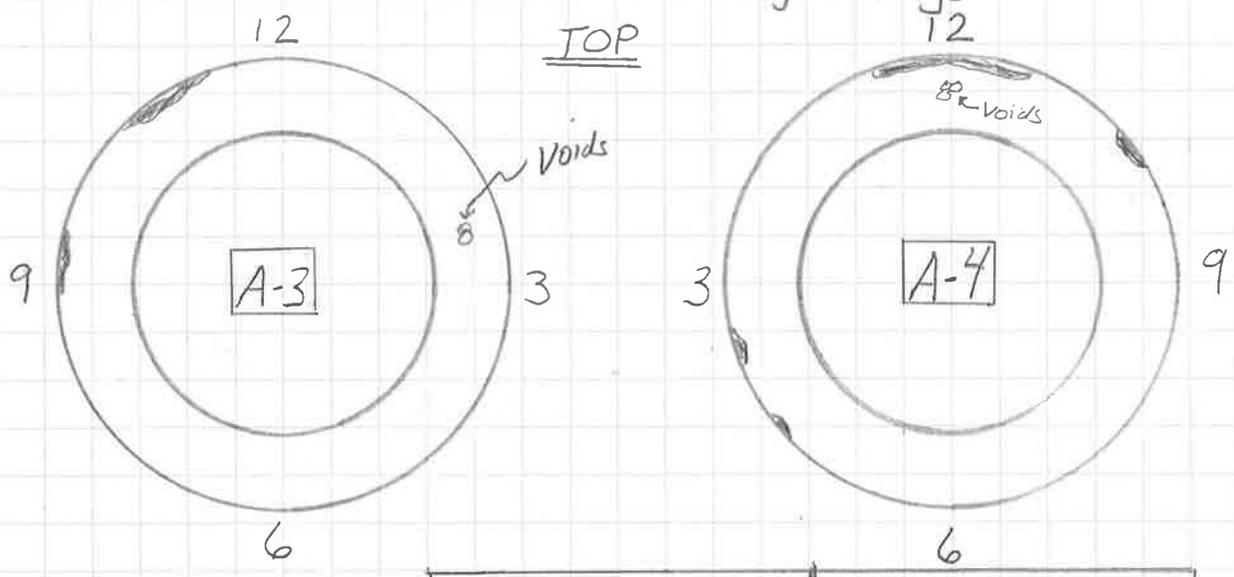
WALL THICKNESS
Measured on Cut Edge of Rings

A-3				A-4				
	1	2	3	6	9	12	3	6	9
Original Wall Thickness, inch	0.4400	0.4305	0.3595	0.3980	0.4430	0.4305	0.3360	0.4040	
Depth of Graphitization, inch	ND	ND	ND	0.0510	0.0645	ND	ND	ND	
Effective Wall Thickness, inch	0.4400	0.4305	0.3595	0.3470	0.3785	0.4305	0.3360	0.4040	
% Wall Loss	0	0	0	13	15	0	0	0

ND = Not Detected

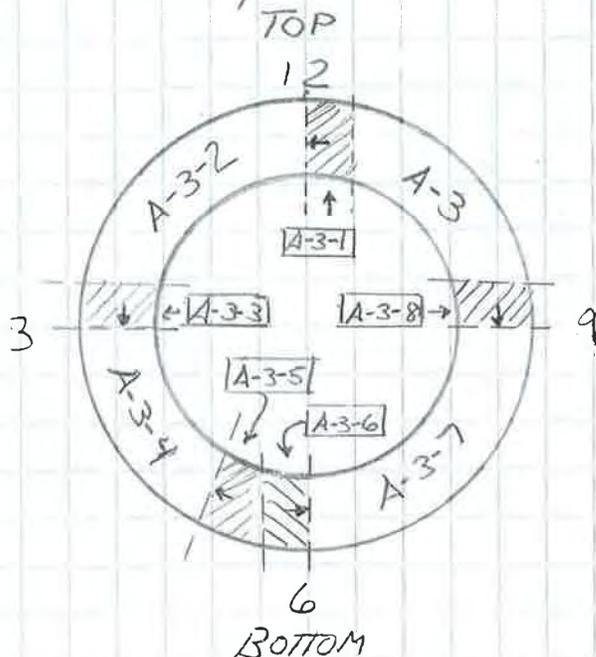
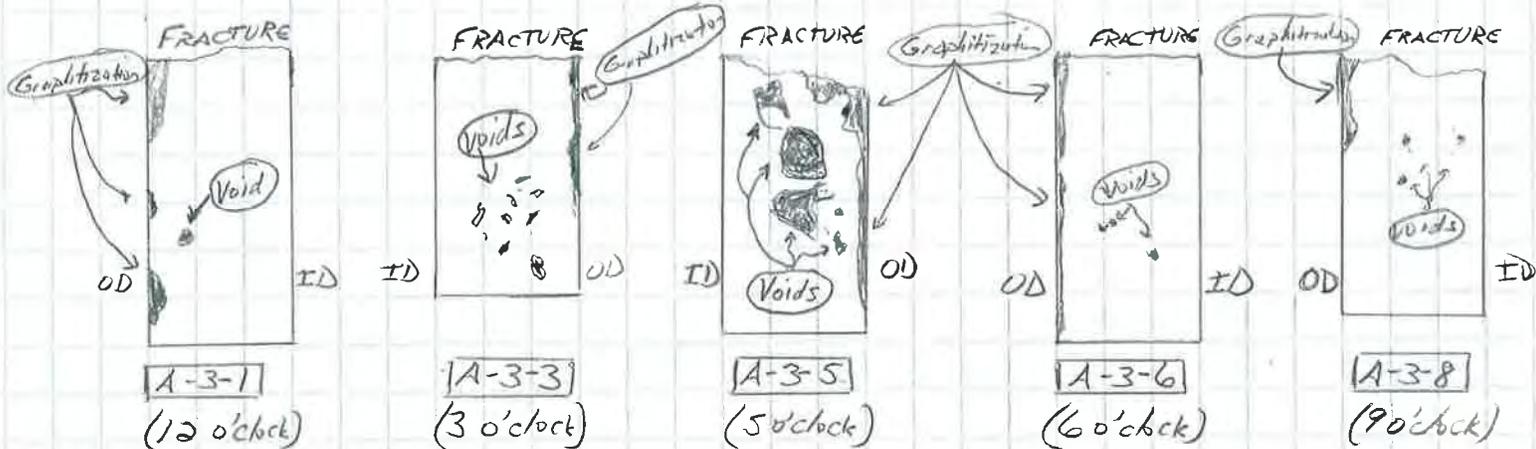
Wall Thickness Measurements at Fracture

A-3				
	12	3	5	6	9
Original Wall Thickness, inch	0.4400	0.4305	0.3535	0.3595	0.3780
Depth of Graphitization, inch	0.0905	0.0465	0.1505	0.0470	0.0510
Effective Wall Thickness, inch	0.3495	0.3840	0.2030	0.3125	0.3470
% Wall Loss	20	11	43	13	13

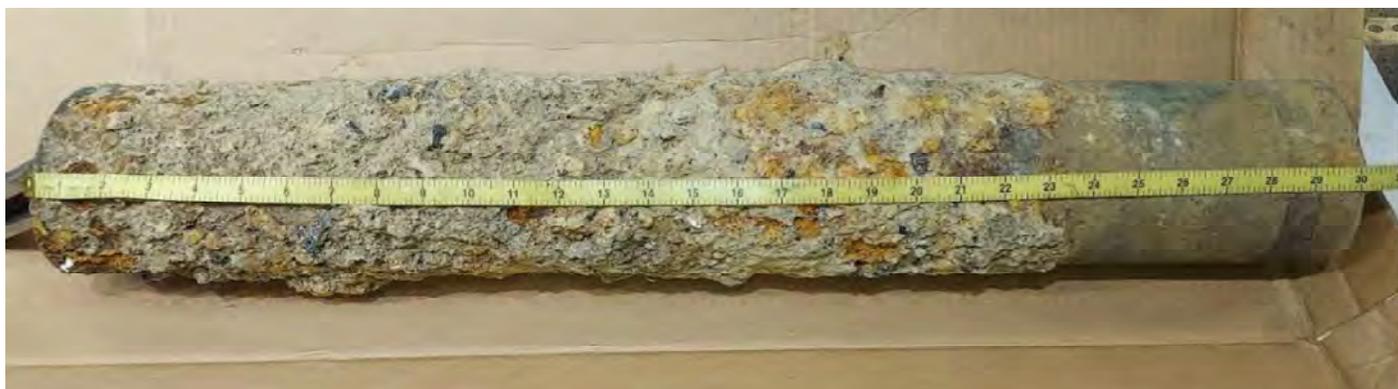
Figure No. 1 Water Main As Received

The chemical analysis and modulus of rupture of the submitted water main **does not conform** to the specified minimum requirement per AWWA C106.
The hardness results and secant modulus of elasticity of the submitted water main conform to the specified minimum requirement per AWWA C106.

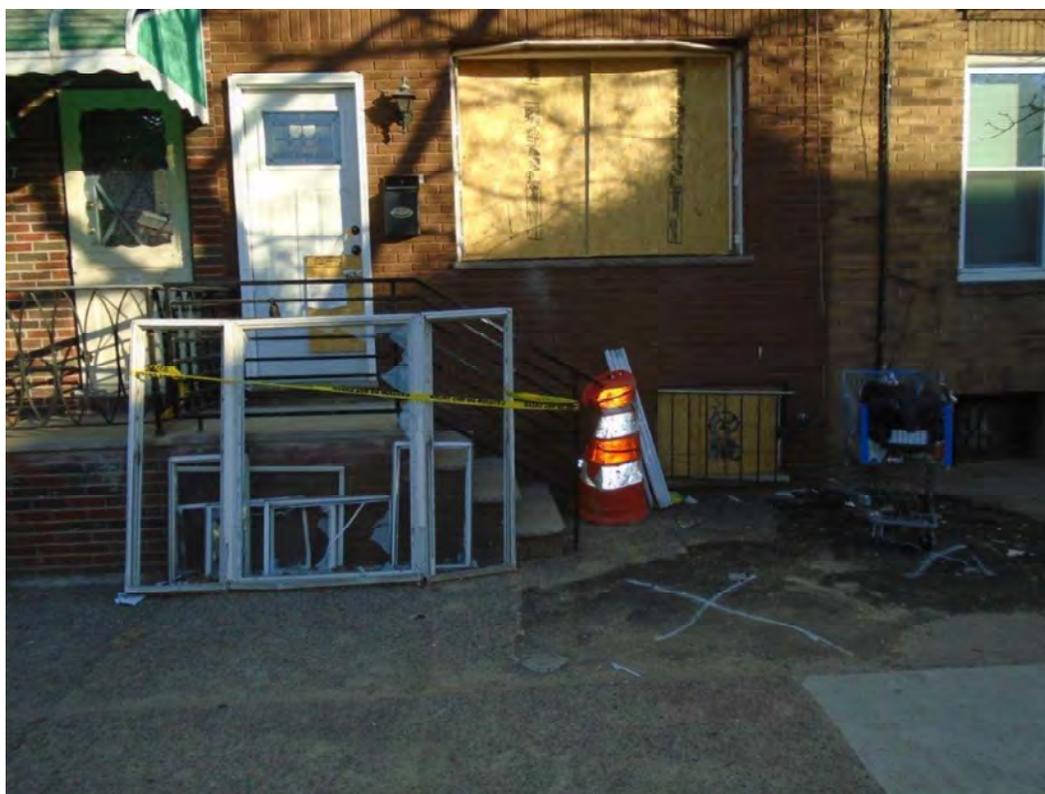
Photograph #2: Front view of 815 Jackson Street.

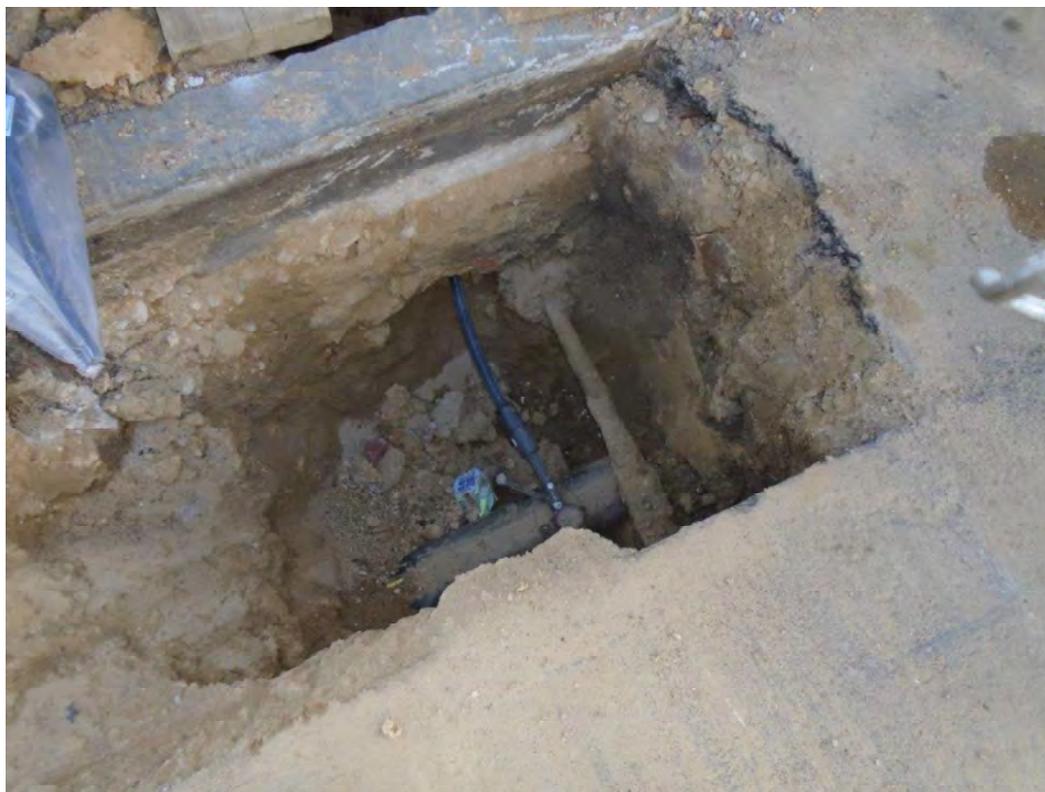
Photograph #4: Gas pipe lateral to 818 Jackson Street.

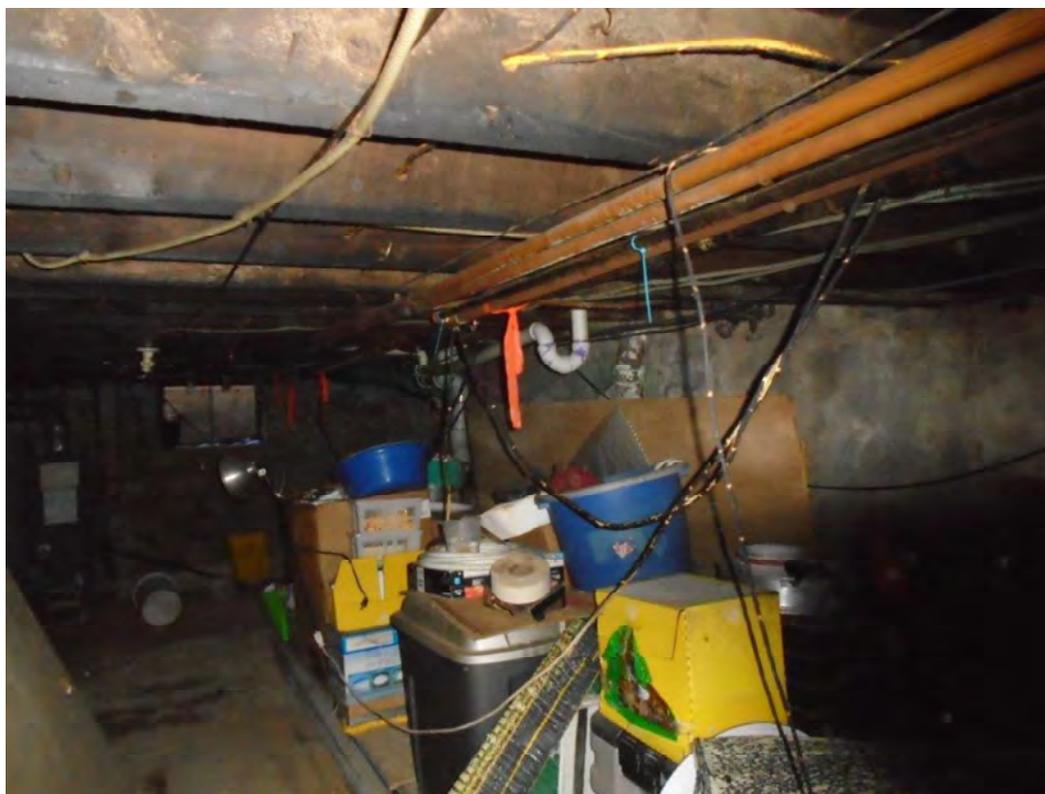
Photograph #13: Natural gas pipes located in basement at 815 Jackson Street.

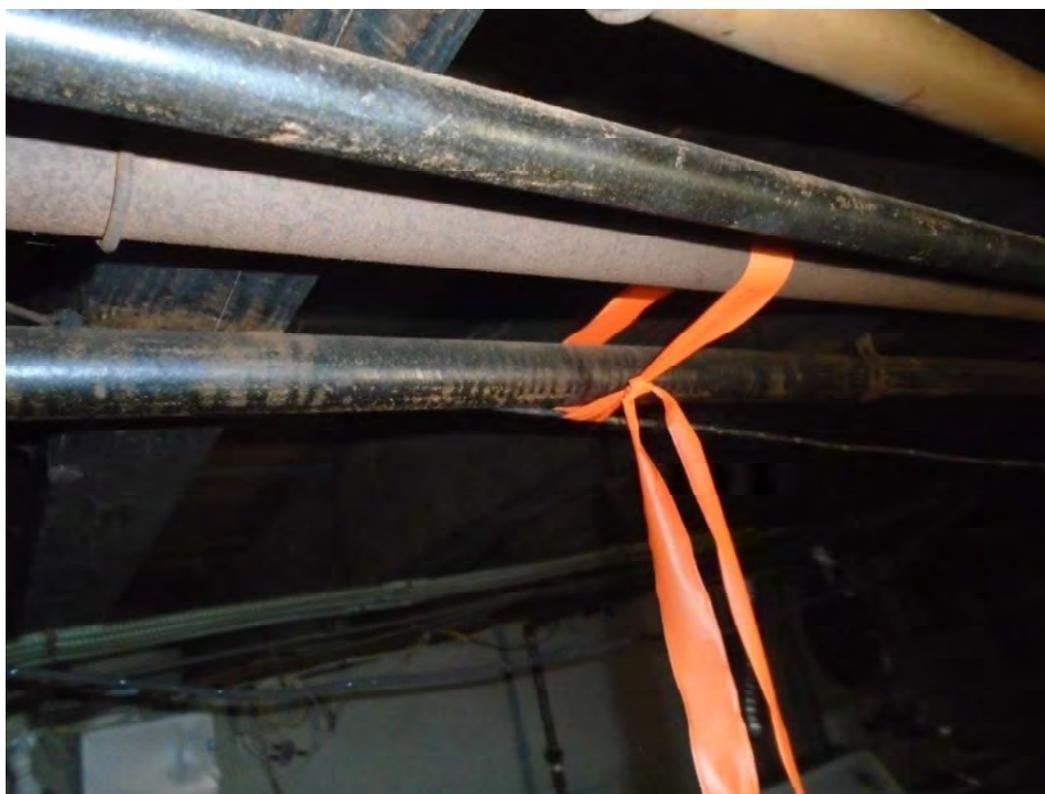
Photograph #14: Natural gas pipes located in basement at 815 Jackson Street.

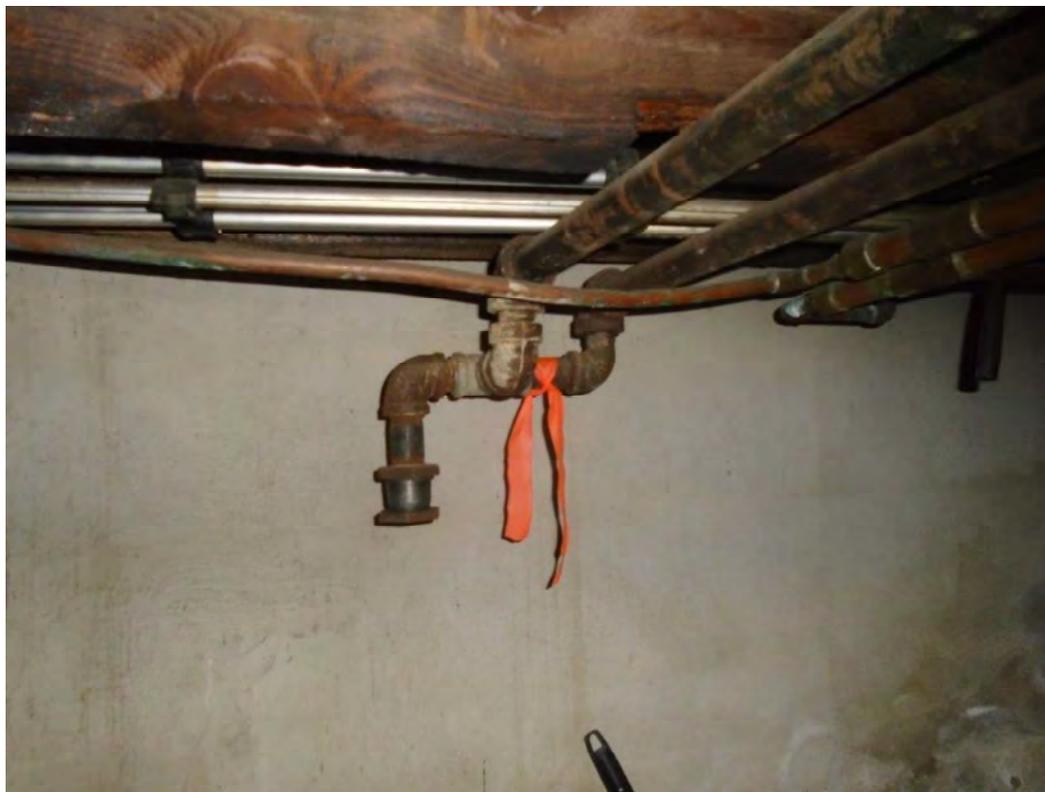
Photograph #17: Gas pipes where gas meter was located.

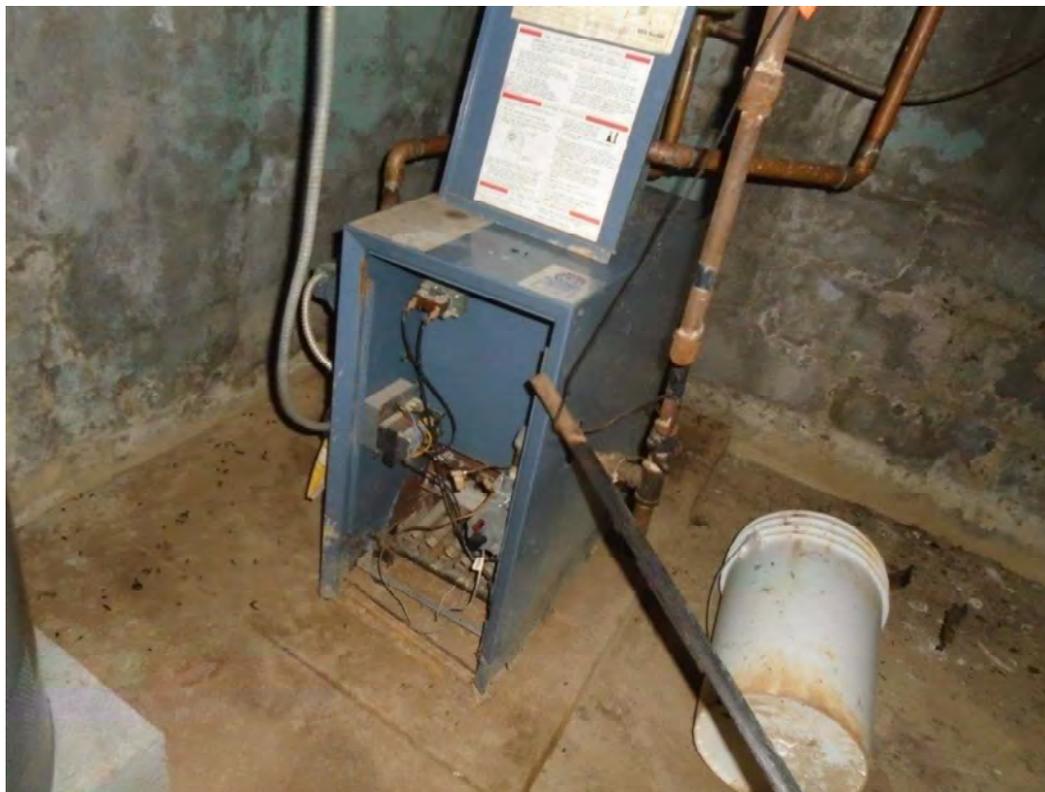
Photograph #27: Natural gas-fired heater in basement.

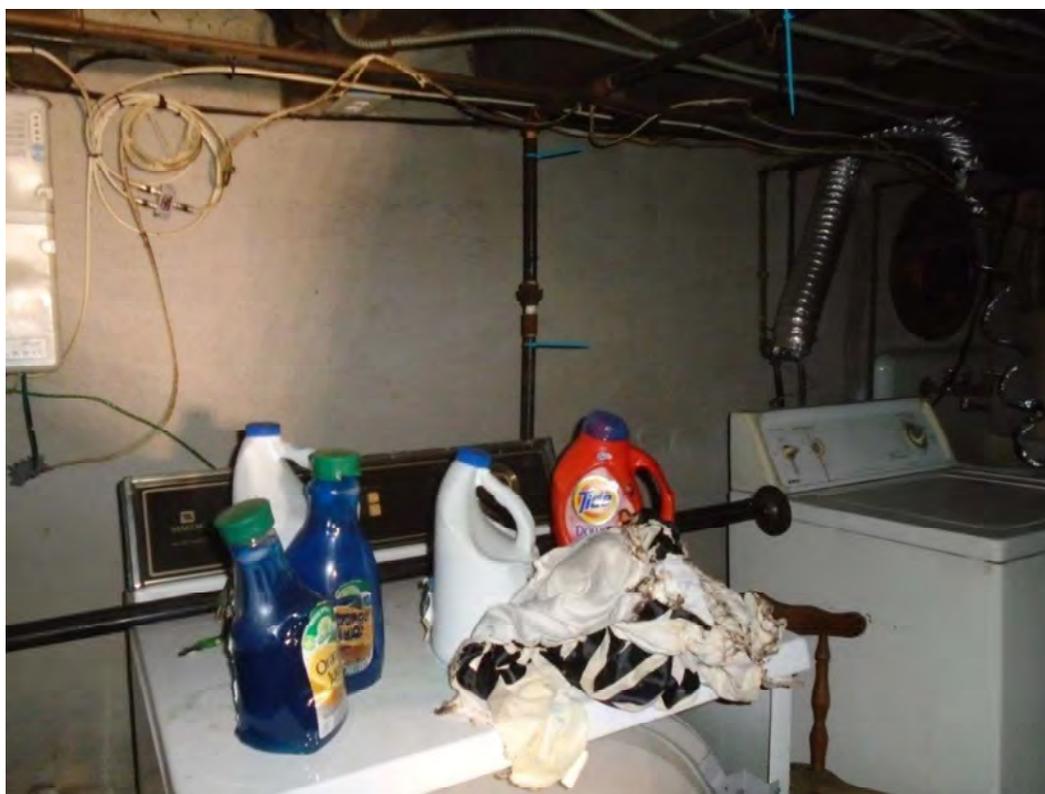
Photograph #34: Melted plastic bag located on dryer.

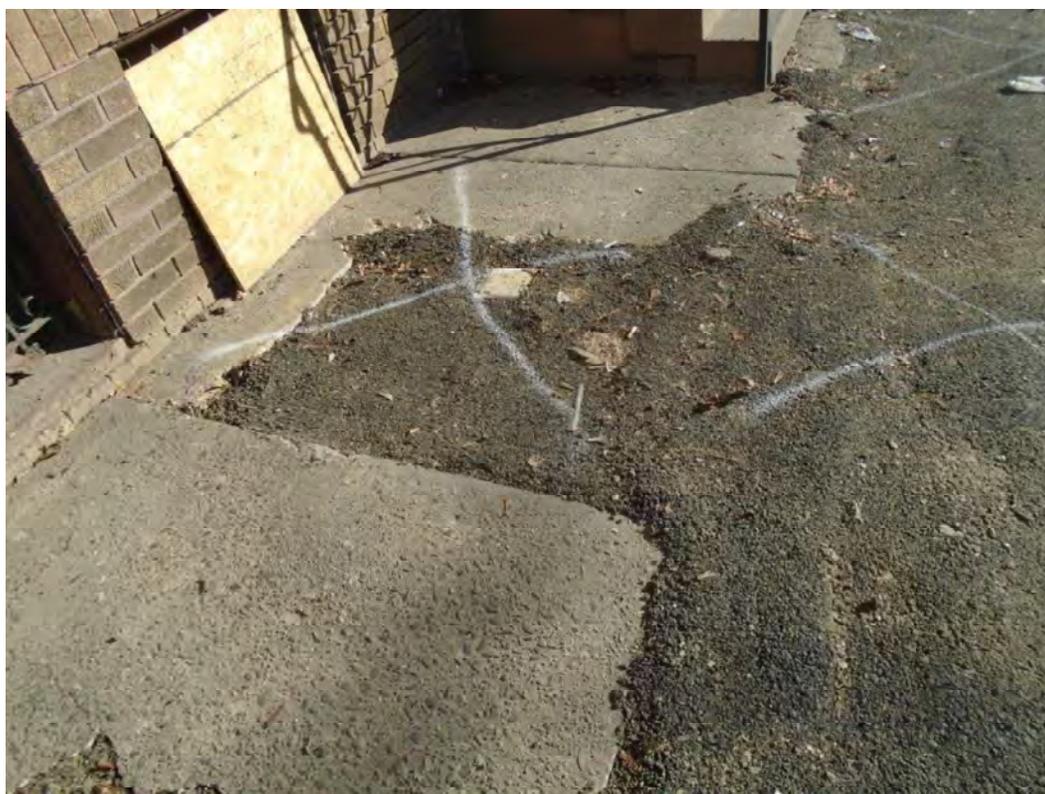
Photograph #37: Sidewalk area in the front of 815 Jackson Street where plumber worked.

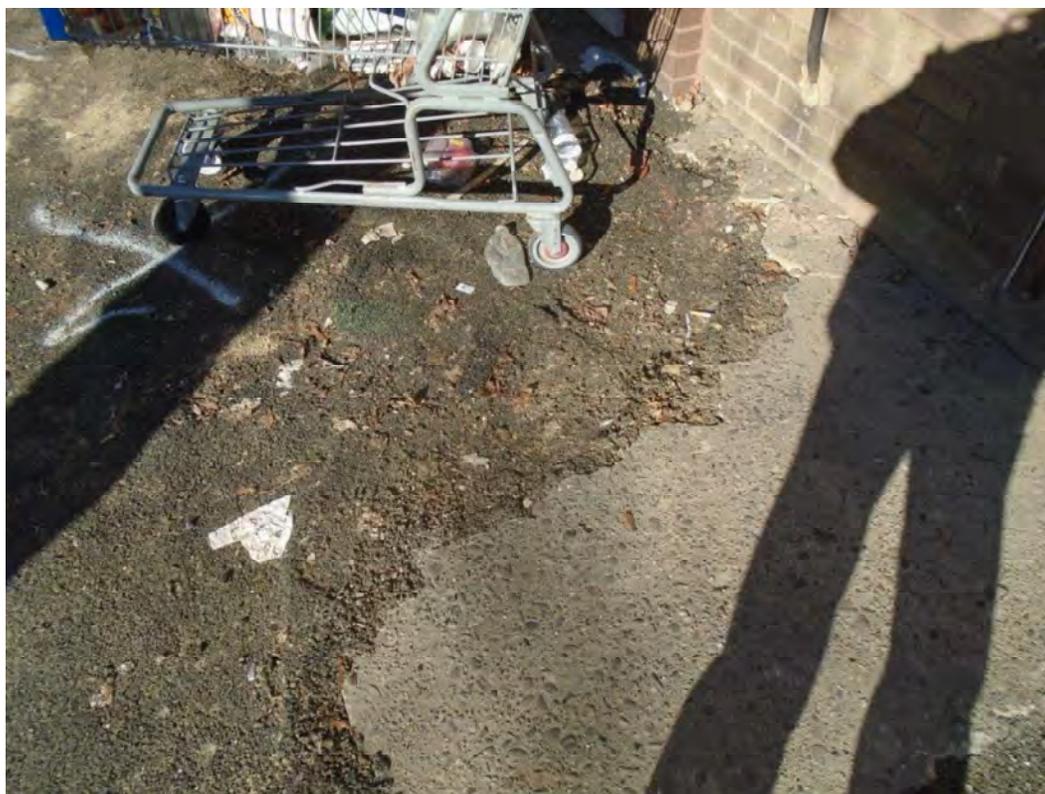
Photograph #38: Sidewalk area in the front of 815 Jackson Street where plumber worked.

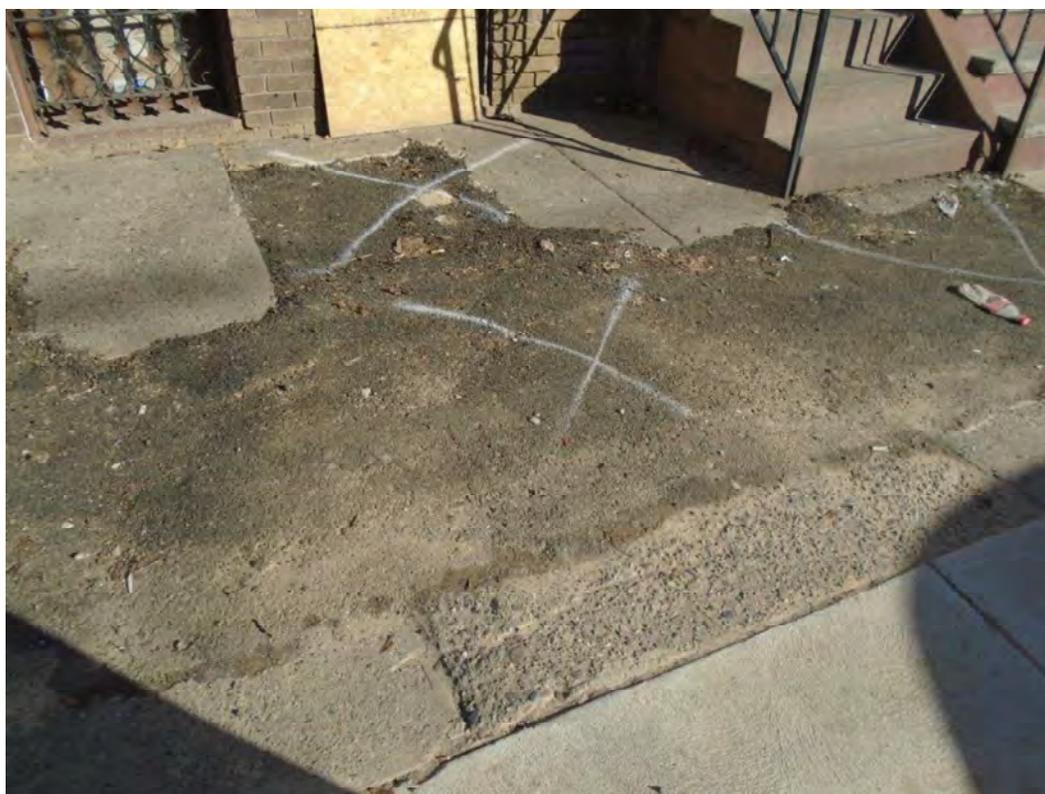
Photograph #39: Sidewalk area in the front of 815 Jackson Street where plumber worked.

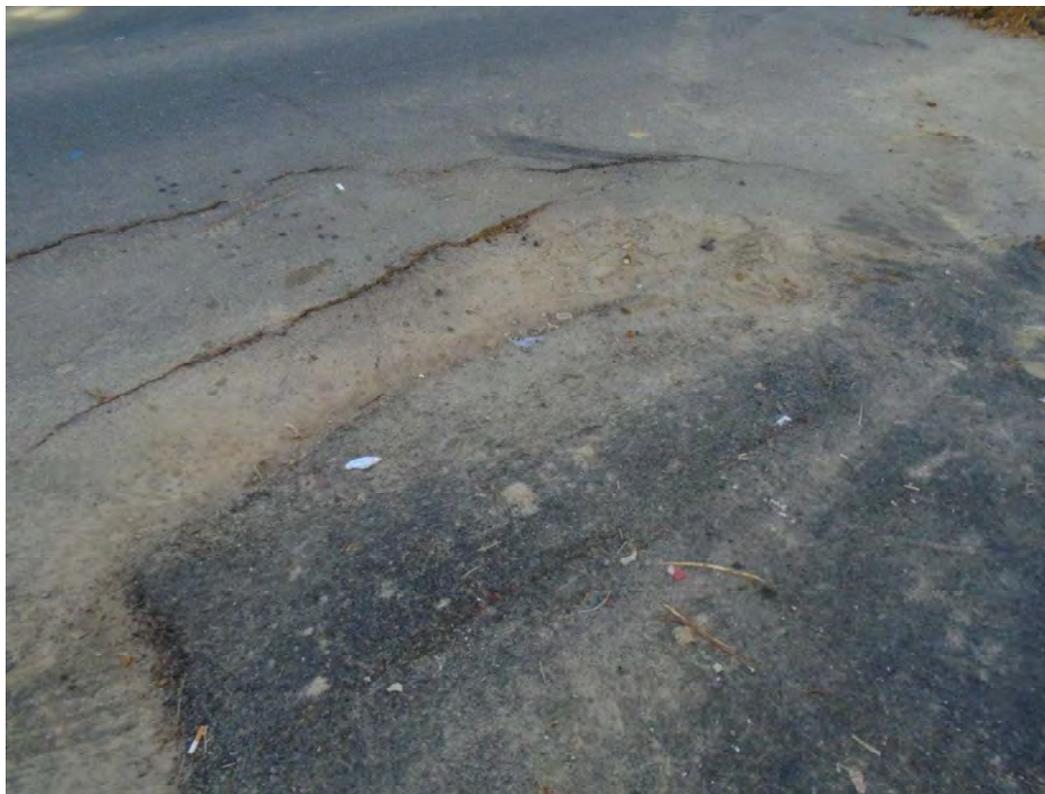
Photograph #40: Sidewalk area in the front of 815 Jackson Street where plumber worked.

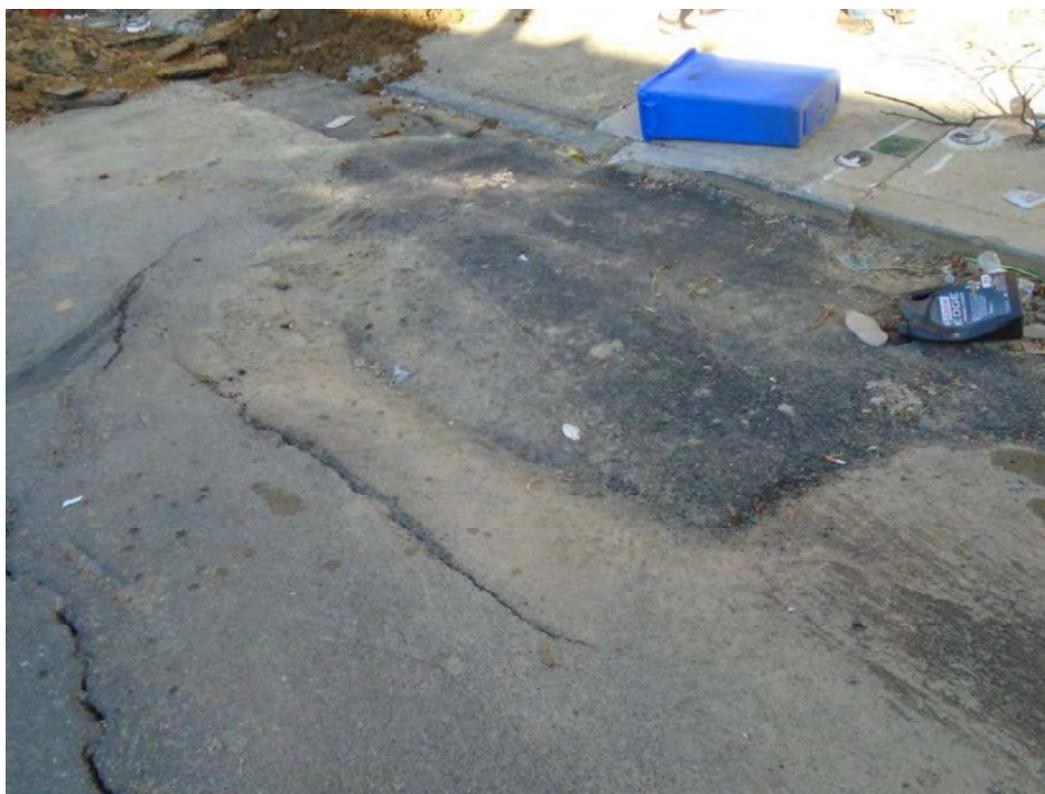
Photograph #41: Ground undermined in the front of 815 Jackson Street.
