Pursuant to your request, the writer conducted a metallurgical evaluation on the submitted section of cast iron gas piping pertaining to the above referenced matter. On November 30, 2021, a gas explosion reportedly occurred at 815 Jackson Street, Philadelphia, Pennsylvania. Subsequently, Philadelphia Gas Works (PGW) launched an investigation for the source of a potential gas leak. As a result of the investigation, PGW's response team located a breach in a 4-inch diameter cast iron pipe located at/near the residence located at 815 Jackson Street (between S. 8th Street and S. Mildred Street) and attributed it to the gas leak (**Figure 1**). The breached section was excavated near the subject residence and stored at the facilities of PGW (**Figures 2 – 3**). It was understood that the Pennsylvania Public Utility Commission (PA PUC) is investigating the incident and, per Federal Pipeline Safety Regulations 49 CFR 192.617, requires that the incident pipe section be evaluated for the cause of failure. Upon which, the undersigned was retained to perform a metallurgical evaluation per the request of the PA PUC and PGW.

Re: Philadelphia Gas Works
July 15, 2022
Page 2 of 29

ITEM A – Extern

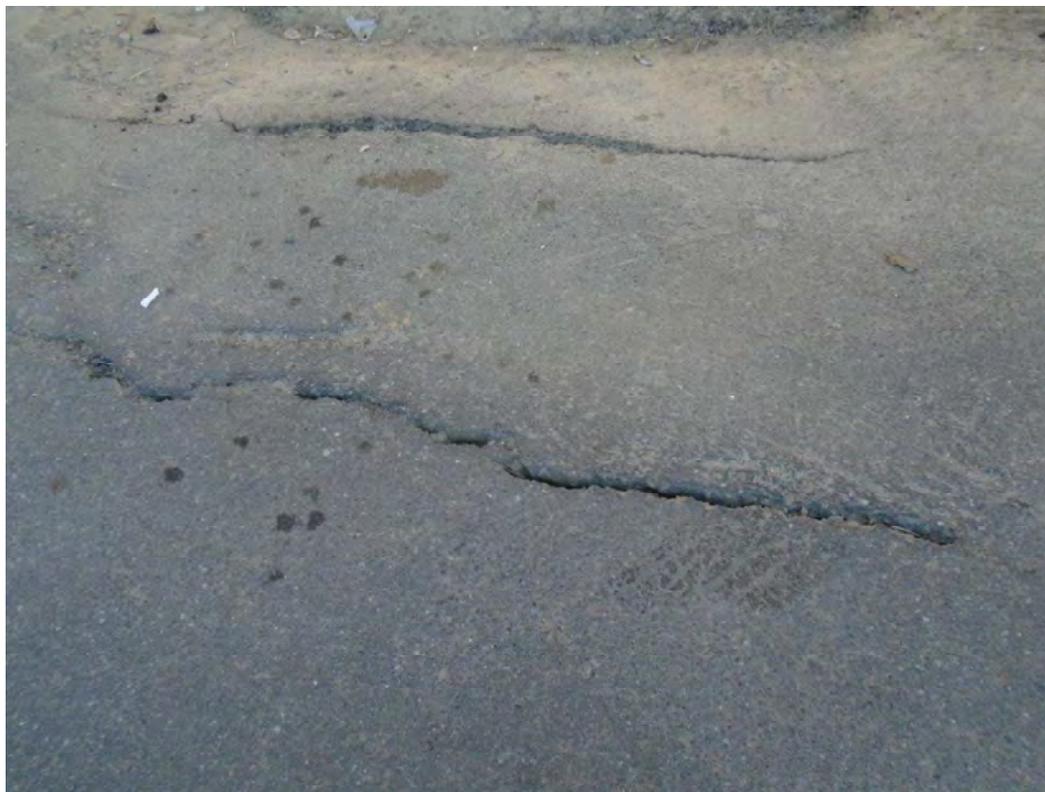
Photograph #42: Ground undermined in the front of 815 Jackson Street.

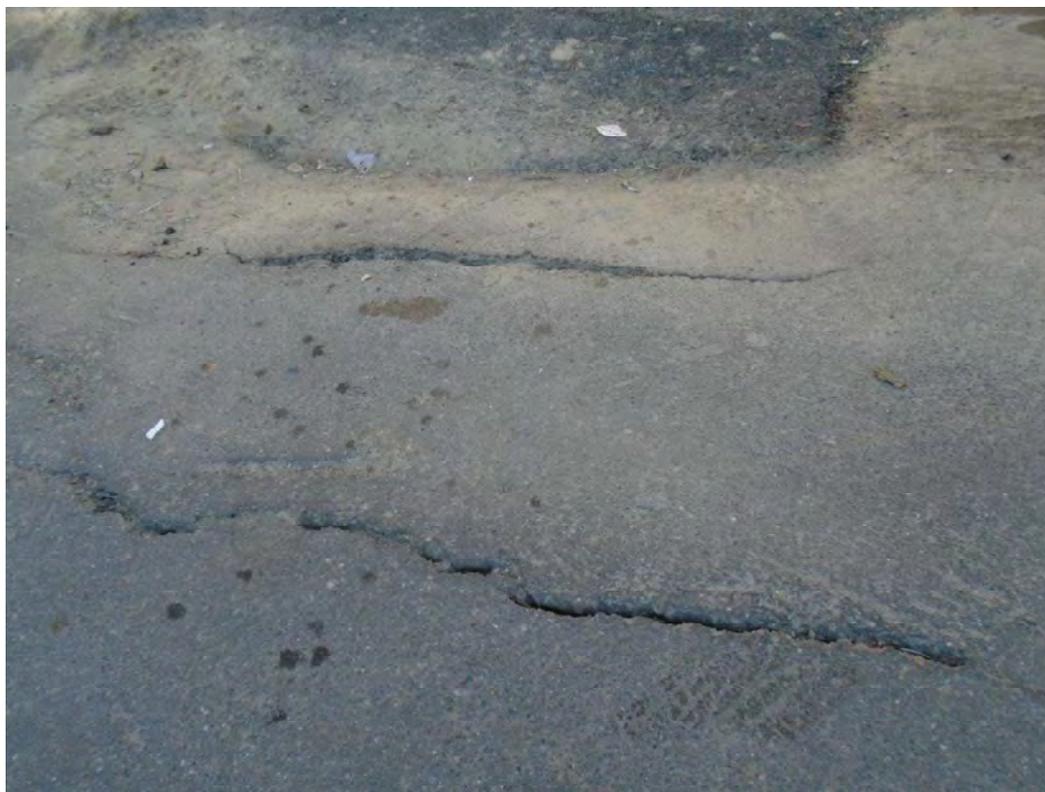
Photograph #43: Ground undermined in the front of 815 Jackson Street.

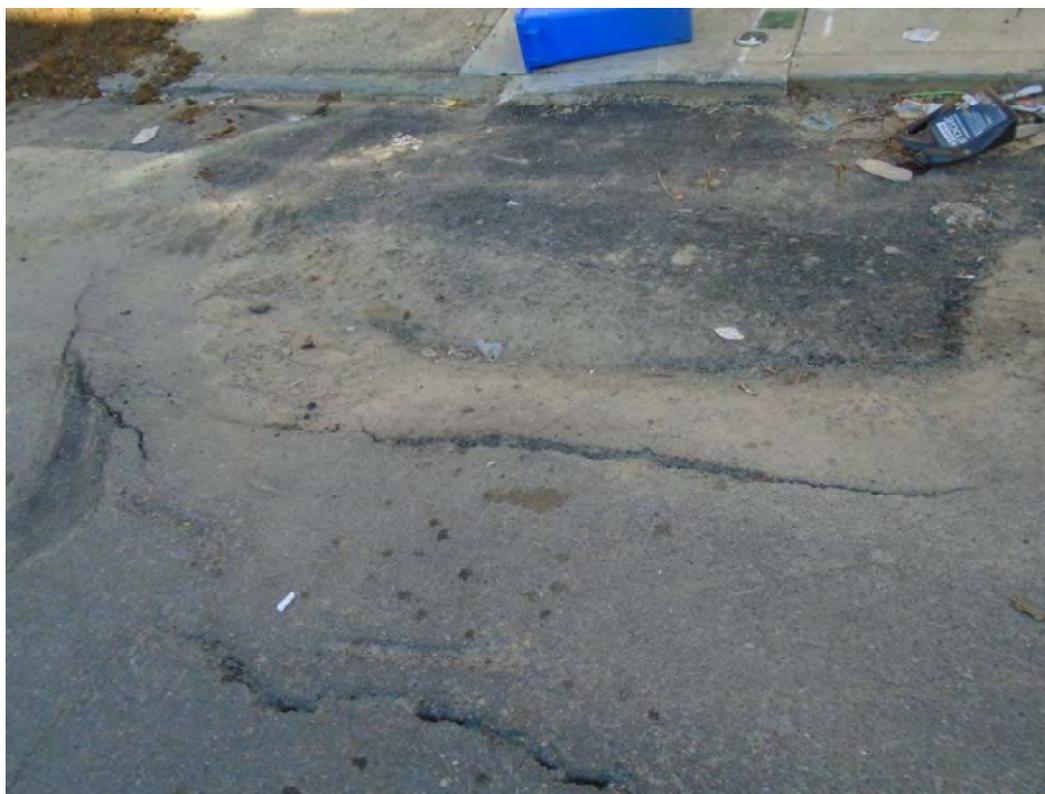
Photograph #44: Ground undermined in the front of 815 Jackson Street.
