**BEFORE  
PENNSYLVANIA PUBLIC UTILITY COMMISSION**

**In re: (1) Application for the reopening of the Randall Avenue Bridge over (crossing AAR # - AAR 530 983 U) AMTRAK-owned railroad tracks located in Bristol Township in Bucks County, PA.**

Randall Avenue  
over  
AMTRAK

**Not for Public Record – Structure Safety Inspection Study**

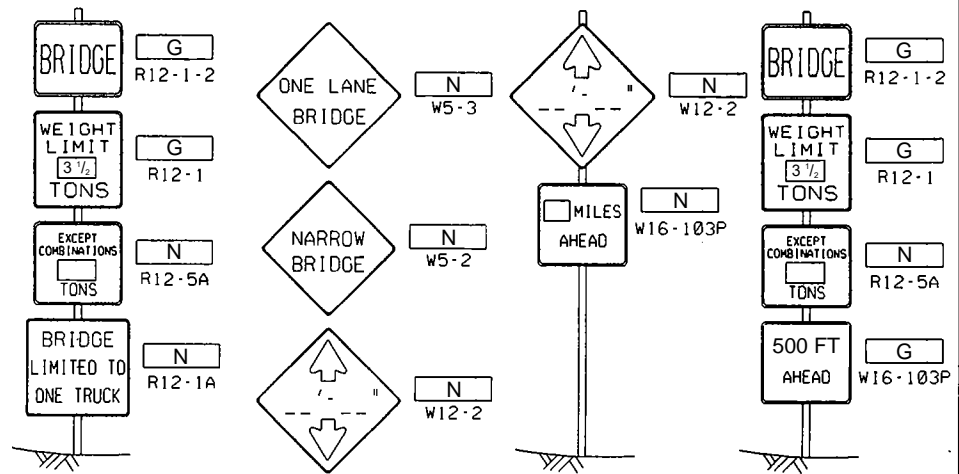
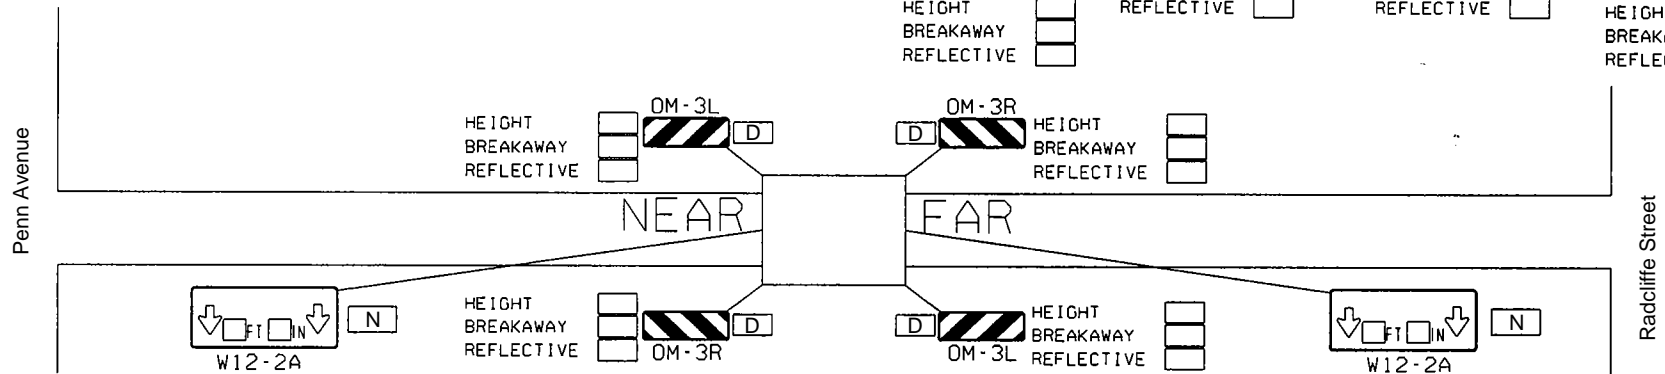
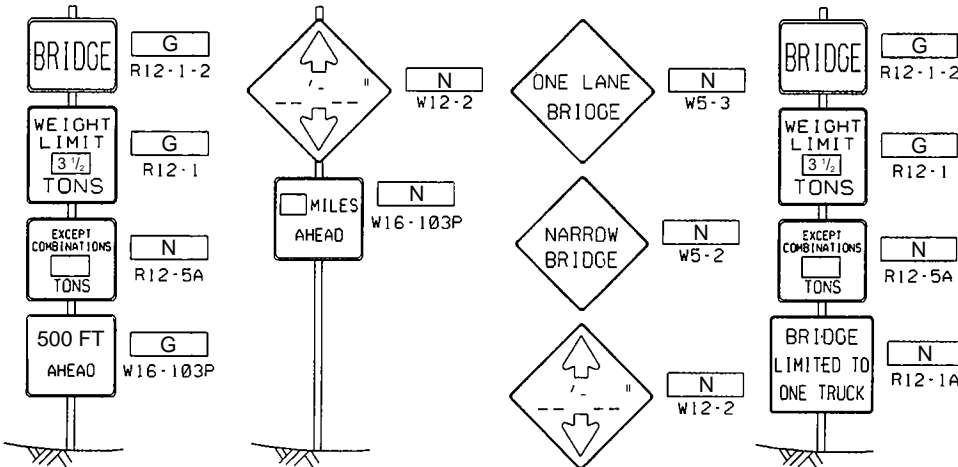
CMN/MAK BRIDGE POSTING SHEET  
7/14/22

**FAR:** An additional load posting is set at the FR corner. All signs are in place and in good condition. The load posting shares a post with the street sign and FR hazard clearance sign.

**Hazard Clearance Signs - NL:** Shares post with supplemental load posting. Graffiti. Minor bend at top.  
**NR:** Shares post with load posting. Minor graffiti.  
**FL:** Too low. Minor graffiti.  
**FR:** Too low, shares post with supplemental load posting and street sign. Minor graffiti, **scraped**.

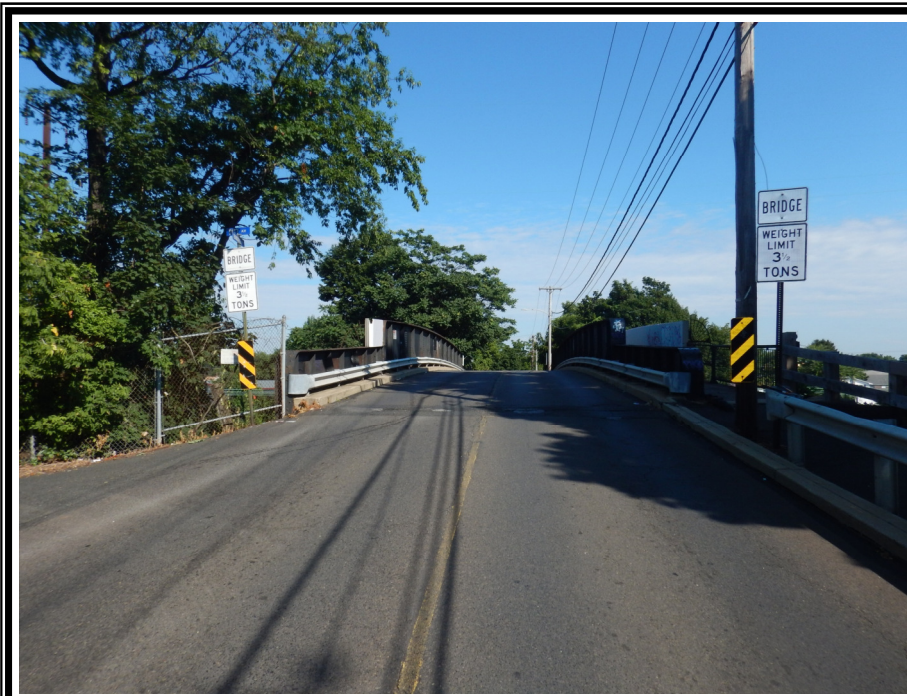
**FAR APPROACH**

All required signs are in place and in good condition.

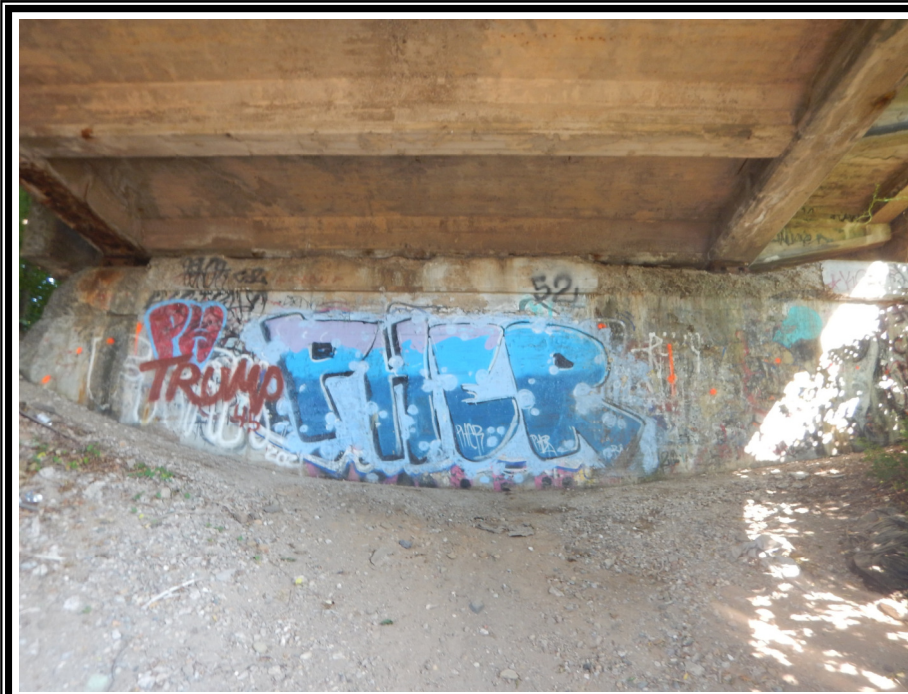
**NEAR ABUTMENT**  
*West*

The bridge seat has 8' long by 20" high by 16" deep spalling in front of the right bearing with very minor bearing loss.

- Repair the severely spalled concrete abutments adjacent to the bearings at each corner. (12 CY)
- Repair the bituminous potholes exposing the joint steel at the near and far transitions. (2 SY)

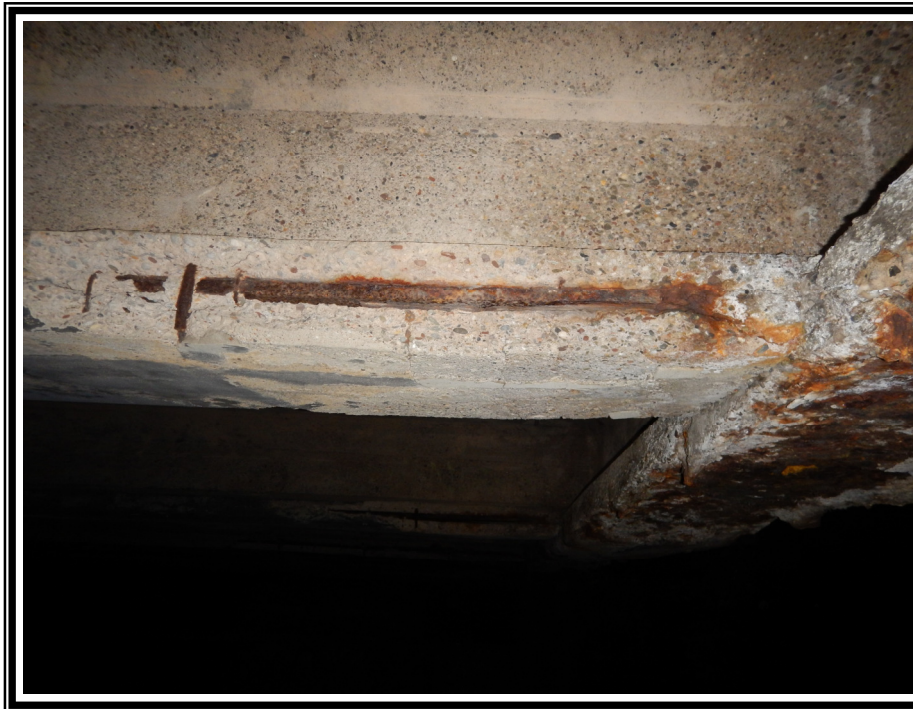
**FLOORBEAM 13, RIGHT END**

Several areas of the right girder encasement concrete have fallen and landed on and adjacent to the railroad tracks.

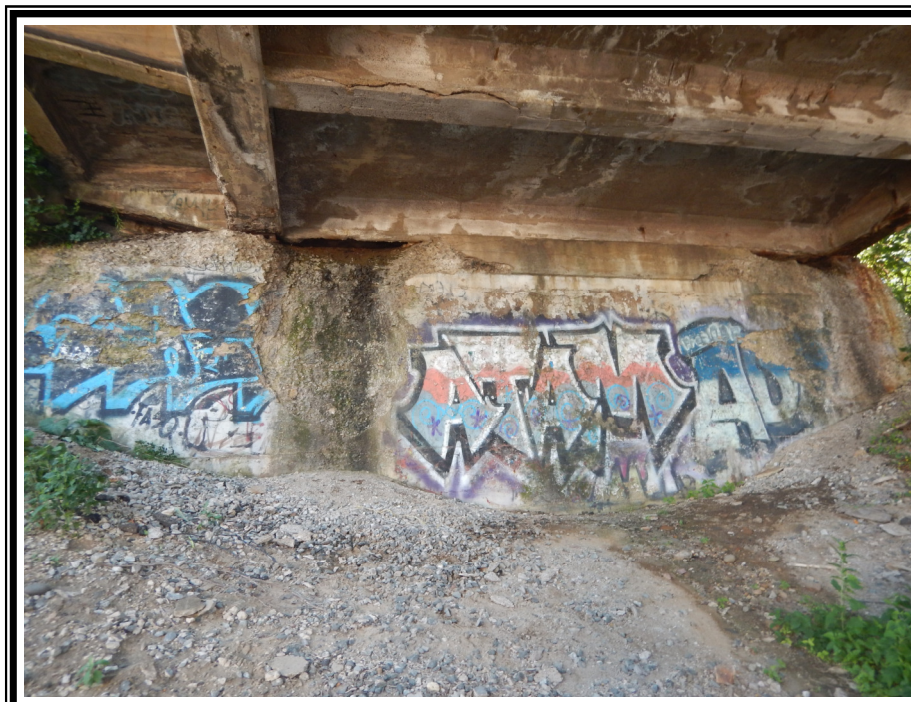
**FAR ABUTMENT**

There is 22" long (full length of plate) by up to 1.5" of bearing loss along the right side of the bearing.

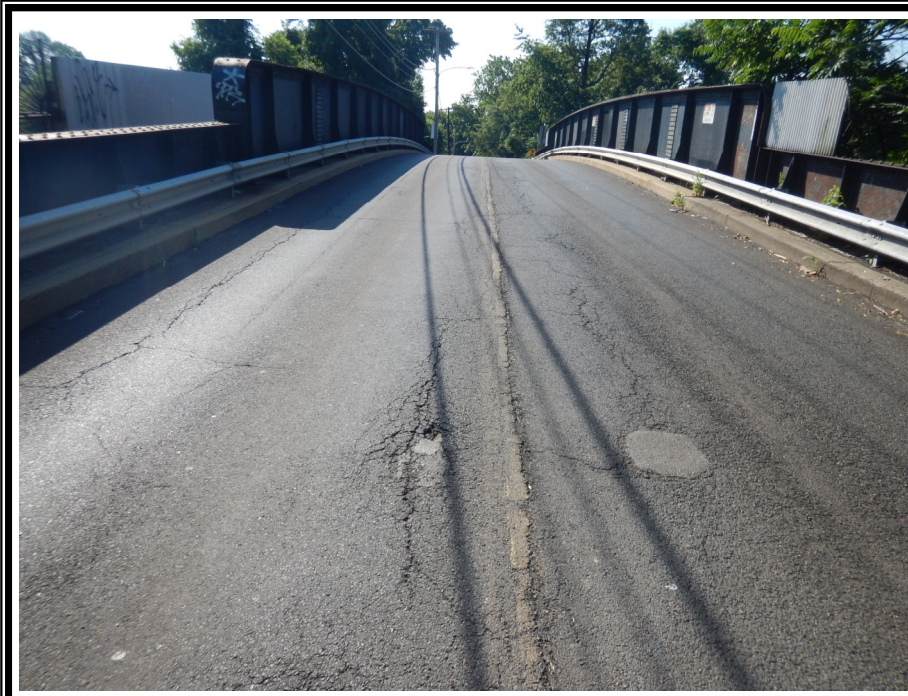
**GENERAL VIEW OF THE WEARING SURFACE**

The bituminous deck wearing surface is in fair condition.

The pavement has moderate to heavy wear, failed and partially patched potholes, and minor wheel rutting throughout. There are partial length slightly open longitudinal cracks along the wheel paths and center of the travel lanes, full length open longitudinal cracking along the centerline of the roadway, and partial width slightly open transverse and diagonal cracking throughout. There is an area of heavy map cracking in the right lane adjacent to the centerline of the roadway full length of Span 2. The map cracking extends into the left travel lane along the far half of the span with associated minor settlement at the far end. The previous pothole at the far left corner was patched since the last inspection.

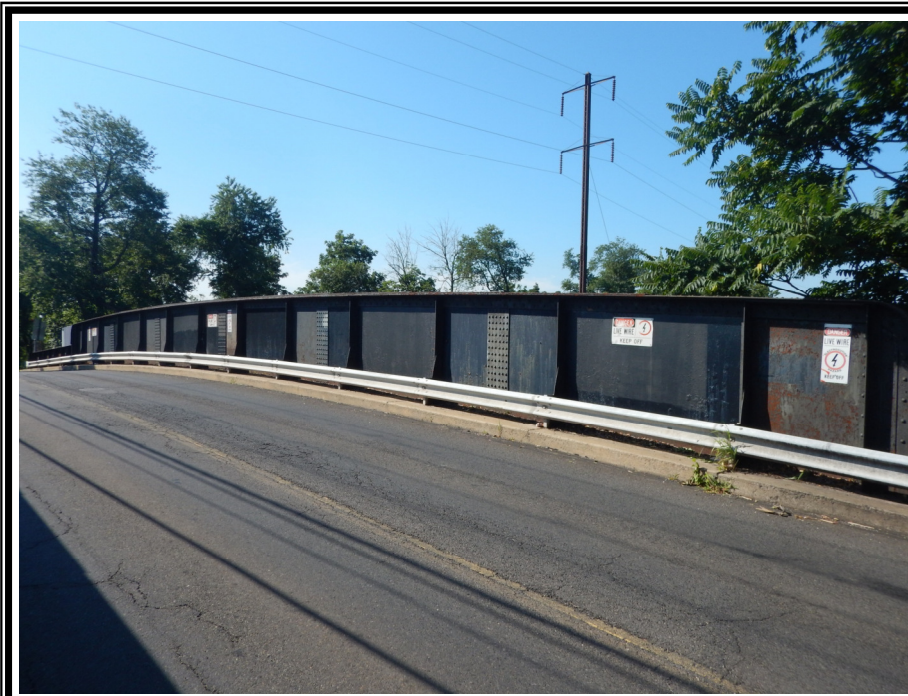
**RIGHT GIRDER, TYPICAL**

The right girder below the deck has numerous areas of heavy cracking and delaminated concrete throughout. There is extensive spalling along the bottom flange of the girder with exposed coverplates, bottom flange, and rivet heads in all spans. No concrete was hanging from the girders but could be knocked off by hammer in small pieces with relative ease. The exposed coverplates and bottom flanges have minor to advanced section loss at the edges. In Span 2, Bay 5 there is a 5" long by 1" wide area of 100% section loss to the interior toe. The bottom flange is exposed 6' long at the far abutment with minor to  $\frac{1}{8}$ " section loss of the bottom flange cover plate and up to 95% section loss to the rivet heads across the bottom flange. The right edge of the bottom flange has a 7" long by  $1\frac{1}{2}$ " wide tear/bend in front of the far bearing.

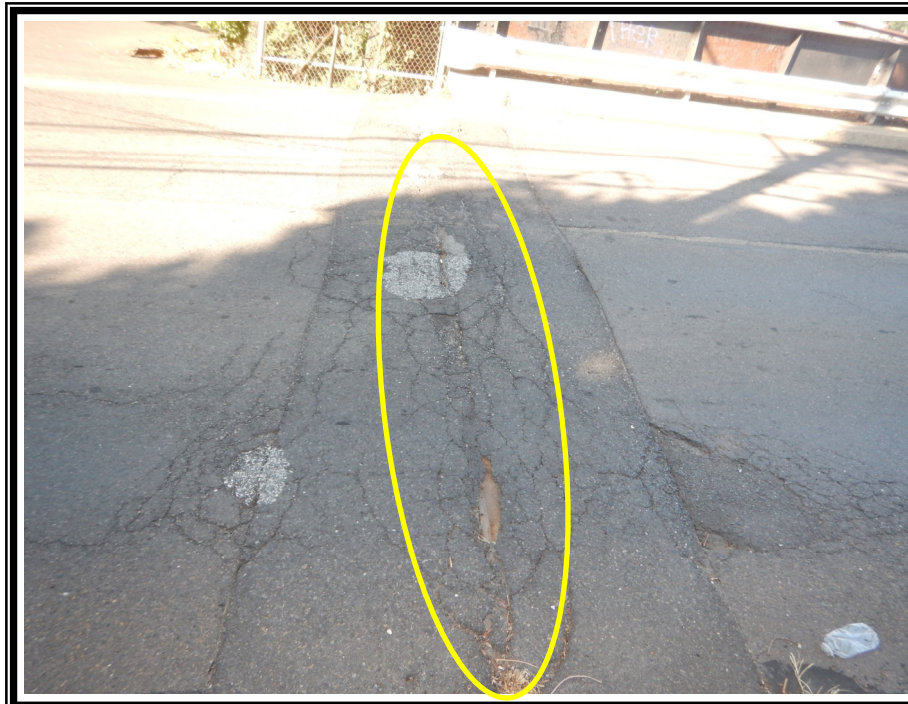
**FAR TRANSITION POTHOLE**

There is a 16" long by 21" wide by 2" deep pothole exposing the steel joint at the center of the right lane.

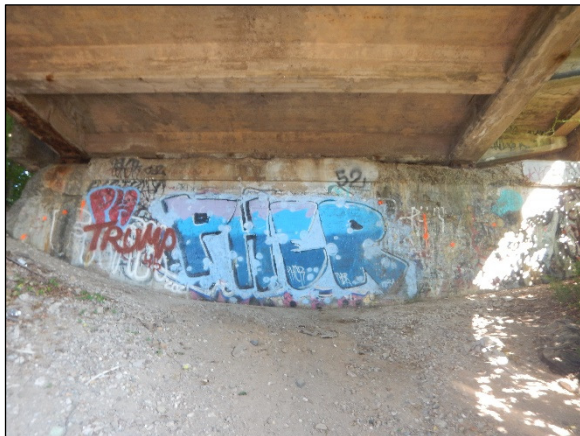
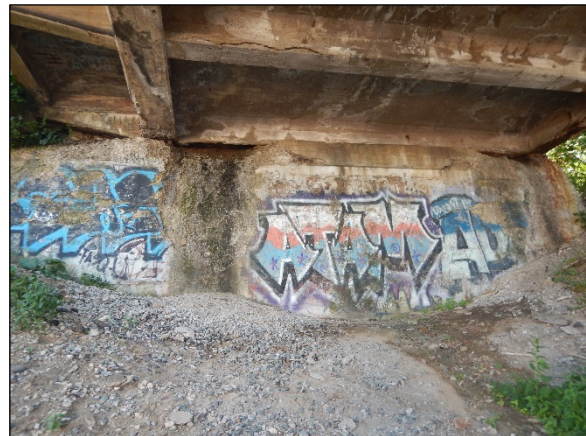
**LEFT:** General view of the reinforced concrete near (west) abutment.

**RIGHT:** General view of the reinforced concrete far (east) abutment.
