-----  
Bureau of Investigation |  
and Enforcement |  
v. |  
Philadelphia Gas Works, |  
In Person Evidentiary |  
-----

Docket No.:  
C-2024-3052277

Thursday, October 16, 2025  
Commencing at 9:59 a.m.

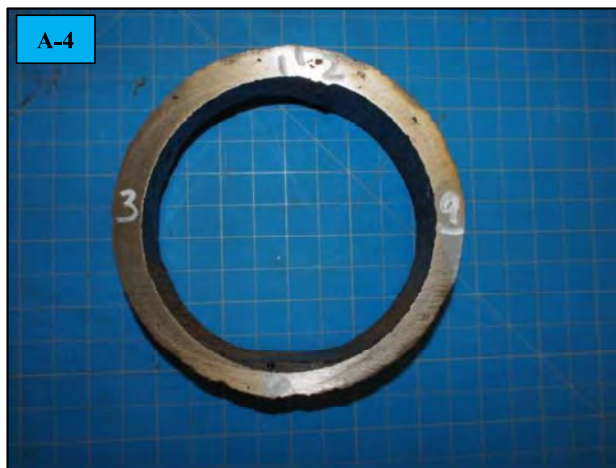
Photo No. 20 (W-6491-E-053.JPG)

Varying degrees of graphitization were observed on the cut edges of ring segments **ITEM A-3** and **ITEM A-4 (Photo Nos. 19 – 20)**. There was no indication of any through-wall penetrations formed by graphitization or any other type of corrosion or mechanical damage as intersected by the cuts. The effective wall thickness of the pipe in those two cross-sections was slightly reduced (up to 15%) as a result of graphitization (**TABLE A**). Notable casting voids were observed distributed along the cut edges of both rings, thereby further reducing the effective wall thickness (**Photo No. 21**).

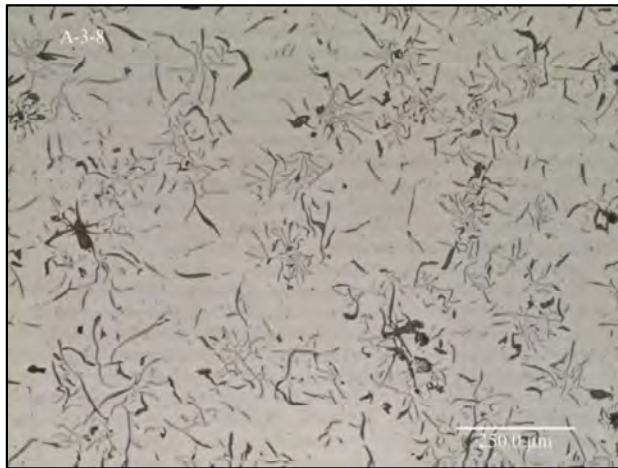
The microspecimens were then examined via Light Optical Microscopy (LOM) in both the unetched and etched conditions. The bulk microstructure of the pipe consisted of a mixture of Type C distribution of graphite (superimposed flake sizes, random orientation) with Type B (Rosette flake graphite), flake size 3-4, in a Pearlite matrix (**Photo Nos. 50 – 53**). Type C graphite, also referred to as Kish graphite, is typical for pit cast iron pipes due to the inherent slow cooling rates. Kish graphite greatly reduces the mechanical properties of cast iron and produces a rough surface finish upon machining.

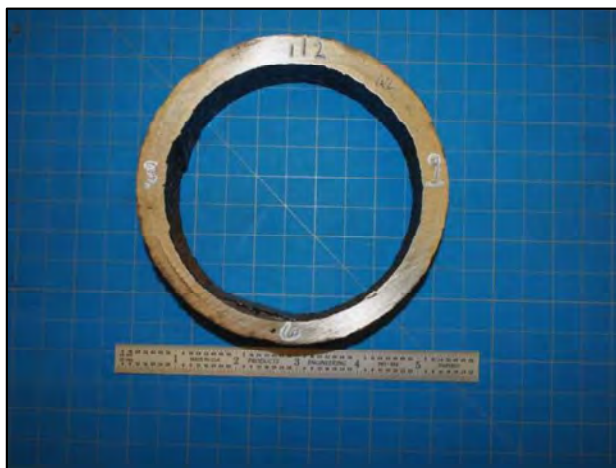
Photo No. 56 (W-6491-E-033.JPG)

Hardness testing was performed on ring segment **ITEM A-2** using Brinell scale with 3000-kg load as per ASTM E10-17 “*Standard Test Method for Brinell Hardness of Metallic Materials*” (**Photo No. 56**). Examination of the ring revealed a large-sized void at the 6 o’clock position (**Photo No. 57**). The following table contains the Brinell hardness values and equivalent Rockwell value (based on published conversion charts):

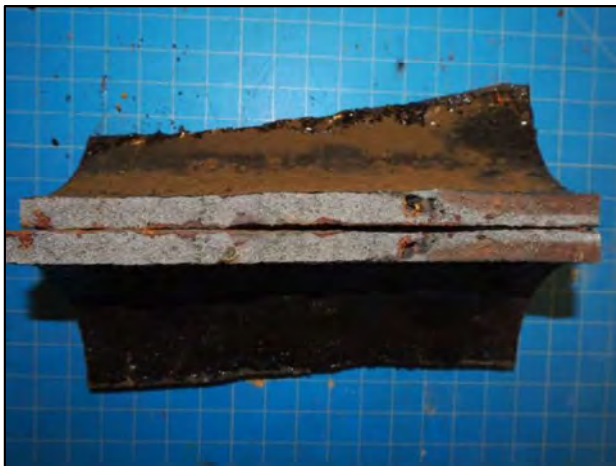
The calculated values from the ring testing indicated that the Modulus of Rupture was **NOT** acceptable or in compliance with the requirements of ASA Specification A-21.3 but the Secant Modulus of Elasticity was considered to be acceptable and in compliance with the requirements of ASA Specification A-21.3.

Examination of the induced fracture surfaces of the Ring Test Sample revealed varying degrees of graphitization and casting voids, similar to that of previously examined and above described ring samples from the cast iron main (**Photo Nos. 58 – 65**).

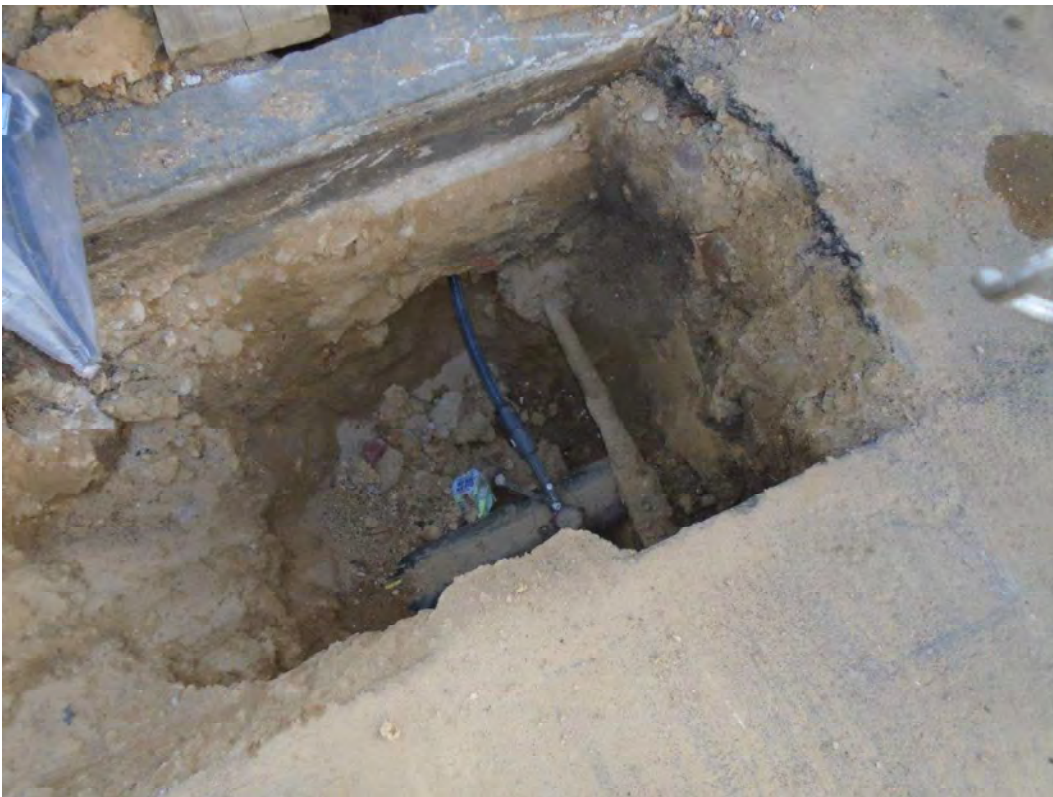
Photograph #4: Gas pipe lateral to 818 Jackson Street.

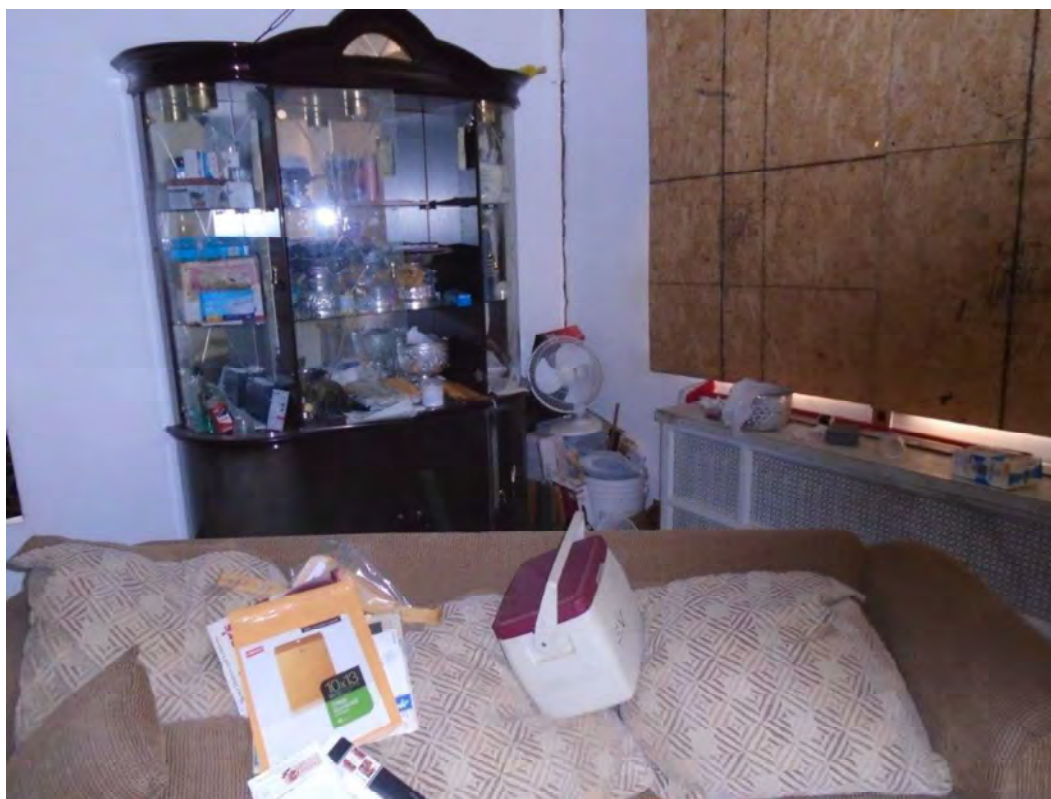
Photograph #6: Living room at 815 Jackson Street.

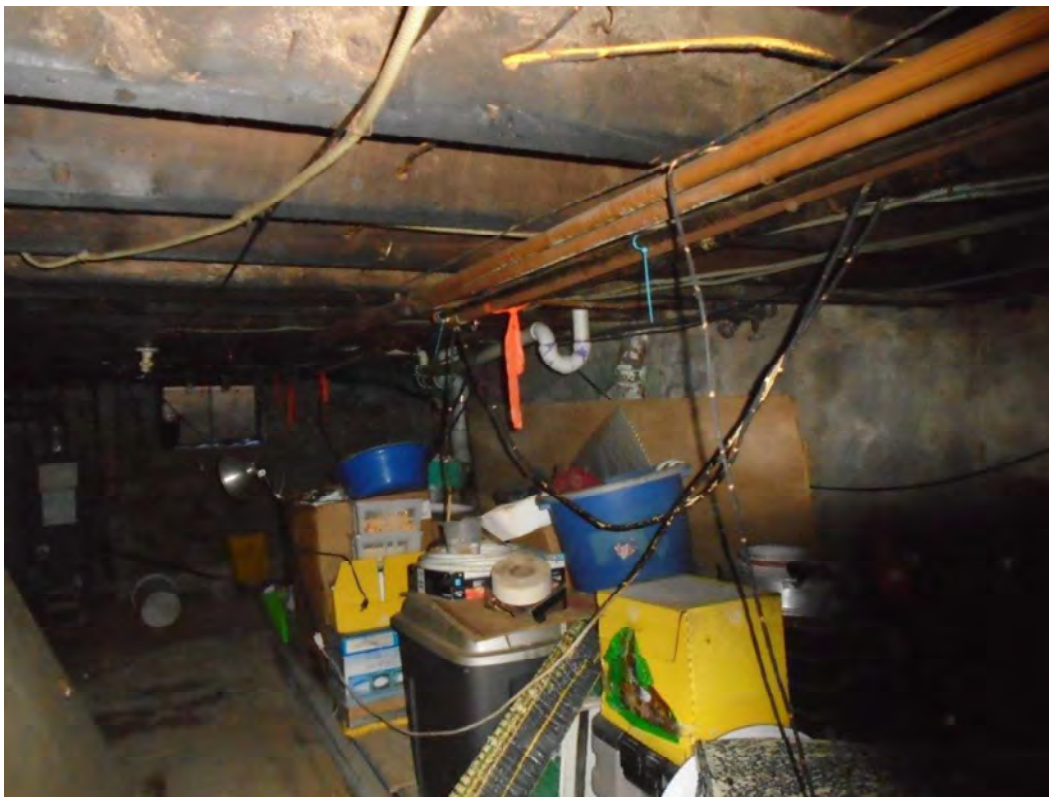
Photograph #13: Natural gas pipes located in basement at 815 Jackson Street.

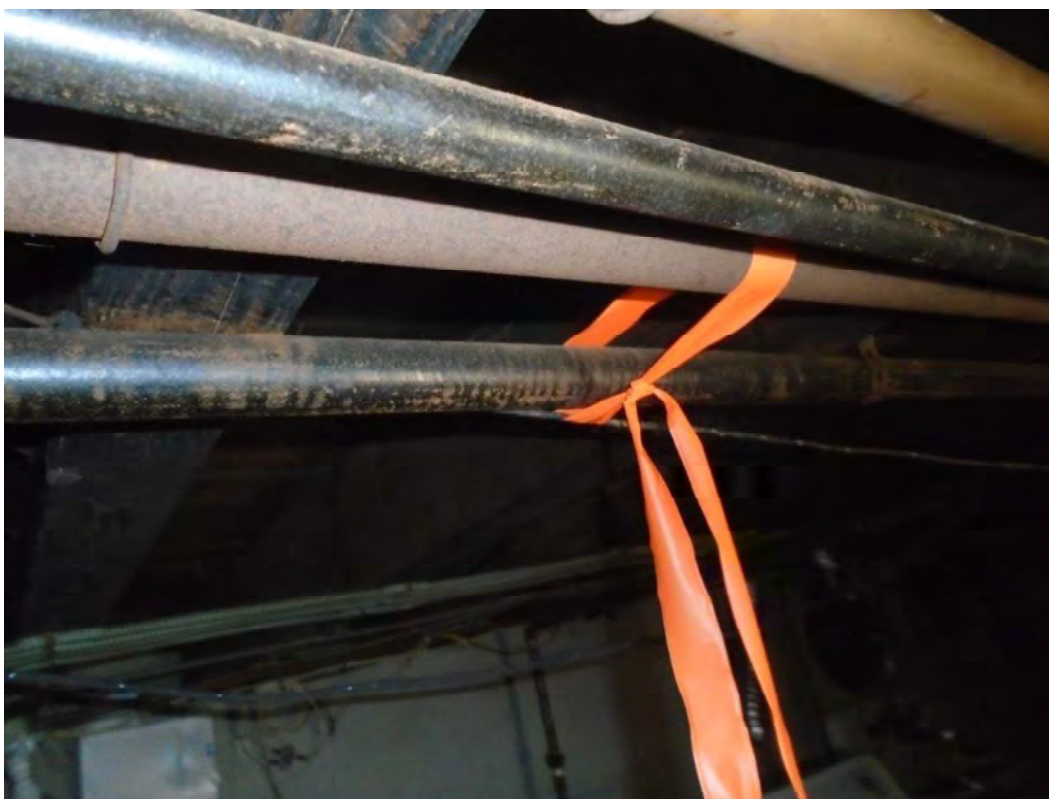
Photograph #14: Natural gas pipes located in basement at 815 Jackson Street.

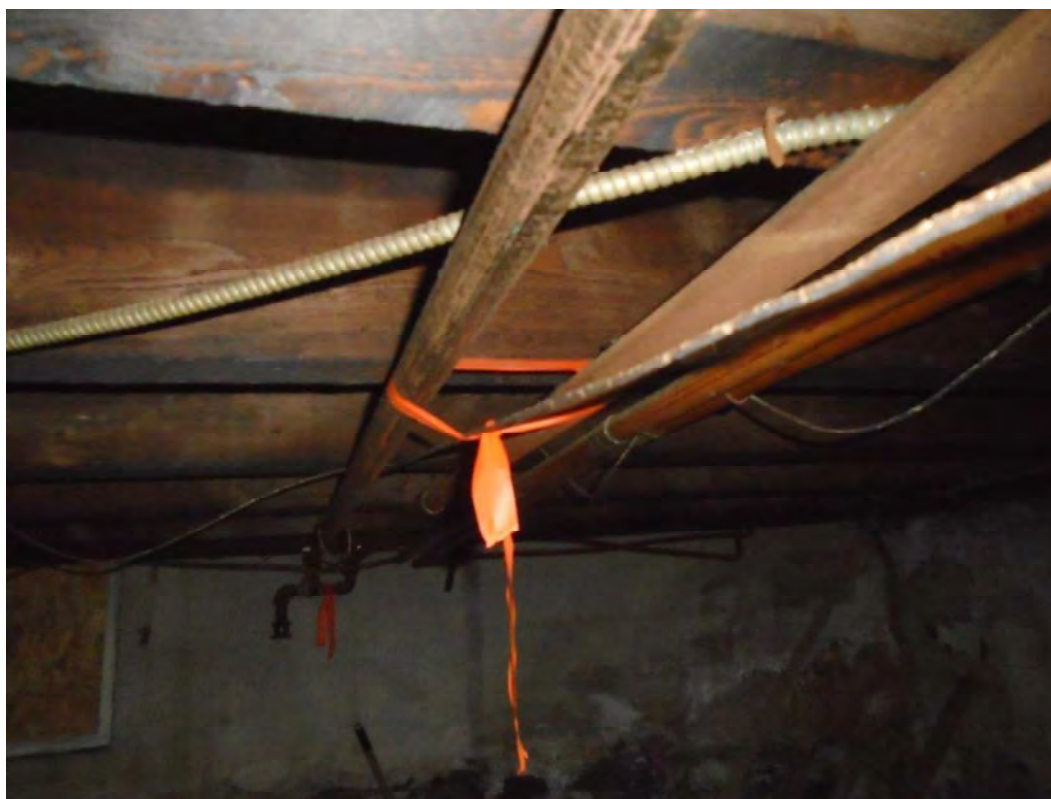
Photograph #16: Natural gas pipes in basement.

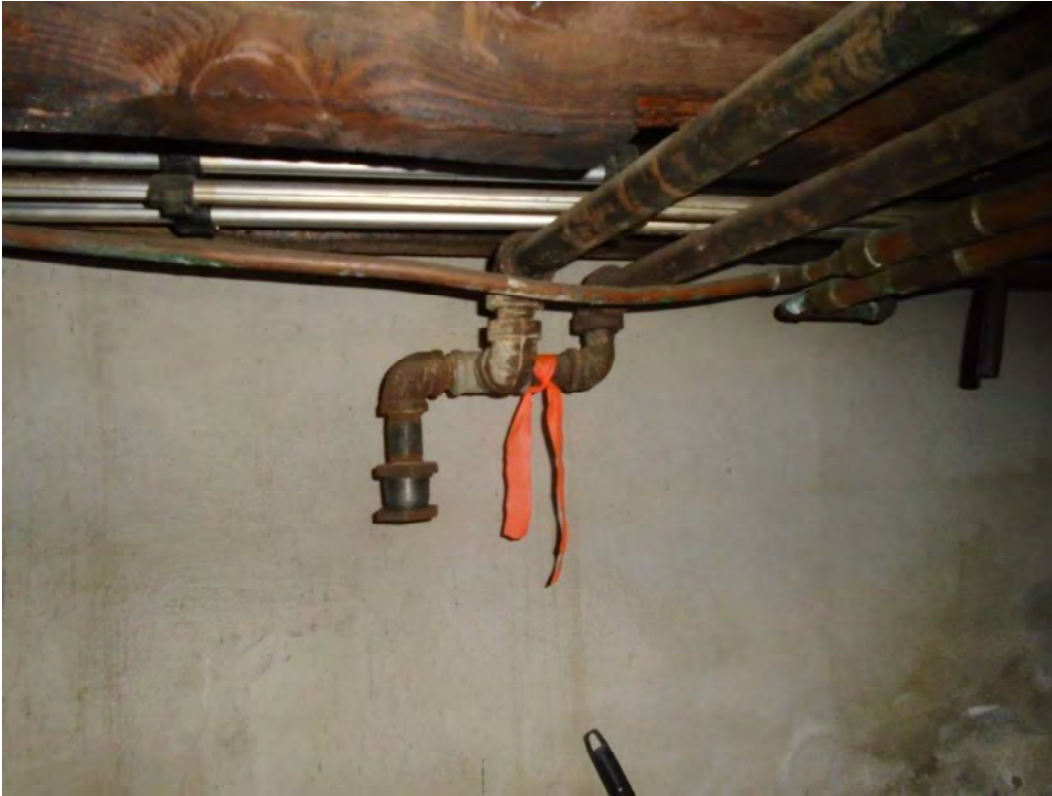
Photograph #17: Gas pipes where gas meter was located.

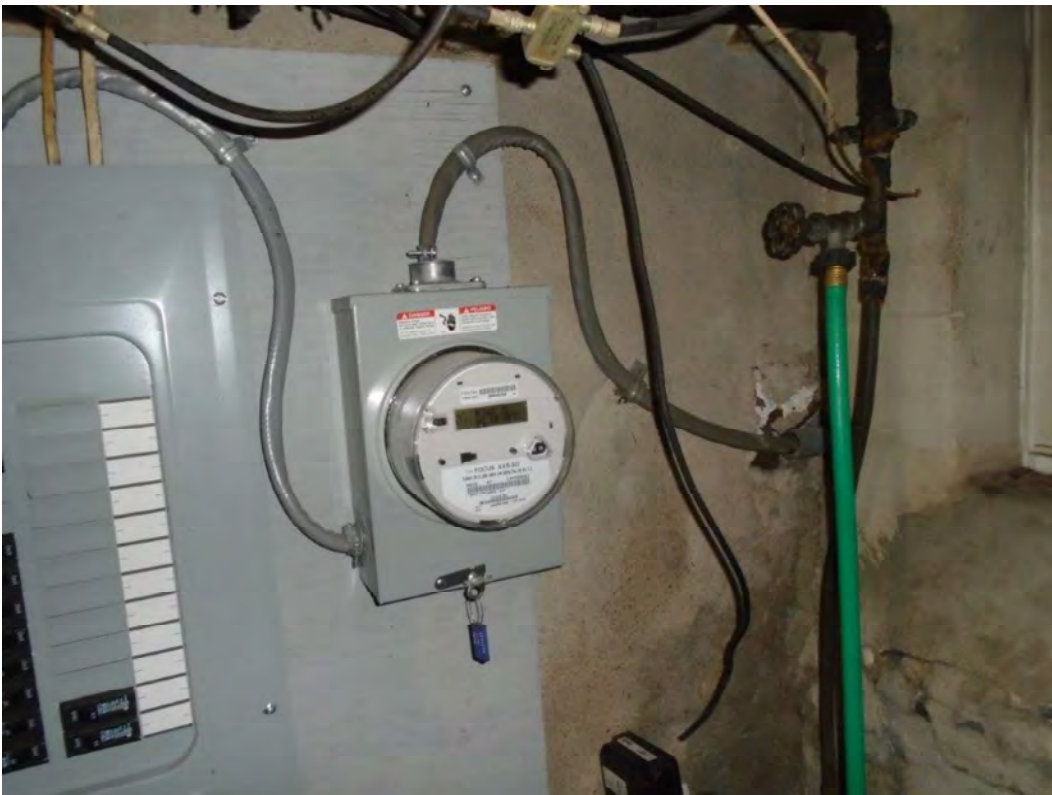
Photograph #18: Electric meter in basement.

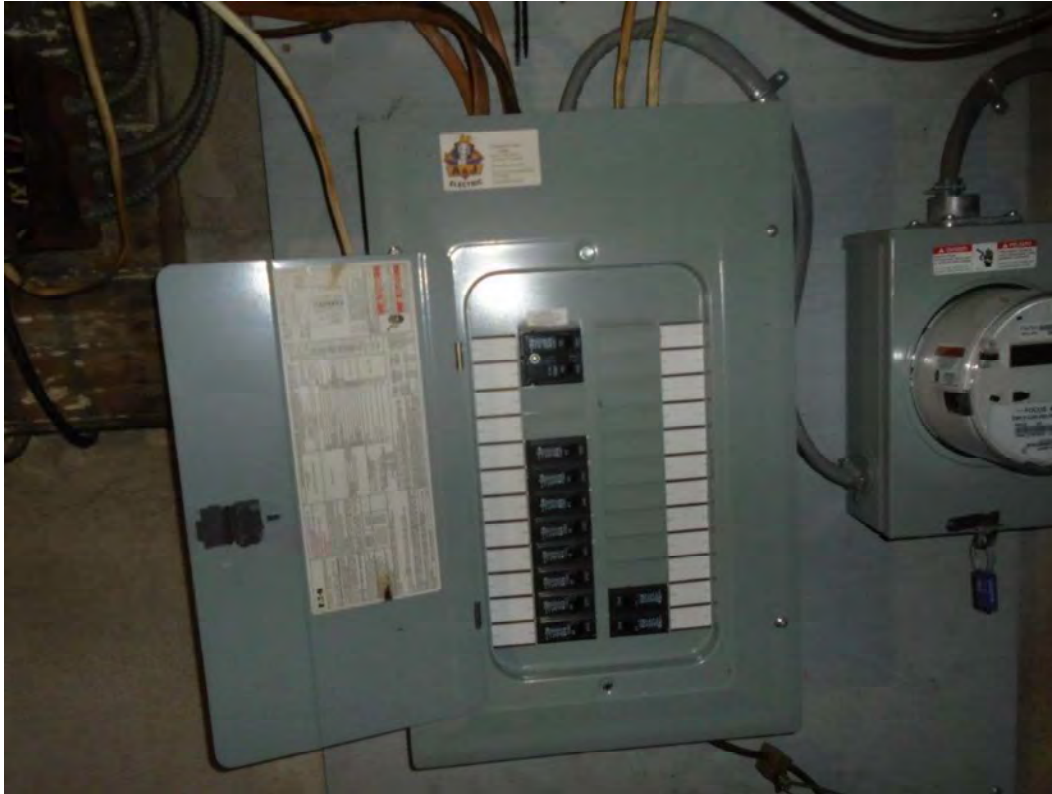
Photograph #19: Circuit breaker panel in basement.

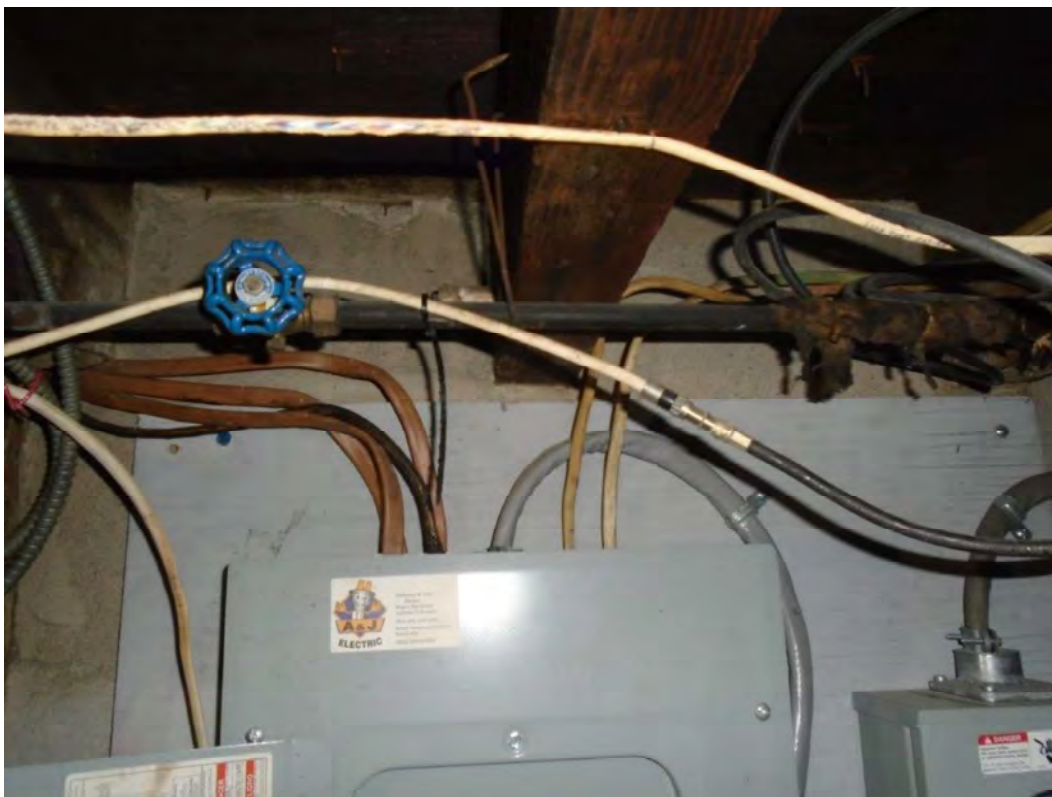
Photograph #20: Associated wiring from circuit breaker panel.

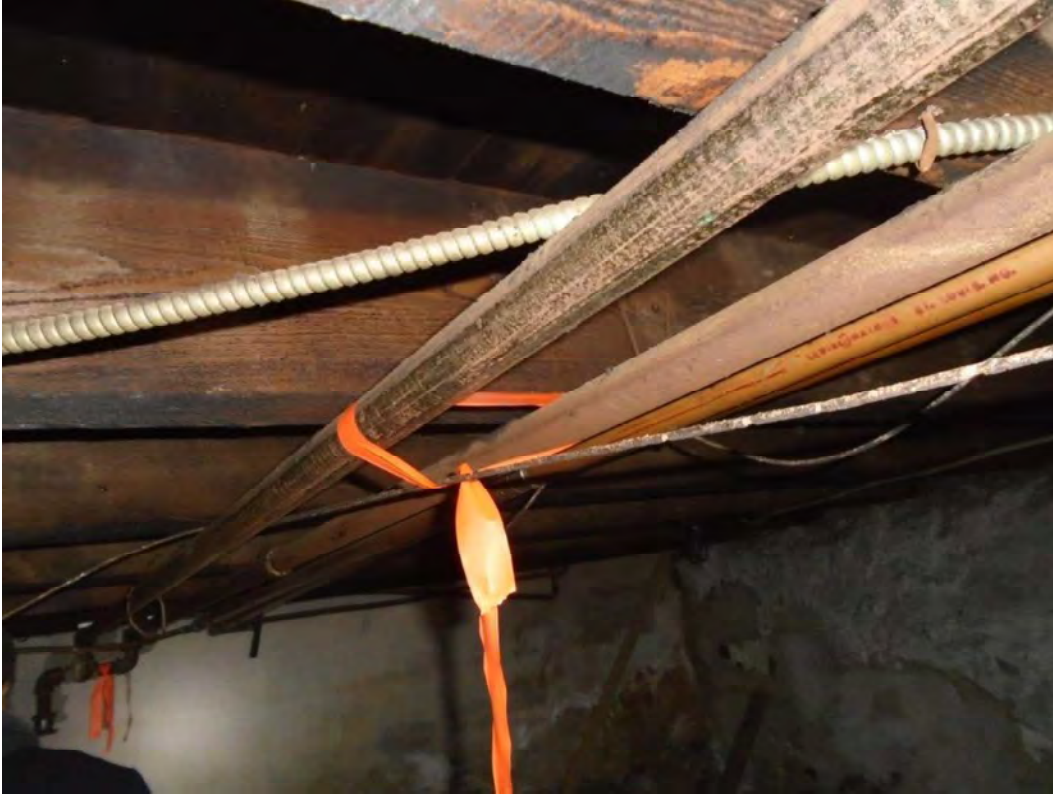
Photograph #21: Natural gas pipes in basement.

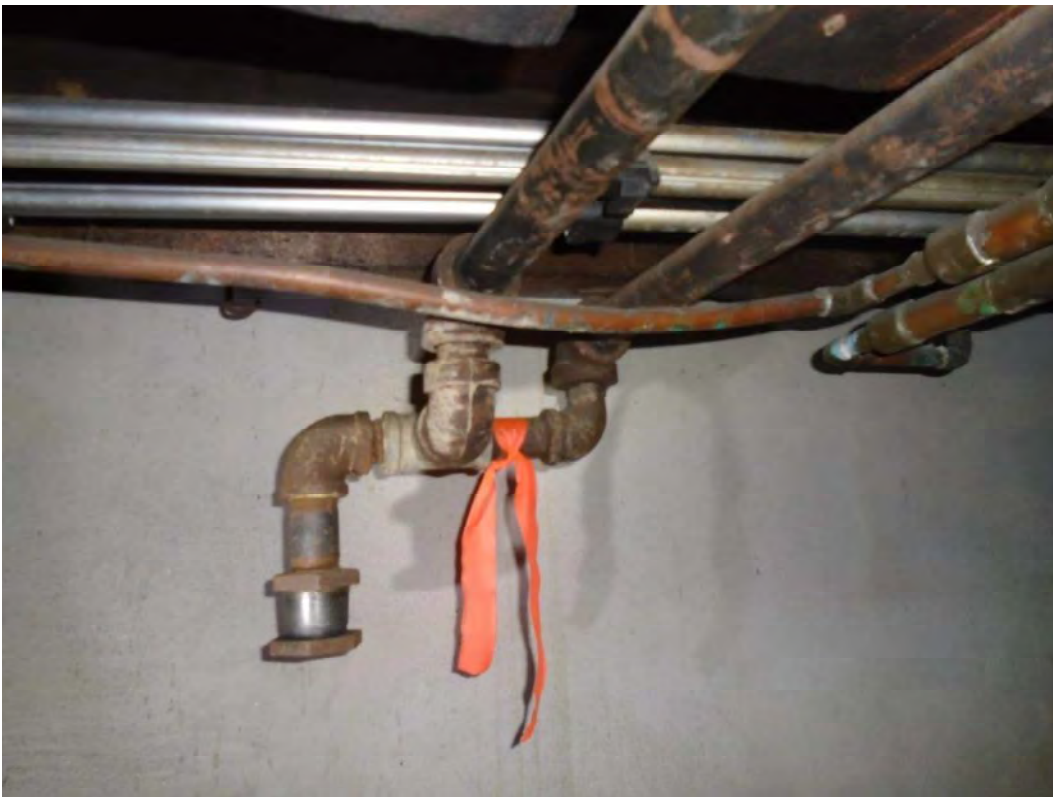
Photograph #22: Natural gas pipes in basement.

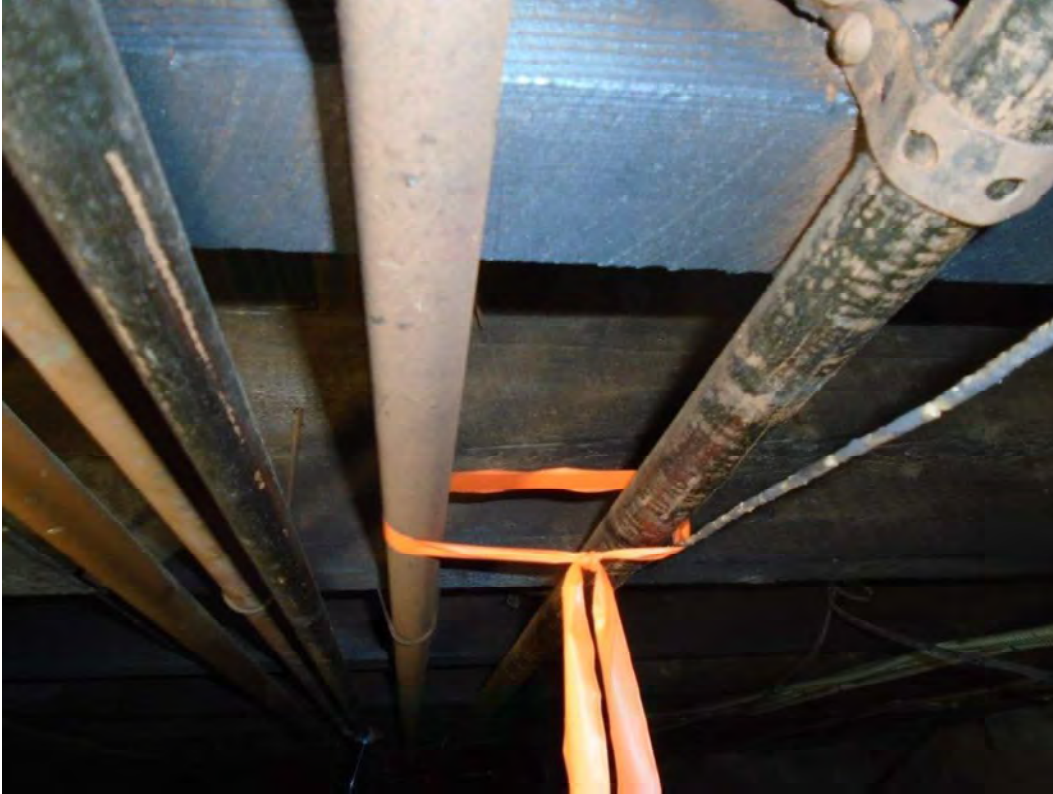
Photograph #23: Natural gas pipes in basement.

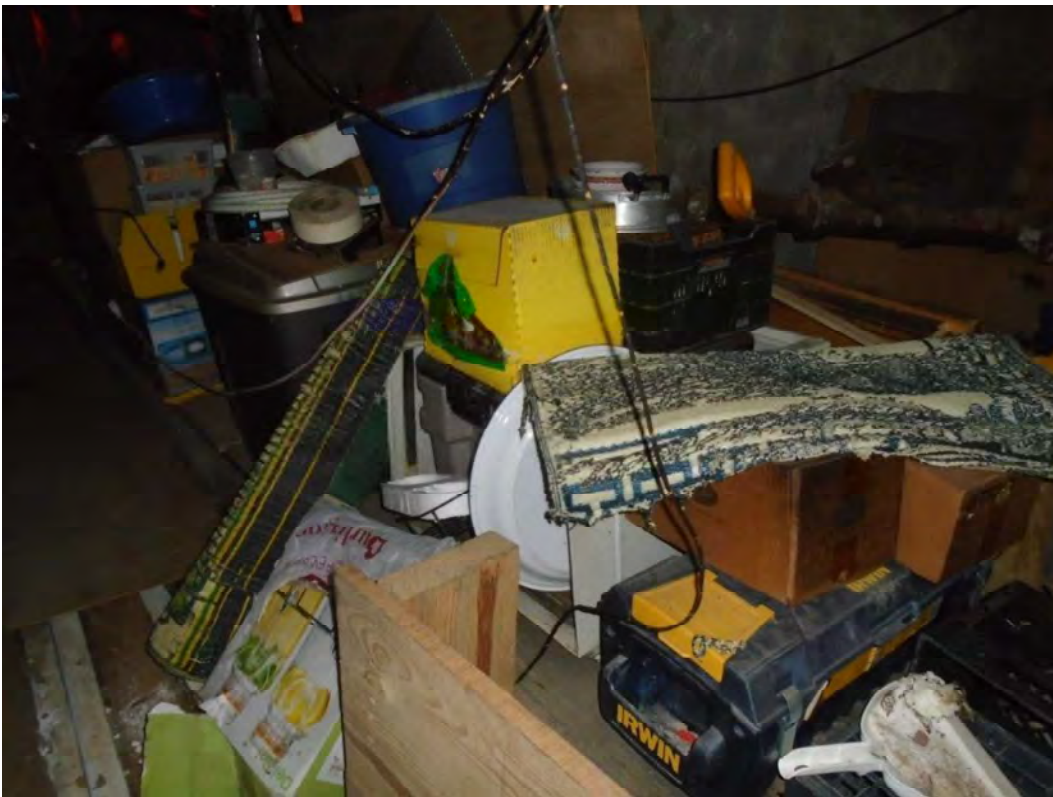
Photograph #24: Storage items in basement.

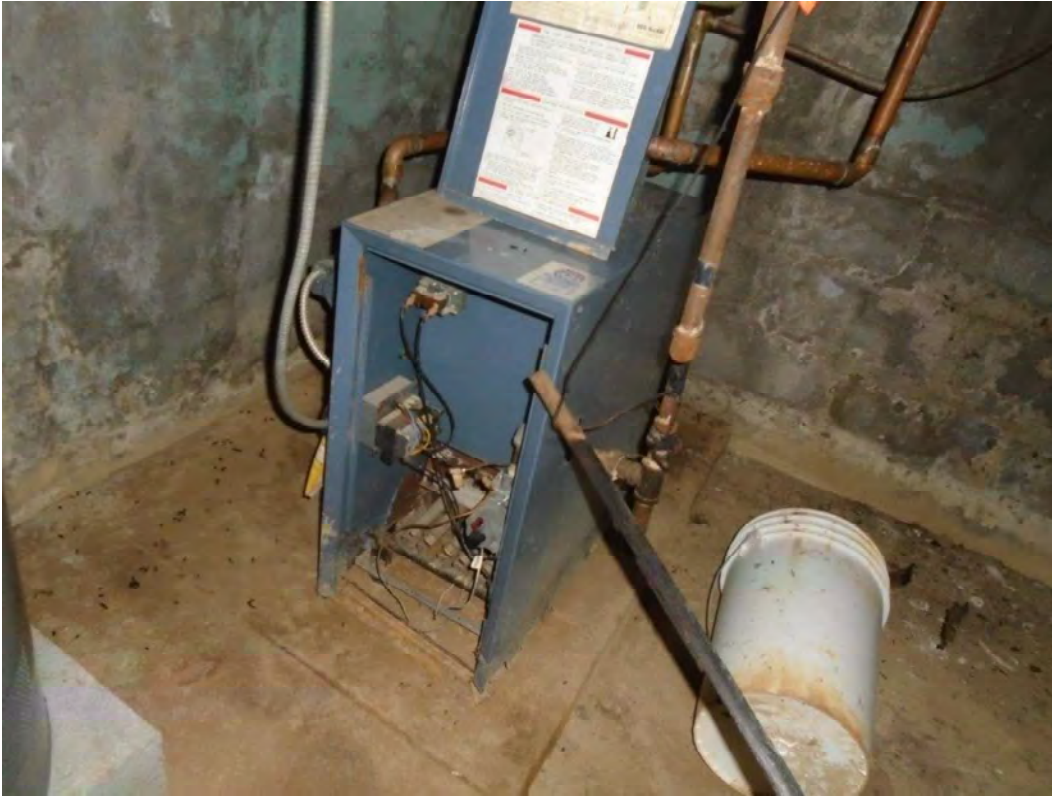
Photograph #27: Natural gas-fired heater in basement.

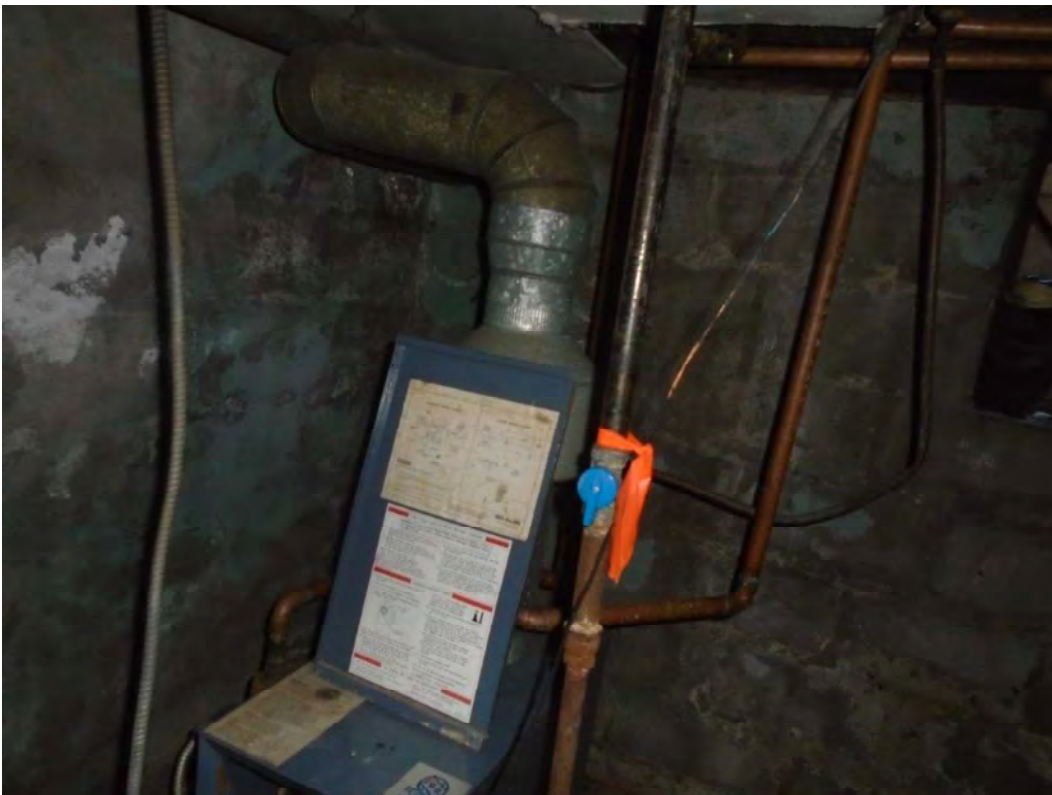
Photograph #28: Flue pipes for heater.

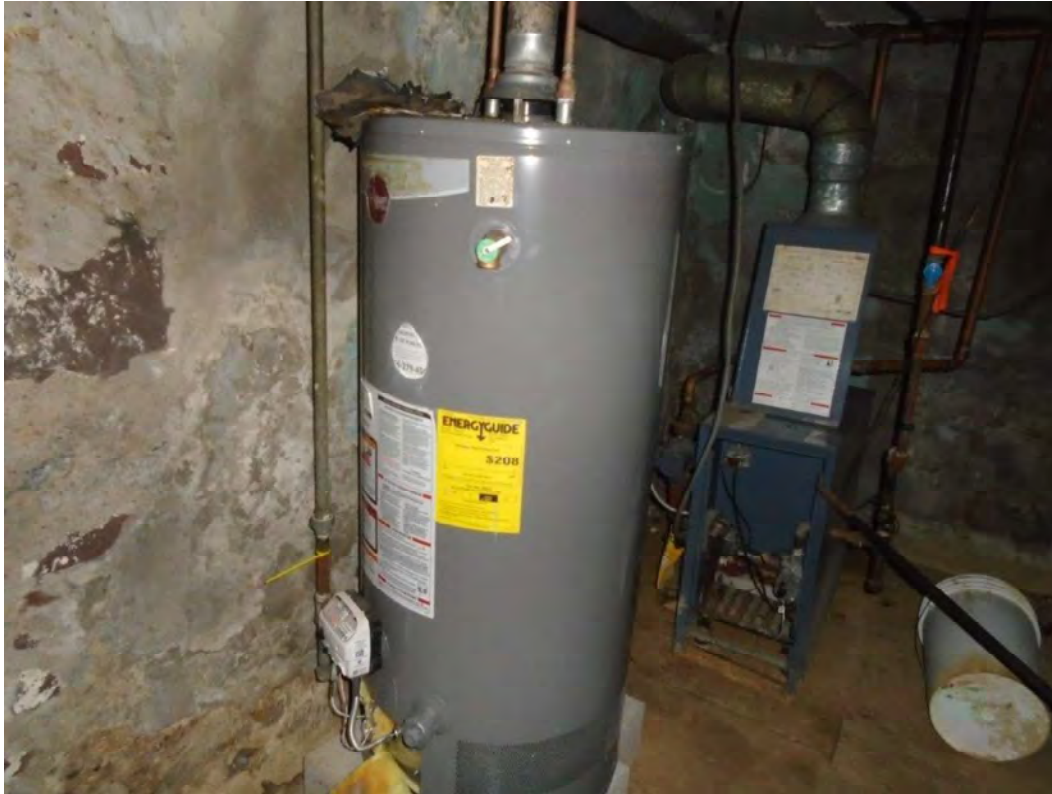
Photograph #29: Natural gas-fired hot water heater located in basement.

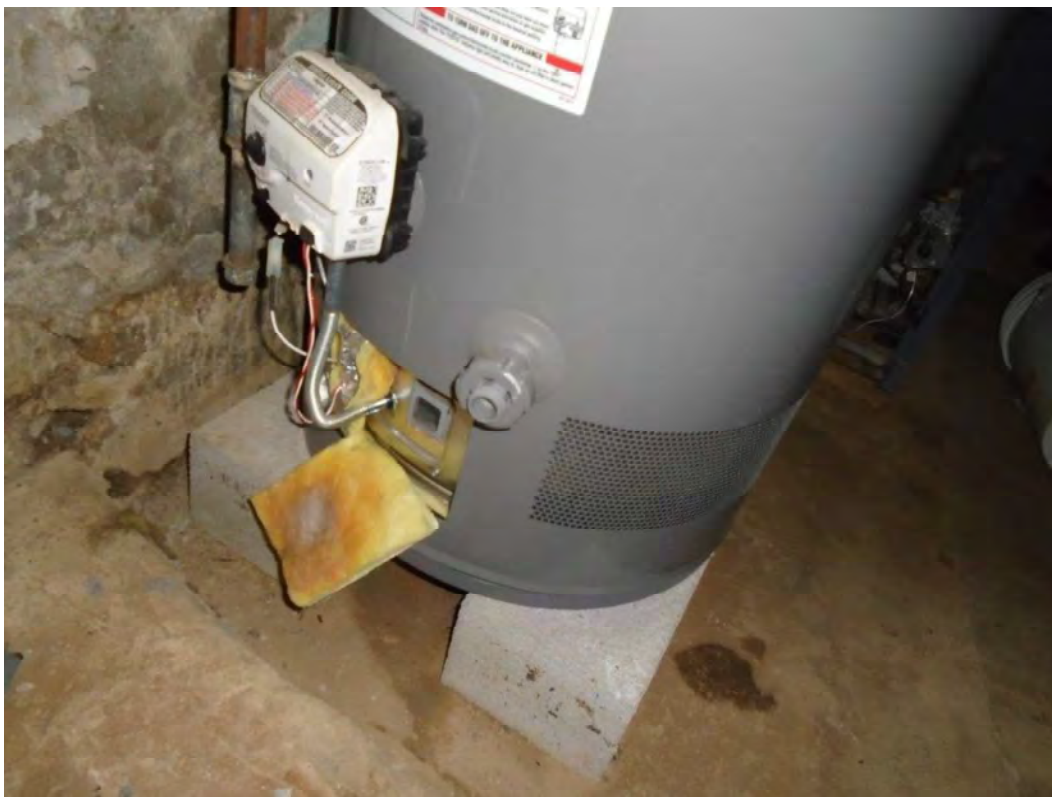
Photograph #30: Flame chamber for hot water.

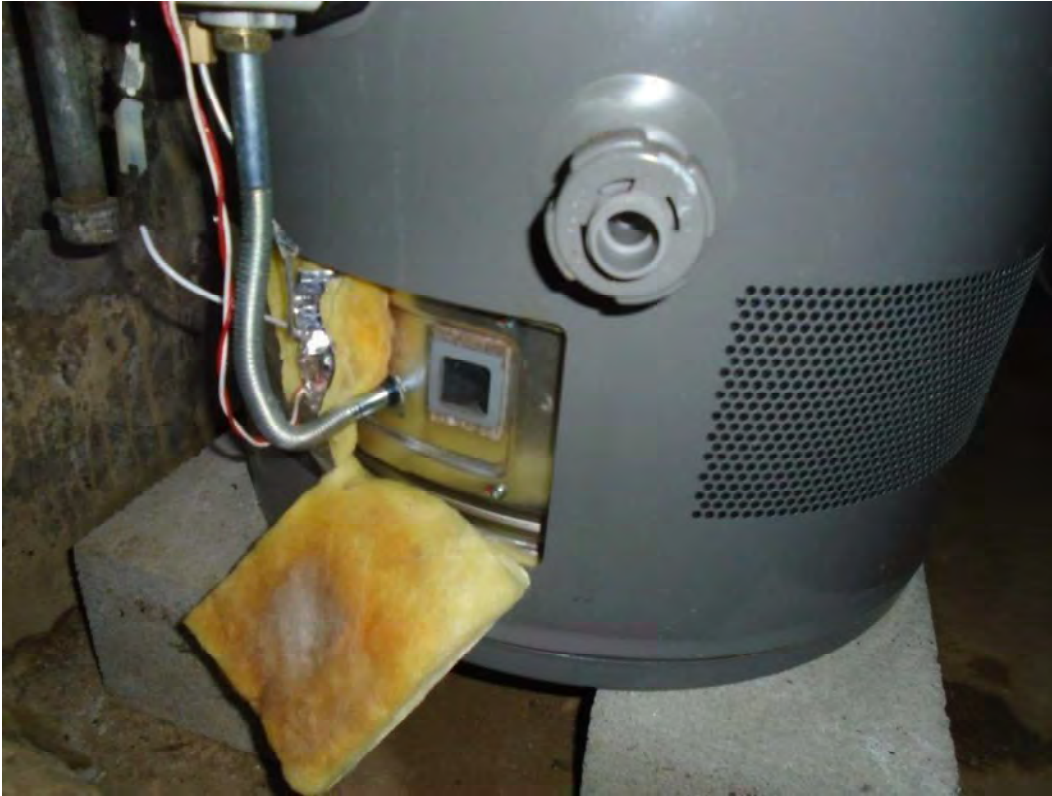
Photograph #31: Flame chamber for hot water.

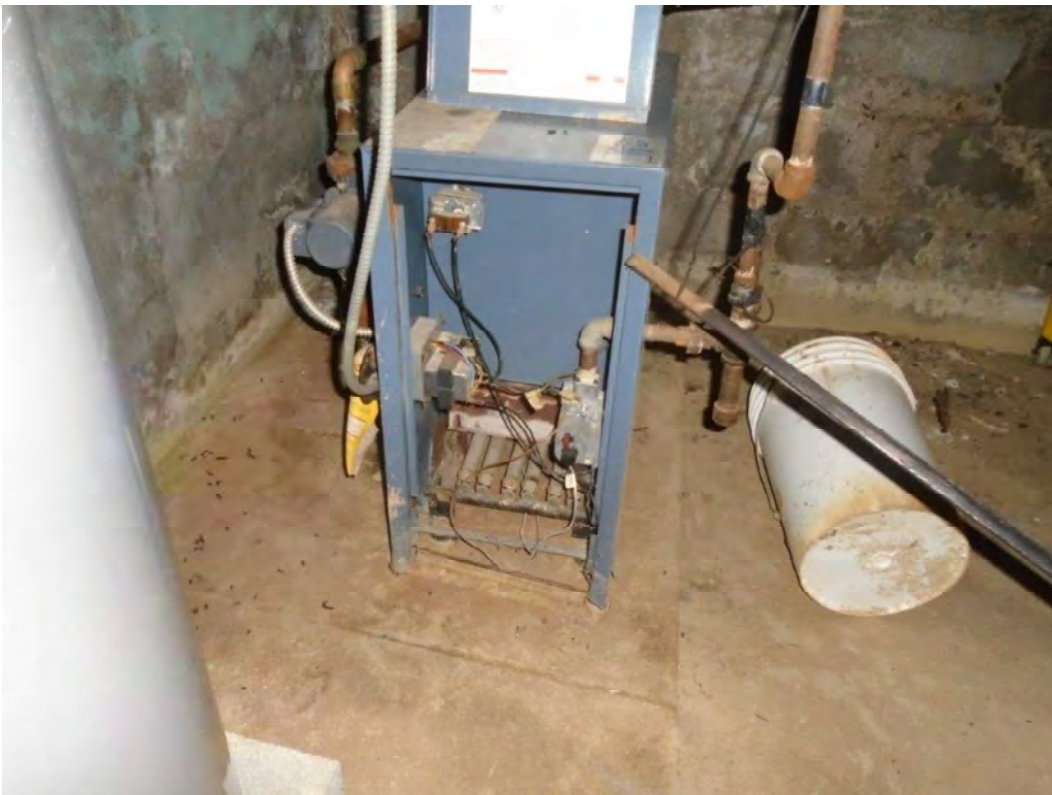
Photograph #32: Flame chamber for heater.

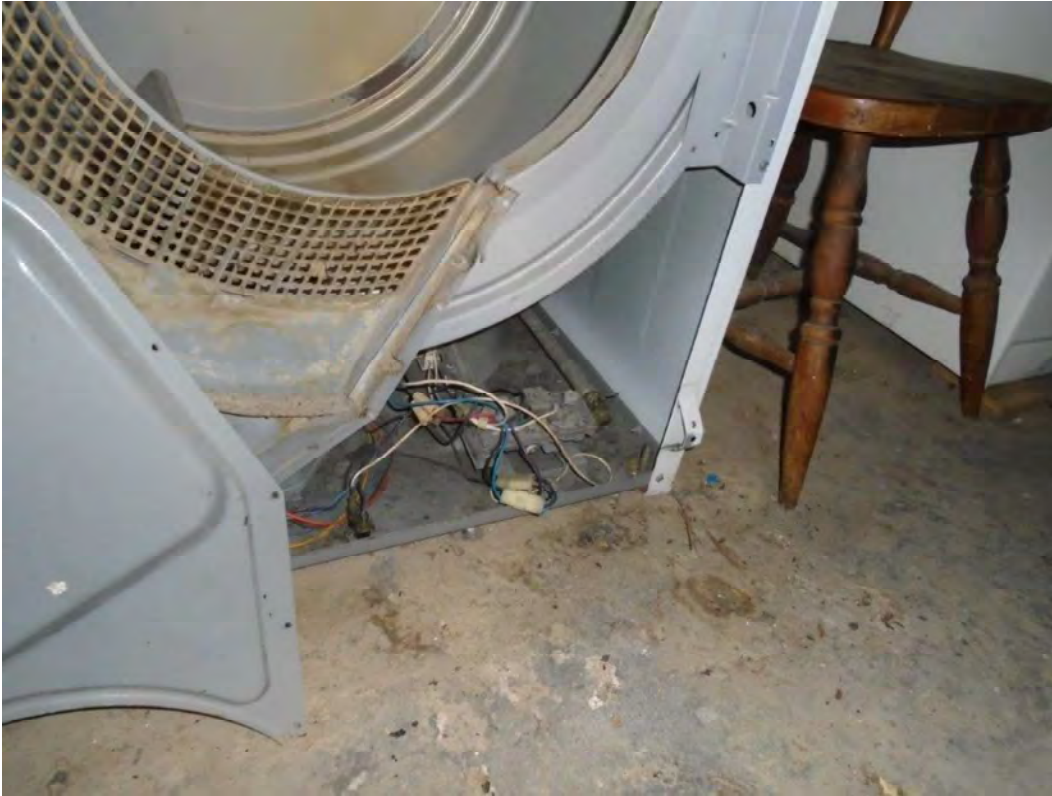
Photograph #33: Flame chamber for gas dryer.

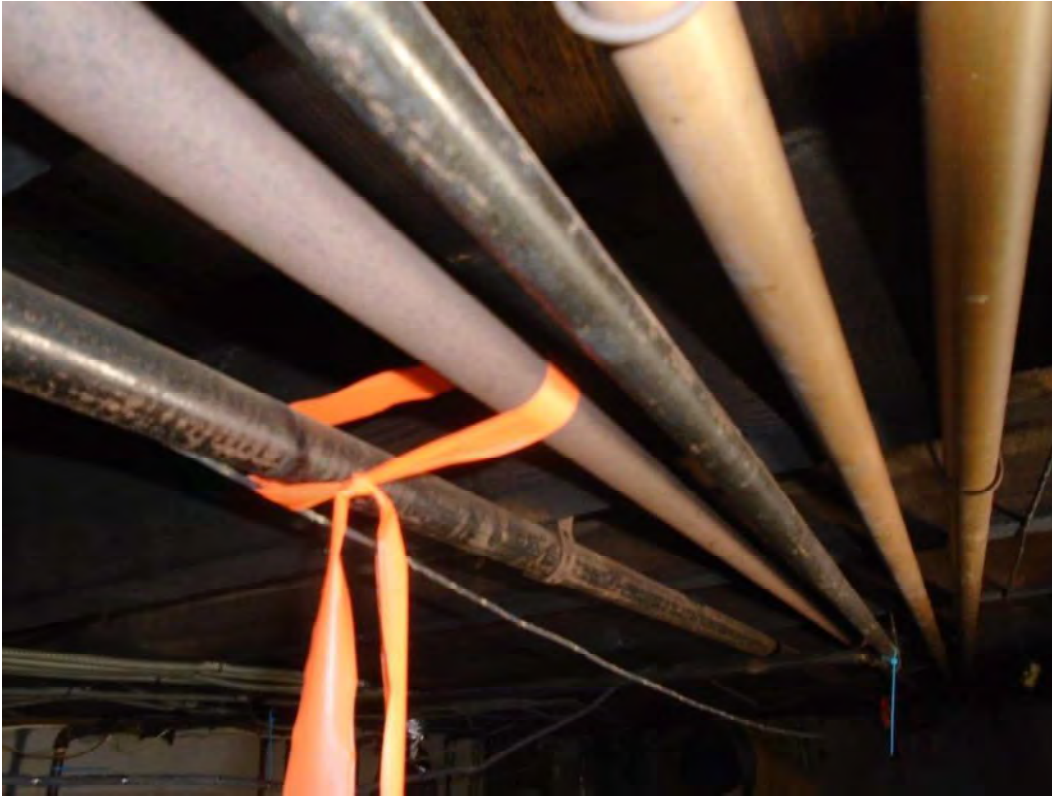
Photograph #35: Gas pipes in basement.

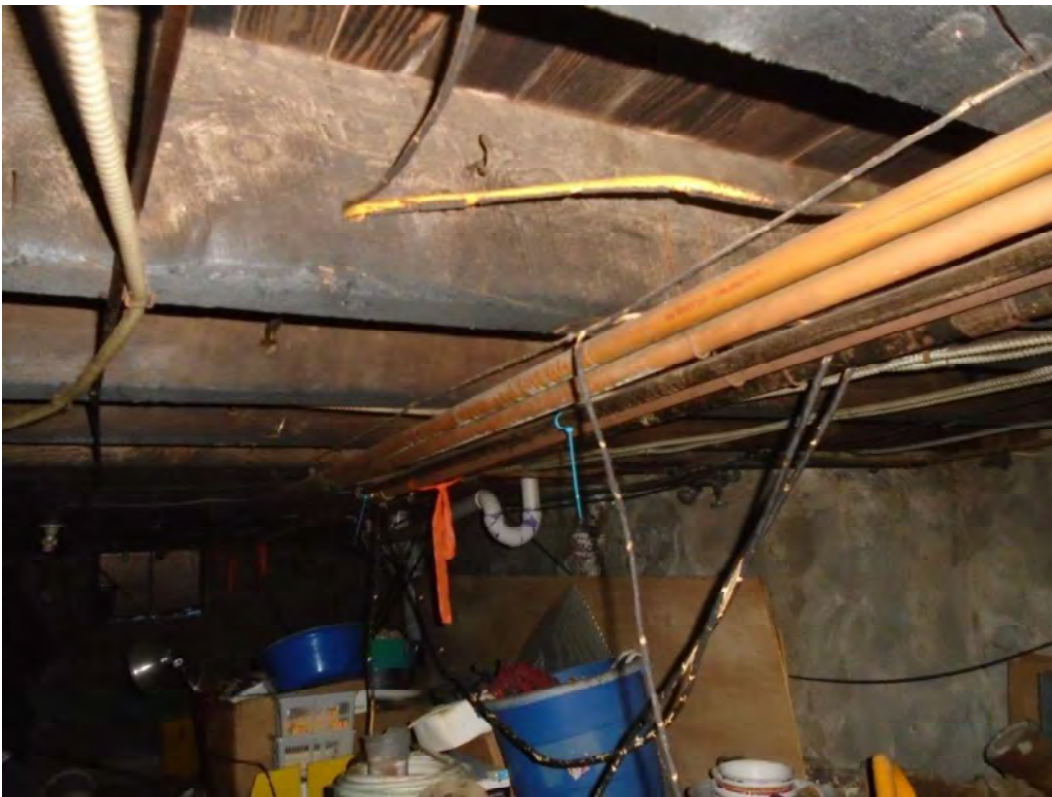
Photograph #36: Gas pipes in basement.

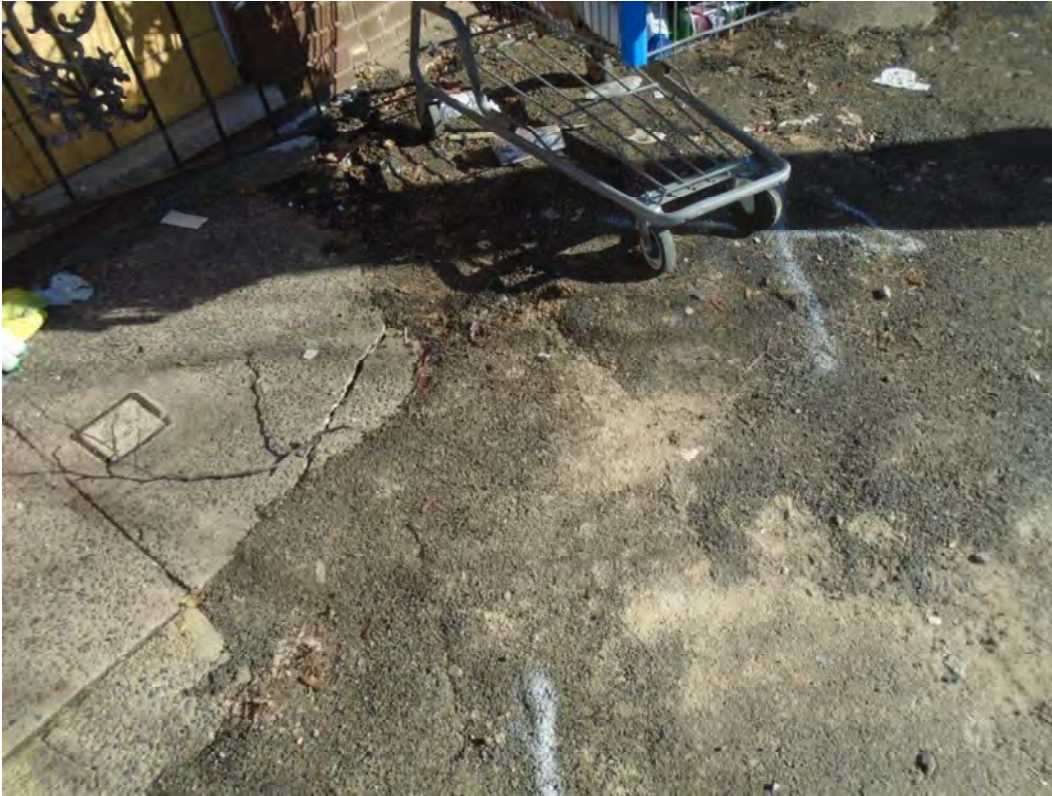
Photograph #37: Sidewalk area in the front of 815 Jackson Street where plumber worked.

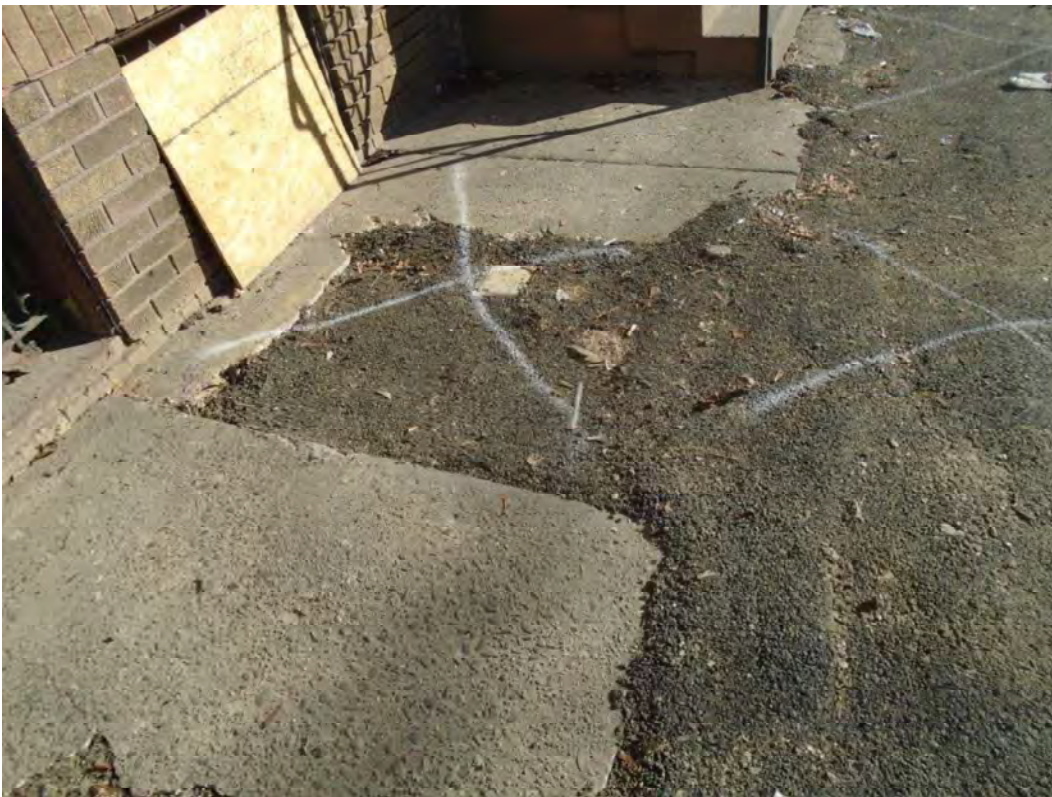
Photograph #38: Sidewalk area in the front of 815 Jackson Street where plumber worked.

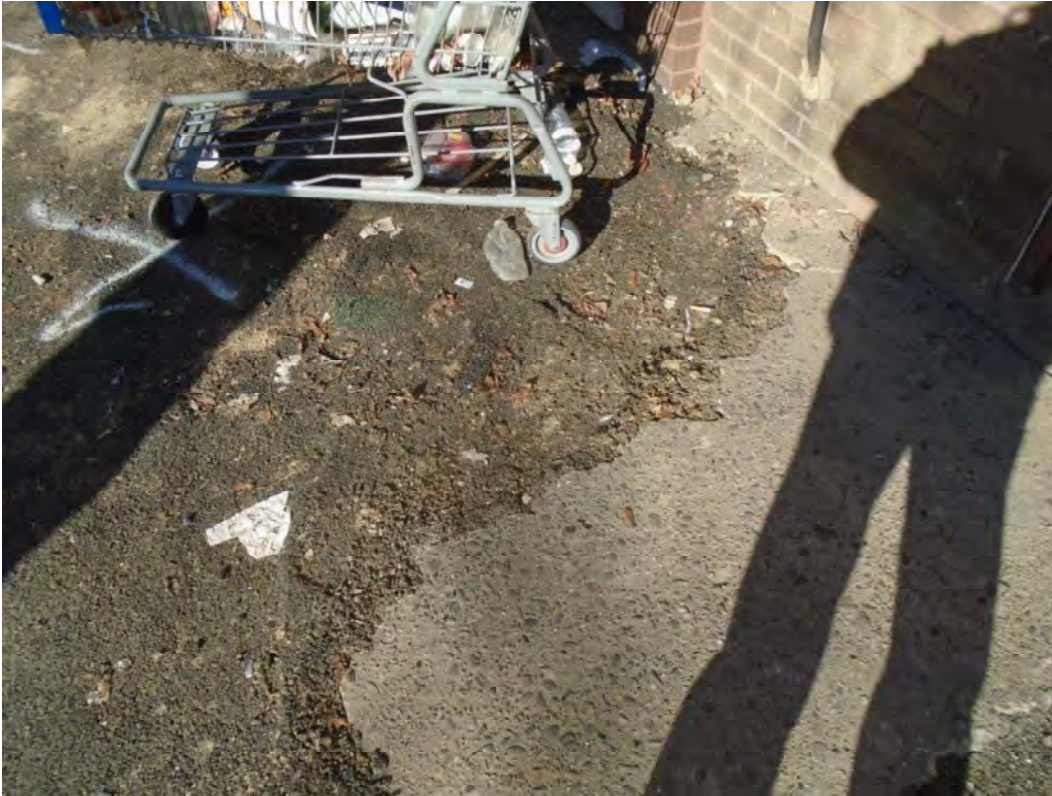
Photograph #39: Sidewalk area in the front of 815 Jackson Street where plumber worked.
