-----  
Bureau of Investigation |  
and Enforcement |  
v. |  
Philadelphia Gas Works, |  
In Person Evidentiary |  
-----

Docket No.:  
C-2024-3052277

Thursday, October 16, 2025  
Commencing at 9:59 a.m.

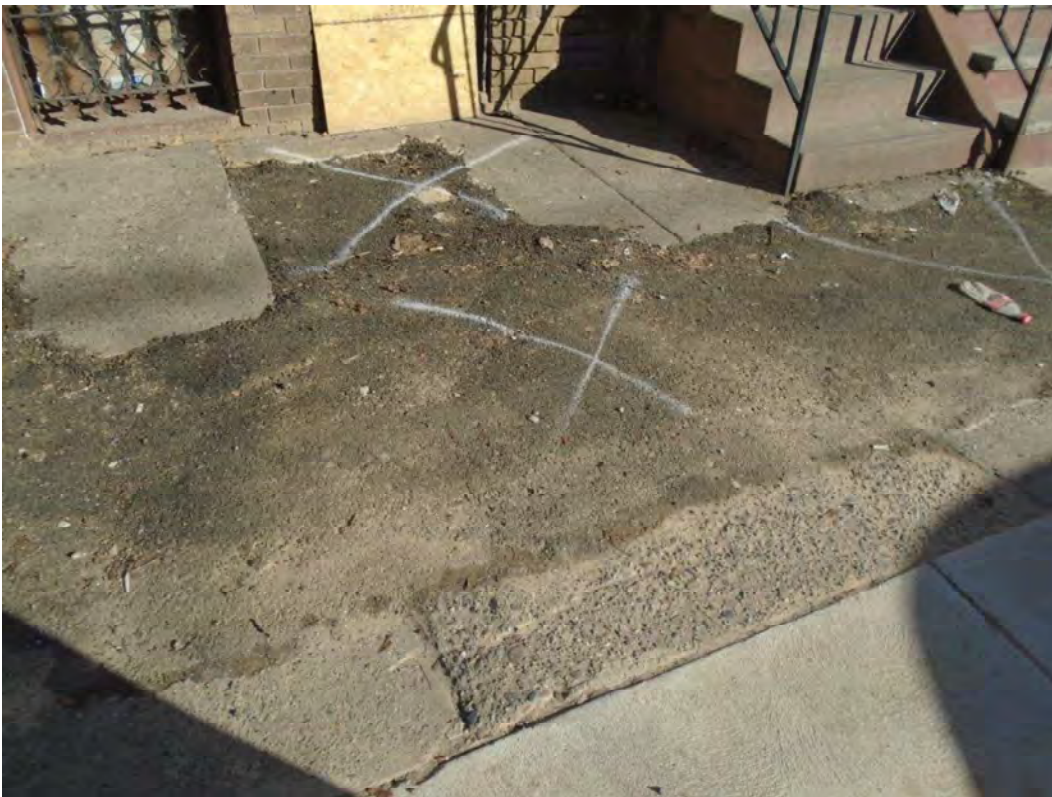
Photograph #40: Sidewalk area in the front of 815 Jackson Street where plumber worked.

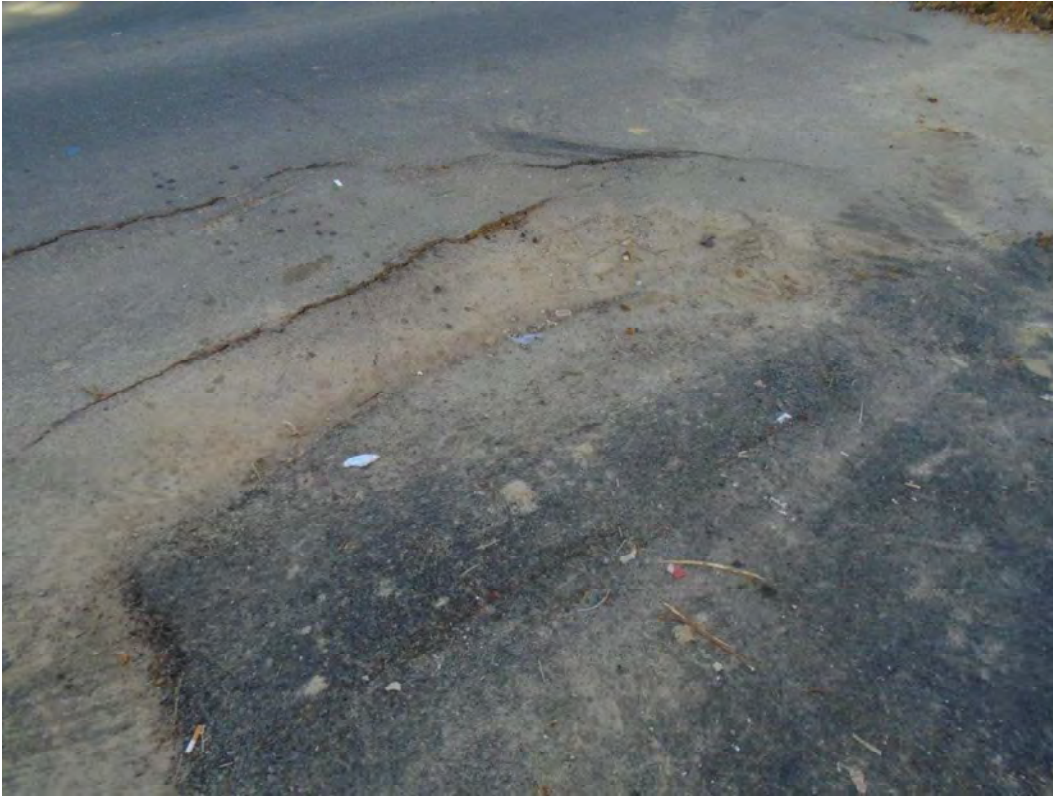
Photograph #41: Ground undermined in the front of 815 Jackson Street.

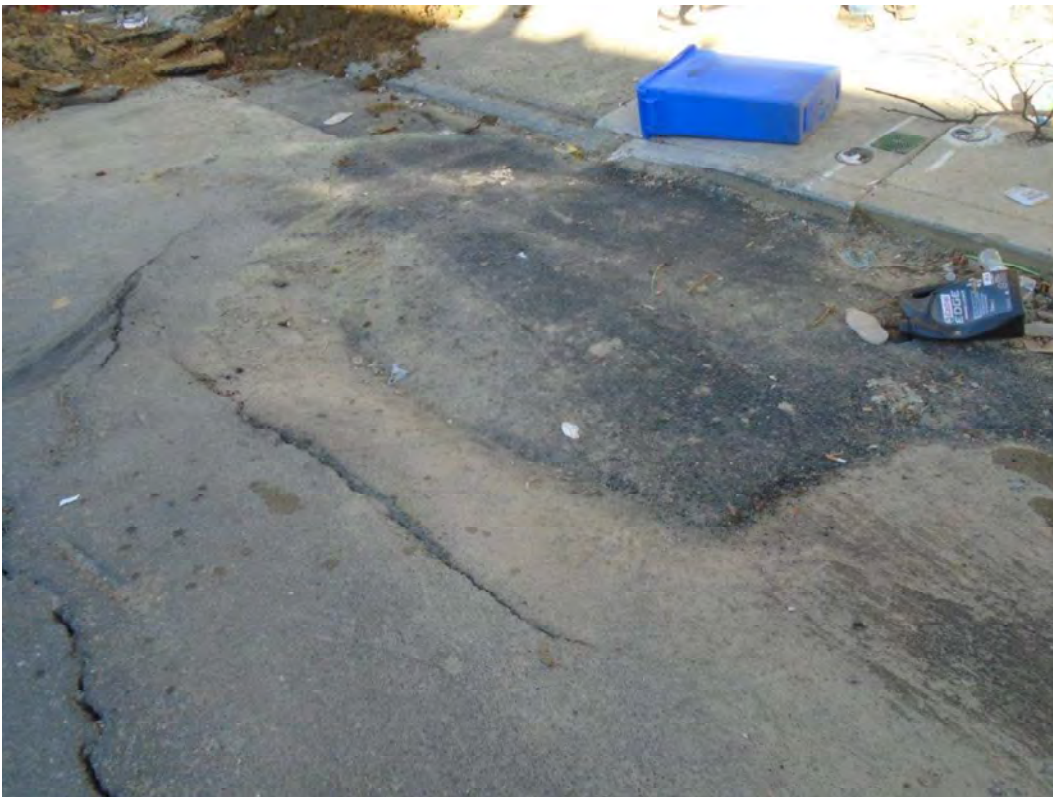
Photograph #42: Ground undermined in the front of 815 Jackson Street.

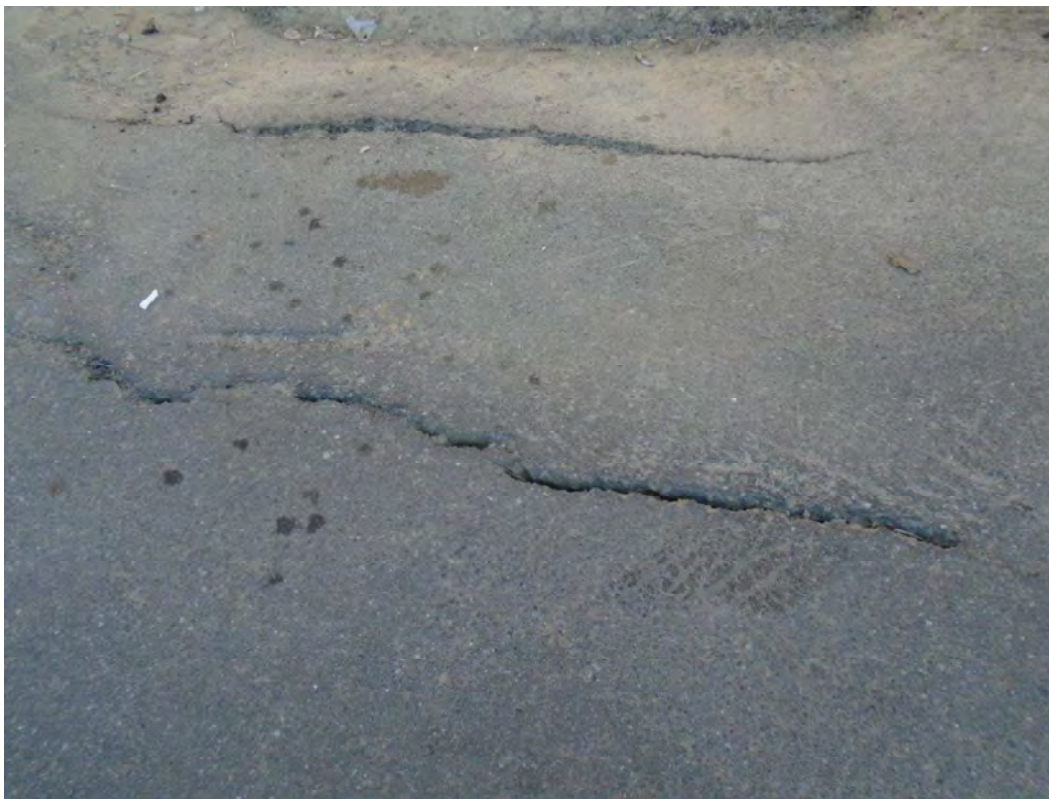
Photograph #43: Ground undermined in the front of 815 Jackson Street.

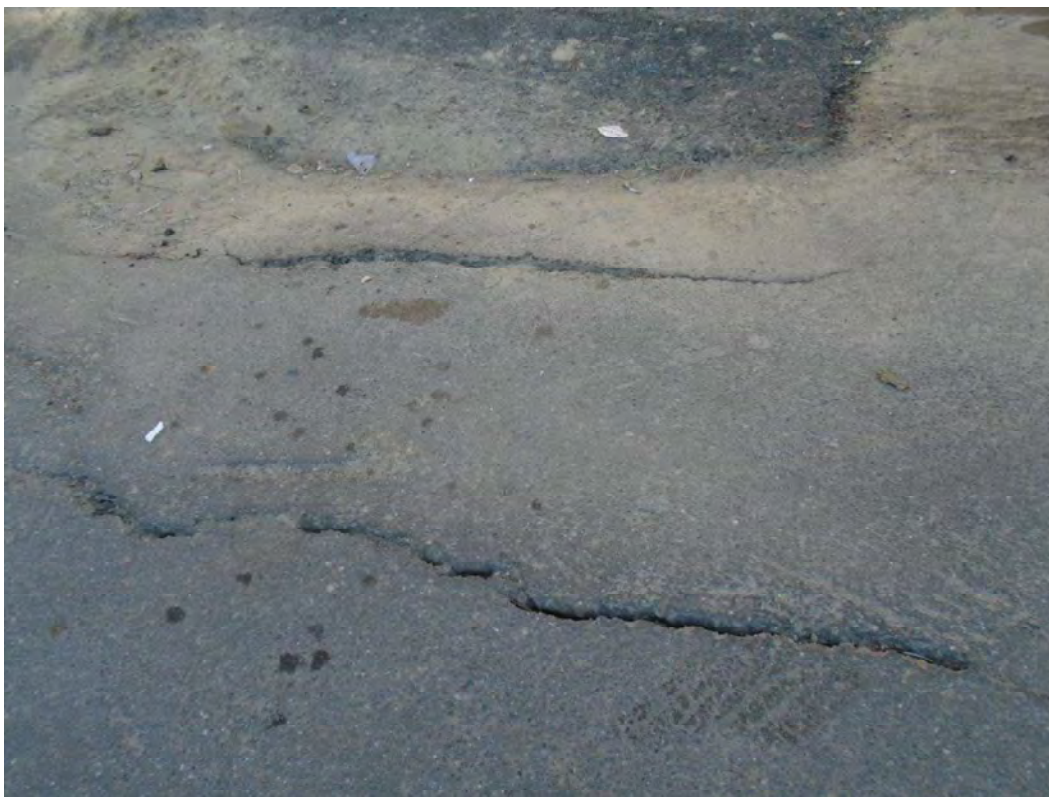
Photograph #44: Ground undermined in the front of 815 Jackson Street.

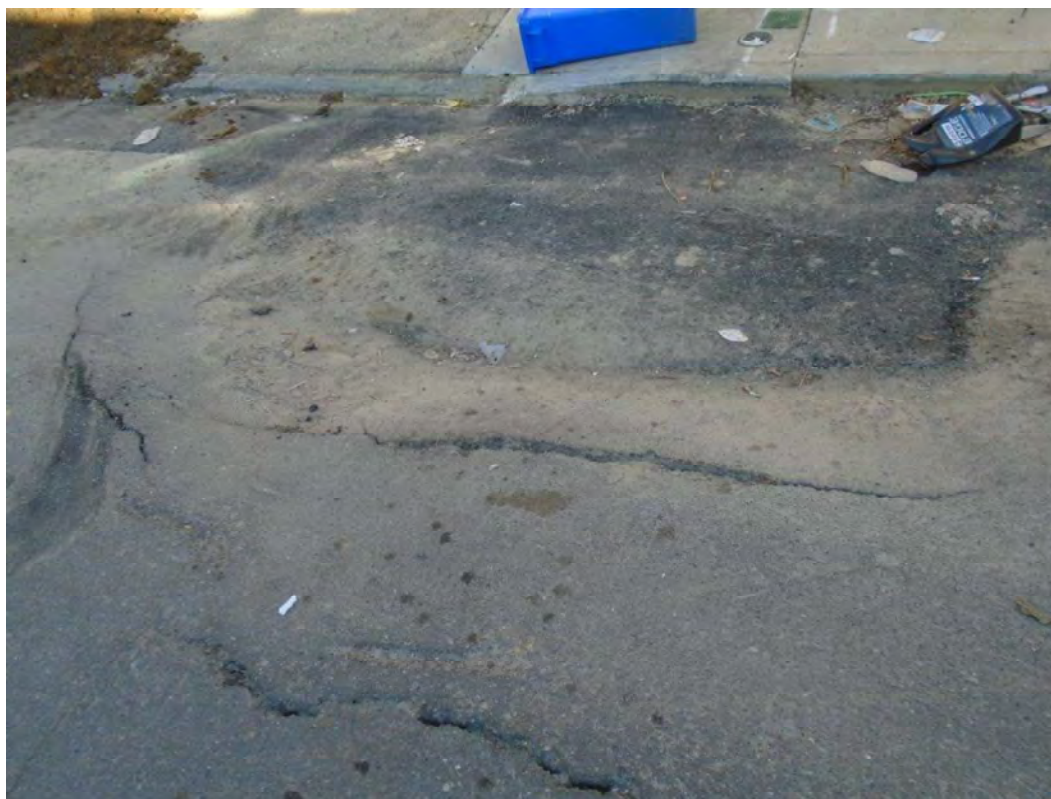
Photograph #45: Ground undermined in the front of 815 Jackson Street.
