**Re: PPL Electric Utilities Corporation
Quarterly Reliability Report for the
Period Ended June 30, 2011
Docket No. L-00030161**

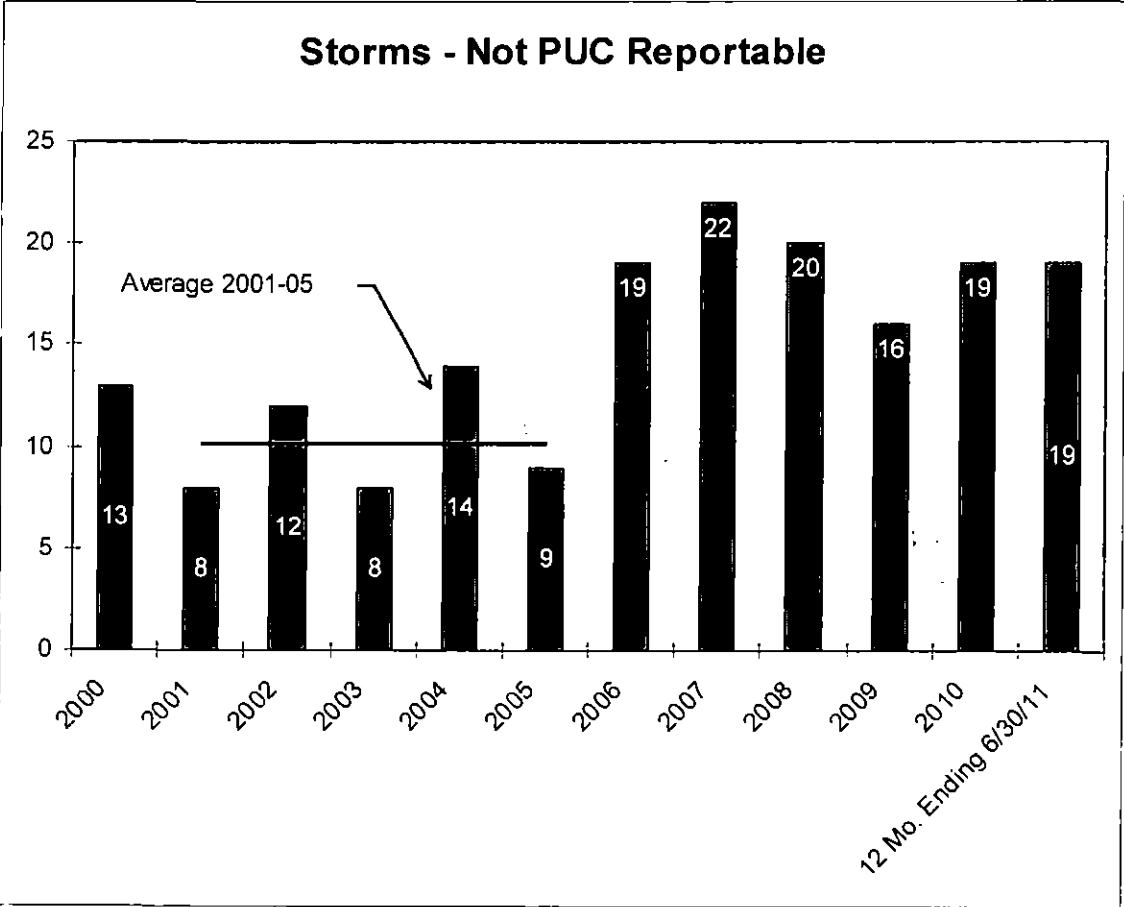
In addition, there were nineteen (19) storms that were not reportable, but which did require the opening of one or more area emergency centers to manage restoration efforts. This is 86% higher than the average of 10.2 non-reportable storms per year for the five years from 2001 through 2005.
