**Re: PPL Electric Utilities Corporation  
Quarterly Reliability Report for the  
Period Ended September 30, 2012  
Docket No. L-00030161**

**PPL Electric Utilities Corporation  
Quarterly Reliability Report  
to the  
Pennsylvania Public Utility Commission**

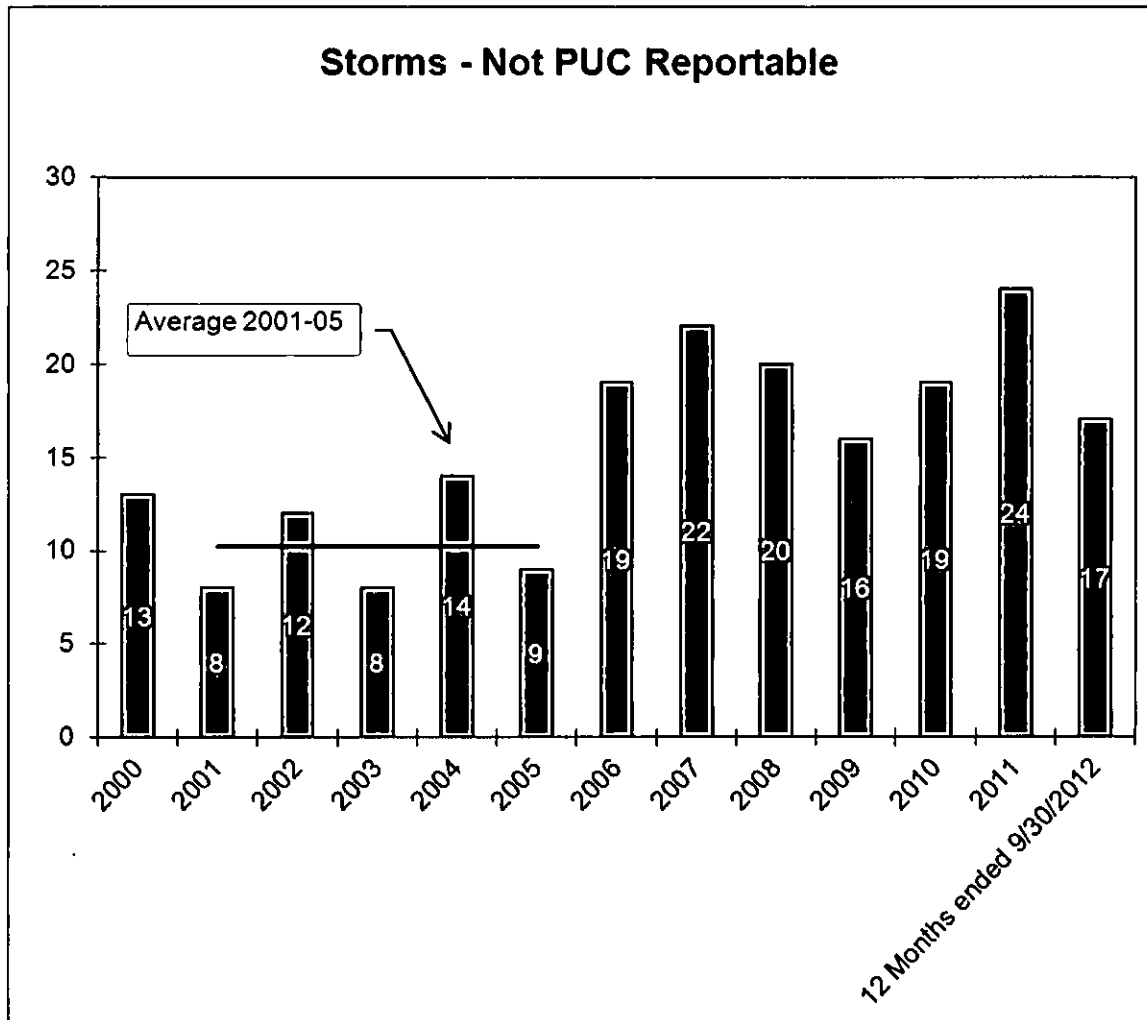
In addition, there were seventeen (17) storms that were not reportable, but which did require the opening of one or more area emergency centers to manage restoration efforts.
