Re: **PPL Electric Utilities Corporation**  
**2012 Annual Reliability Report**

L-00030161

**PPL Electric Utilities**

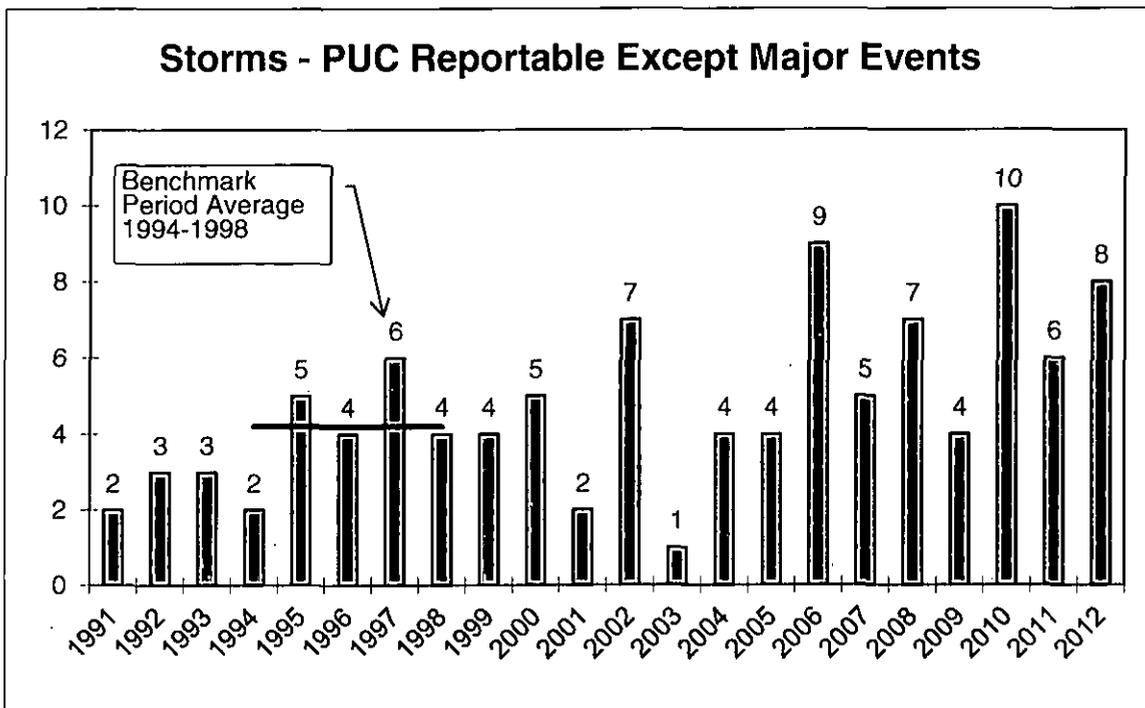
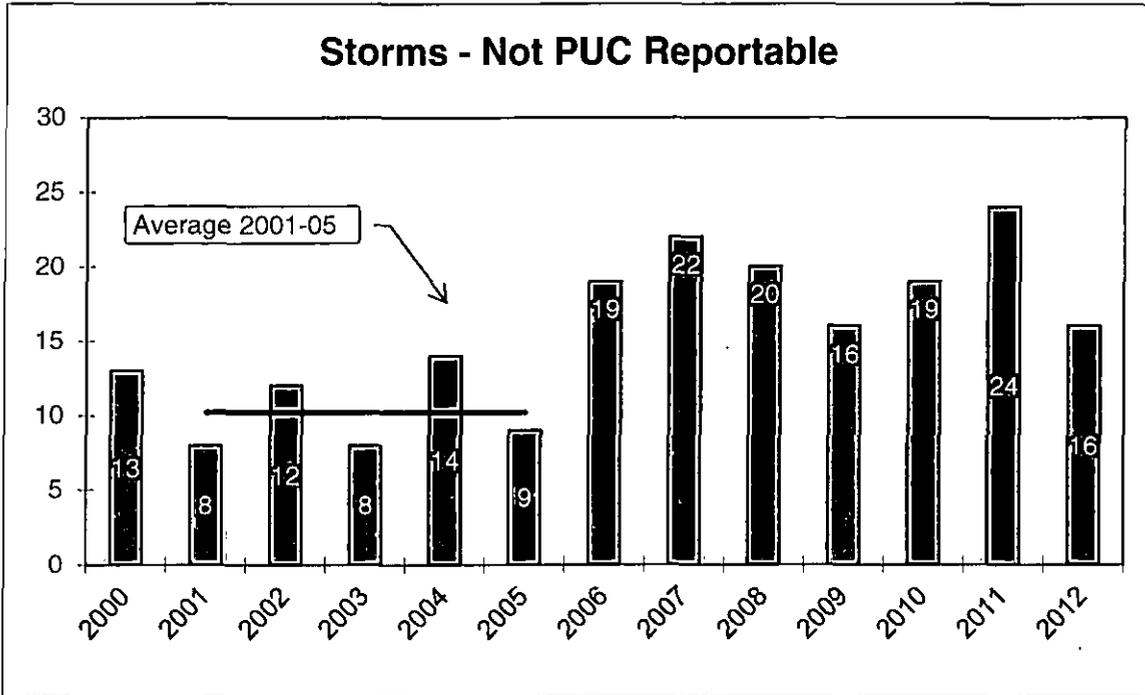
The three-year rolling average for SAIFI, CAIDI and SAIDI remained below the three-year standard, as well as the rolling 12-month standard. The three-year rolling average for SAIFI, SAIDI, and CAIDI were above the benchmark standard by 10%, 11% and 1% respectively.

All metrics were negatively impacted due to an increase in total storm activity as compared to the prior previous years. Specifically, PPL Electric experienced an average of 5.7 PUC reportable storms per year during the ten years from 2002 through 2011. The number of PUC reportable storms jumped to 8 in 2012, a 28% increase.

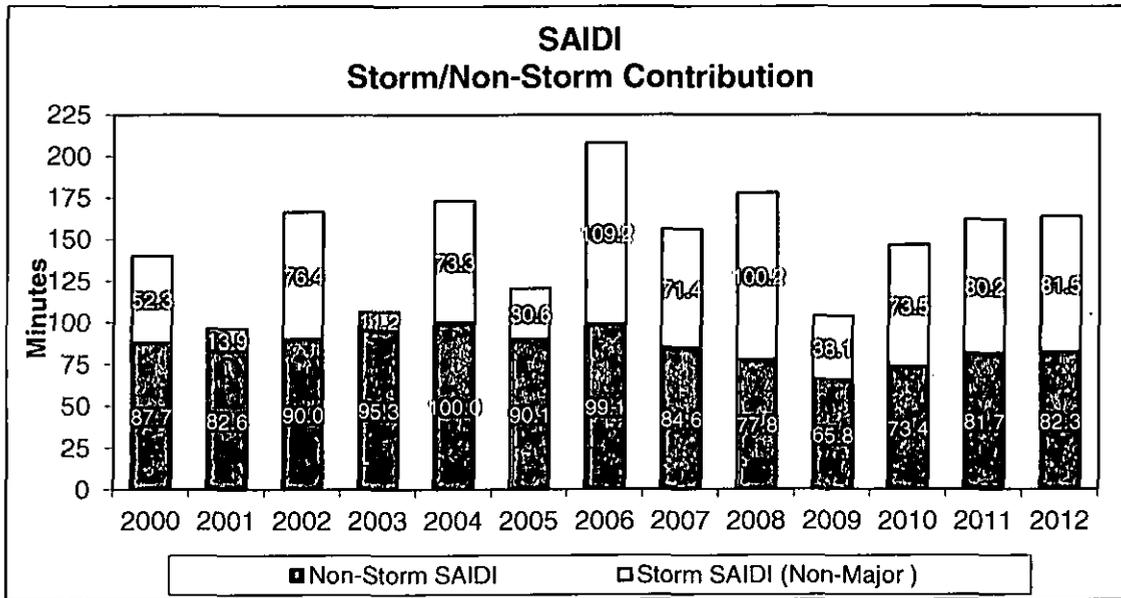
In a year with an average number of storms, customer service interruptions during storms typically contribute about one-third to the total SAIDI value. In 2012, storm interruptions contributed 50% of the SAIDI value.

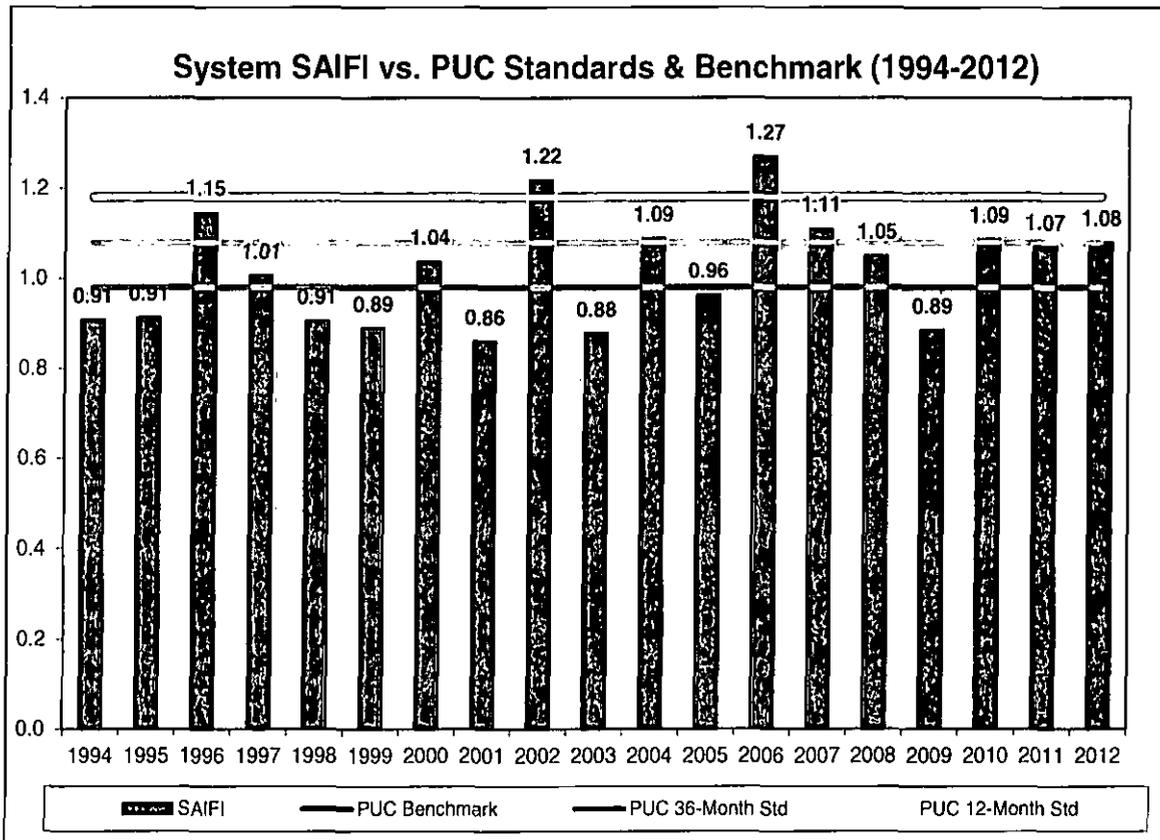
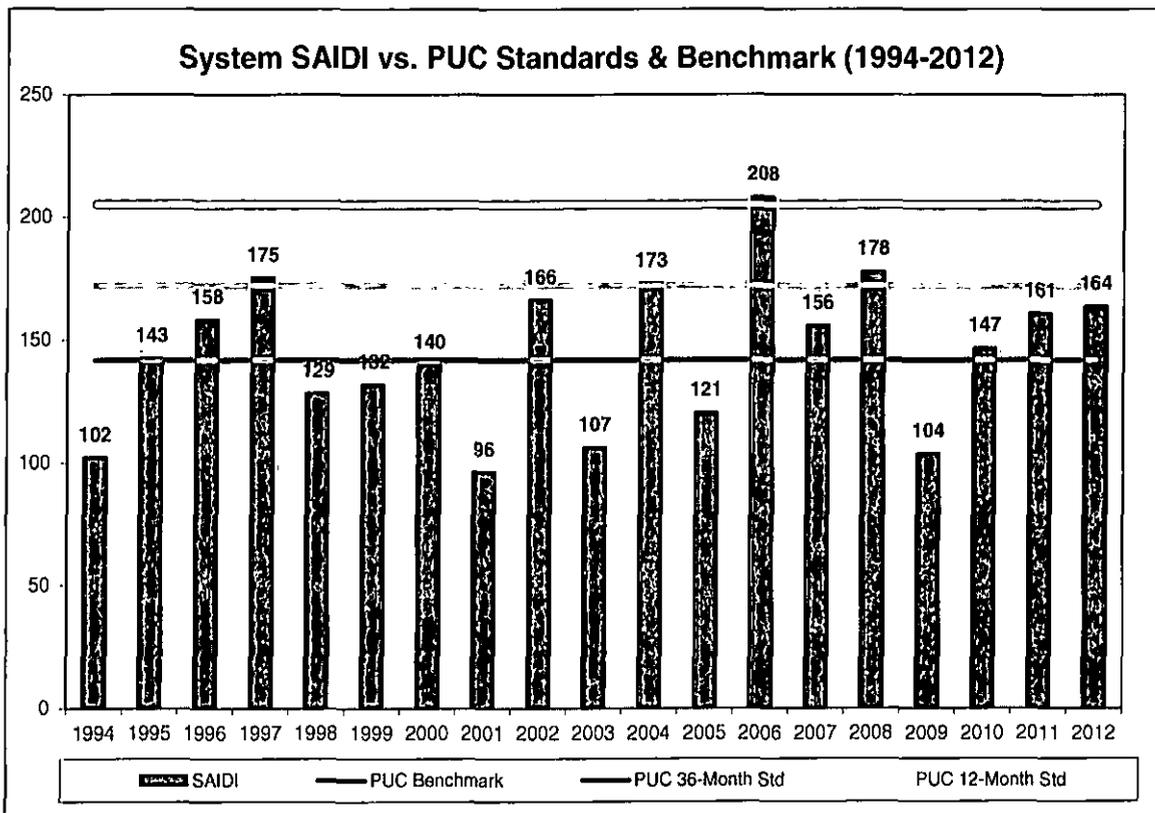
SAIFI, CAIDI and SAIDI generally have been maintained near benchmark levels and below the 36-month standard levels since the benchmark years of 1994 through 1998, as evidenced by the following three charts:
