**Re: PPL Electric Utilities Corporation
Quarterly Reliability Report for the
Period Ended December 31, 2009
Docket No. L-00030161**

**PPL Electric Utilities Corporation
Quarterly Reliability Report
to the
Pennsylvania Public Utility Commission**

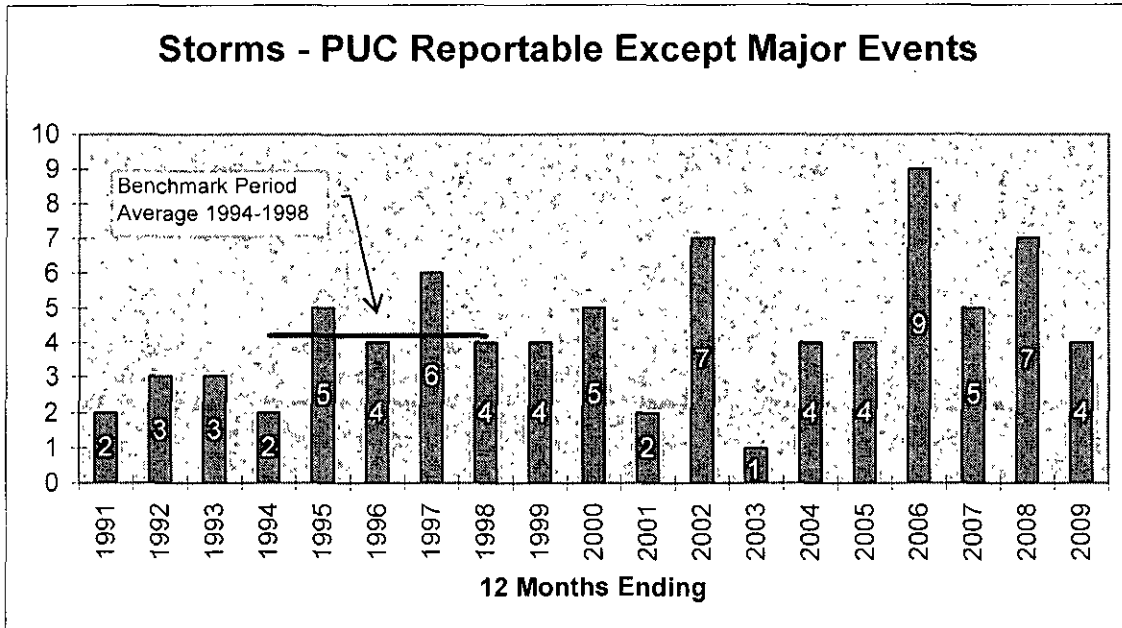
Specifically, during the 12-month reporting period, there were four (4) PUC-reportable storms ($\geq 2,500$ customers interrupted for ≥ 6 hr.) other than major events. This is slightly below the average of 4.2 storms per year during the benchmark years, 1994 through 1998.
