**Re: PPL Electric Utilities Corporation
Quarterly Reliability Report for the
Period Ended June 30, 2010
Docket No. L-00030161**

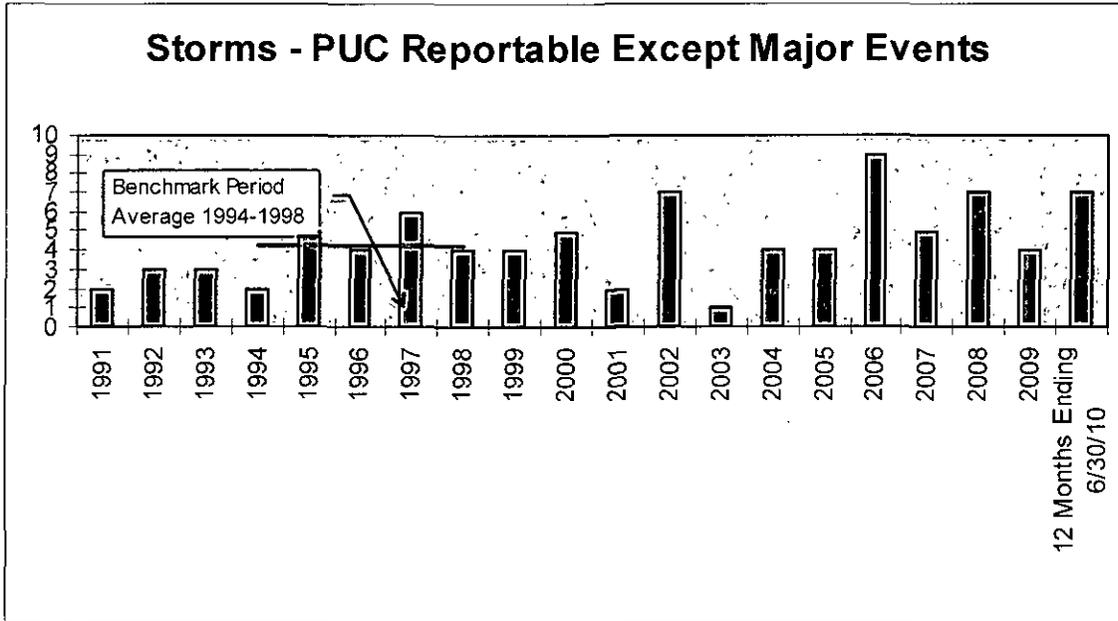
Specifically, during the 12-month reporting period, there were seven (7) PUC-reportable storms ($\geq 2,500$ customers interrupted for ≥ 6 hours) other than major events.

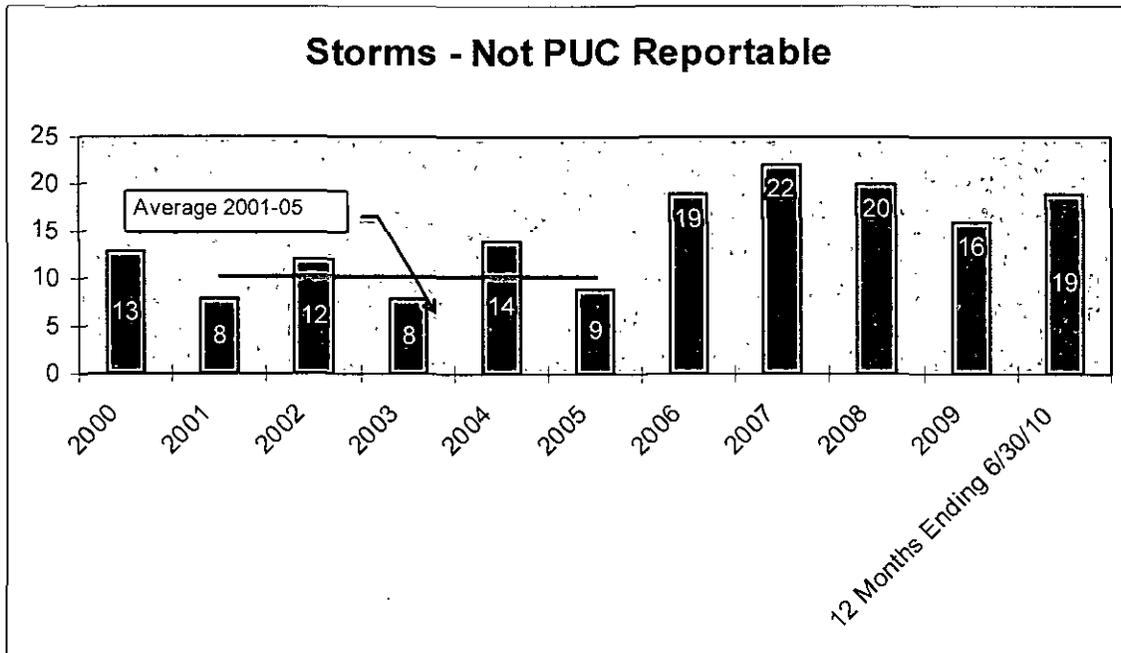
In addition, there were nineteen (19) storms that were not reportable, but which did require the opening of one or more area emergency centers to manage restoration efforts. This is 46% higher than the average of 10.2 storms per year for the five years from 2001 through 2005.
