**Re: PPL Electric Utilities Corporation
2014 Annual Reliability Report
Docket No. L-00030161**

Enclosed for filing on behalf of PPL Electric Utilities Corporation ("PPL Electric") is an original of PPL Electric's 2014 Annual Reliability Report to the Pennsylvania Public Utility Commission. This report is being filed pursuant to the Commission's regulations at 52 Pa. Code § 57.195(a).

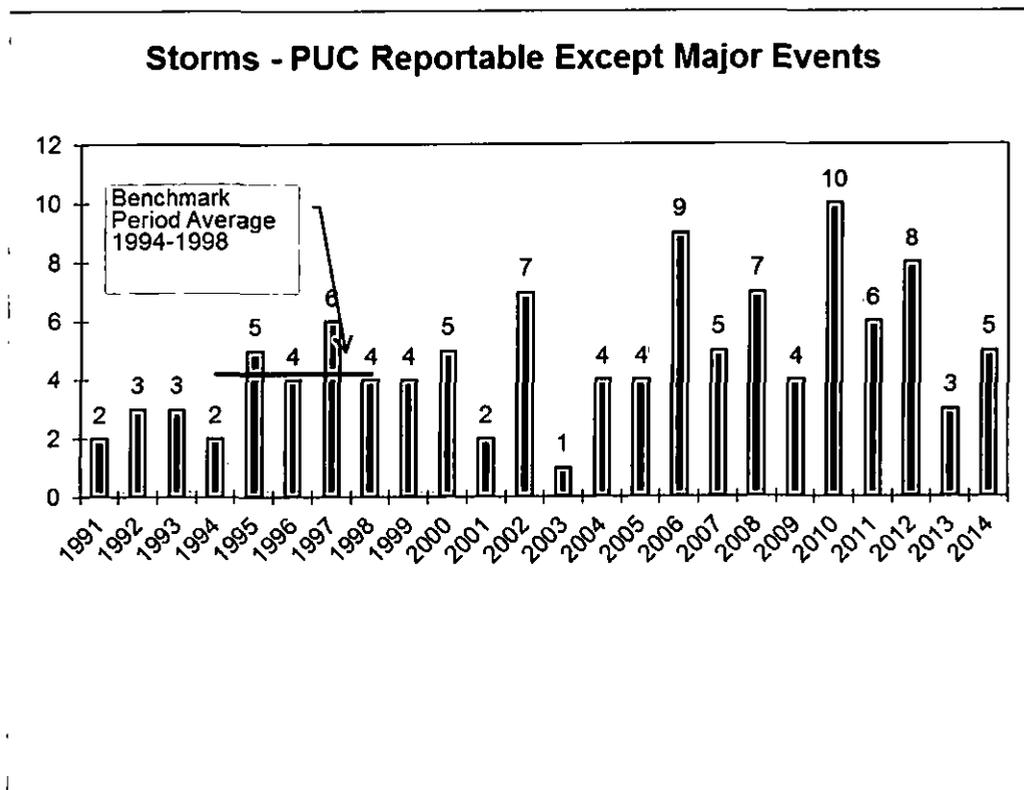
In 2014, SAIFI, SAIDI, and CAIDI values rose from the prior year. While SAIFI was within the benchmark value, SAIDI exceeded the benchmark, and CAIDI exceeded the benchmark, and 12 and 36 month standards for PPL Electric Utilities Corporation ("PPL Electric"). This effect, with SAIFI remaining within benchmark and both SAIDI and CAIDI exceeding benchmark, is largely attributable to a significant ice storm concentrated in the Lancaster region that began on February 5, 2014. Due to the concentrated nature of the storm, it did not affect enough customers to be declared a PUC major event, although it did produce significant damage to our system. Without this storm, which would be excluded under the Institute of Electrical and Electronics Engineers (IEEE) 2.5B standard, system values would be: SAIFI 0.85; CAIDI 143; and SAIDI 122, all within the benchmark.

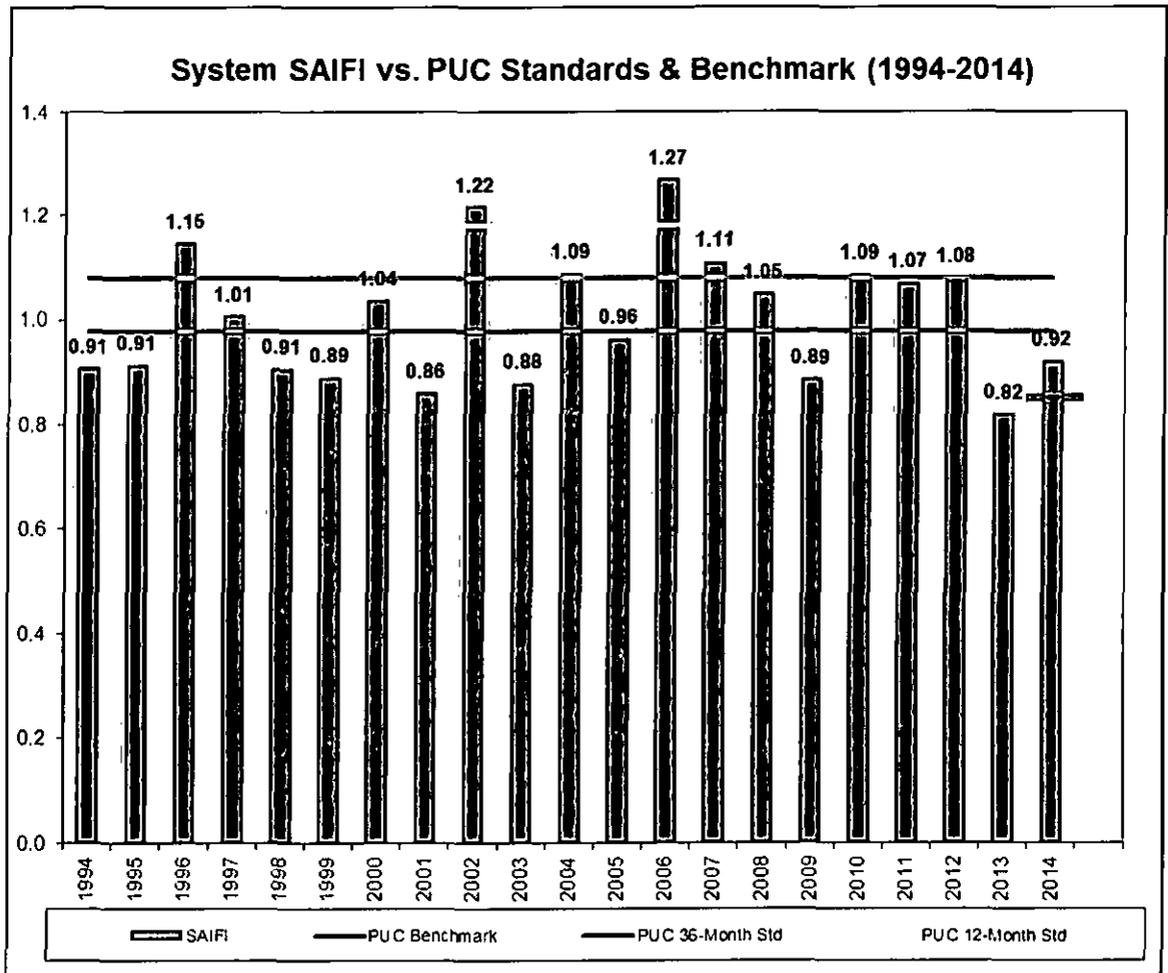
SAIFI, CAIDI and SAIDI generally have been maintained near benchmark levels and below the 36-month standard levels since the benchmark years of 1994 through 1998, as evidenced by the following three charts. For 2014, SAIFI was below benchmark but SAIDI and CAIDI were adversely affected by a concentrated ice storm in February that added 44 SAIDI minutes to the system total. On each chart, the short red bar on the 2014 column indicates the value of the metric with ice storm Nika removed.
