**Re: PPL Electric Utilities Corporation
Quarterly Reliability Report for the
Period Ended June 30, 2016
Docket No. L-00030161**

PPL Electric Utilities Corporation
Quarterly Reliability Report
to the
Pennsylvania Public Utility Commission

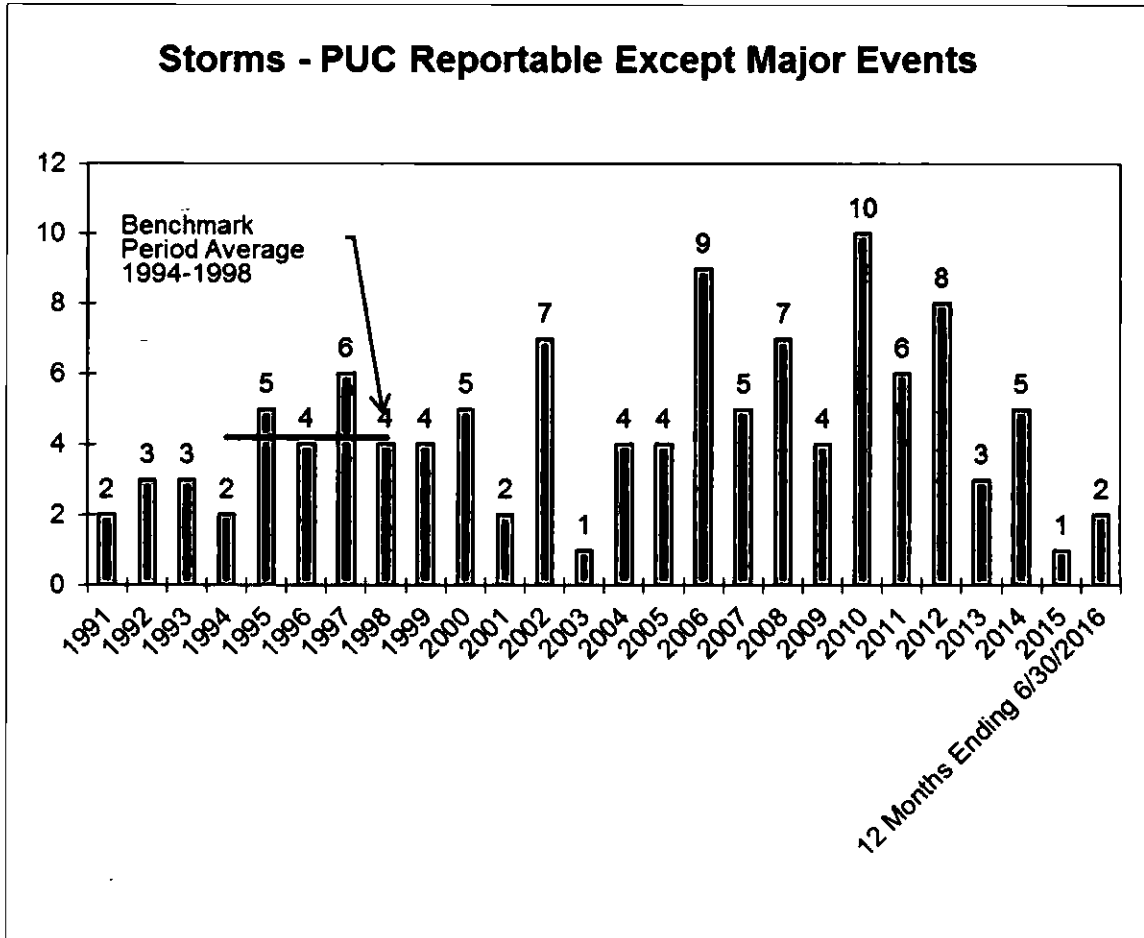
Specifically, during the 12-month reporting period, there were no (0) PUC major events and two (2) PUC-reportable storms ($\geq 2,500$ customers interrupted for ≥ 6 hours) other than major events.

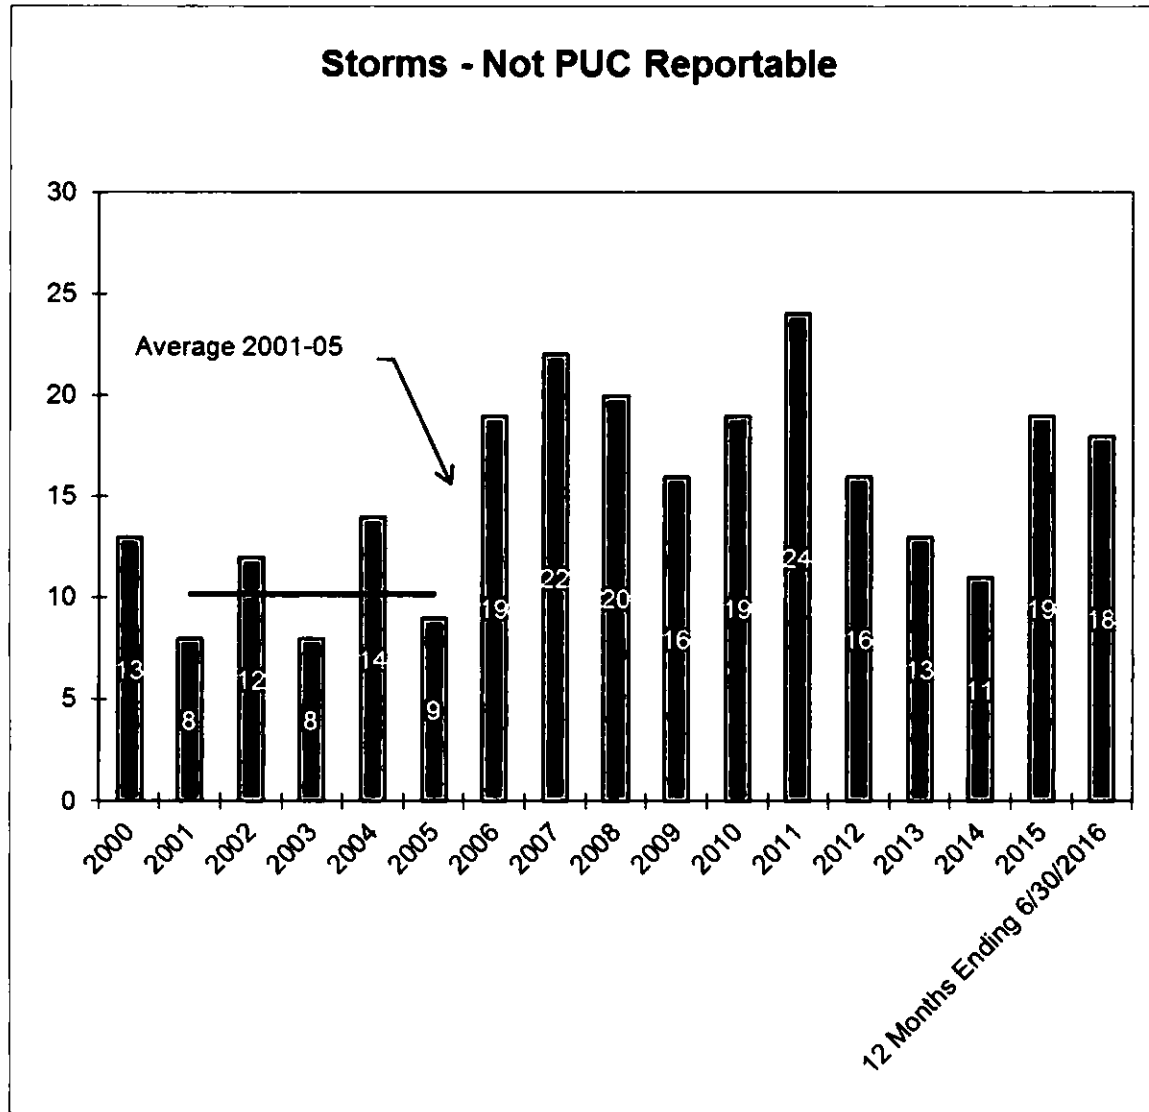
In addition, there were eighteen (18) storms that were not reportable, but which did require the opening of one or more area emergency centers to manage restoration efforts.
