Re: Fourth Quarter 2006 Quarterly Report for Pike County Light and Power  
PUC Docket No. L-00030161; Rulemaking Re Amending Electric  
Service Reliability Regulations At 52 Pa. Code Chapter 57

Pike County Light & Power Company ("Pike") hereby submits six copies of its Fourth Quarter 2006 quarterly report as set forth in the Pennsylvania Public Utility Commission's ("Commission, PUC") Docket No. L-00030161 adopted Rulemaking Re Amending Electric Service Reliability Regulations At 52 Pa. Code Chapter 57 ("Order"). As such, Pike's quarterly reporting Requirements, as set forth in Section 57.195(e) (1) (2) and (5) of the Order, are enclosed. At a Public hearing on August 17th, the Commission ordered that the Pike Reliability Standards be modified in order to reflect major events that were improperly excluded from the years on which the standards were based. O&R received formal notice of this Order on October 11th. This Filing reflects the revised Standards.

**PPL Electric Utilities Corporation  
Quarterly Reliability Report  
to the  
Pennsylvania Public Utility Commission**

**PPL Electric Utilities Corporation  
Annual Reliability Report  
to the  
Pennsylvania Public Utility Comm

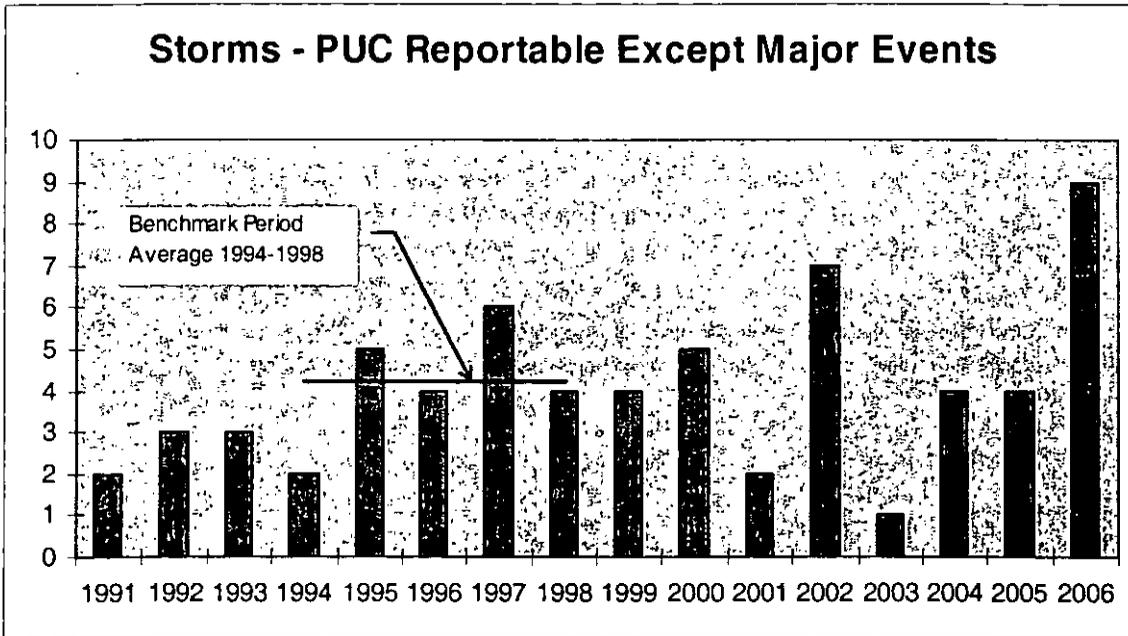
encompassing the benchmark years through the present day, and more than double the average of 4.2 storms per year during the benchmark years, 1994-1998.

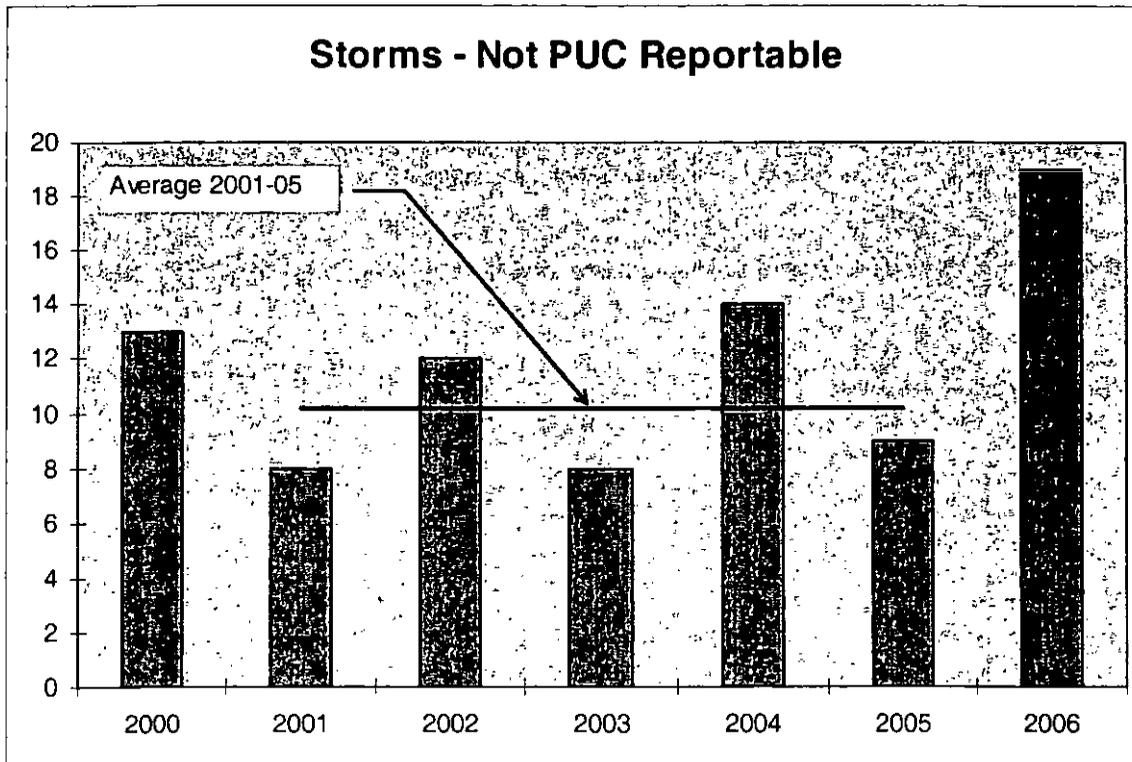
In addition, there were nineteen (19) storms that were not reportable, but which did require opening one or more area emergency centers to manage restoration efforts. This is more than any other year in the last seven (7) years when PPL Electric first began tracking the incidence of non-reportable storms, and 86% higher than the average of 10.2 storms per year for the five years from 2001 through 2005.

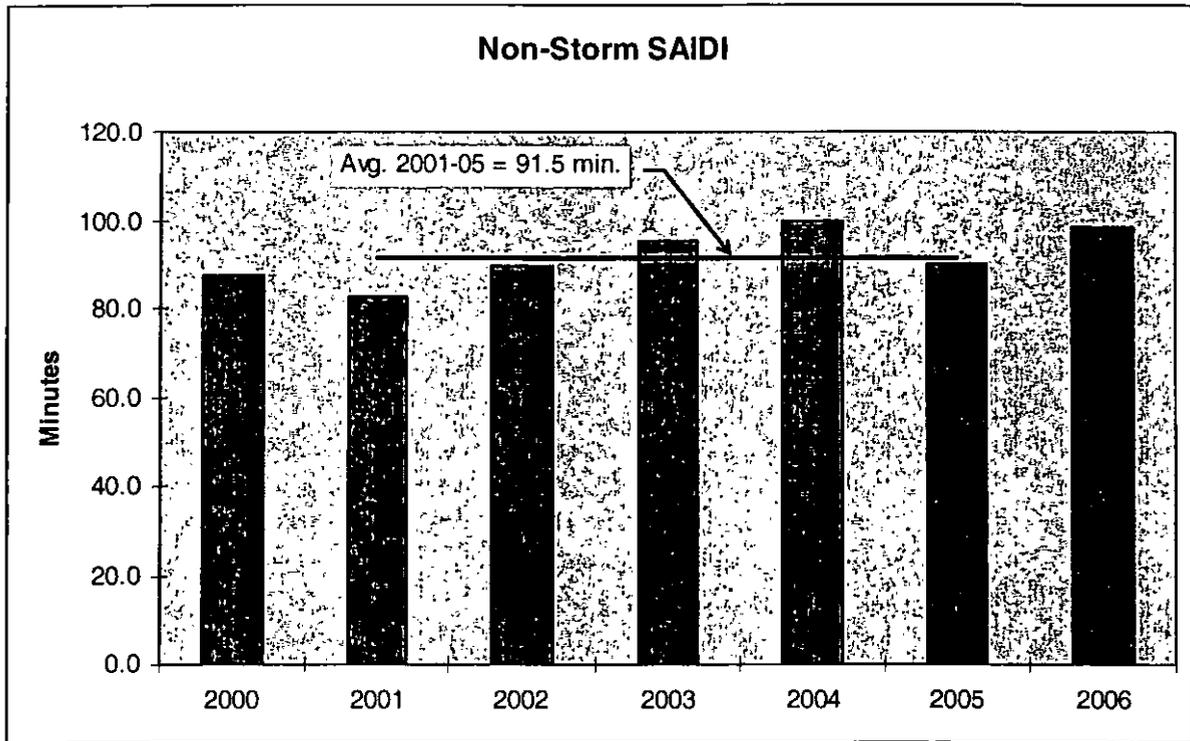
In a year with an average number of storms, customer service interruptions during storms contribute about one-third to the total SAIDI value. By contrast, during 2006, customer service interruptions during storms contributed more than one-half of the total SAIDI value. As a result, 110 of the 209 SAIDI minutes were due to storm-related interruptions.

SAIDI during non-storm conditions for 2006 was 98.5 minutes, comparable to that of 2003 through 2005 which were 95.4 minutes, 99.9 minutes and 90.0 minutes, respectively, and only 7 minutes higher than the 2001-2005 five-year average.

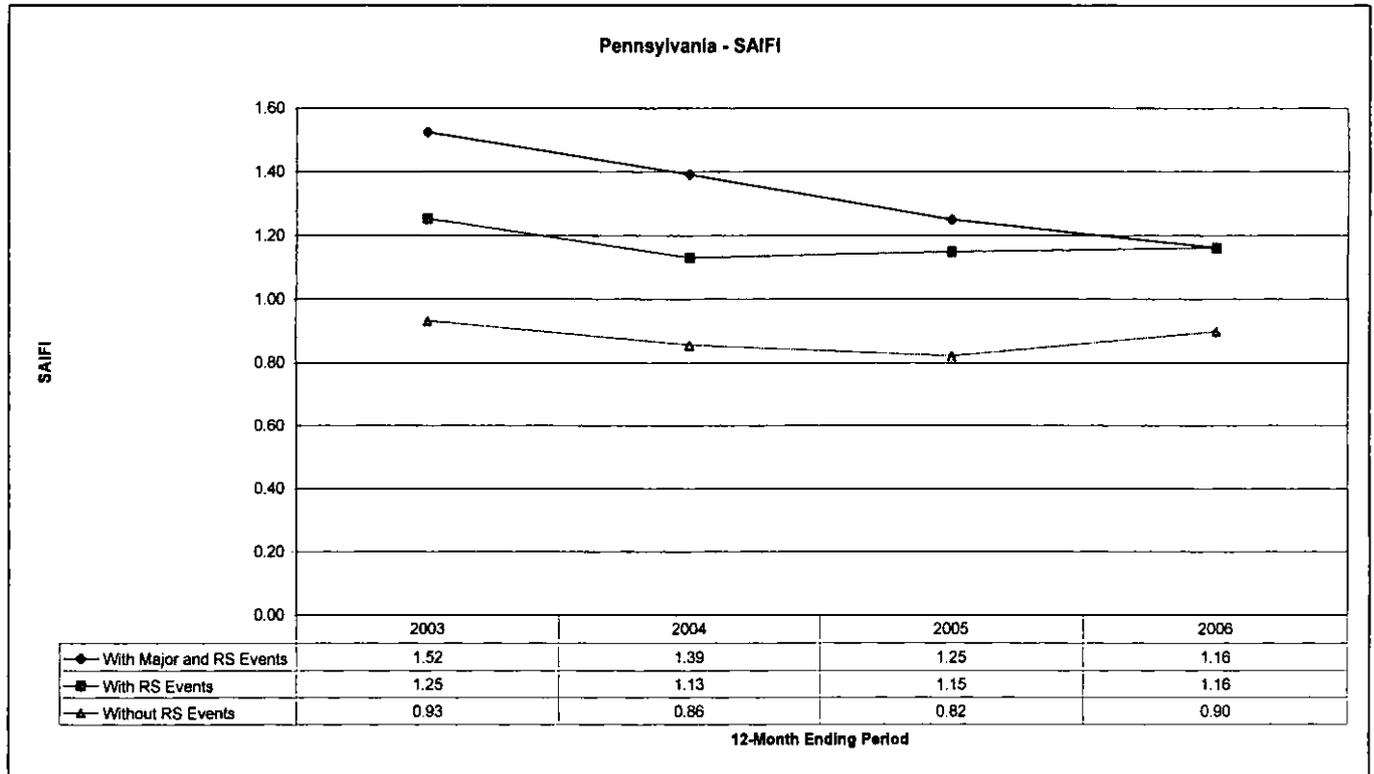
Although not excluded from statistics, AP's Pennsylvania service territory experienced several minor events ('RS Events') characterized by having received a severe weather alert accompanied by at least 5,000 Allegheny Power customers interrupted. The following chart shows the effect on SAIFI of Major Events and RS Events for Pennsylvania customers:

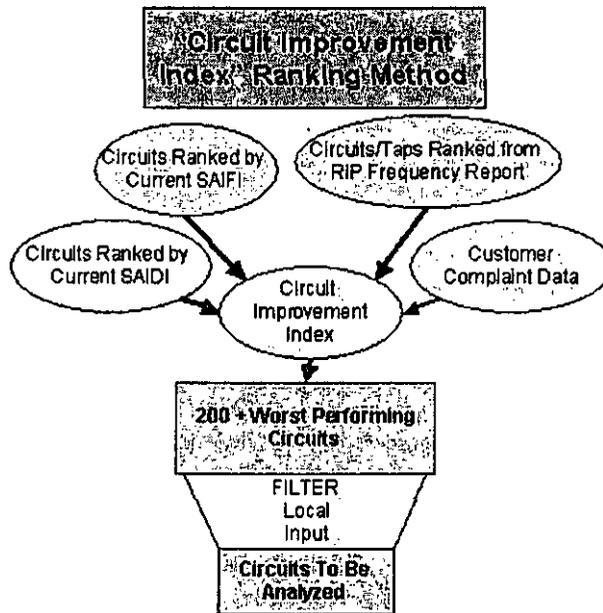
AP is considering a circuit improvement index which includes a number of factors such as frequency of lockouts, frequency of major tap interruptions representing individual customer outage frequency, customer complaint data (if applicable), plus traditional reliability indexes such as SAIFI and SAIDI. A 'master' circuit improvement list will be generated annually and reviewed at the local levels for field input. Field offices, being closer to the customer, have information needed to complete the selection process based on known circuit problems. The master list will then be narrowed to the 100 or so circuits to be studied for the next year. No less than the required applicable state commission requirement will be addressed. Under this circuit selection method, about the same number of circuits will be evaluated since 5% of AP's 1850 circuits equals 93 circuits. Once circuits are selected for the next year, individual analysis will take place as part of AP's ongoing structured Reliability Improvement Program (RIP). Outage causes will be evaluated, circuit outage maps will be created to assist in the evaluation if needed, and budgets and work plans will be established to improve reliability for viable projects.

A schematic diagram of the process follows:

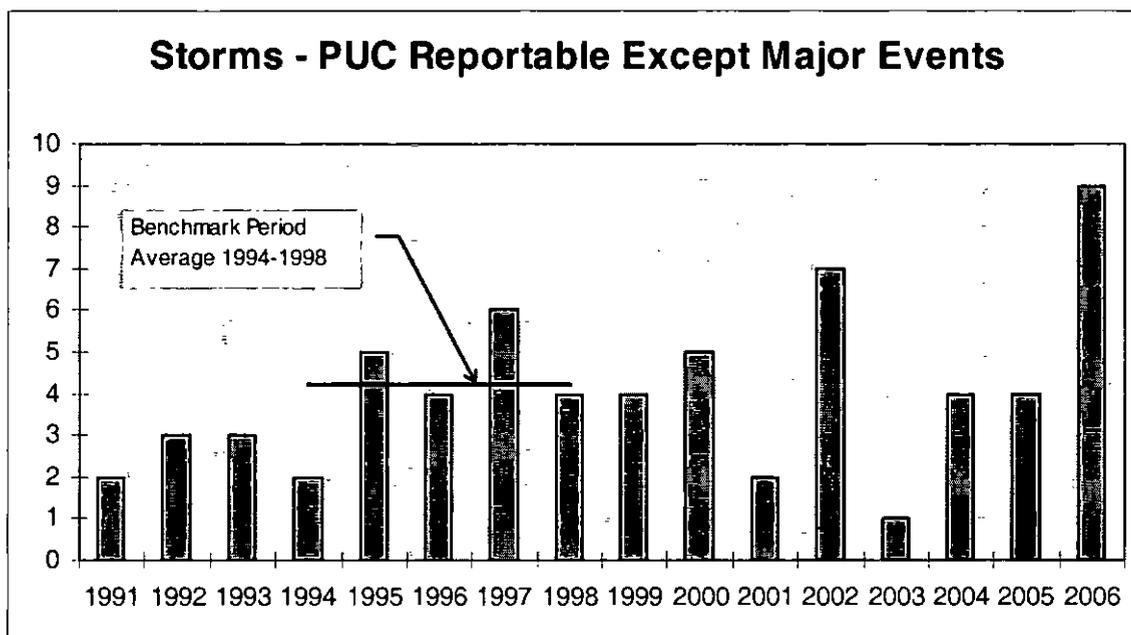
Specifically, there were nine (9) PUC-reportable storms ( $\geq 2,500$  customers interrupted for  $\geq 6$  hr.) during the reporting period, more than any other single year in the 16 years encompassing the benchmark years through the present day, and more than double the average of 4.2 storms per year during the benchmark years, 1994-1998.

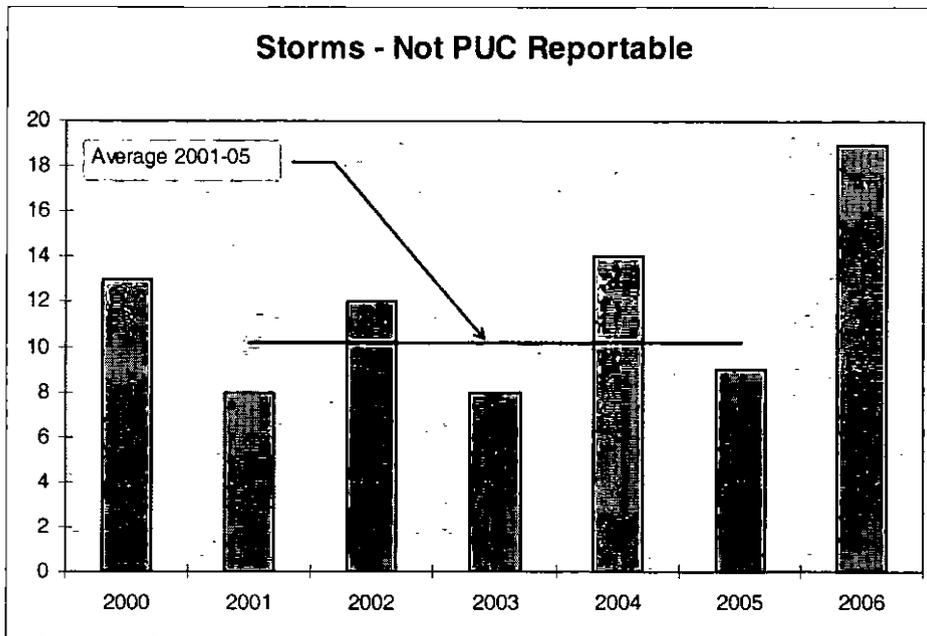
In addition, there were nineteen (19) storms that were not reportable, but which did require opening one or more area emergency centers to manage restoration efforts. This is more than any other year in the last seven (7) years when PPL Electric first began tracking the incidence of non-reportable storms, and 86% higher than the average of 10.2 storms per year for the five years from 2001 through 2005.

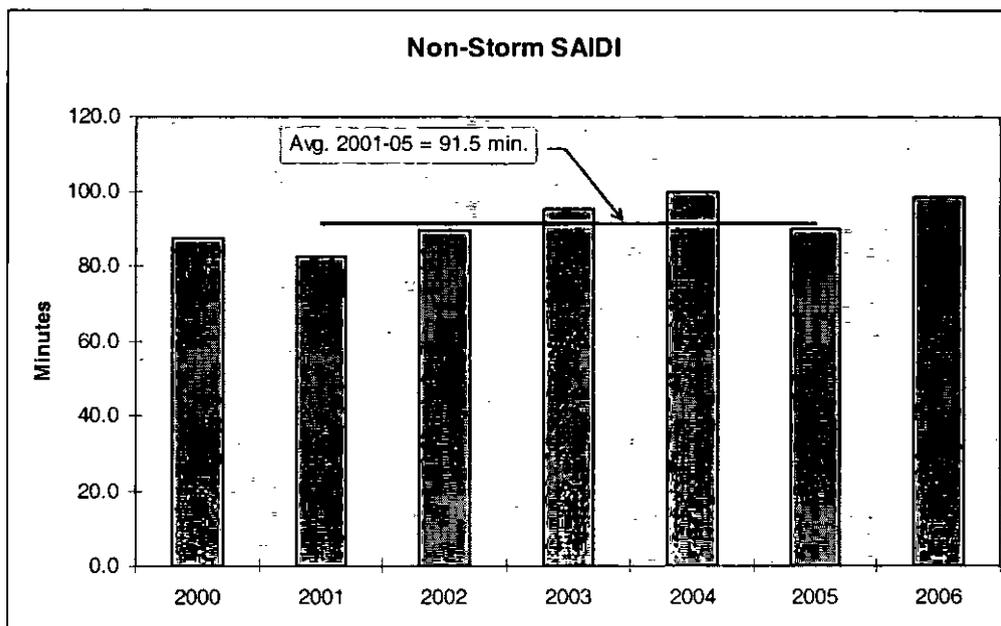
In a year with an average number of storms, customer service interruptions during storms contribute about one-third to the total SAIDI value. By contrast, during 2006, customer service interruptions during storms contributed more than one-half of the total SAIDI value. As a result, 110 of the 209 SAIDI minutes were due to storm-related interruptions.

SAIDI during non-storm conditions for 2006 was 98.5 minutes, comparable to that of 2003 through 2005 which were 95.4 minutes, 99.9 minutes and 90.0 minutes, respectively, and only 7 minutes higher than the 2001-2005 five-year average.

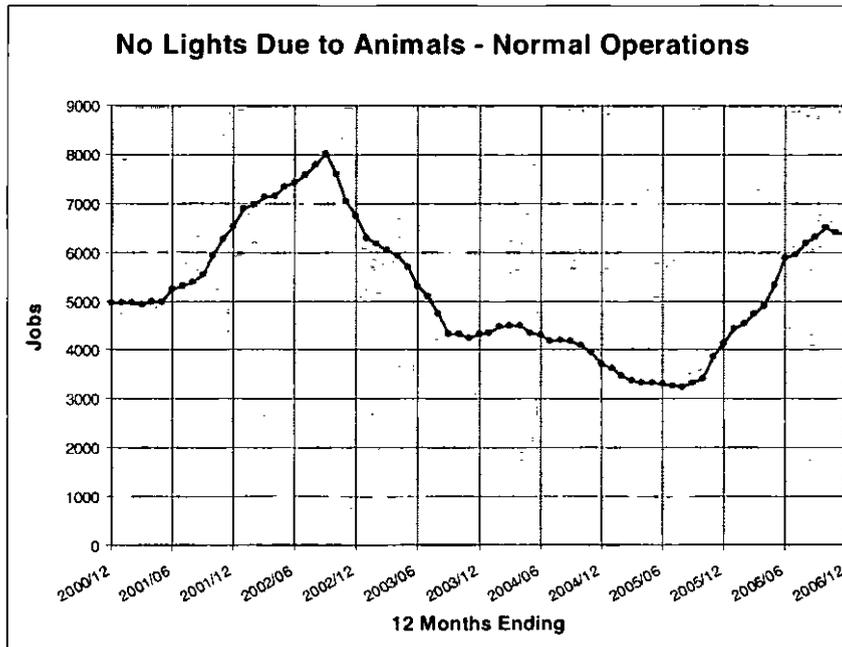
In addition to the unusual peak in storm activity, customer service interruptions caused by animals also reached a peak in its cycle. Animal caused outages are primarily a function of the size of the squirrel population. That population rises and falls with the rise and fall of acorn and other nut-bearing tree production, as well as periodic disease epidemics. The period and amplitude of future cycles cannot be predicted. The cyclical nature of the resulting interruption cases (jobs) is shown below:
