**PPL**  
Two North Ninth Street  
Allentown, PA 18101-1179  
Tel. 610.774.5696 Fax 610.774.6726  
KKlock@pplweb.com

Re: **PPL Electric Utilities Corporation  
Quarterly Reliability Report for the  
Period Ended March 31, 2017  
Docket No. E-00030161**

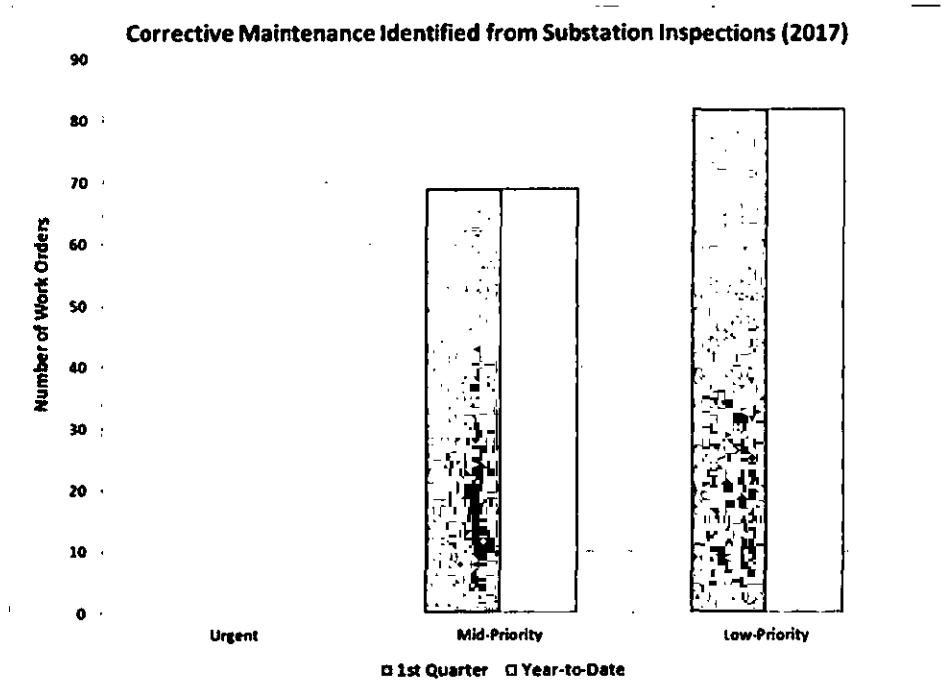
**(a) The Number of Corrective Work Orders by Type (Low-Priority, Mid-Priority, Urgent)**

During 1<sup>st</sup> Quarter 2017, 151 corrective work orders were created with the following breakdown by priority.

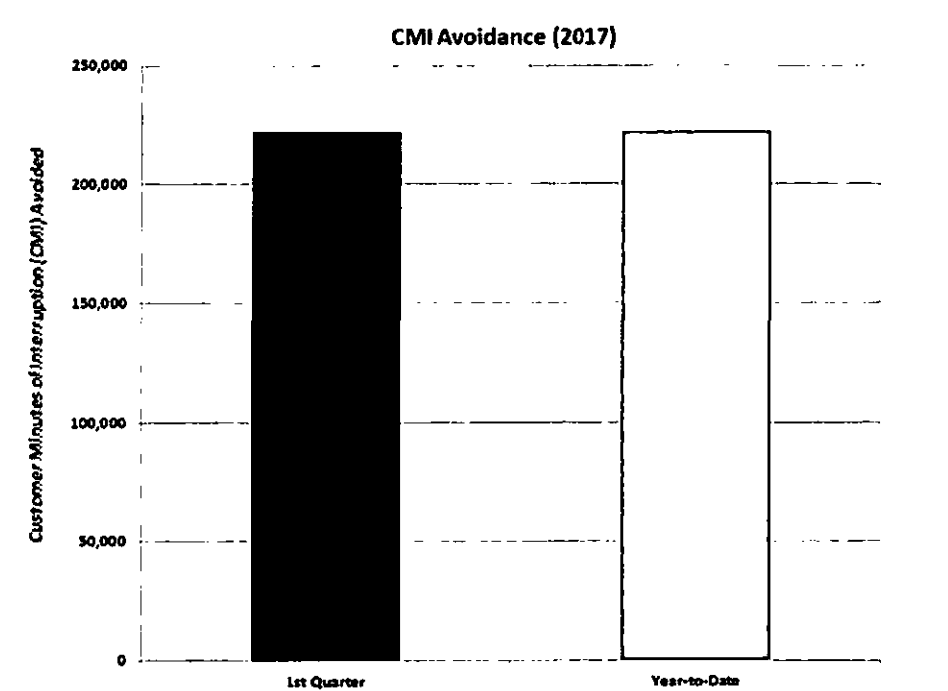
**(d) The Projected CMI Avoidance due to Substation Inspections**

The figure below shows the amount that PPL Electric has the estimated CMI avoidance, for the 1<sup>st</sup> Quarter and Year-to-Date. During 1<sup>st</sup> Quarter 2017, PPL Electric has potentially avoided around 222,000 CMI.

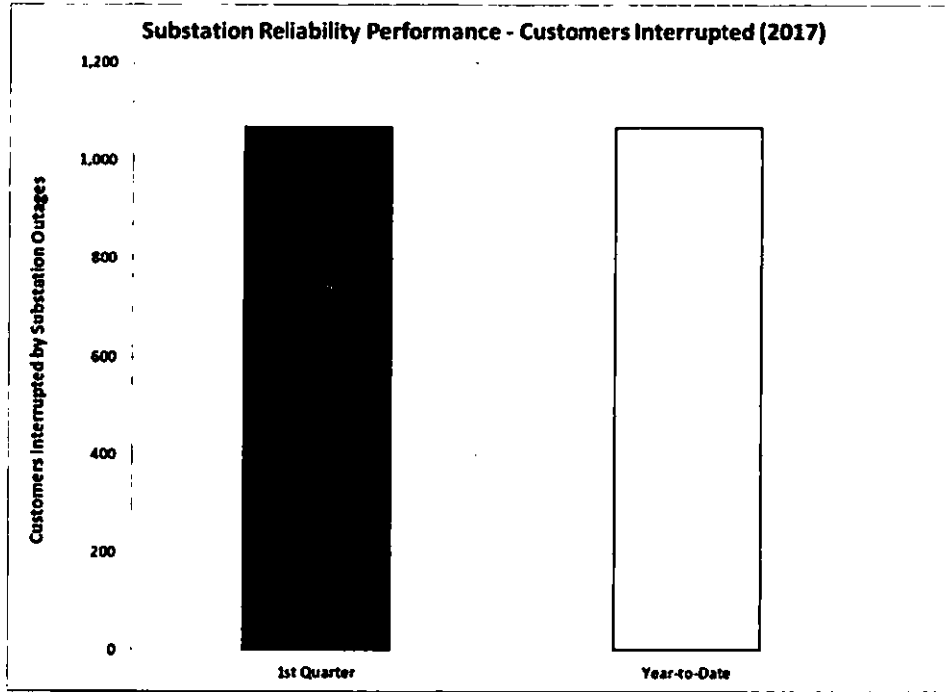
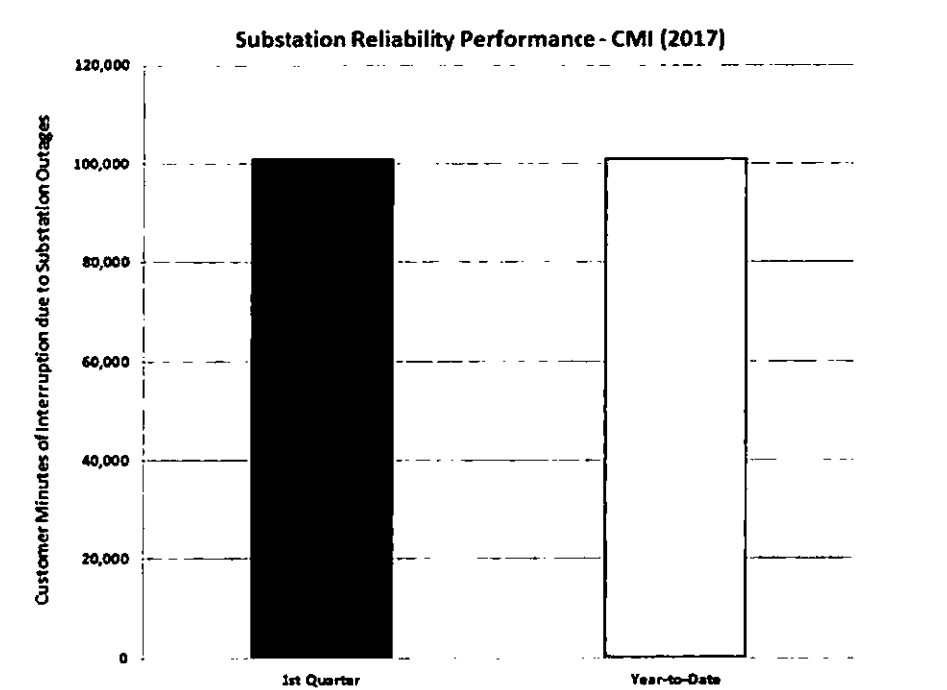
**(e) Customer Minutes and Number of Customers Affected due to Substation Sustained Outages**

In the past three years, distribution substations have contributed a small amount toward the reliability metrics. During 1<sup>st</sup> Quarter 2017, the company interrupted just over 1,000 customers for a total of approximately 101K CMI. The figures below show these results for the number of customers interrupted and CMI experienced, respectively.
