**Re: PPL Electric Utilities Corporation
Quarterly Reliability Report for the
Period Ended June 30, 2017
Docket No. L-00030161**

PPL Electric Utilities Corporation
Quarterly Reliability Report
to the
Pennsylvania Public Utility Commission

July 2017

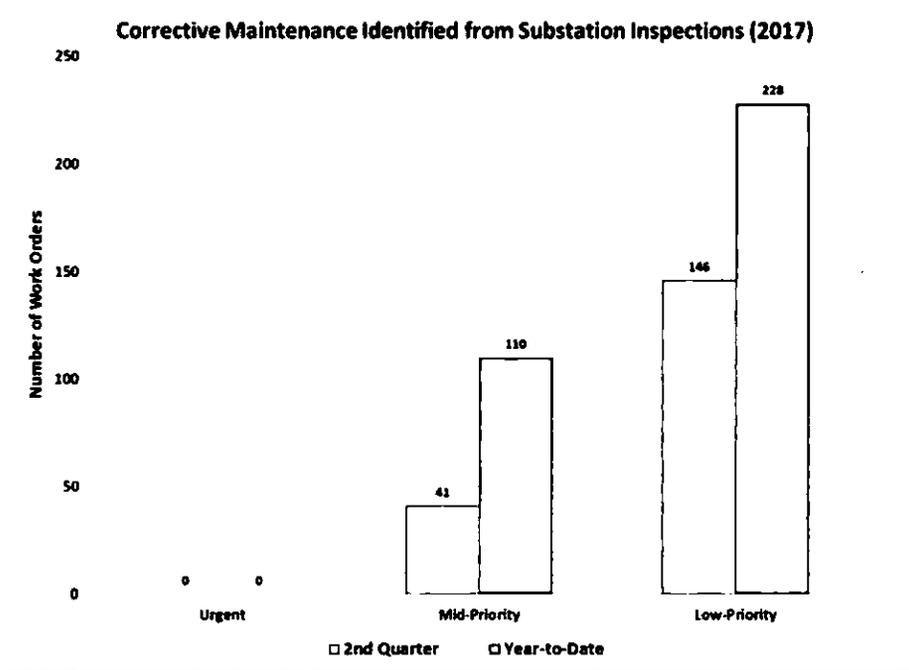
During the second quarter of 2017, 187 corrective work orders were created with the following breakdown by priority.

Figure 1: Corrective Maintenance Work Orders by Priority Level for second quarter and year-to-date 2017

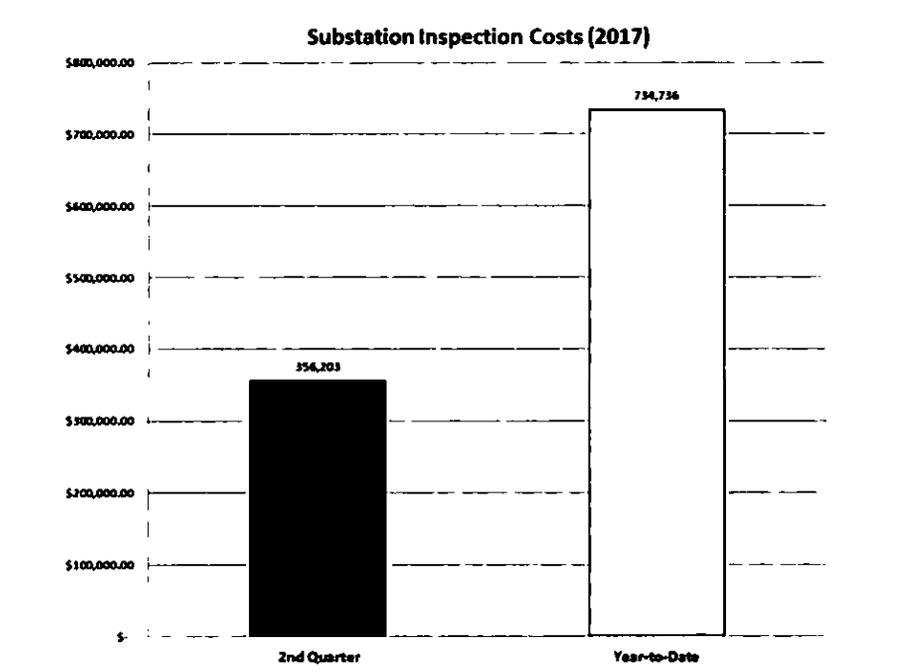
During the second quarter of 2017, PPL Electric spent approximately \$350,000 on substation inspections. This amount also represents the year-to-date total, as shown in the figure below.

Figure 2: Substation Inspection Costs for second quarter and year-to-date 2017.

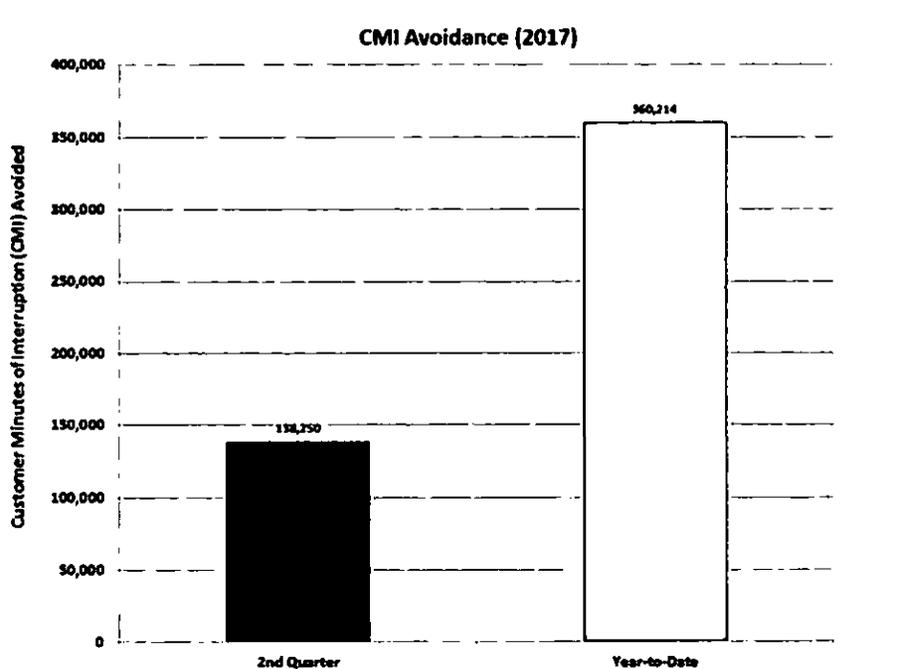
The figure below shows the amount that PPL Electric has the estimated CMI avoidance, for the second quarter and year-to-date. During second quarter of 2017, PPL Electric has potentially avoided approximately 138,000 CMI.

Figure 3: CMI Avoidance Due to Inspections for second quarter and year-to-date 2017

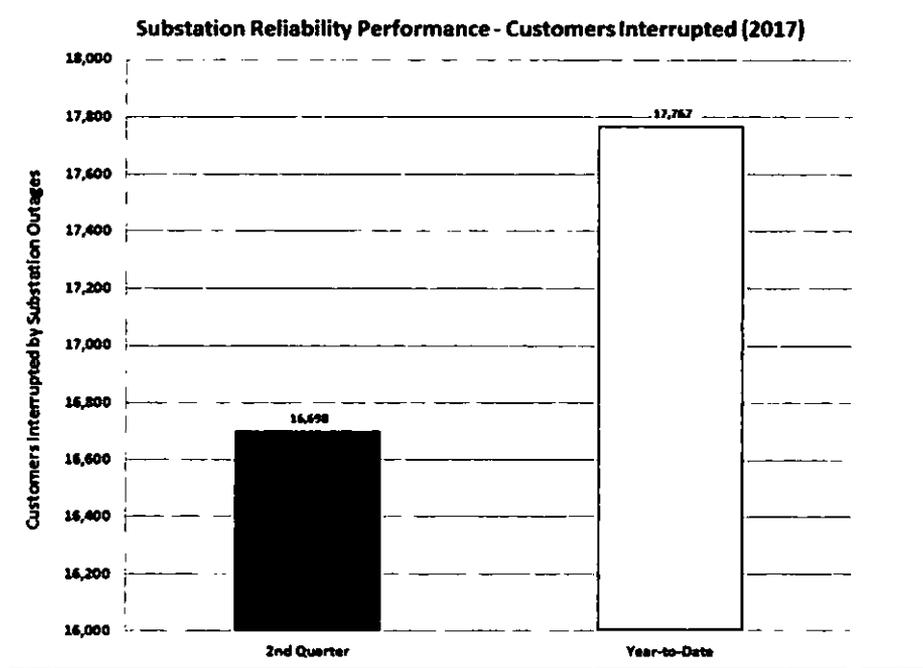
In the past three years, distribution substations have contributed a small amount toward the reliability metrics. During the second quarter of 2017, the company interrupted approximately 16,700 customers for a total of approximately 488,000 CMI. The figures below show these results for the number of customers interrupted and CMI experienced, respectively.

Figure 4: Substation Customers Interrupted for second quarter and year-to-date 2017

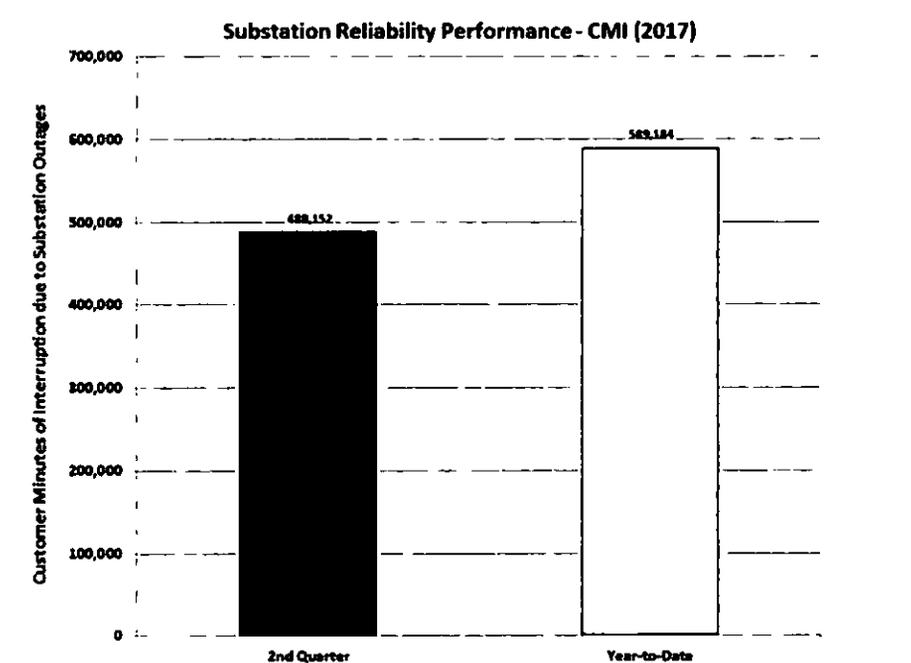
Figure 5: Substation Customer Minutes of Interruption for second quarter and year-to-date 2017
