**Re: PPL Electric Utilities Corporation  
Quarterly Reliability Report for the  
Period Ended December 31, 2017  
Docket No. ~~E-00030161~~**

**PPL Electric Utilities Corporation**  
**Quarterly Reliability Report**  
**to the**  
**Pennsylvania Public Utility Commission**

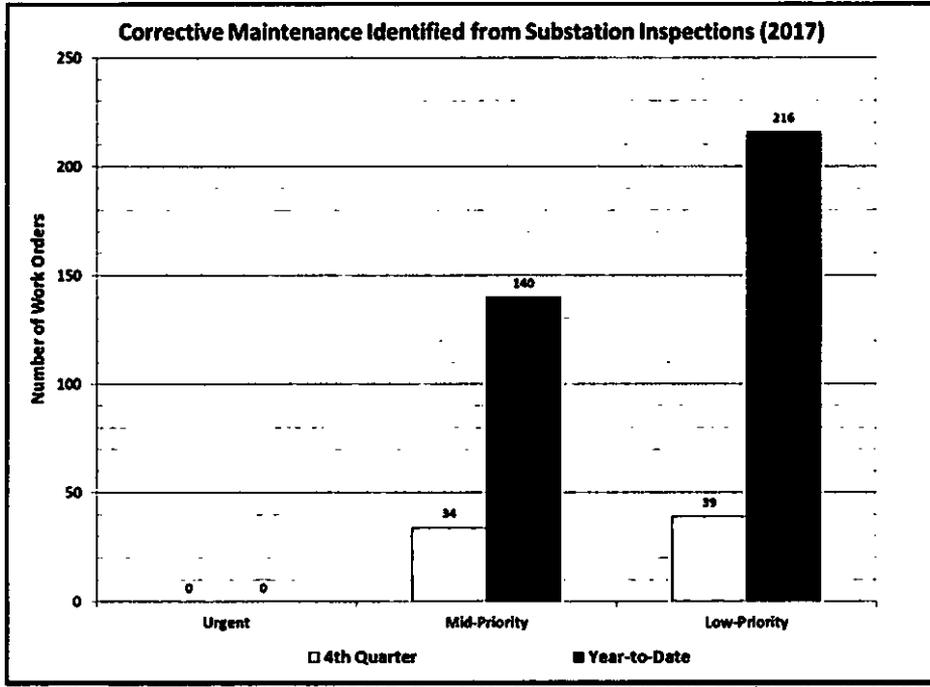
During the fourth quarter of 2017, 73 corrective work orders were created with the following breakdown by priority.

Figure 1: Corrective Maintenance Work Orders by Priority Level for fourth quarter and year-to-date 2017

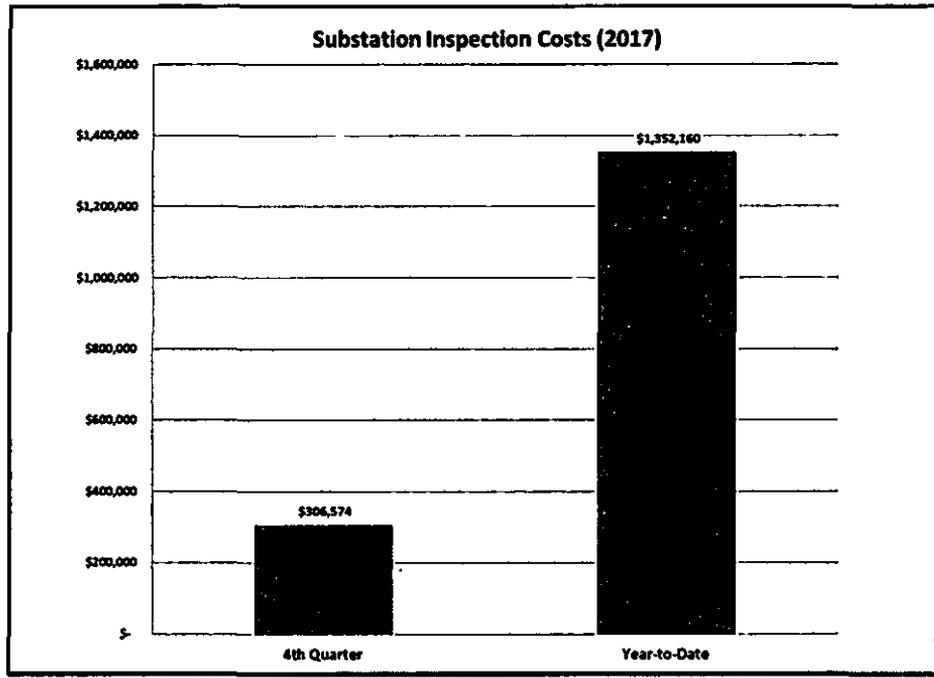
During the fourth quarter of 2017, PPL Electric spent approximately \$307,000 on substation inspections.

Figure 2: Substation Inspection Costs for third quarter and year-to-date 2017.

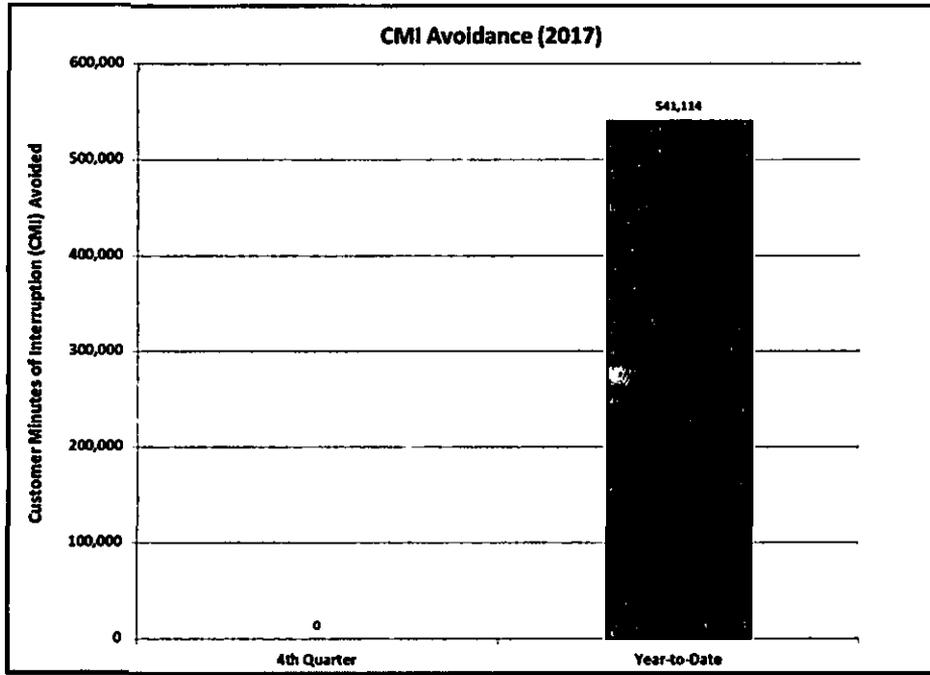
The figure below shows the amount that PPL Electric has the estimated CMI avoidance, for the fourth quarter and year-to-date. During fourth quarter of 2017, PPL Electric performed this follow-up work, but registered no potentially avoided CMI due to the low criticality of the work performed as a result of inspections

Figure 3: CMI Avoidance Due to Inspections for fourth quarter and year-to-date 2017

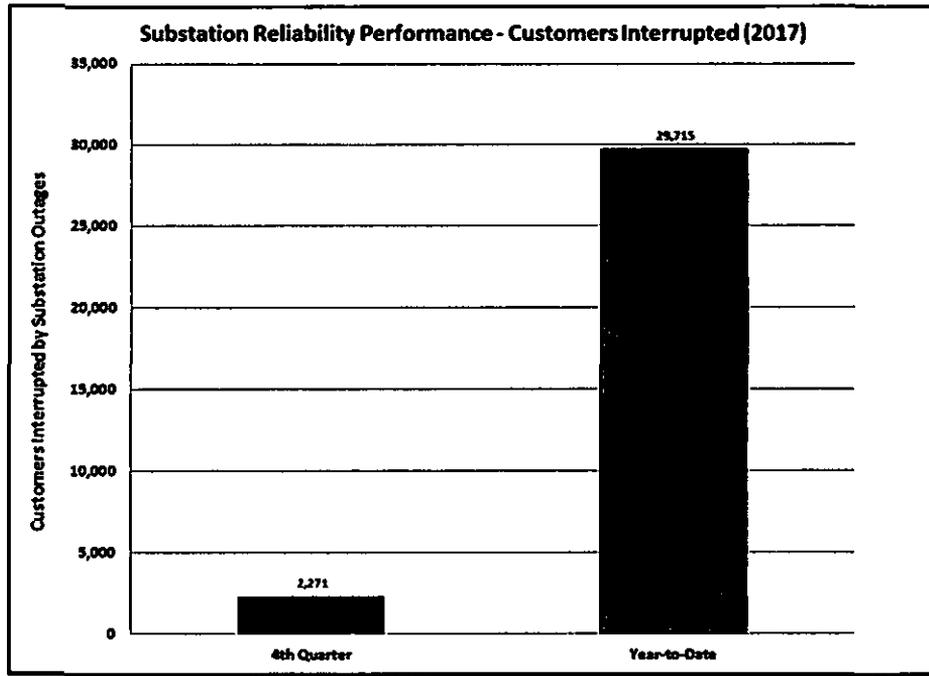
In the past three years, distribution substations have contributed a small amount toward the reliability metrics. During the fourth quarter of 2017, the Company interrupted about 2,271 customers for a total of approximately 269K CMI. The figures below show these results for the number of customers interrupted and CMI experienced, respectively.

Figure 4: Substation Customers Interrupted for fourth quarter and year-to-date 2017

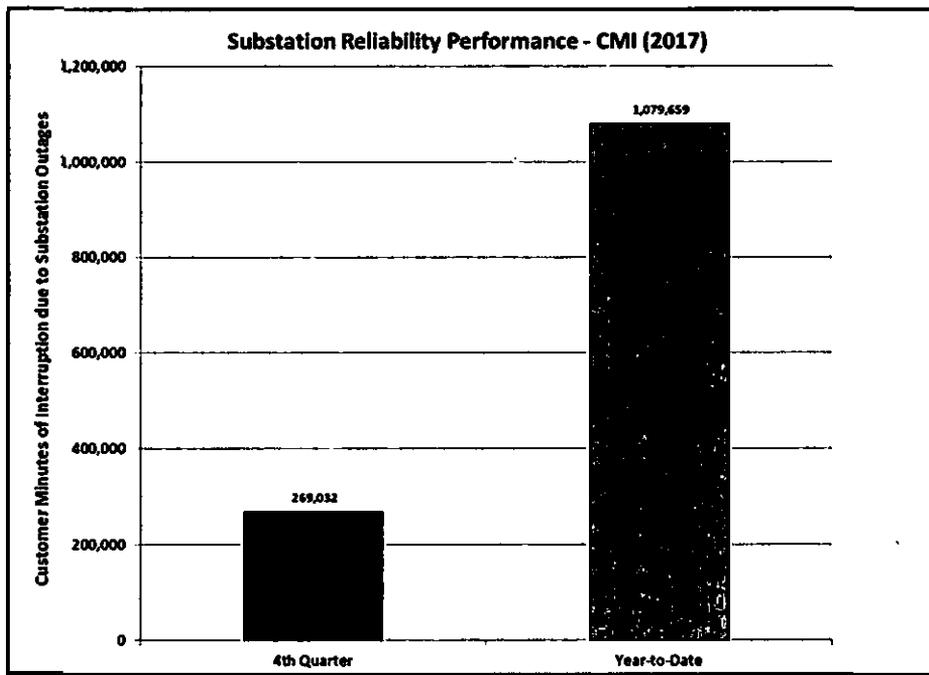
Figure 5: Substation Customer Minutes of Interruption for fourth quarter and year-to-date 2017
