**Re: PPL Electric Utilities Corporation
Quarterly Reliability Report for the
Period Ended June 30, 2018
Docket No. L-00030161**

PPL Electric Utilities Corporation
Quarterly Reliability Report
to the
Pennsylvania Public Utility Commission

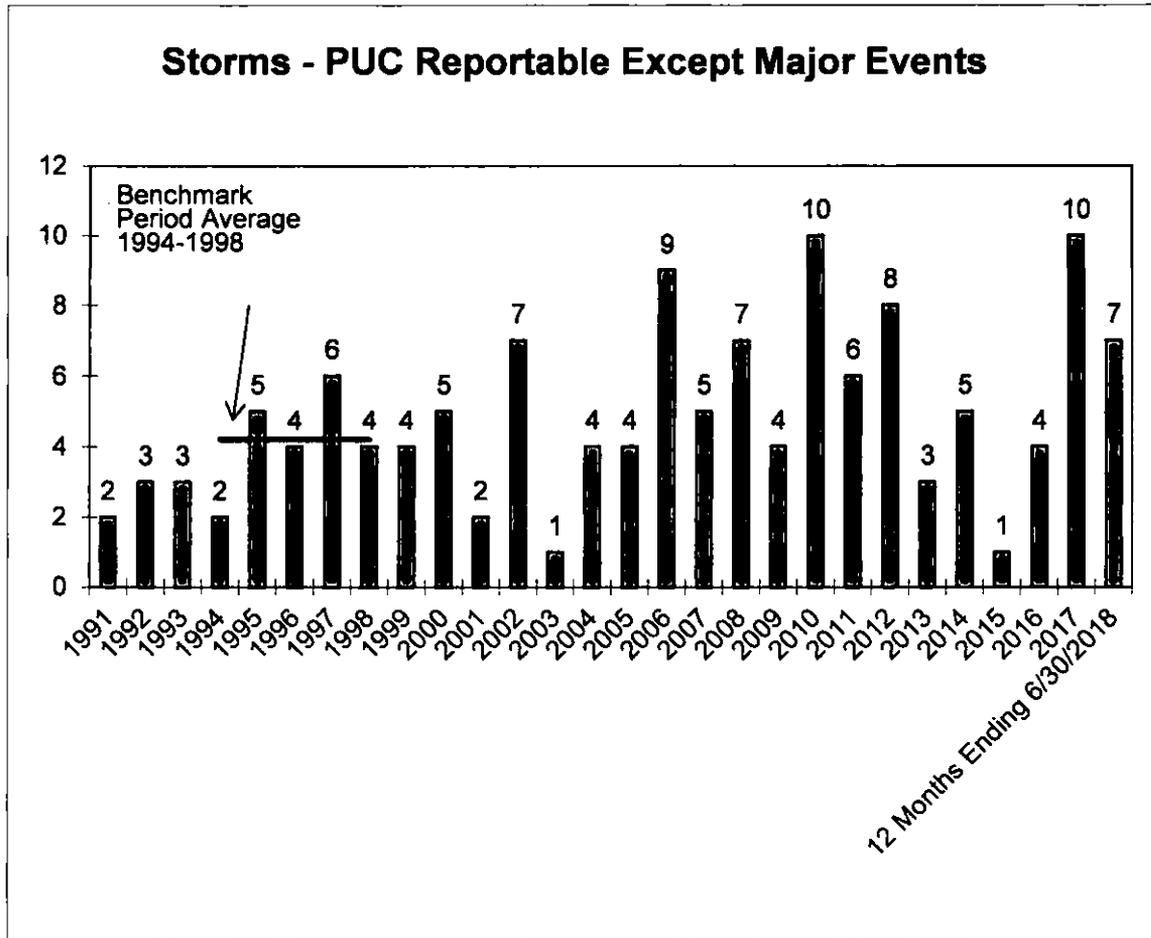
During the 12-month reporting period, there was one (1) PUC major events and seven (7) PUC-reportable storms other than major events.

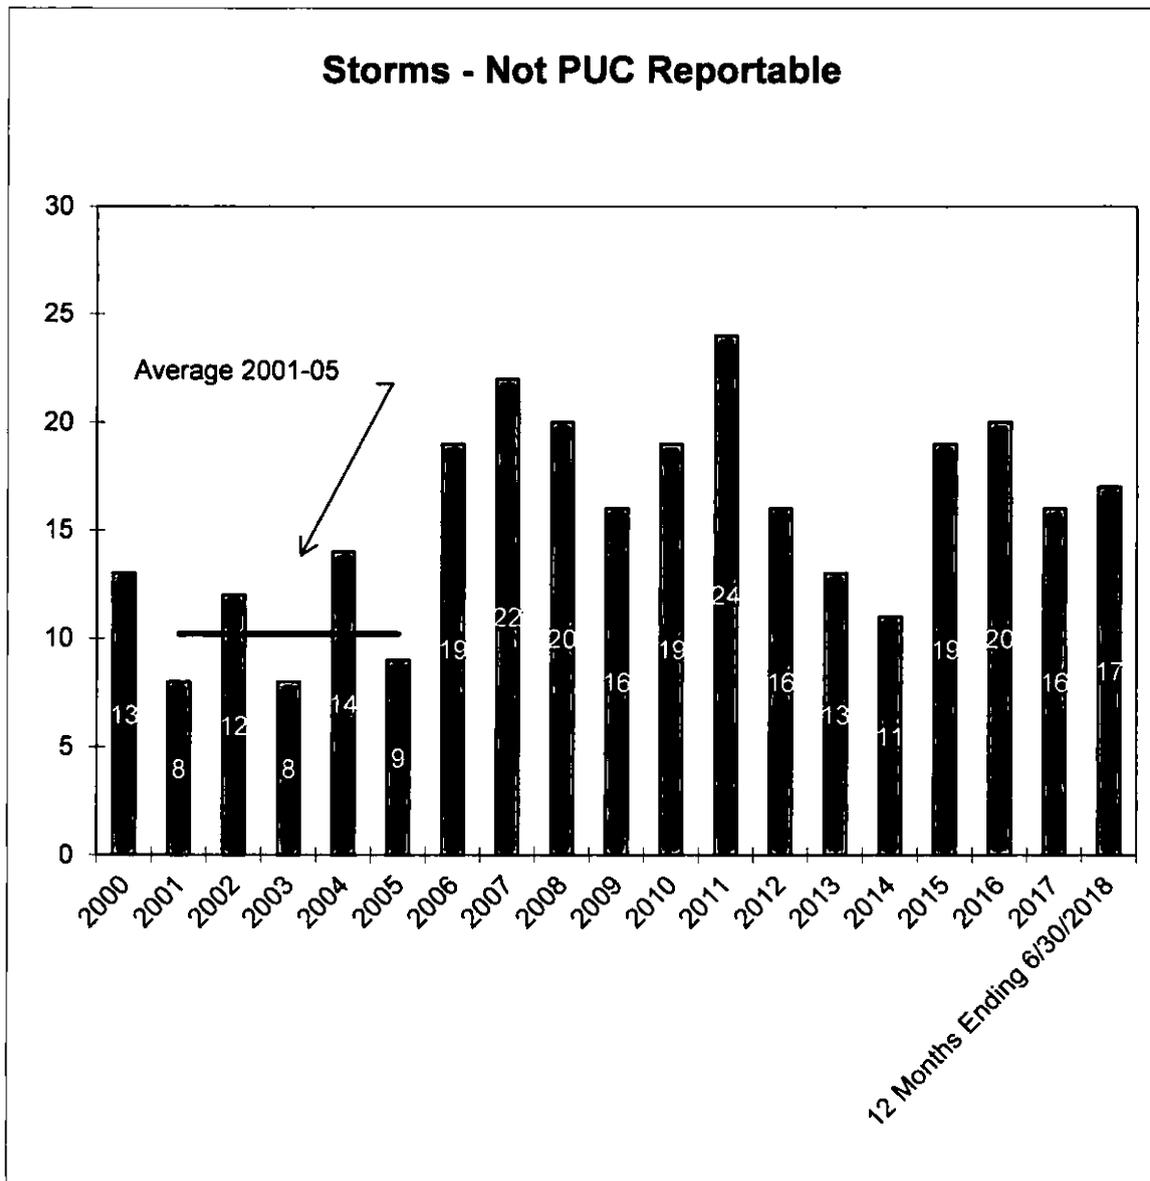
In addition, there were seventeen (17) storms that were not reportable, but which did require the opening of one or more area emergency centers to manage restoration efforts.

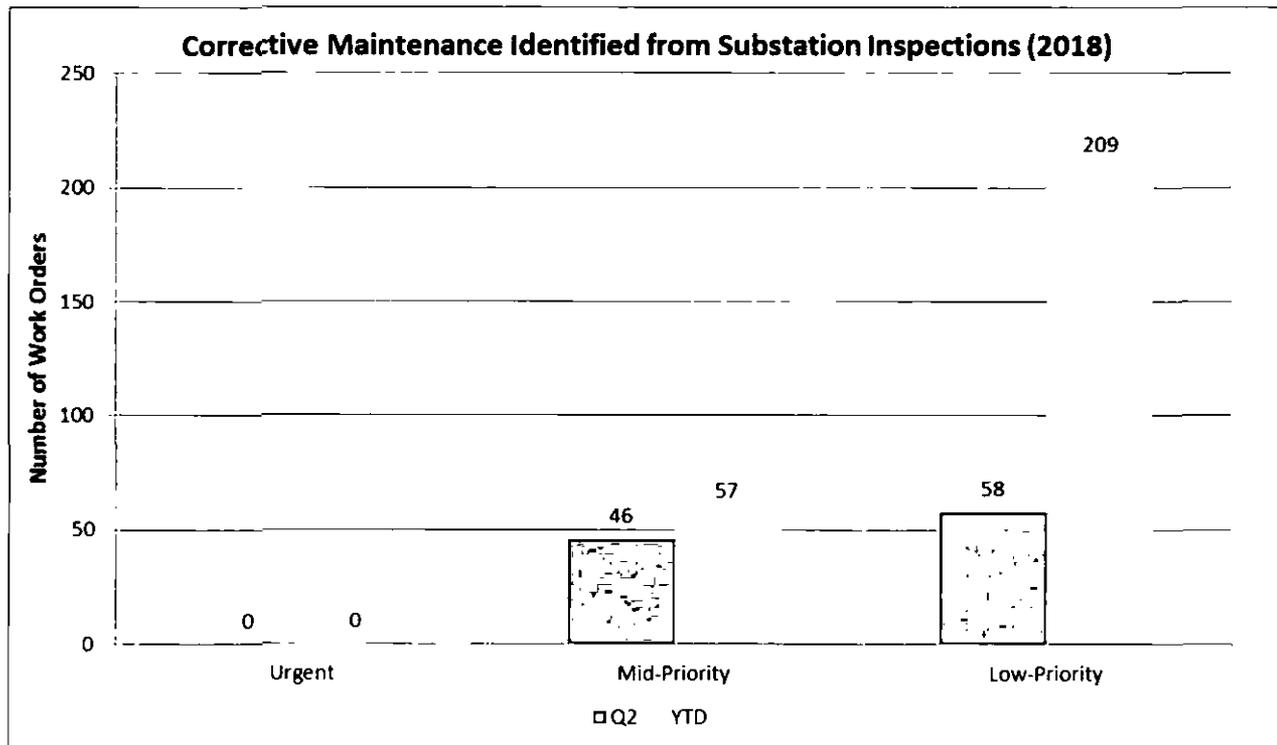
During the second quarter of 2018, 104 corrective work orders were created with the following breakdown by priority.

Figure 1: Corrective Maintenance Work Orders by Priority Level for second quarter and year-to-date 2018

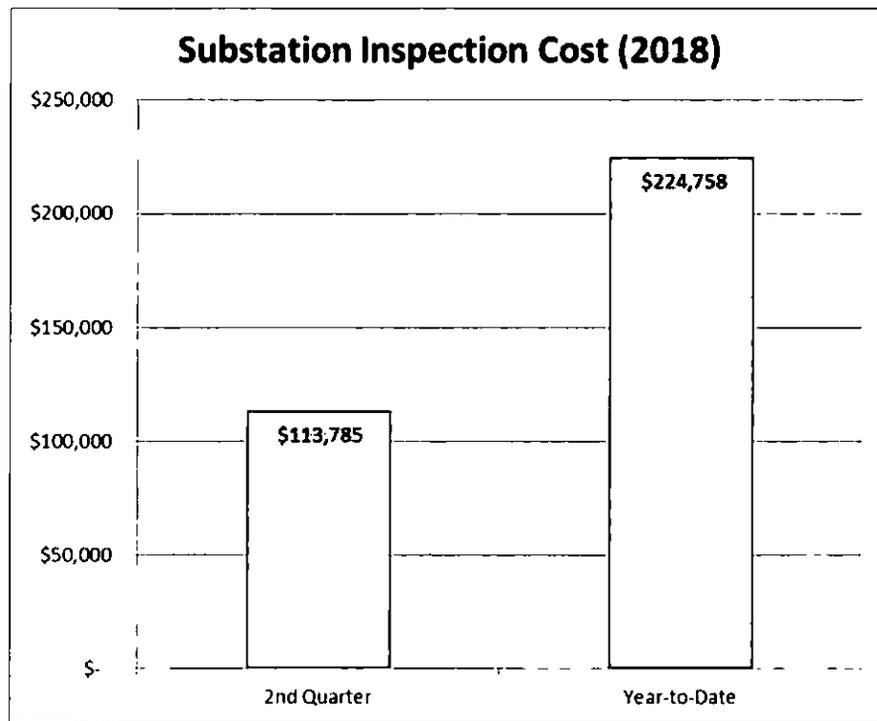
During the second quarter of 2018, PPL Electric spent approximately \$114,000 on substation inspections.

Figure 2: Substation Inspection Costs for second quarter and year-to-date 2018.

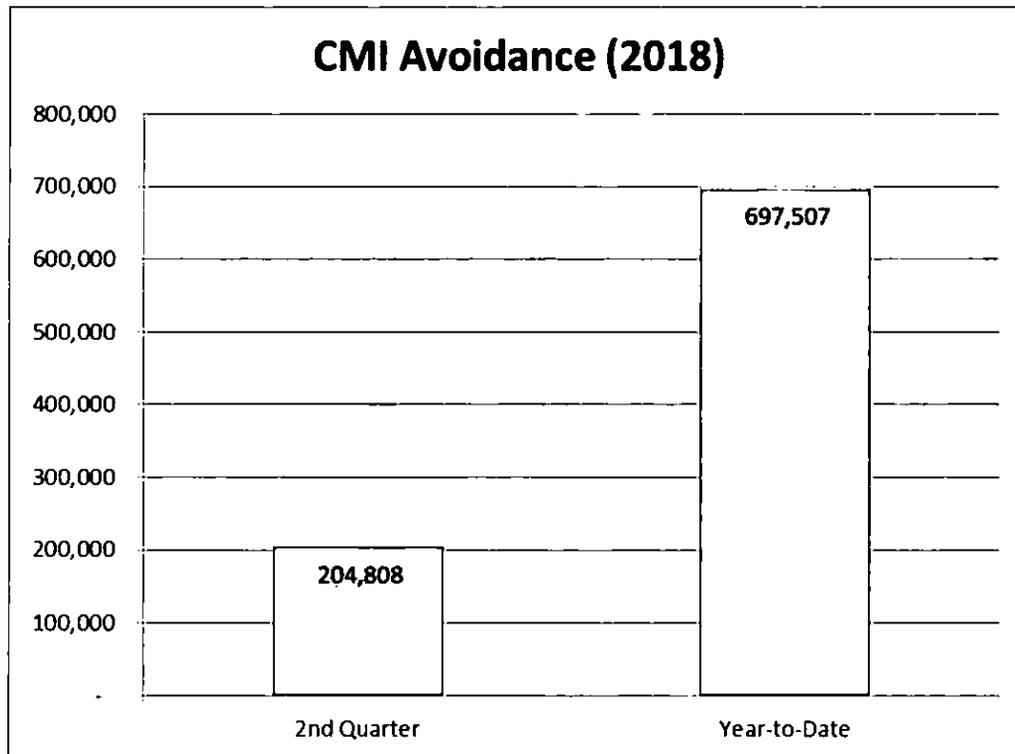
The figure below shows the amount of CMI avoidance that PPL Electric has estimated for the second quarter and year-to-date. During second quarter of 2018, PPL Electric avoided a projected 205,000 CMI.

Figure 3: CMI Avoidance Due to Inspections for second quarter and year-to-date 2018

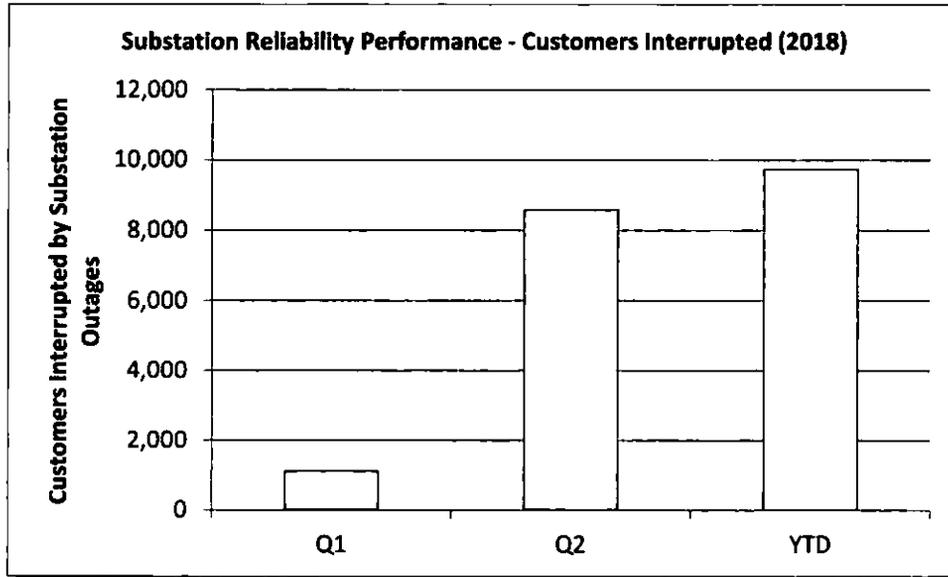
In the past three years, distribution substations have contributed a small amount toward the reliability metrics. During the second quarter of 2018, the Company interrupted about 8,615 customers for a total of approximately 258,000 CMI. The figures below show these results for the number of customers interrupted and CMI experienced, respectively.

Figure 4: Substation Customers Interrupted for second quarter and year-to-date 2018

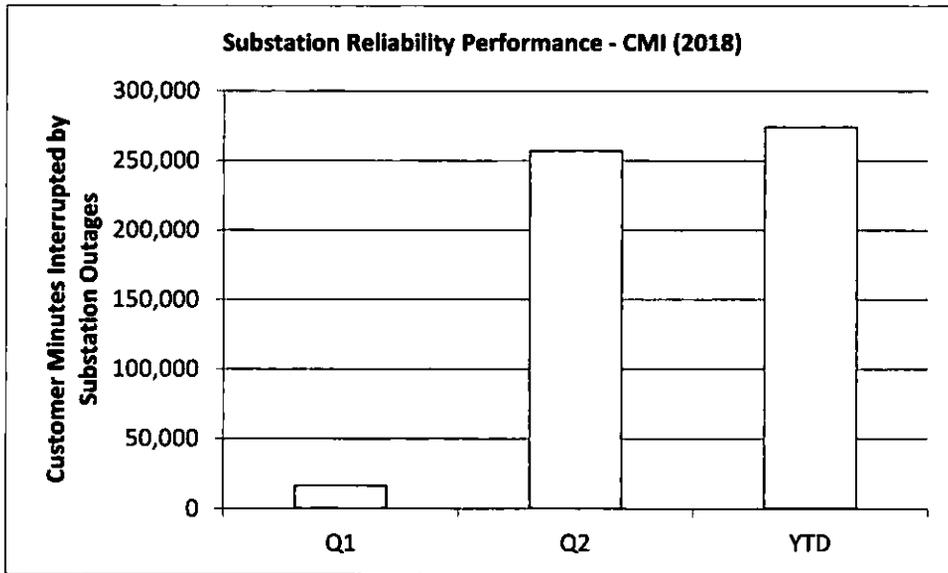
Figure 5: Substation Customer Minutes of Interruption for second quarter and year-to-date 2018
