**Re: PPL Electric Utilities Corporation
Quarterly Reliability Report for the
Period Ended September 30, 2018
Docket No. L-00030161**

PPL Electric Utilities Corporation
Quarterly Reliability Report
to the
Pennsylvania Public Utility Commission

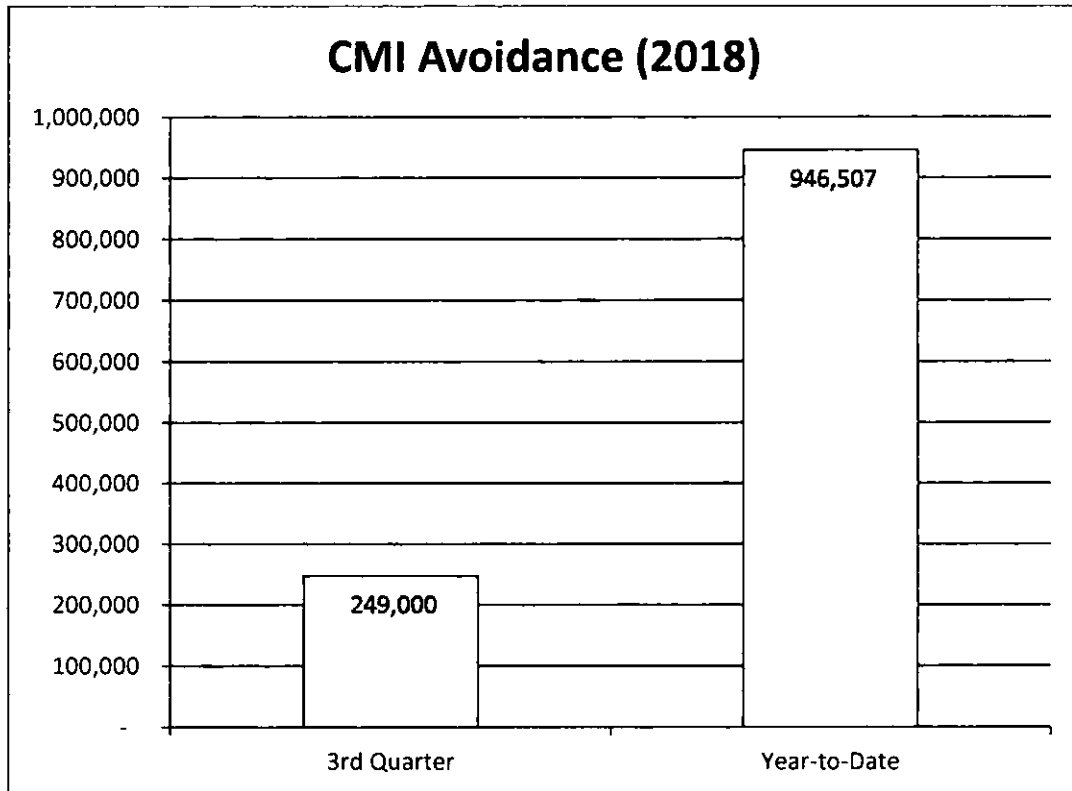
The figure below shows the amount of CMI avoidance that PPL Electric has estimated for the third quarter and year-to-date. During third quarter of 2018, PPL Electric avoided a projected 249,000 CMI.

Figure 3: CMI Avoidance Due to Inspections for third quarter and year-to-date 2018

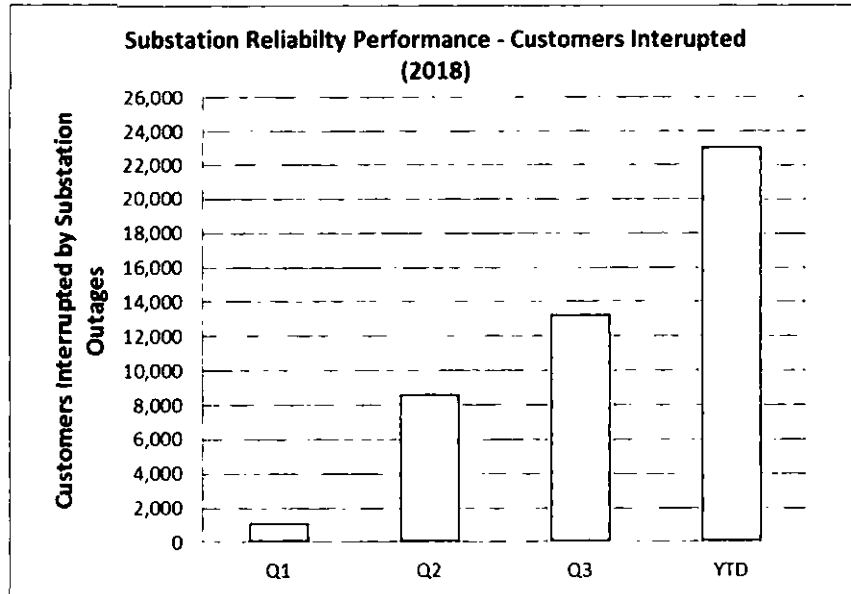
In the past three years, distribution substations have contributed a small amount toward the reliability metrics. During the third quarter of 2018, the Company interrupted about 13,276 customers for a total of approximately 501,000 CMI. The figures below show these results for the number of customers interrupted and CMI experienced, respectively.

Figure 4: Substation Customers Interrupted for third quarter and year-to-date 2018
