**Re: PPL Electric Utilities Corporation
Quarterly Reliability Report for the
Period Ended December 31, 2018
Docket No. M-2016-2522508**

PPL Electric Utilities Corporation
Quarterly Reliability Report
to the
Pennsylvania Public Utility Commission

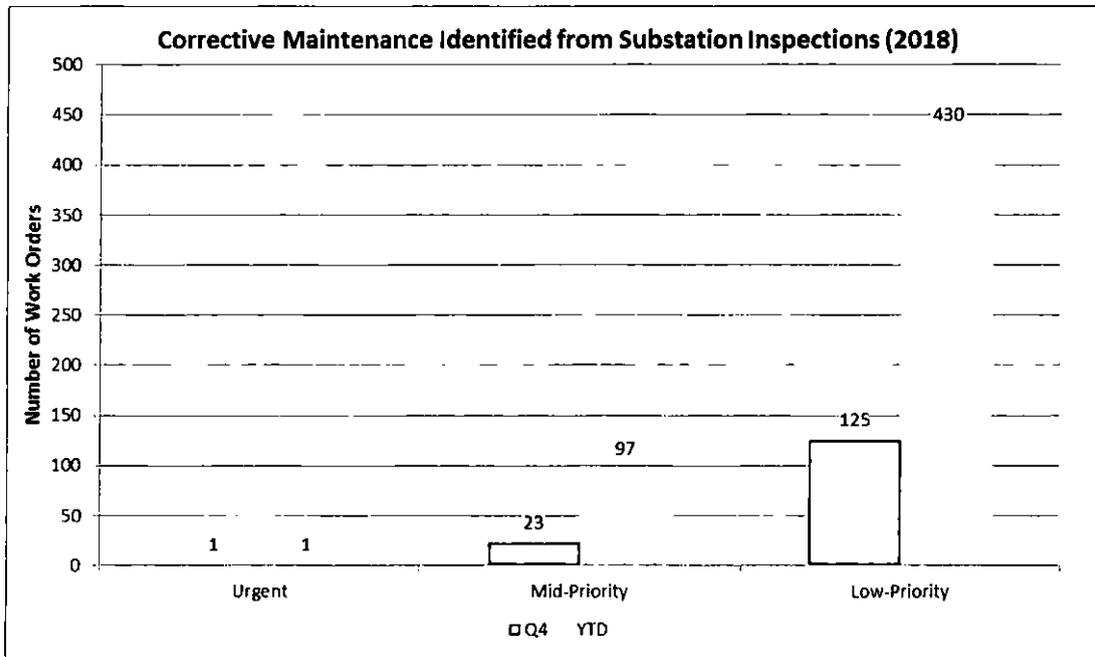
During the fourth quarter of 2018, 149 corrective work orders were created with the following breakdown by priority.

Figure 1: Corrective Maintenance Work Orders by Priority Level for fourth quarter and year-to-date 2018

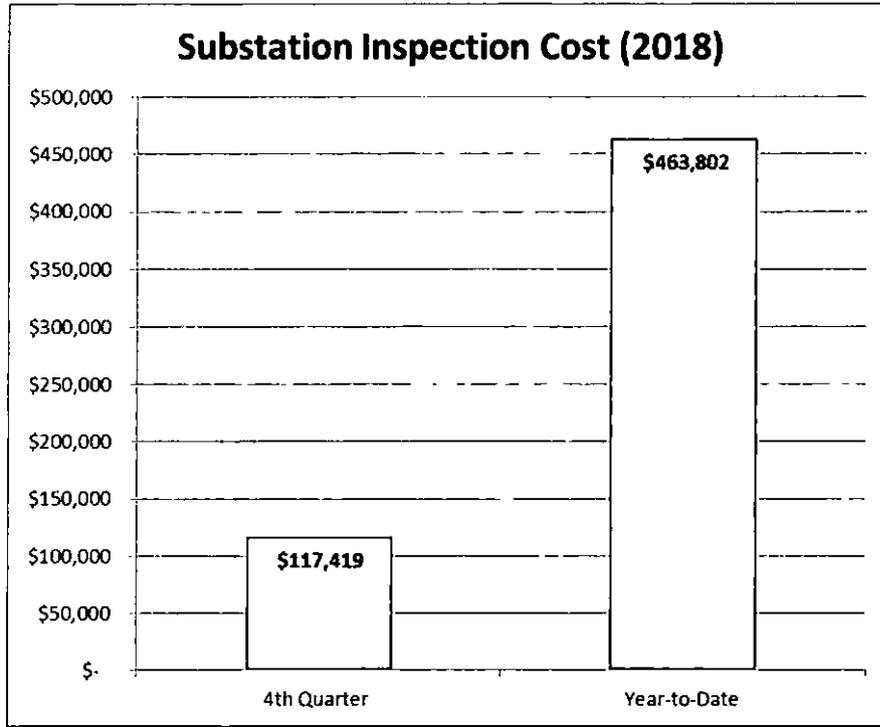
During the fourth quarter of 2018, PPL Electric spent approximately \$117,000 on substation inspections.

Figure 2: Substation Inspection Costs for fourth quarter and year-to-date 2018.

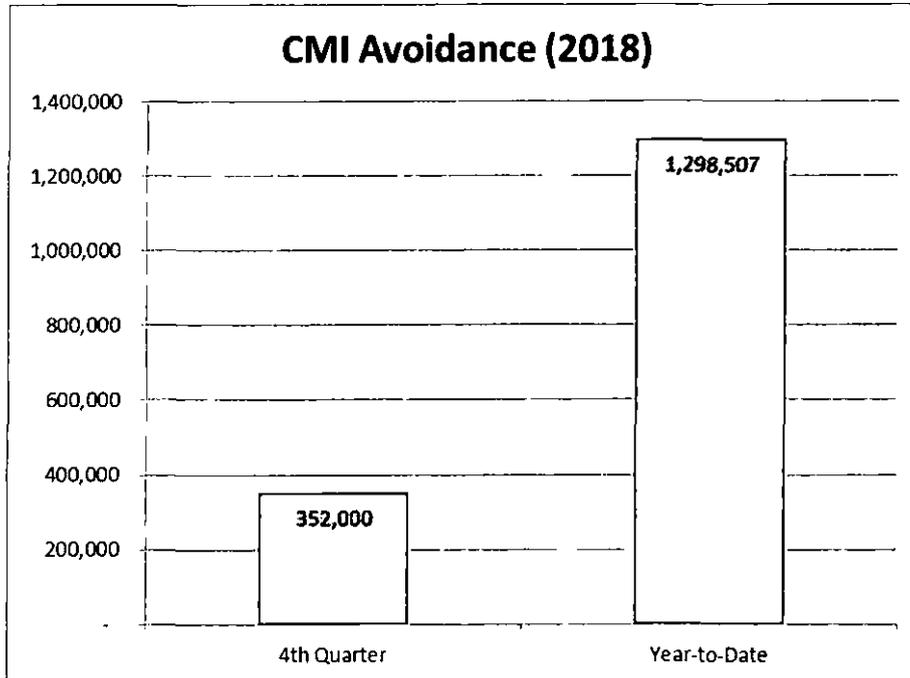
The figure below shows the amount of CMI avoidance that PPL Electric has estimated for the fourth quarter and year-to-date. During fourth quarter of 2018, PPL Electric avoided a projected 352,000 CMI.

Figure 3: CMI Avoidance Due to Inspections for fourth quarter and year-to-date 2018

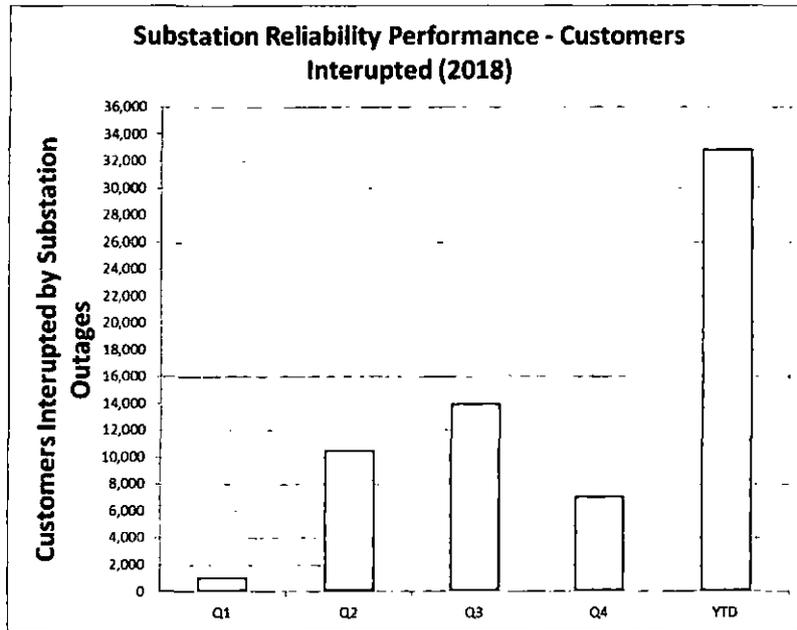
In the past three years, distribution substations have contributed a small amount toward the reliability metrics. During the fourth quarter of 2018, the Company interrupted about 7,158 customers for a total of approximately 84,716 CMI. The figures below show these results for the number of customers interrupted and CMI experienced, respectively.

Figure 4: Substation Customers Interrupted for fourth quarter and year-to-date 2018

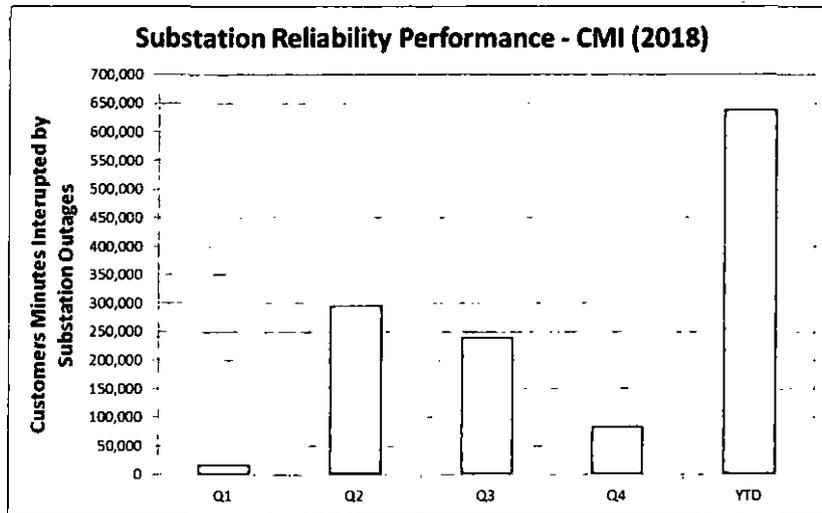
Figure 5: Substation Customer Minutes of Interruption for fourth quarter and year-to-date 2018
