**PPL**  
Two North Ninth Street  
Allentown, PA 18101-1179  
Tel. 610.774.5696 Fax 610.774.6726  
AEHirakis@pplweb.com

**Re: PPL Electric Utilities Corporation  
Quarterly Reliability Report for the  
Period Ended March 31, 2019  
Docket No. M-2016-2522508**

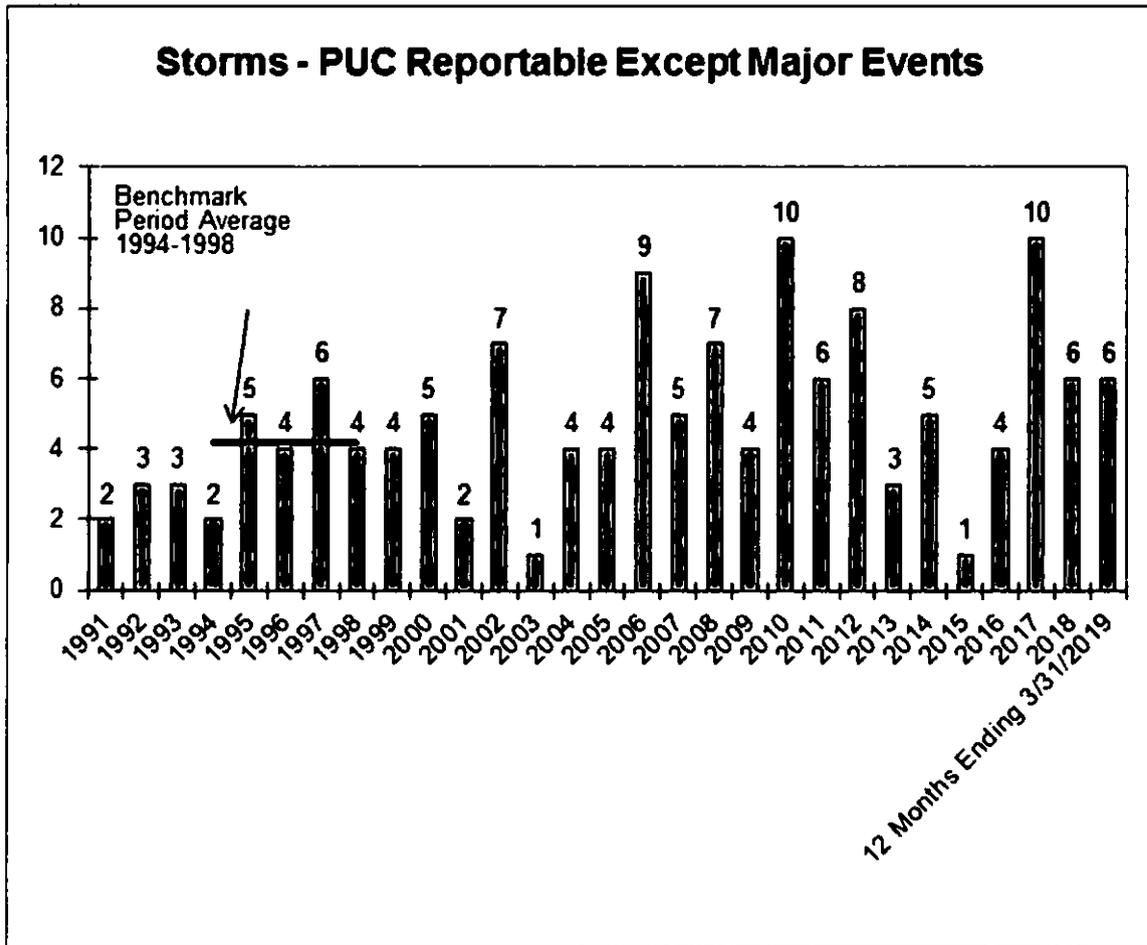
During the 12-month reporting period, there were no (0) PUC major events and six (6) PUC-reportable storms.

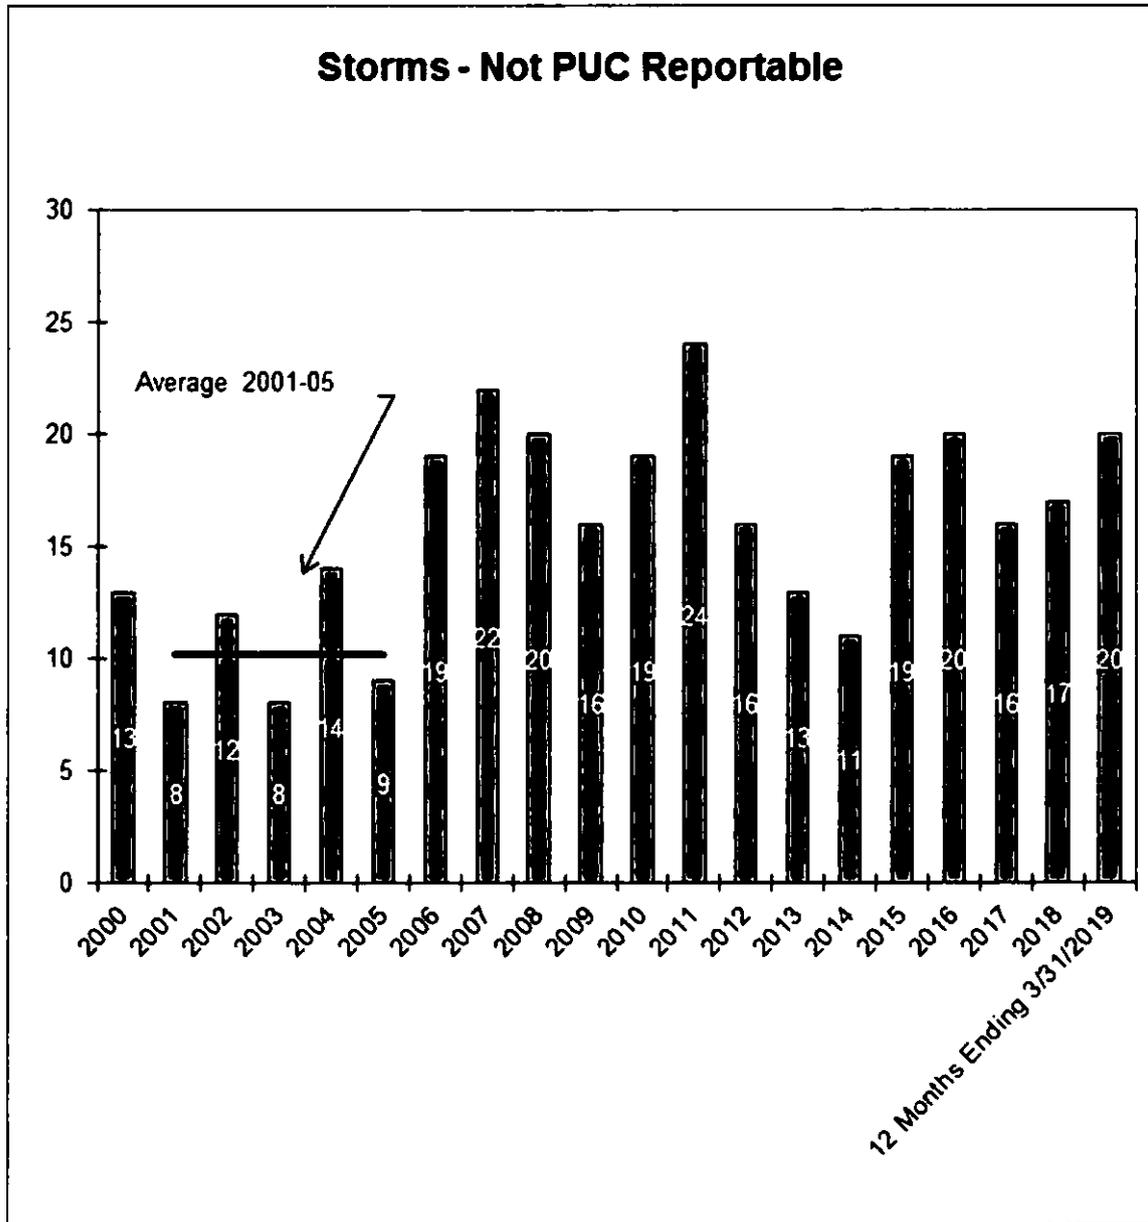
In addition, there were twenty (20) storms that were not reportable, but which did require the opening of one or more area emergency centers to manage restoration efforts.

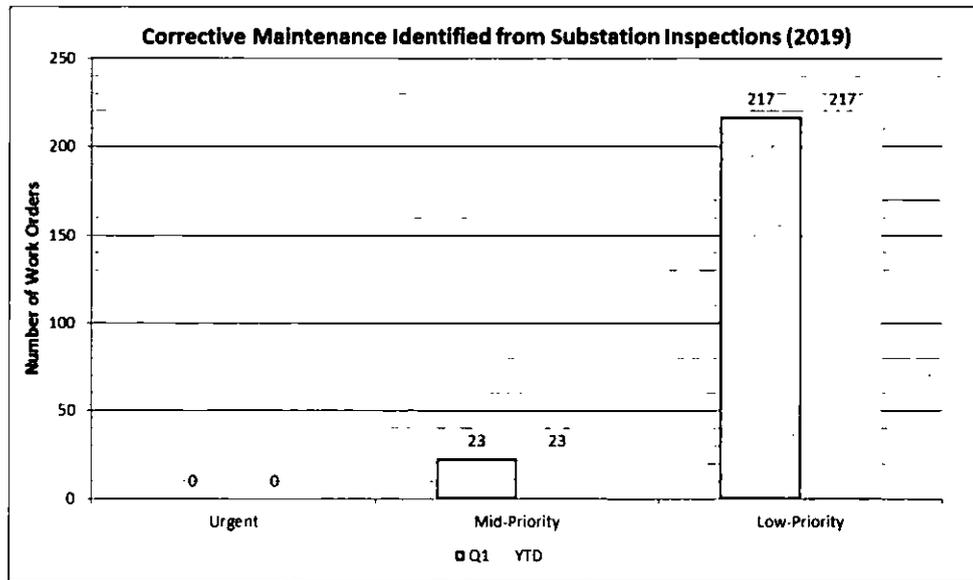
During the first quarter of 2019, 217 corrective work orders were created with the following breakdown by priority.

Figure 1: Corrective Maintenance Work Orders by Priority Level for first quarter and year-to-date 2019

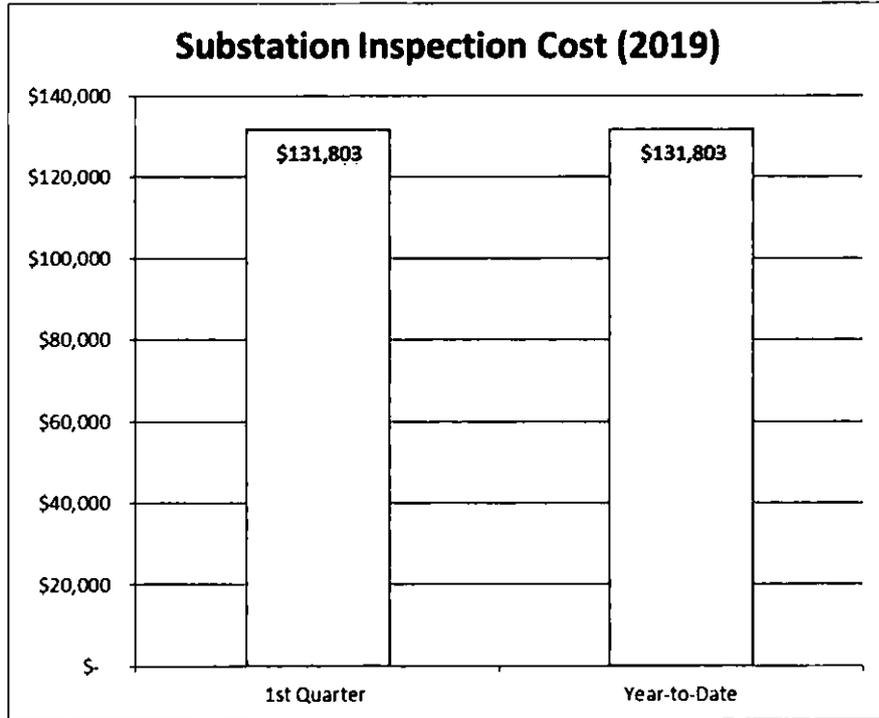
During the first quarter of 2019, PPL Electric spent approximately \$132,000 on substation inspections.

Figure 2: Substation Inspection Costs for first quarter and year-to-date 2019.

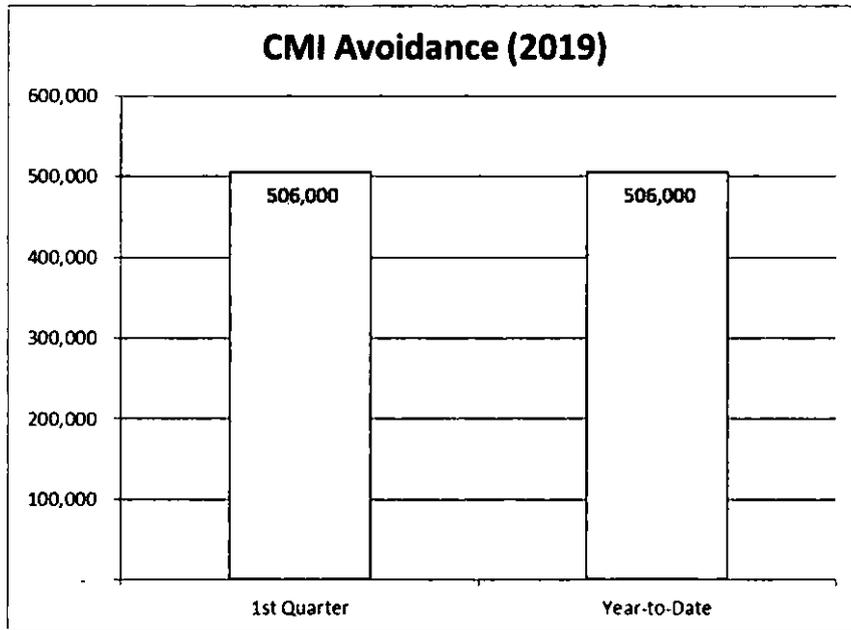
The figure below shows the amount of CMI avoidance that PPL Electric has estimated for the first quarter and year-to-date. During first quarter of 2019, PPL Electric avoided a projected 506,000 CMI.

**Figure 3: CMI Avoidance Due to Inspections for first quarter and year-to-date 2019**

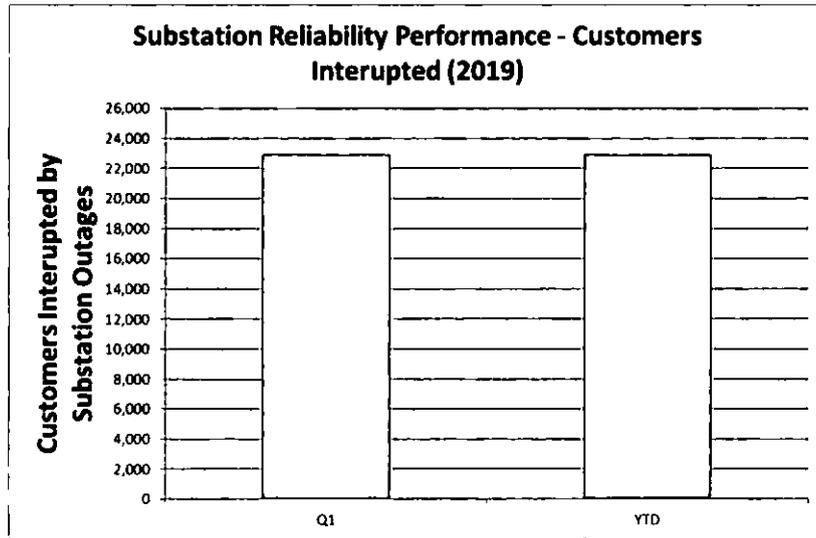
In the past three years, distribution substations have contributed a small amount toward the reliability metrics. During the first quarter of 2019, the Company interrupted about 22,935 customers for a total of approximately 989,431CMI. The figures below show these results for the number of customers interrupted and CMI experienced, respectively.

Figure 4: Substation Customers Interrupted for first quarter and year-to-date 2019

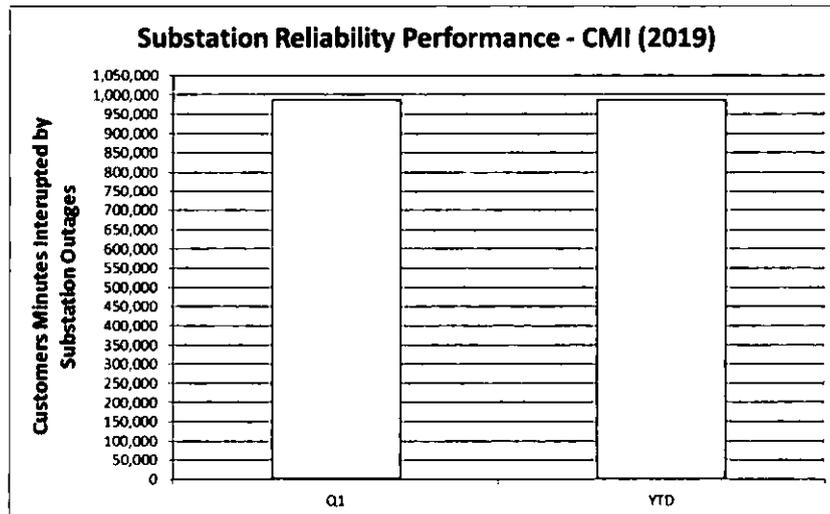
Figure 5: Substation Customer Minutes of Interruption for first quarter and year-to-date 2019
