**Re: PPL Electric Utilities Corporation
Quarterly Reliability Report for the
Period Ended June 30, 2019
Docket No. M-2016-2522508**

PPL Electric Utilities

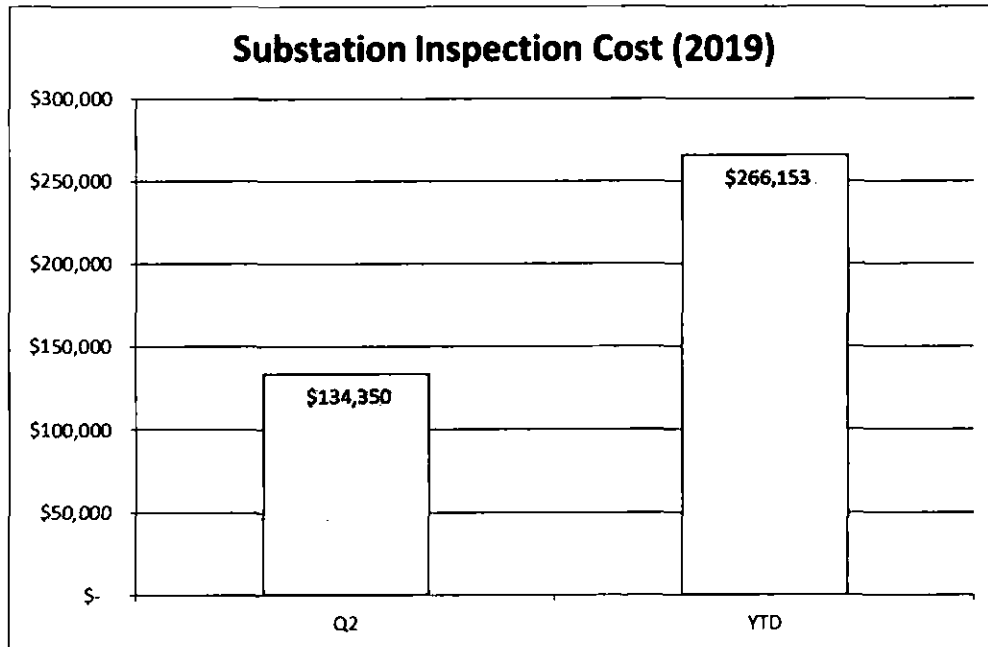
During the second quarter of 2019, PPL Electric spent approximately \$134,000 on substation inspections.

Figure 2: Substation Inspection Costs for second quarter and year-to-date 2019.

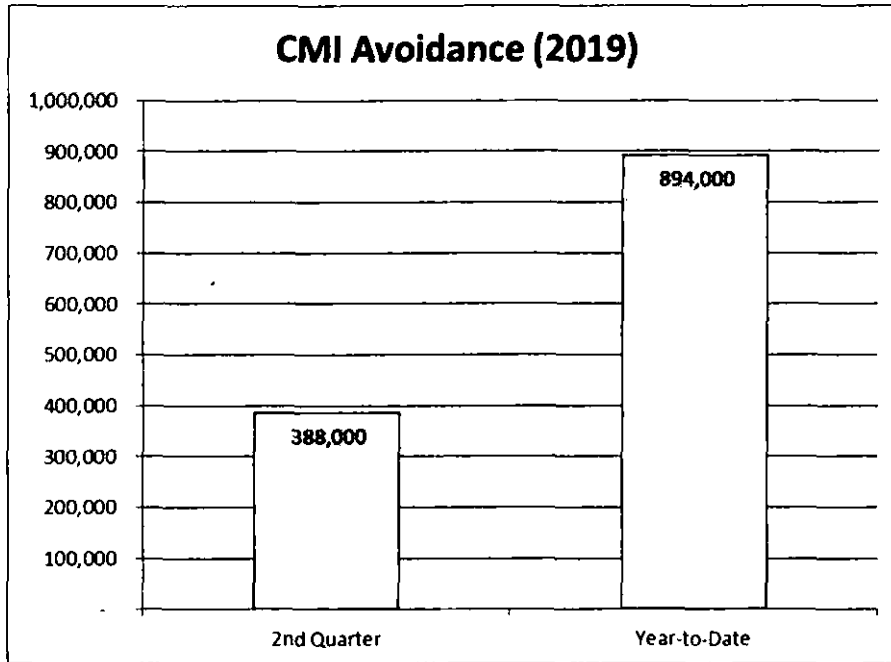
The figure below shows the amount of CMI avoidance that PPL Electric has estimated for the second quarter and year-to-date. During second quarter of 2019, PPL Electric avoided a projected 388,000 CMI.

Figure 3: CMI Avoidance Due to Inspections for second quarter and year-to-date 2019
